Safety Inspection Report

Annual Inspection

Clear Crescent Play Area

Melbourn Parish Council

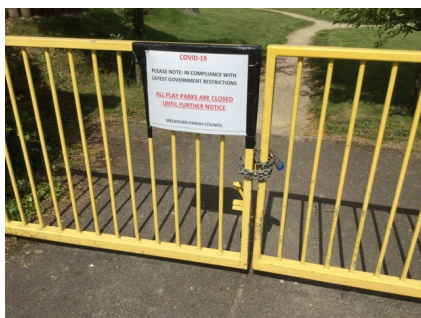
We know that children will be using playgrounds when they shouldn't be. It is important that we continue to undertake our safety inspections so that playgrounds are safe now and when they reopen to the public. We access playgrounds using ladders and other techniques. We will undertake a risk assessment to ensure that we have suitable control measures in place to protect ourselves and members of the public. If we have been unable to gain access this will be noted in our report, but otherwise a full and effective inspection has been undertaken.

Read the notes for further action.

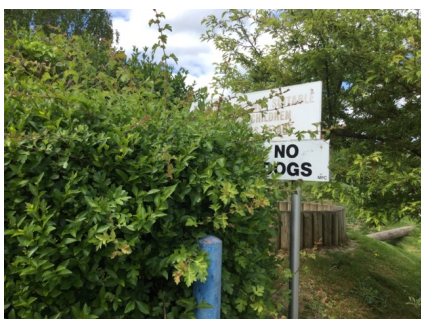
Vegetation obstructing sign or causing hazard.

Both signs are in readable due to location - either cut back the hedge or re-locate signs.

Remove.

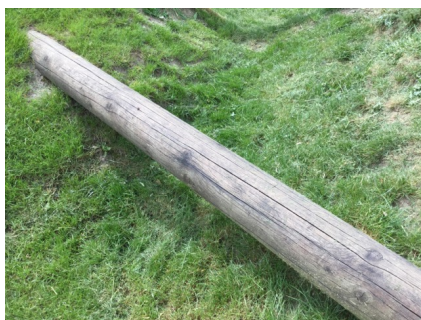
The timber components are slippery.

Log balance beams slippery.

Remove slipperiness. Consider adding surface texture.

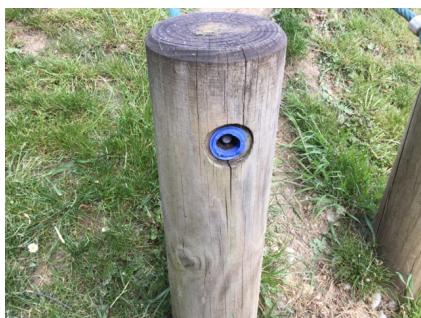
Bolt cap damaged.

Replace.

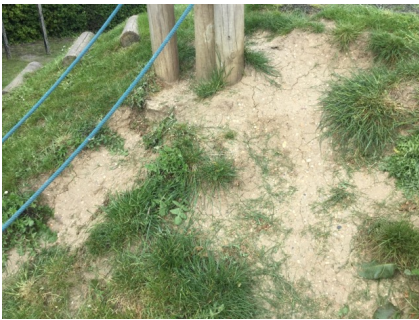
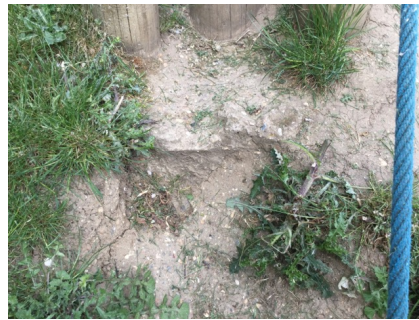
Ground erosion present.

Foundations exposed - reinstate mound.

Repair the worn areas.

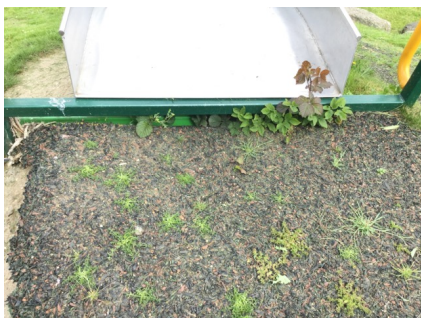
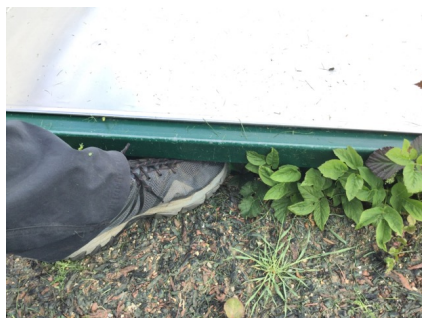
Surface needs repair.

Surfacing shrunk at top of embankment at entrance to slide, creating a potential entrapment.

Repair.

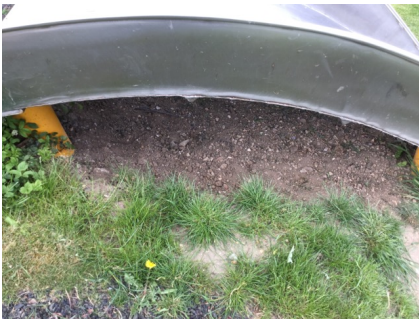
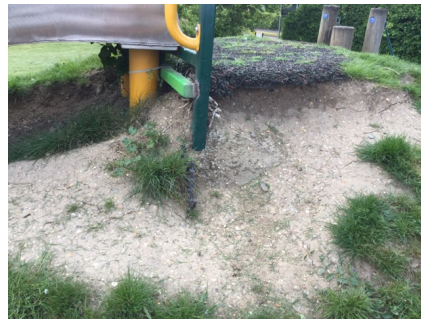
Worn ground areas.

Build up ground levels to remove trip hazard.

Build up area while playground is closed off to the public.

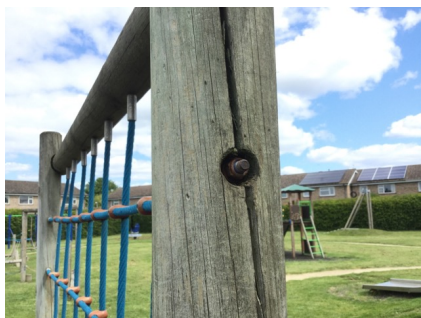
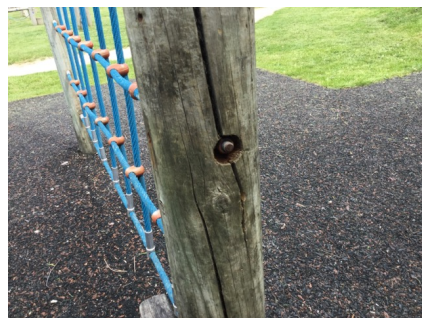
Cap missing.

Replace.

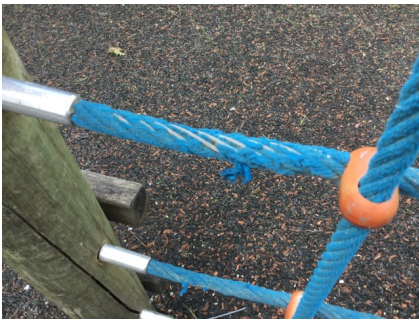
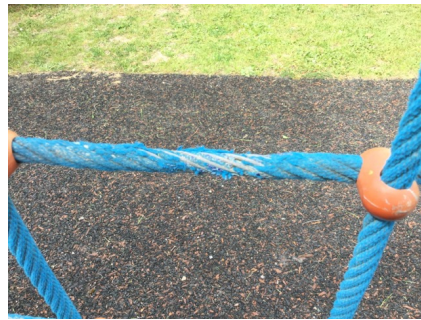
The core of the wire is exposed.

Replace net when wire is broken.

No reasonably practicable action is identified.

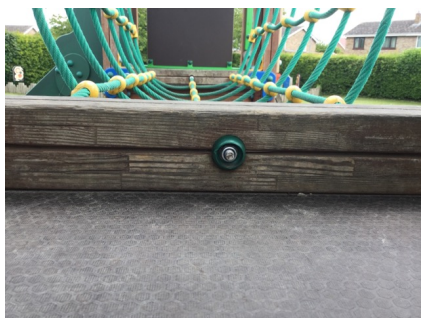
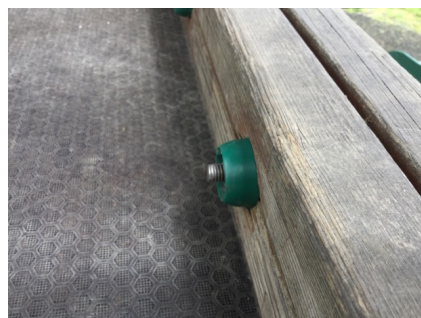
Cap missing.

Cap plug missing exposing the thread - replace.

Replace.

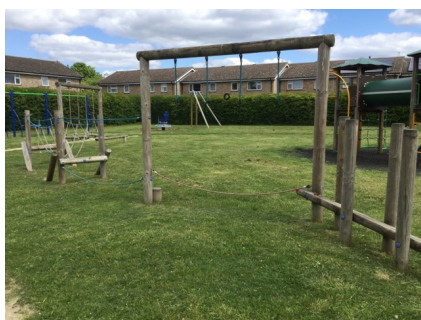
This equipment relies on one post for its stability. Special attention should be paid to maintenance (e.g. by monitoring degradation) and if necessary decommissioning the item before the end of its operating life.

Consult with the manufacturer's guidance to determine suitable maintenance.

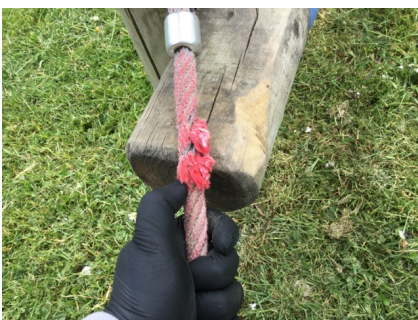
The rope is rubbing on the balance beam and wearing down to the wire - monitor for broken wires and replace if found.

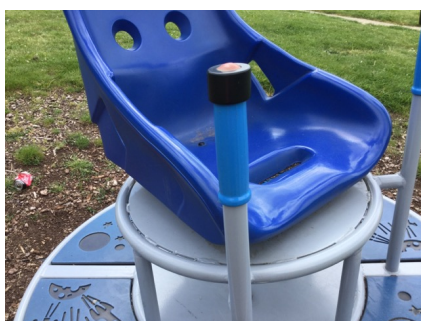
The seat has water inside its frame - contact the manufacturer for their recommendations.

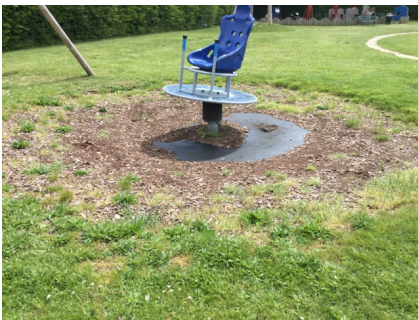
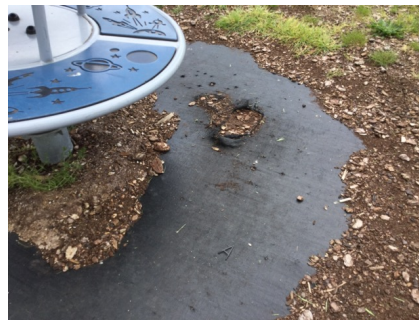
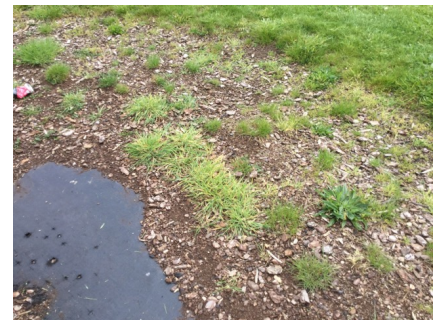
Surface needs repair.

The surfacing has worn away exposing and damaging the liner beneath. Grass & weeds have grown inside. The plastic edging strips are sharp. The whole area requires immediate repairs and alterations.

Repair.

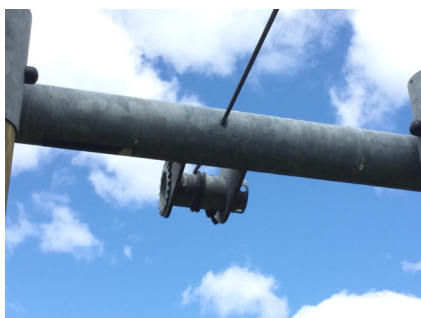
Where the cable enters into a tube, top bar or similar it is not possible to determine its condition, therefore this is excluded from our inspection. It is vital that the operator arranges to dismantle the unit to inspect the full length of the cable for any corrosion, wear or damage.

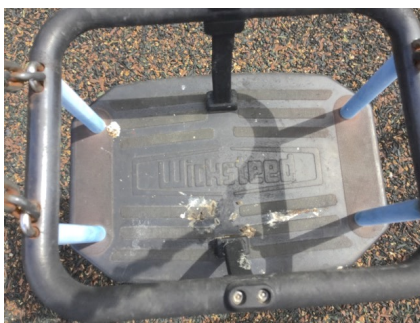
It is recommended that playground equipment be regularly checked for bird fouling - if found, the affected items should be cleaned with a disinfectant solution.

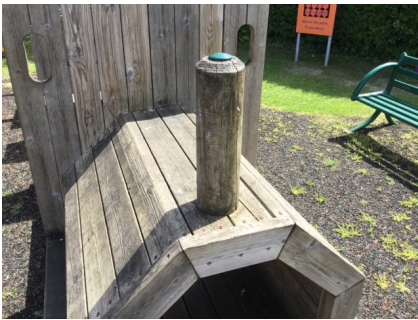
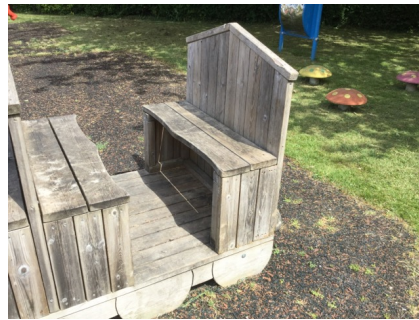
Fixtures loose or missing.

Exhaust loose to tunnel and seat rest panels loose - secure.

Tighten/replace.

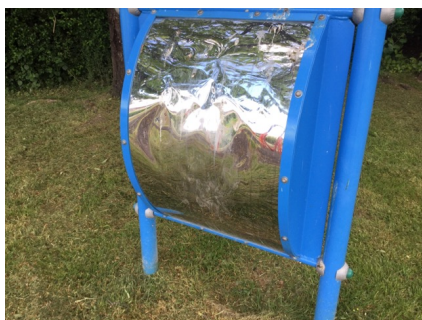
Mirror bent - monitor for splits / cracks, replace if found.

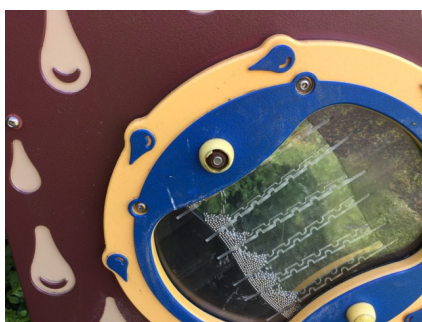
Bolt cap damaged.

Replace.
