Safety Inspection Report

Annual Inspection

Clear Crescent Play Area

21 April 2021

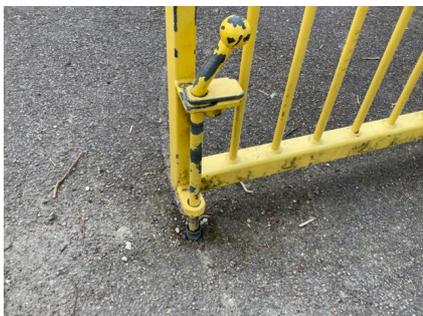
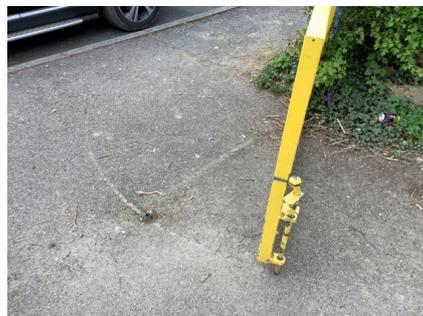
Gates - Combination

The item is unlocked.

The maintenance gate is not locked and could be opened by the public.

Lock.

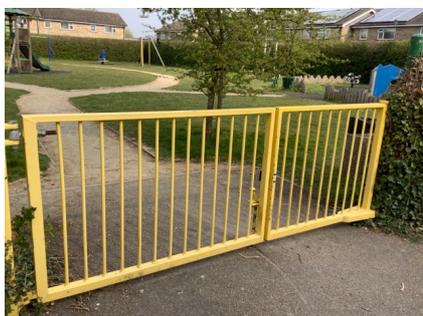
Signage

Dog ban & ownership signs recommended.

Operator signs should be installed at each entrance with the correct information on them, operator's name and contact number etc. - please see link attached. www.rospa.com/Play-Safety/Advice/Signs.aspx

See <https://www.rospa.com/en/Play-Safety/Advice/Signs>

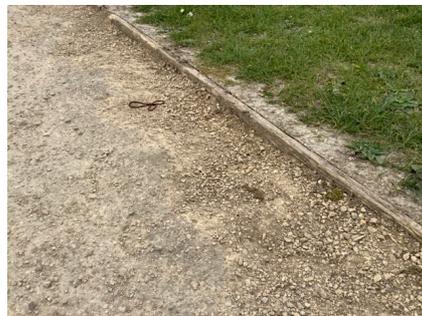
Pathways

Surface is wearing.

Surface wearing and creating a trip point around the edgings.

Repair.

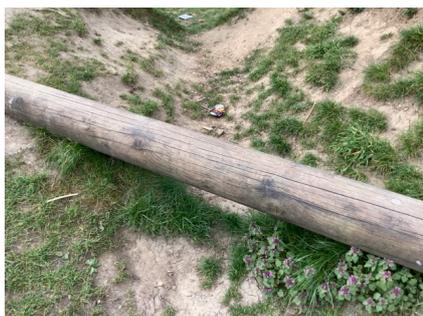
Log Stockade - With Balance Logs

The timber components are slippery.

Log balance beams slippery when wet.

Remove slipperiness. Consider adding surface texture.

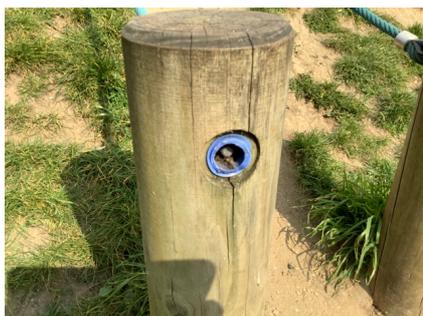
Rope Balance - Embankment

Bolt cap damaged.

Replace.

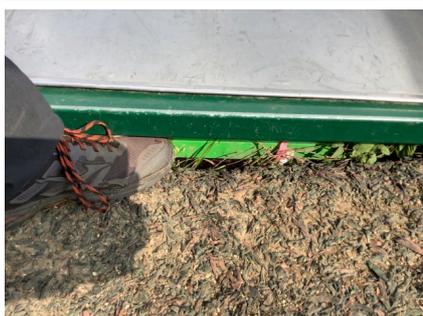
Slide - Embankment - With Log Steps

Surface needs repair.

Surfacing shrunk at top of embankment at entrance to slide, creating a potential entrapment.

Repair.

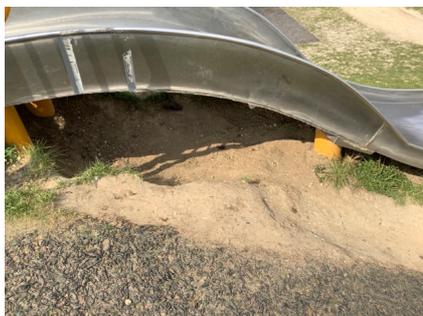
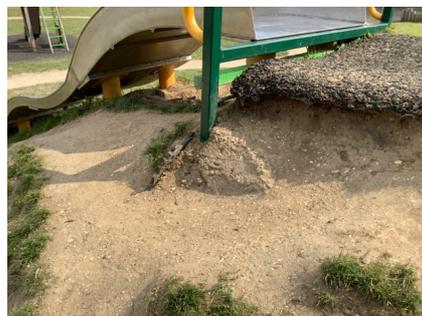
Worn ground areas.

Embankment has eroded around the sides and a large area has been excavated beneath the slide - reinstate the whole affected area.

Build up ground levels to remove trip hazard.

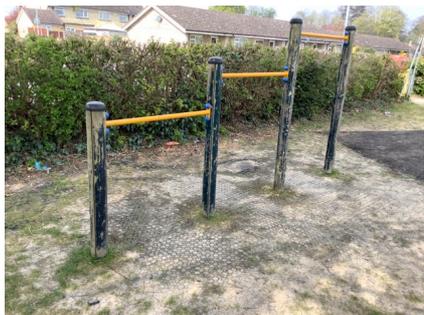
Agility Bars - 3 Tier

This equipment relies on one post for its stability. Special attention should be paid to maintenance (e.g. by monitoring degradation) and if necessary decommissioning the item before the end of its operating life.

Consult with the manufacturer's guidance to determine suitable maintenance.

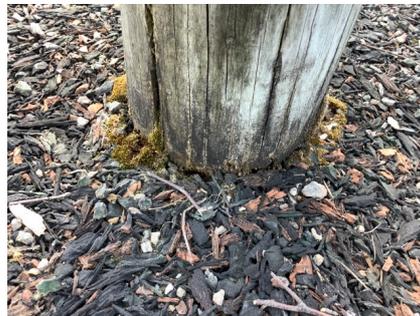
Climber - Net & Ladder

There is decay to timber components which may affect structural integrity. We do not recommend replacing rotten supports with timber posts which are directly set in the ground due to the increased problem of timber rot, especially in posts in contact with the ground.

One post is showing signs of softening and decay at ground level - monitor.

Read the notes for further action.

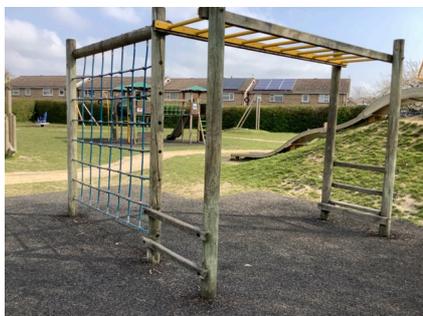
This equipment relies on one post for its stability. Special attention should be paid to maintenance (e.g. by monitoring degradation) and if necessary decommissioning the item before the end of its operating life.

Consult with the manufacturer's guidance to determine suitable maintenance.

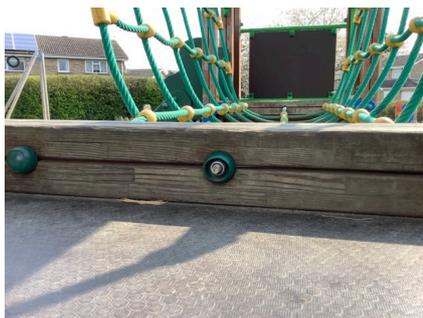
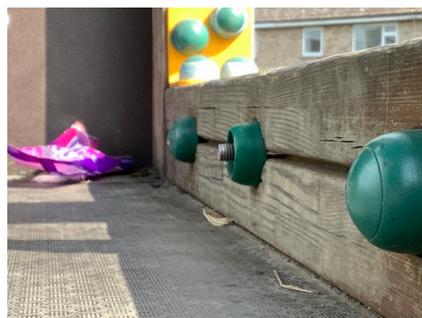
Multiplay - Junior

Cap missing.

Cap plug missing exposing the thread - replace.

Replace.

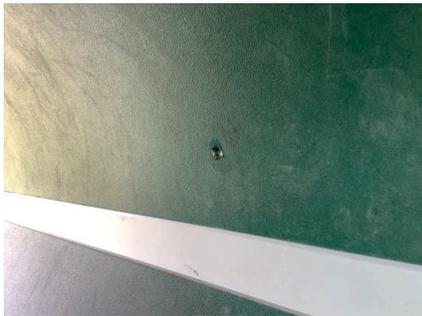
Vandalised (arson).

Two burn marks inside the tunnel - monitor.

No reasonably practicable action is identified.

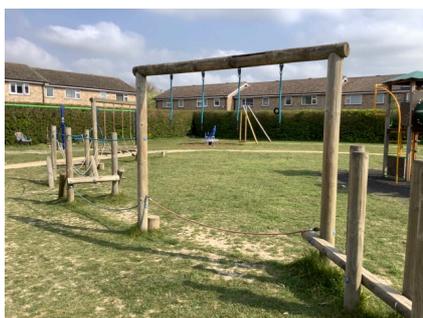
Agility Trail - 7 Element

This equipment relies on one post for its stability. Special attention should be paid to maintenance (e.g. by monitoring degradation) and if necessary decommissioning the item before the end of its operating life.

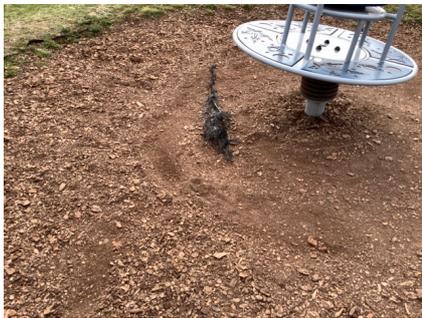
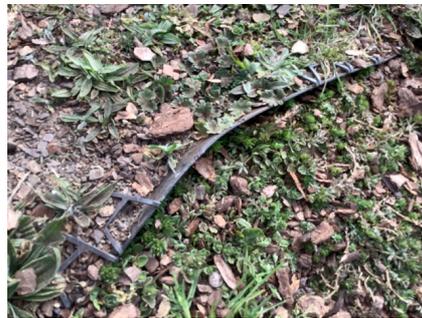
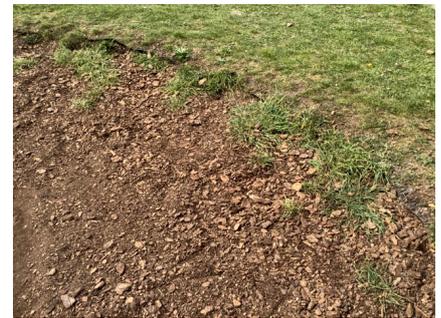
Rocker / Rotator - Chair - Space Rocket

Surface needs repair.

The surfacing has worn away exposing and damaging the liner beneath. Grass & weeds have grown inside. The plastic edging strips are sharp - the whole area requires immediate repairs and alterations. Bark requires topping up.

Repair.

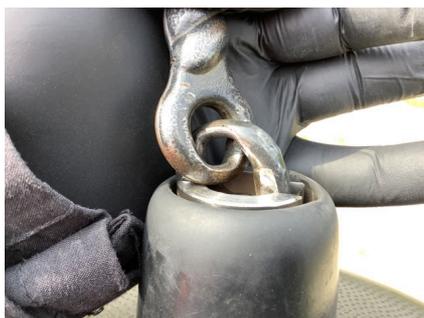
Cableway

Chains links worn.

Chain link and seat connector worn.

Replace the worn parts.

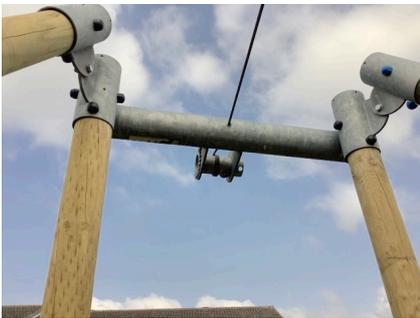
Cables have been known to fail under load due to wear and corrosion. This is generally where the cable enters into a tube, top bar or similar, where the wire is in contact and wears and frays over time. Damaged cables require replacement. This cannot be determined during an annual inspection, and is excluded from our inspection. This finding is generically high risk and action is required. Refer to the manufacturer's instructions to ensure the correct check is carried out.

Conduct an appropriate dismantling inspection.

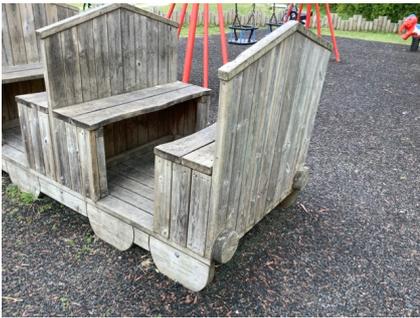
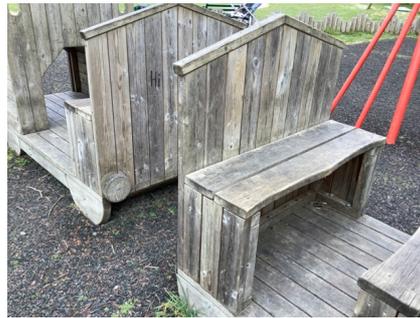
Play Train & Carriage - With Play Panel - Station

Fixtures loose or missing.

Exhaust loose to tunnel and seat rest panels loose - secure.

Tighten/replace.

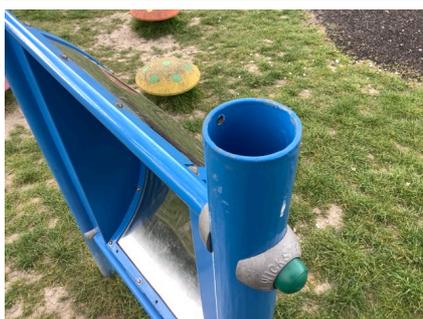
Play Panel - Mirror

Cap missing.

Post caps missing where objects could be inserted and water ingress is likely to occur.

Replace.

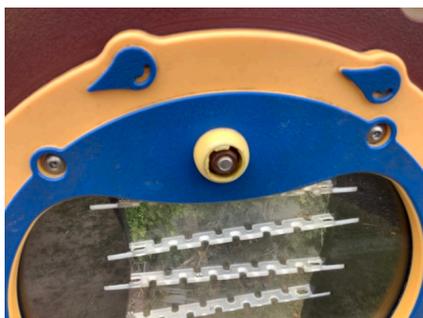
Play Panel - Make it Rain

Bolt cap damaged.

Replace.
