Safety Inspection Report

Annual Inspection

The Moor Play Area

21 April 2021

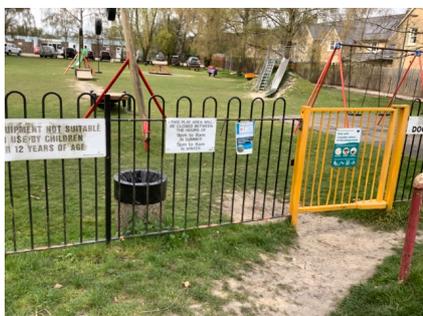
Dog ban & ownership signs recommended.

Operator signs should be installed at each entrance with the correct information on them, operator's name and contact number etc. - please see link attached. www.rospa.com/Play-Safety/Advice/Signs.aspx

See <https://www.rospa.com/en/Play-Safety/Advice/Signs>

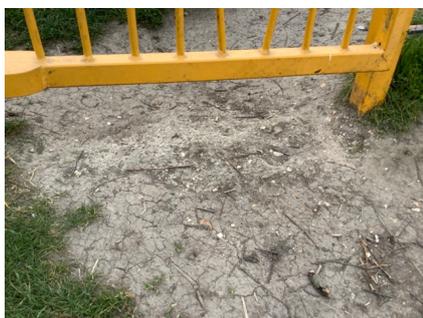
Ground erosion present.

Ground is eroding at entrance exposing concrete foundations.

Repair the worn areas.

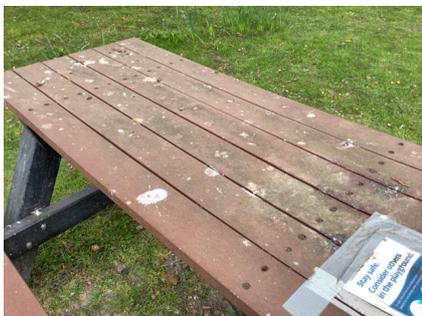
Bird fouling present.

Clean tables.

Medium

8

It is recommended that playground equipment be regularly checked for bird fouling - if found, the affected items should be cleaned with a disinfectant solution.

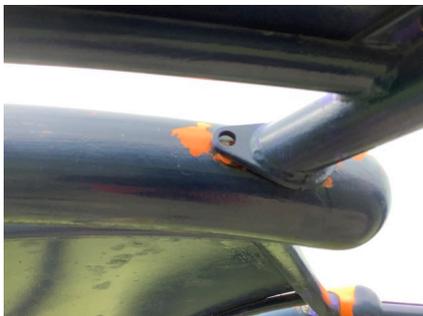
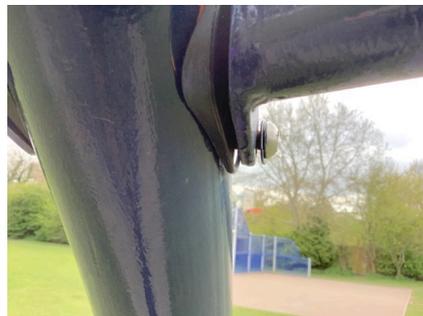
Bolt is missing.

Roof bolt missing and others loose - replace.

Medium

9

Replace.

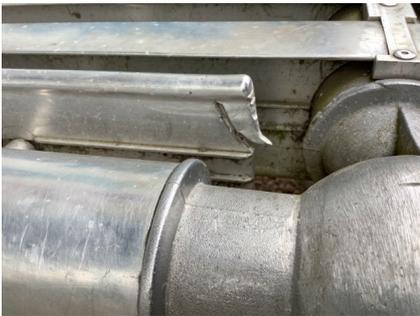
Hard or sharp projections.

Second seat from the right has been cut, leaving a sharp edge projecting - smooth off area leaving a 3 mm radius.

Medium

8

Remove hard, pointed and sharp projections.

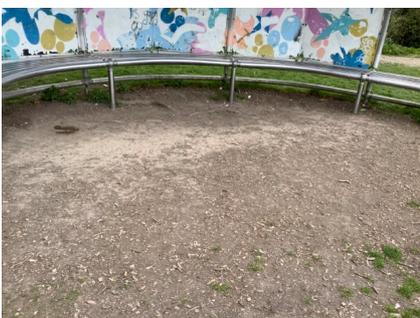
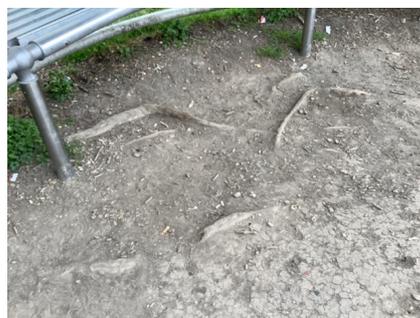
Surface is wearing.

Surface wearing exposing tree roots - reinstate.

Low

7

Repair.

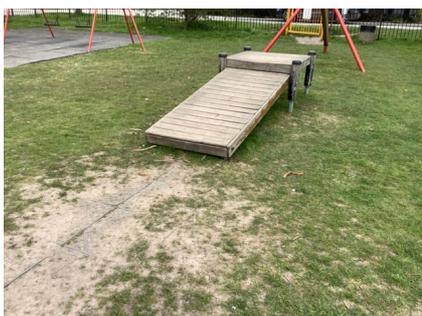
There is an obstacle in the falling space or minimum space.

Low

7

Both ramps are within the falling space of the unit.

No reasonably practicable action is identified.

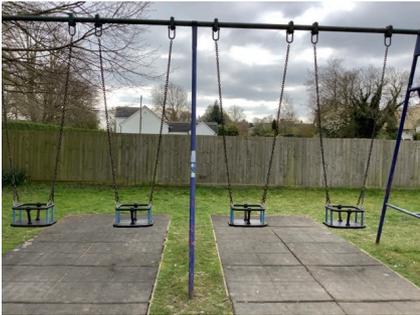
The distance between the seat side and the support is insufficient.

Very low

3

No reasonably practicable action is identified.

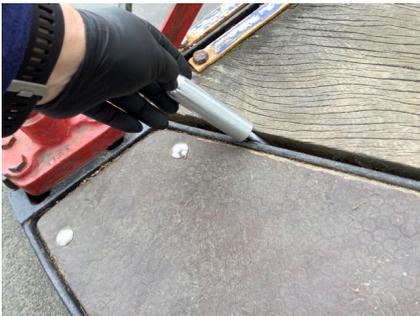
Finger entrapment.

There is a finger entrapment between the boards - eliminate trap.

Medium

9

Eliminate the entrapment.

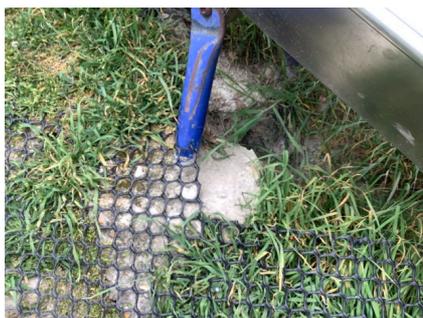
Ground erosion present.

Ground erosion exposing the slide foundations - reinstate.

Low

7

Repair the worn areas.

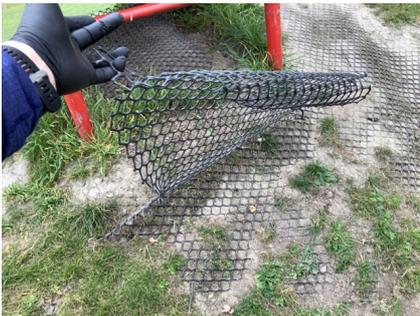
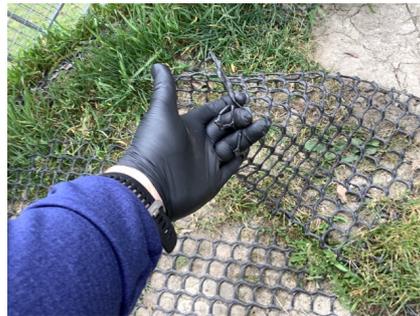
Surface needs repair.

Ground mesh exposed and loose leaving sharp edges projecting - remove mesh.

Medium

10

Read the notes for further action.

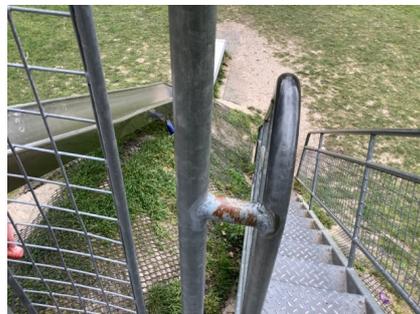
Wedge (head/neck) entrapment is present.

Between the step hand rail and the platform.

Low

6

Modify to eliminate the entrapment.

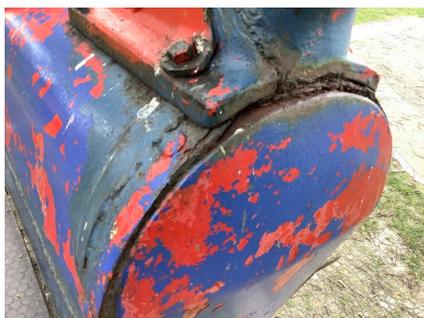
Item has corrosion.

Corrosion under the horse's head - descale and paint.

Risk level:
Low

Risk score:
5

Treat and repair.

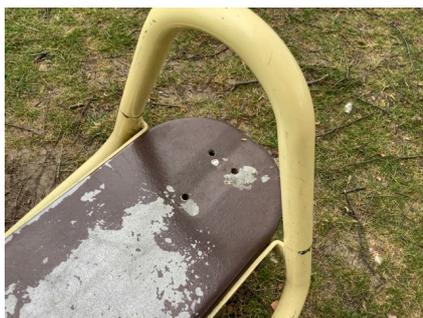
Item has some parts missing.

Tail missing - replace or blank off holes.

Very low

3

Replace the missing parts.

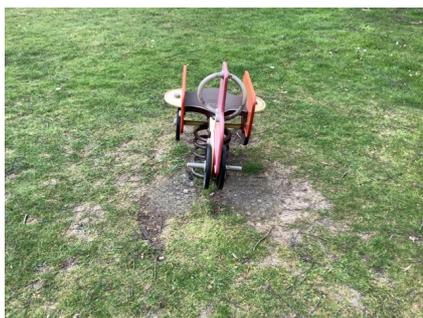
The unit is leaning - monitor.

Risk level:
Low

Risk score:
5

Monitor.

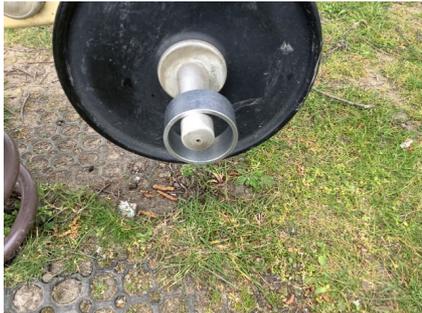
Protruding handles / foot rests.

Very low

3

No reasonably practicable action is identified.
