Project Name: 276430.Little Hands Nursery.SG8 6ED.BWW.Melbourn

Project Description: WinCan Import in Miraculix WRc4 Standard

Project Date: 18/06/2021

Inspection Standard: MSCC4 Sewers & Drainage GB (SRM4 Scoring)

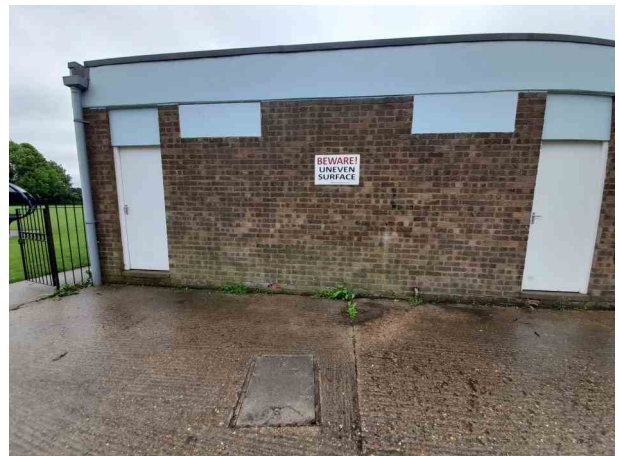
TL384523AF is broken needs replacing as its in the car park

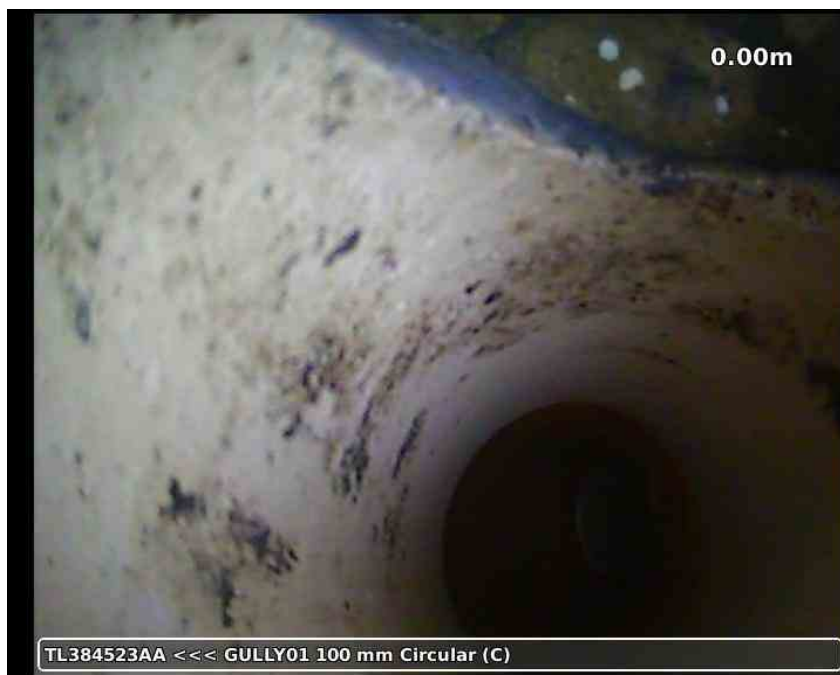
20210617-161336-snap0001.jpg, 00:00:02, 0.00 m
 Water level, 5% % of the vertical dimension

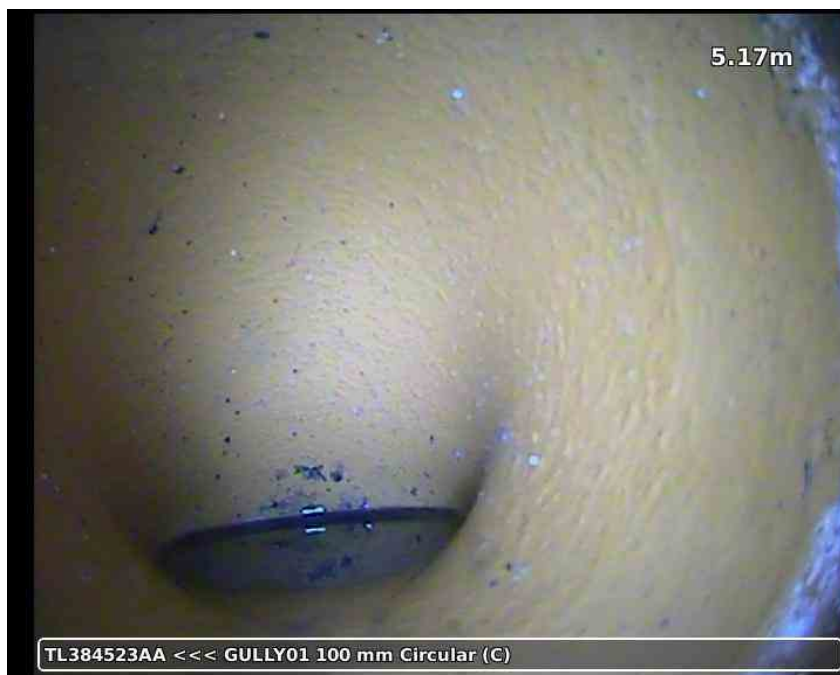
20210617-161336-snap0005.jpg, 00:00:56, 5.17 m
Finish node type, gully, reference number: GULLY01, Internal gully

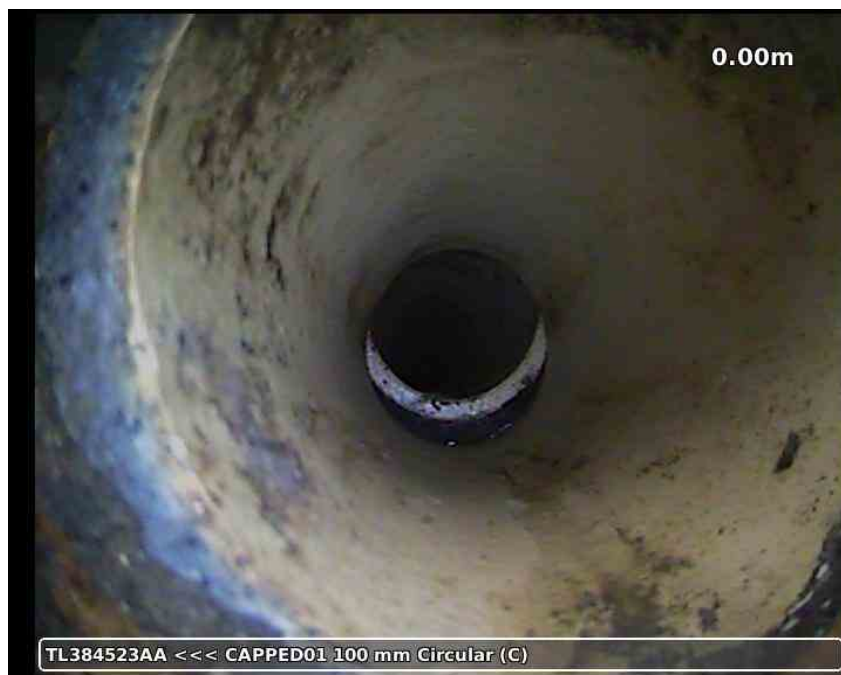
20210617-161651-snap0001.jpg, 00:00:01, 0.00 m
 Water level, 0% % of the vertical dimension

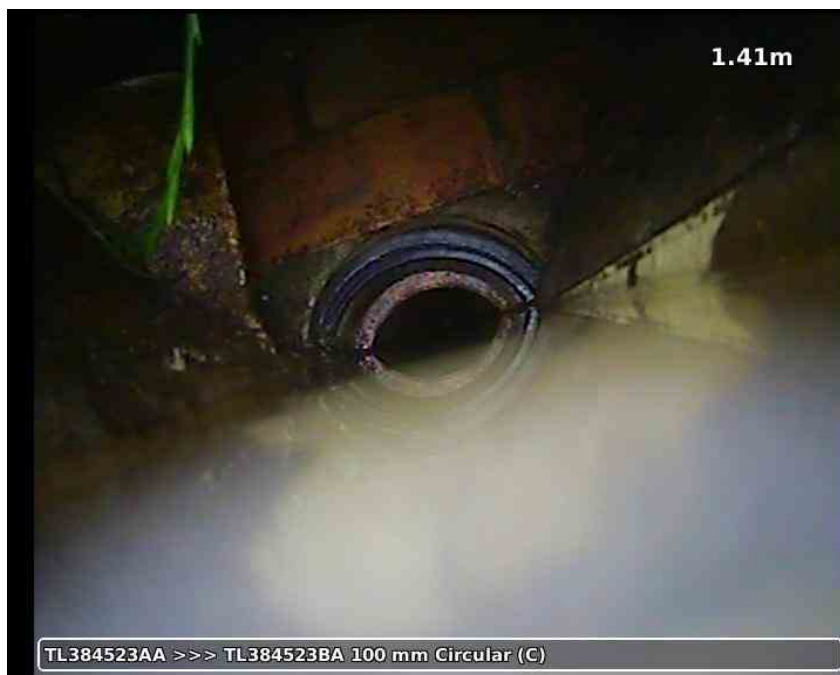
20210617-163005-snap0007.jpg, 00:01:13, 1.41 m
Finish node type, manhole, reference number: TL384523BA, CHAMBER WAS FOUND WHEN SURVEY STARTED

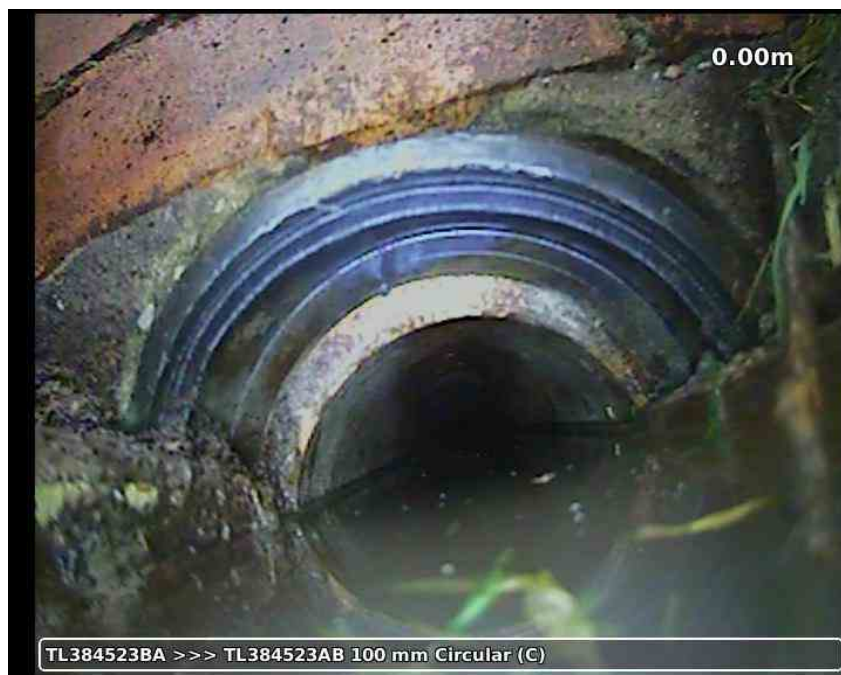
Section 7, Starting water level is 50% & the camera was under water from 0.23m to 1.29m, medium open joint at 1.48m, medium open & displaced joint at 2.85m & 20% hard deposits at 2.93.

20210617-164942-snap0001.jpg, 00:00:01, 0.00 m
 Water level, 50% % of the vertical dimension

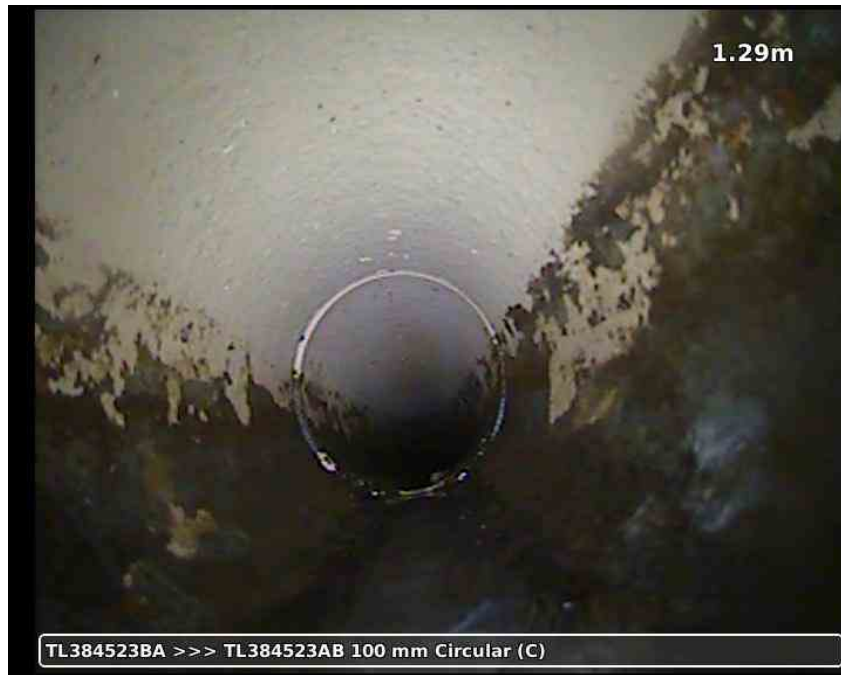
20210617-164942-snap0004.jpg, 00:00:40, 1.29 m
Attached deposits, fouling, from 02 to 10 o'clock, 5% % cross-sectional area loss, S02

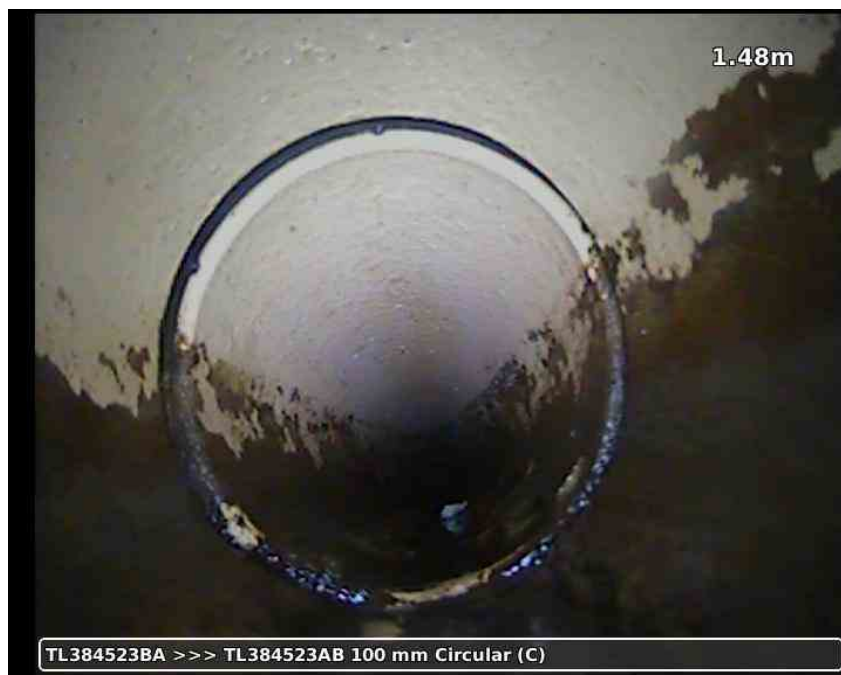
20210617-164942-snap0005.jpg, 00:00:52, 1.48 m
Open joint, medium

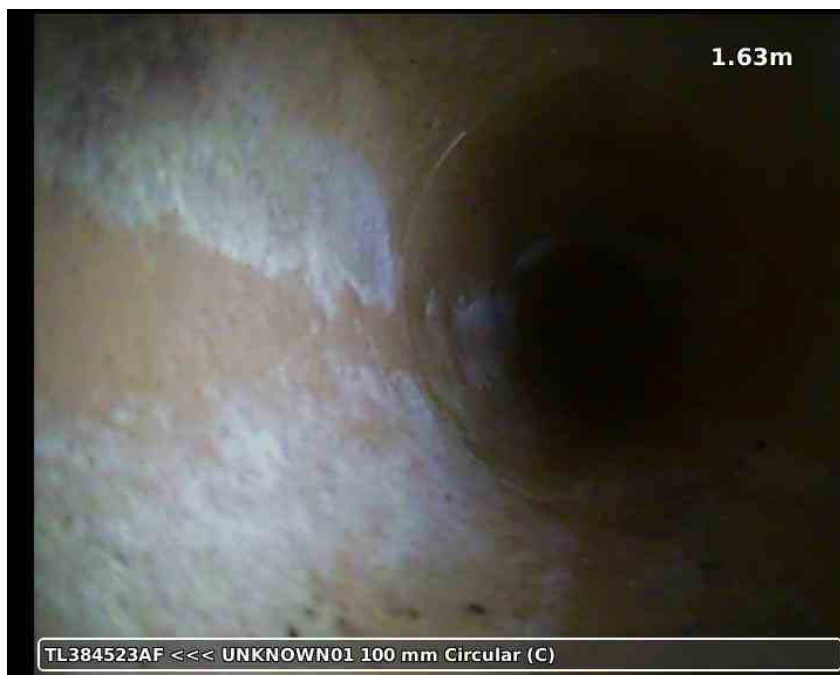
Section 16, Circumferential fracture at 1.63m, unknown as to whether this line is in use.

20210617-175837-snap0003.jpg, 00:00:41, 1.63 m
Fracture, circumferential, from 03 to 11 o'clock

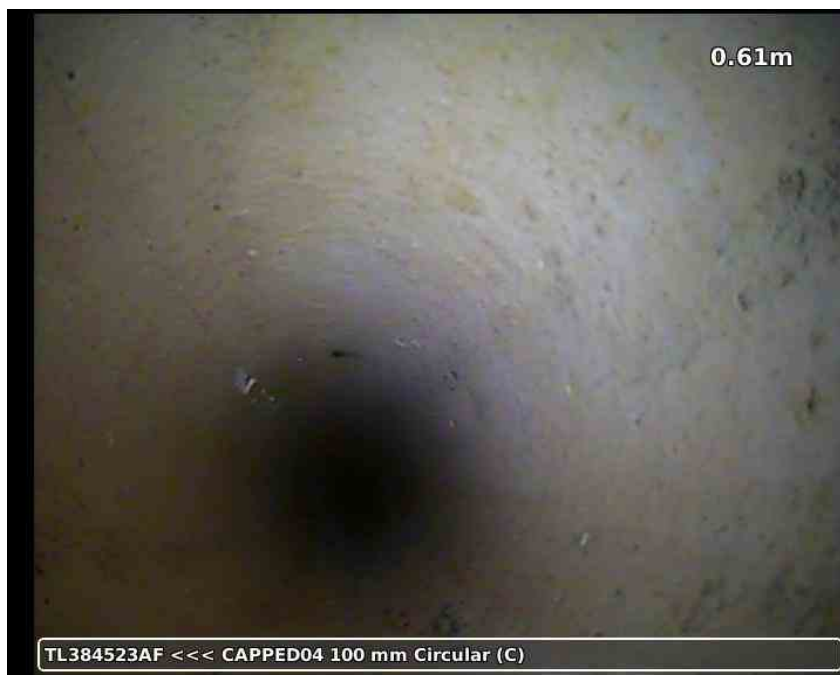
20210617-180144-snap0003.jpg, 00:00:35, 0.61 m
Fracture, longitudinal, at 11 o'clock, S01

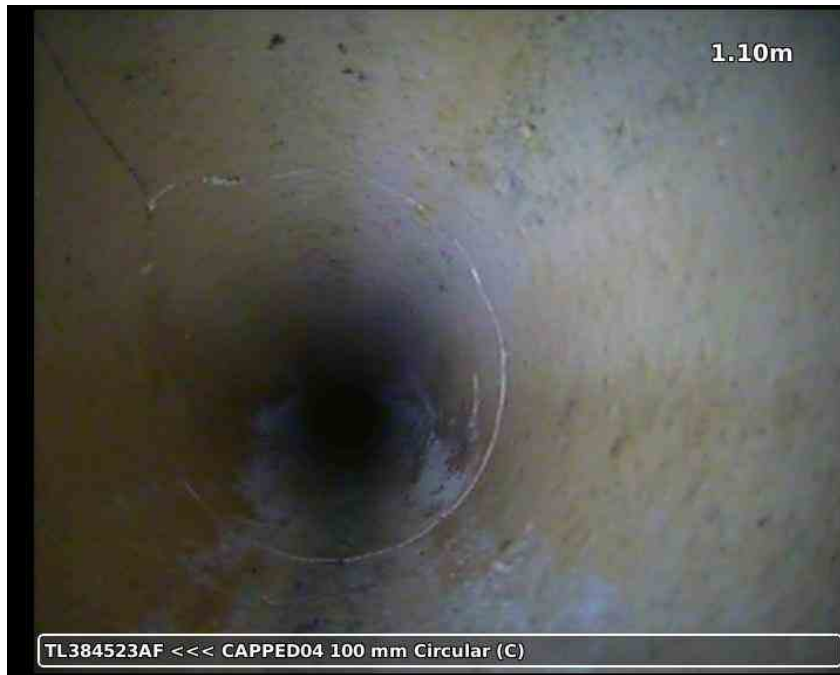
20210617-180144-snap0004.jpg, 00:00:50, 1.10 m
Fracture, circumferential, from 11 to 10 o'clock

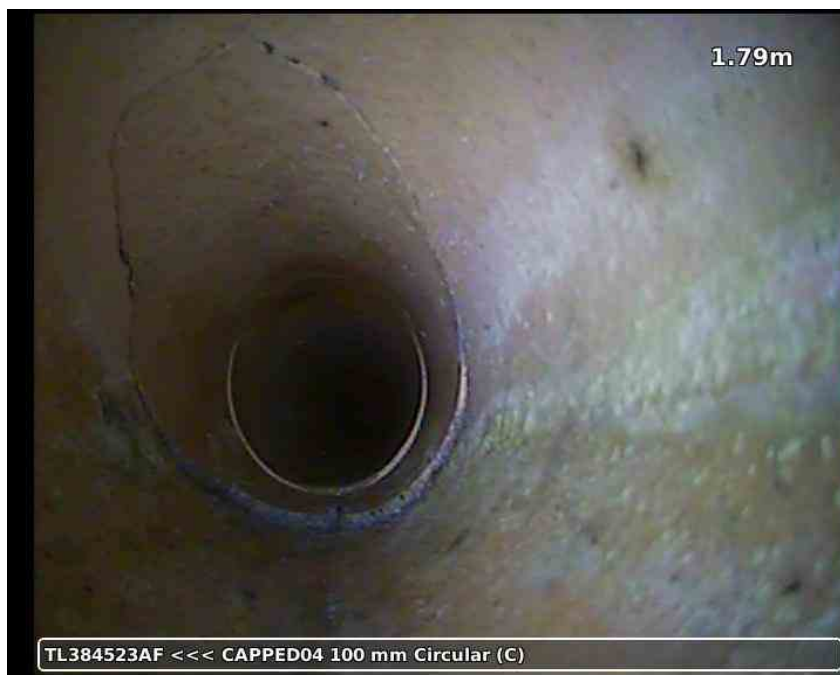
Section 17, This line is capped off at the rest bend. Longitudinal fracture at 0.61m to 1.25m, circumferential fracture at 1.10m & spiral fracture at 1.79m.

20210617-180144-snap0005.jpg, 00:01:11, 1.79 m
Fracture spiral, from 12 to 11 o'clock

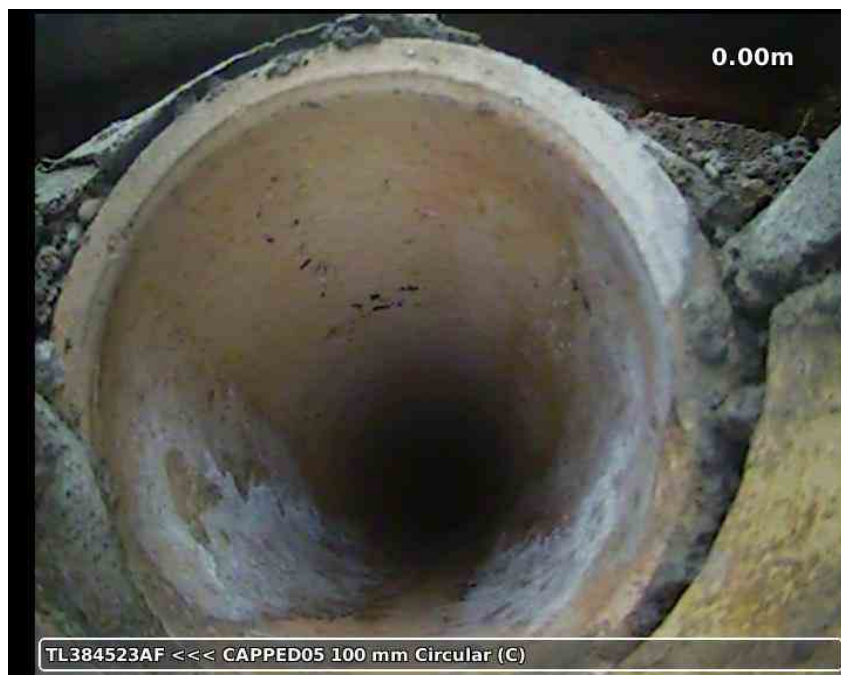
20210617-180419-snap0001.jpg, 00:00:02, 0.00 m
 Water level, 0% % of the vertical dimension, CAPPED OFF

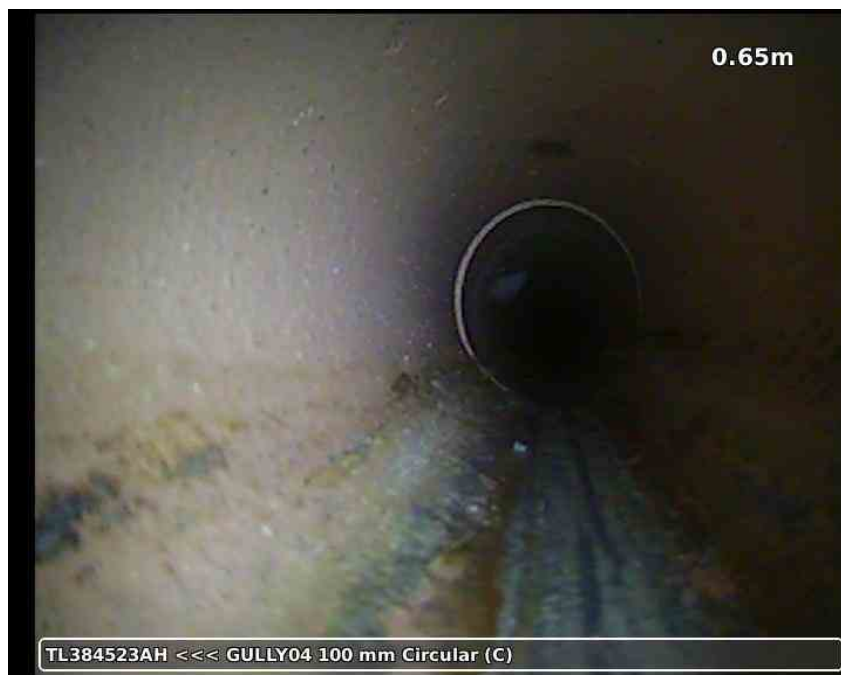
20210617-183231-snap0003.jpg, 00:00:12, 0.65 m
Attached deposits, encrustation, from 05 to 07 o'clock, 5% % cross-sectional area loss, S01,
Scale

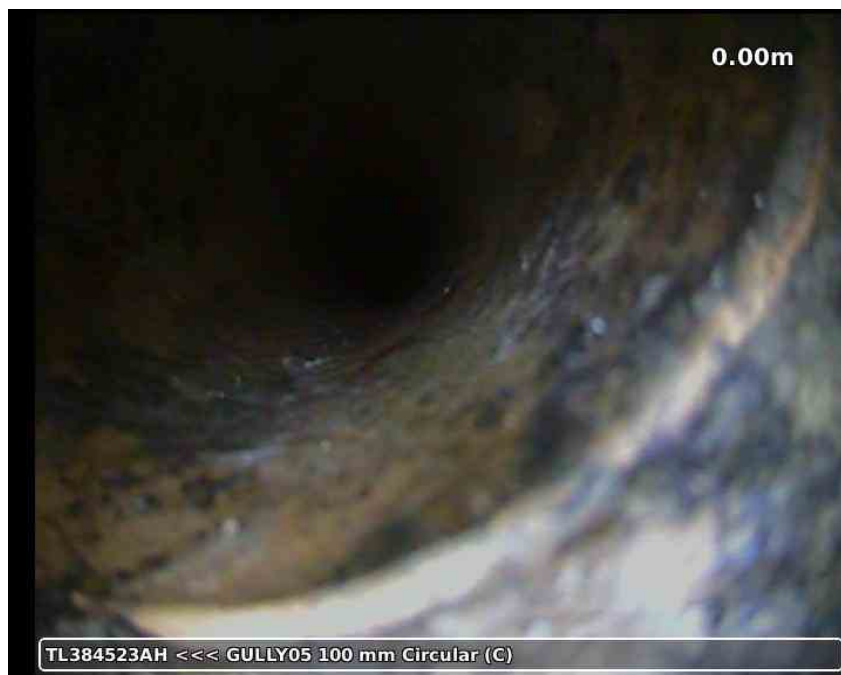
20210617-183433-snap0001.jpg, 00:00:02, 0.00 m
 Water level, 5% % of the vertical dimension

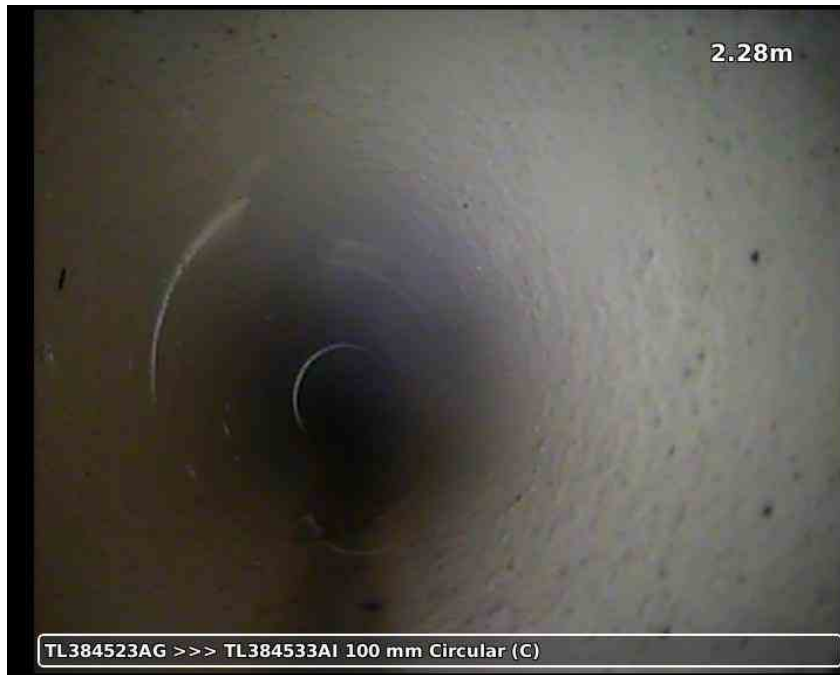
<table><tr> <td style="text-align: right;">0.00</td> <td>MH</td> <td>Start node type, manhole, reference number: TL384523AG</td> <td></td> <td></td> <td></td> <td> </td> </tr><tr> <td style="text-align: right;">2.28</td> <td>FL</td> <td>Fracture, longitudinal, at 11 o'clock</td> <td></td> <td>3</td> <td></td> <td></td> </tr></table>

20210617-185600-snap0006.jpg, 00:01:02, 2.28 m
Fracture, longitudinal, at 11 o'clock

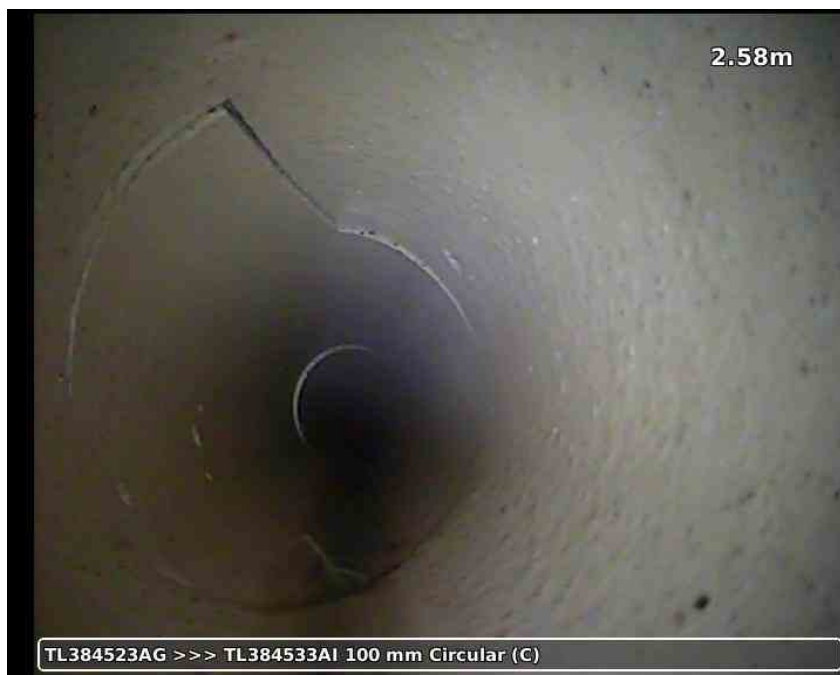
<table><tr> <td style="text-align: right;">0.00</td> <td>MH</td> <td>Start node type, manhole, reference number: TL384523AG</td> <td></td> <td></td> <td></td> <td> </td> </tr><tr> <td style="text-align: right;">2.58</td> <td>FS</td> <td>Fracture spiral, from 12 to 11 o'clock</td> <td></td> <td>4</td> <td></td> <td> </td> </tr></table>

20210617-185600-snap0007.jpg, 00:01:12, 2.58 m
Fracture spiral, from 12 to 11 o'clock

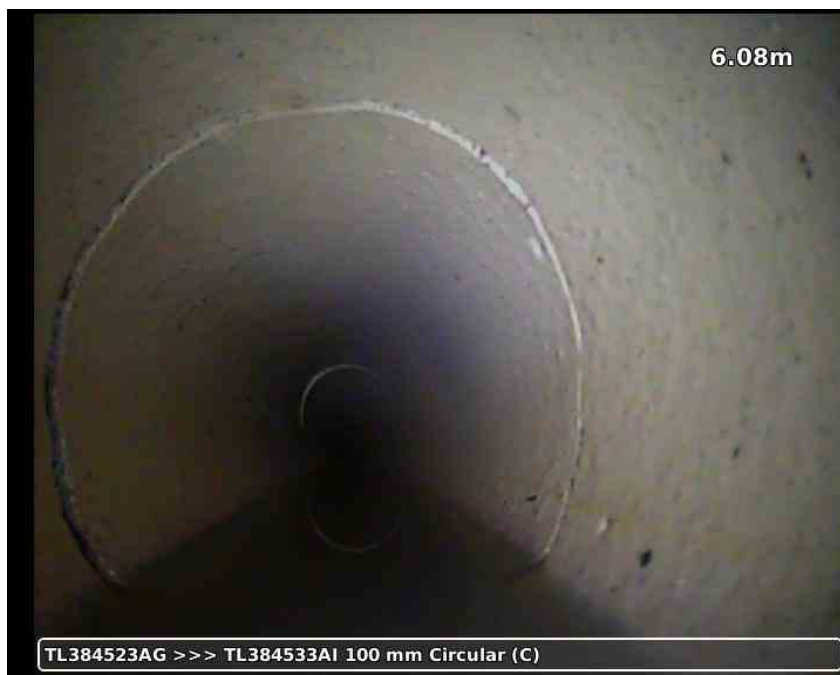
<table><tr> <td style="text-align: right;">0.00</td> <td>MH</td> <td>Start node type, manhole, reference number: TL384523AG</td> <td></td> <td></td> <td></td> <td> </td> </tr><tr> <td style="text-align: right;">6.08</td> <td>FC</td> <td>Fracture, circumferential, from 07 to 05 o'clock</td> <td></td> <td>3</td> <td></td> <td> </td> </tr></table>

20210617-185600-snap0009.jpg, 00:02:01, 6.08 m
Fracture, circumferential, from 07 to 05 o'clock

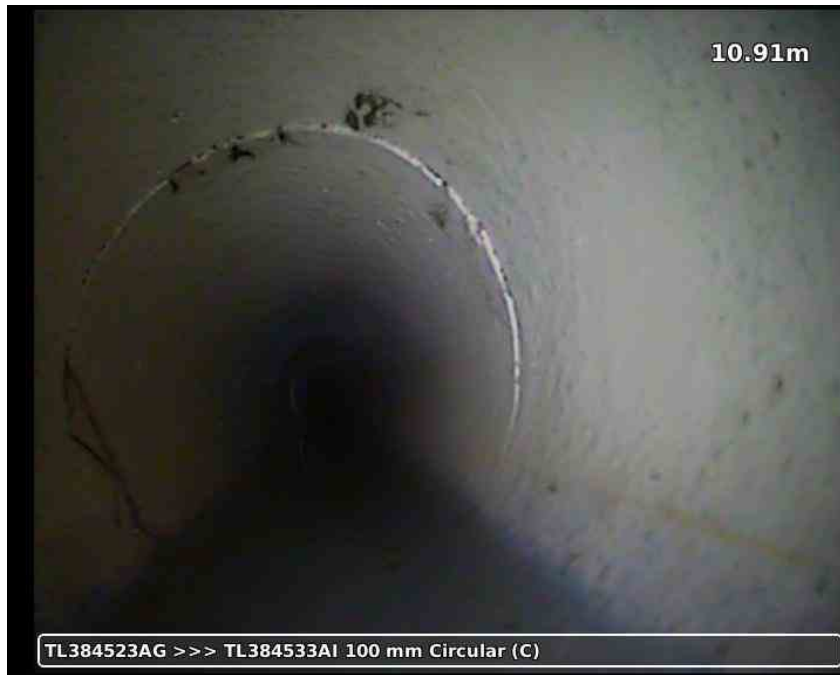
20210617-185600-snap0016.jpg, 00:03:14, 10.91 m
Fracture, circumferential, from 07 to 05 o'clock

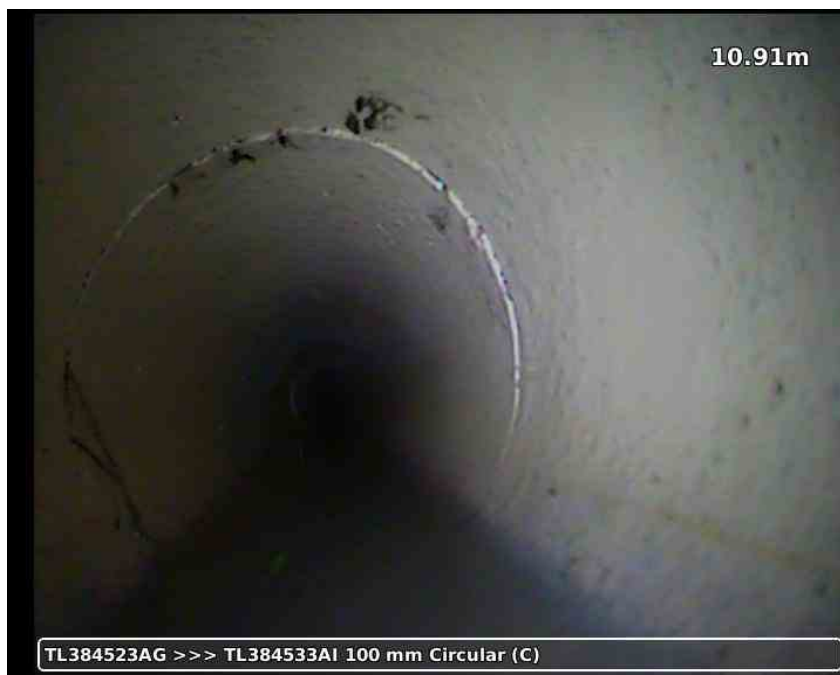
10.91	FC	Fracture, circumferential, from 07 to 05 o'clock	3	JDM @ 1.41 m
		10.91	RF	Roots, fine: ENTERING THROUGH FC	2

20210617-185600-snap0017.jpg, 00:03:18, 10.91 m
Roots, fine, ENTERING THROUGH FC

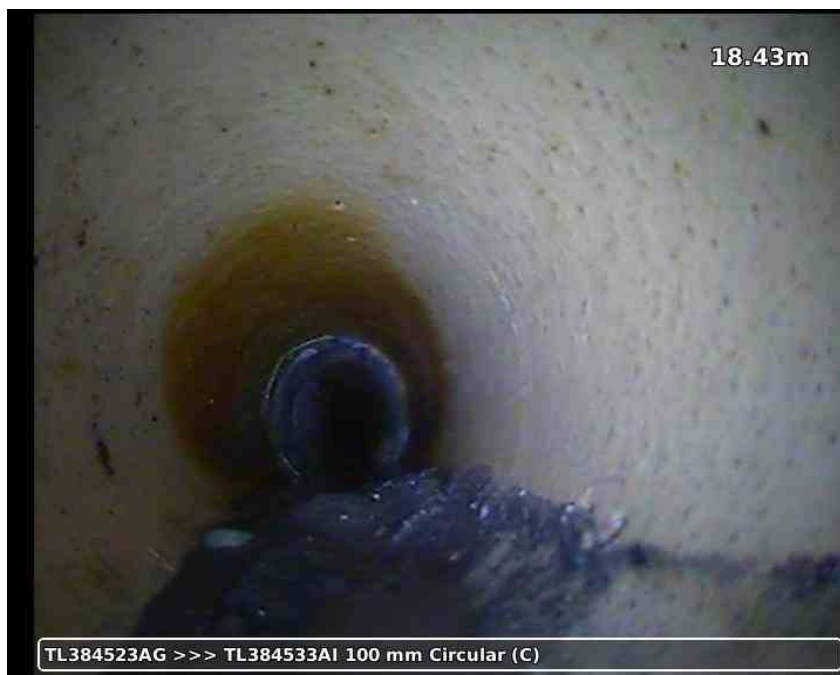
18.43	CC	Crack, circumferential, from 07 to 05 o'clock	2	WL @ 5.97 m
		18.43	S02	DES Settled deposits, fine, 10% % cross-sectional area loss, S02

20210617-185600-snap0023.jpg, 00:04:41, 18.43 m
Crack, circumferential, from 07 to 05 o'clock
