MELBOURN PARISH COUNCIL - MAINTENANCE COMMITTEE

A meeting of the Maintenance Committee held on Thursday, 22 July 2021 at 09:30 at The Pavilion on the New Rec, The Moor, Melbourn, SG8 6ED

Inspection Standard: MSCC4 Sewers & Drainage GB (SRM4 Scoring)

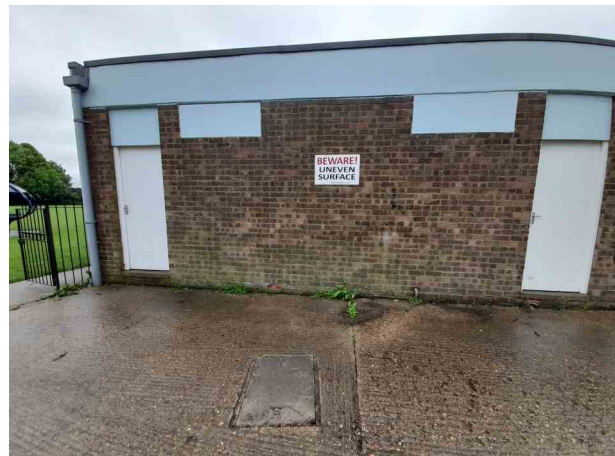
TL384523AF is broken needs replacing as its in the car park

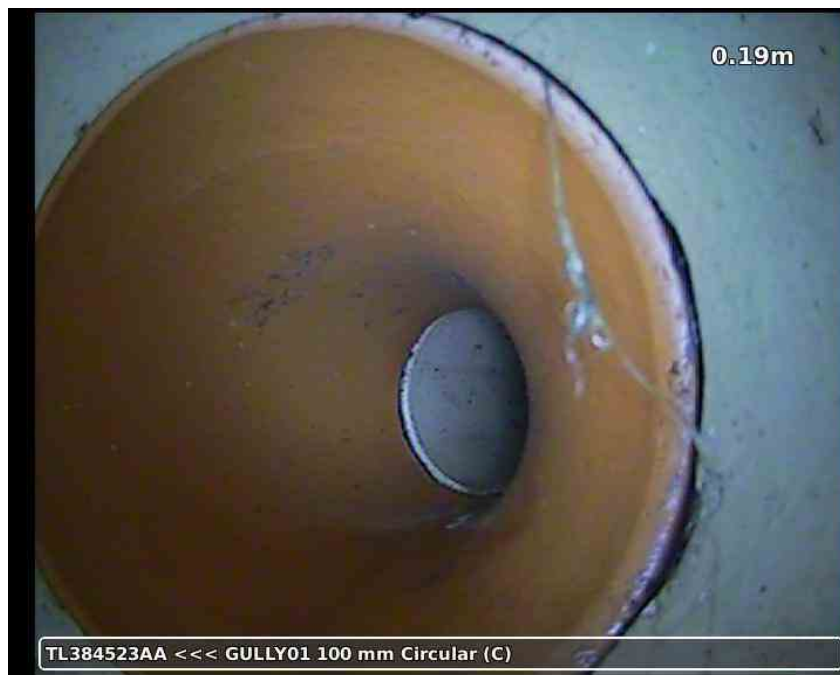
20210617-161336-snap0002.jpg, 00:00:11, 0.19 m
Roots, fine at joint

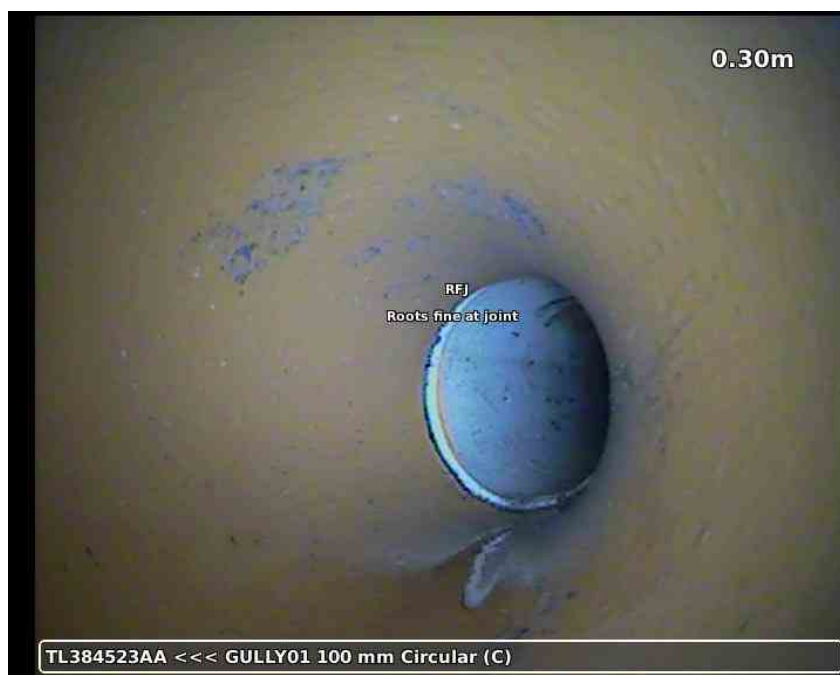
20210617-161336-snap0003.jpg, 00:00:17, 0.30 m
Line deviates right

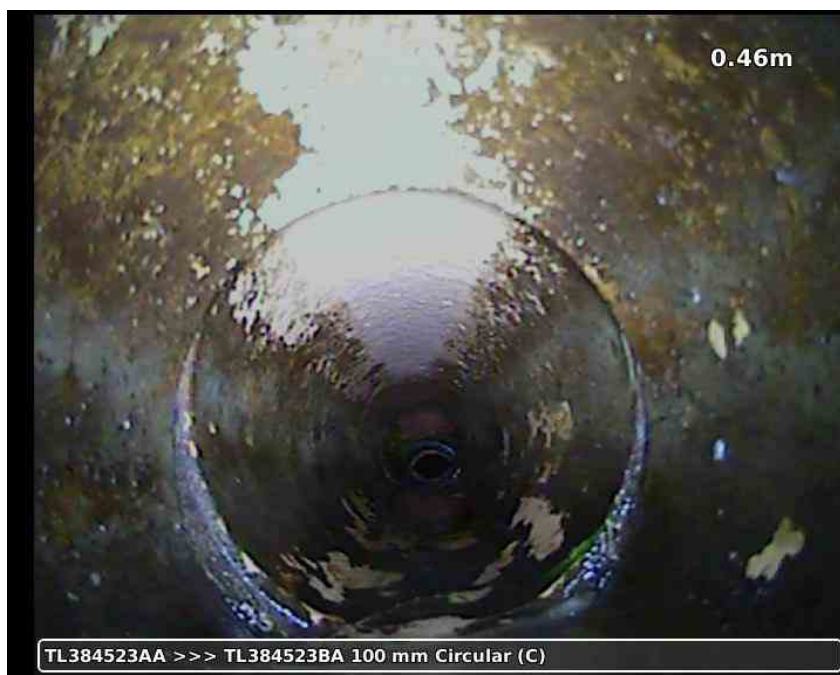
20210617-163005-snap0004.jpg, 00:00:39, 0.46 m
Joint displaced, medium

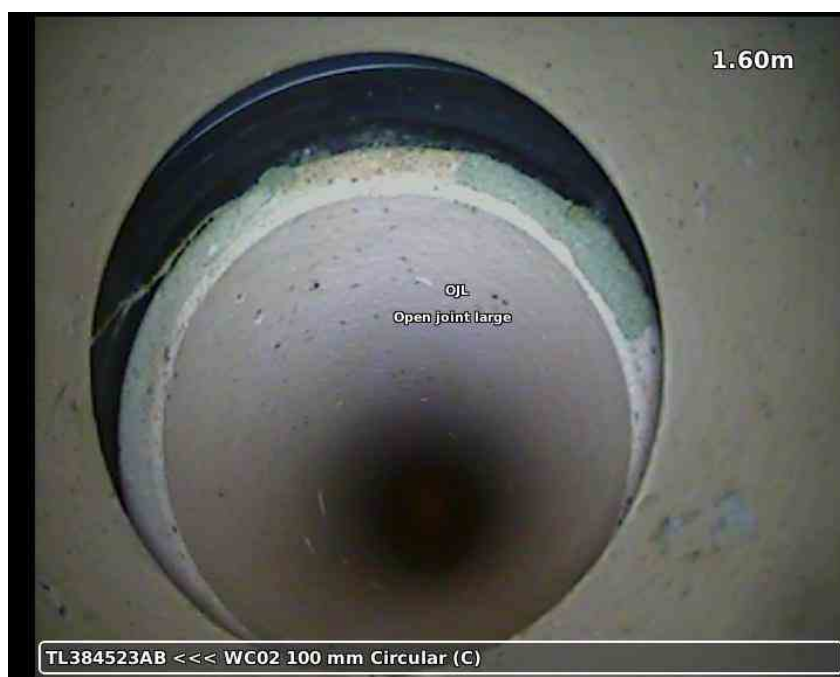
20210617-165855-snap0004.jpg, 00:00:40, 1.60 m
 Joint displaced, 20 mm displacement

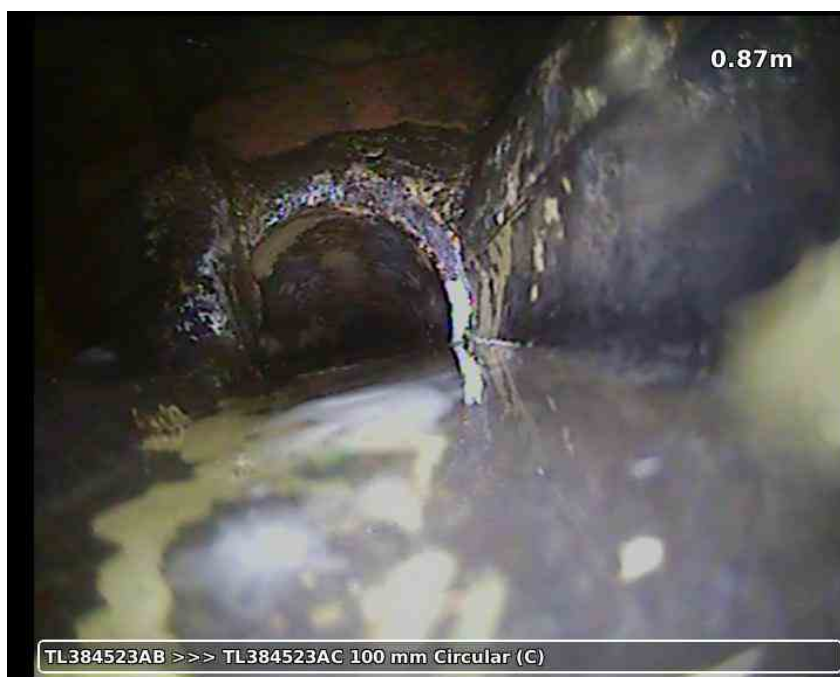
20210617-170147-snap0003.jpg, 00:00:29, 0.87 m
 Water level, 20% % of the vertical dimension, BACK FLOWING

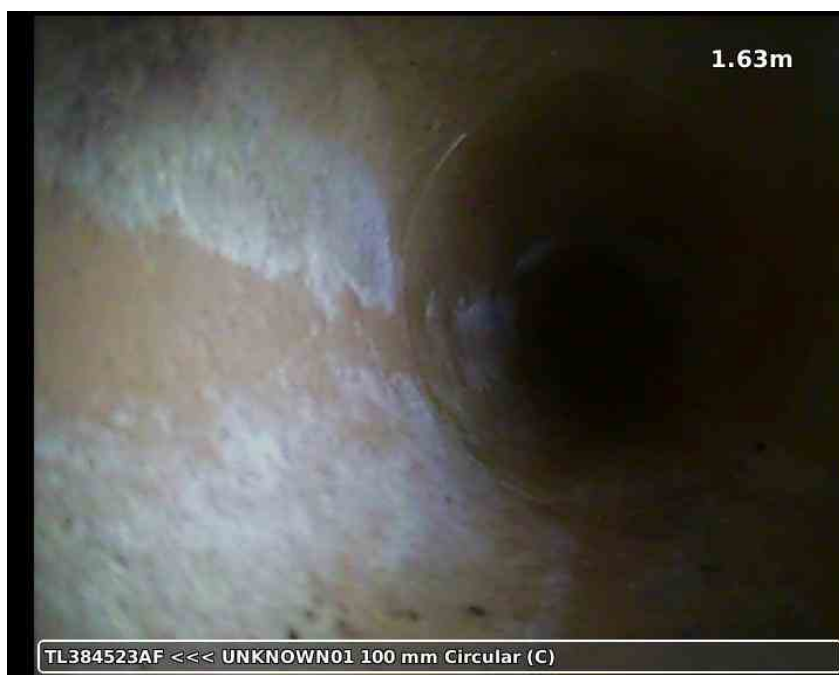
20210617-175837-snap0003.jpg, 00:00:41, 1.63 m
Fracture, circumferential, from 03 to 11 o'clock

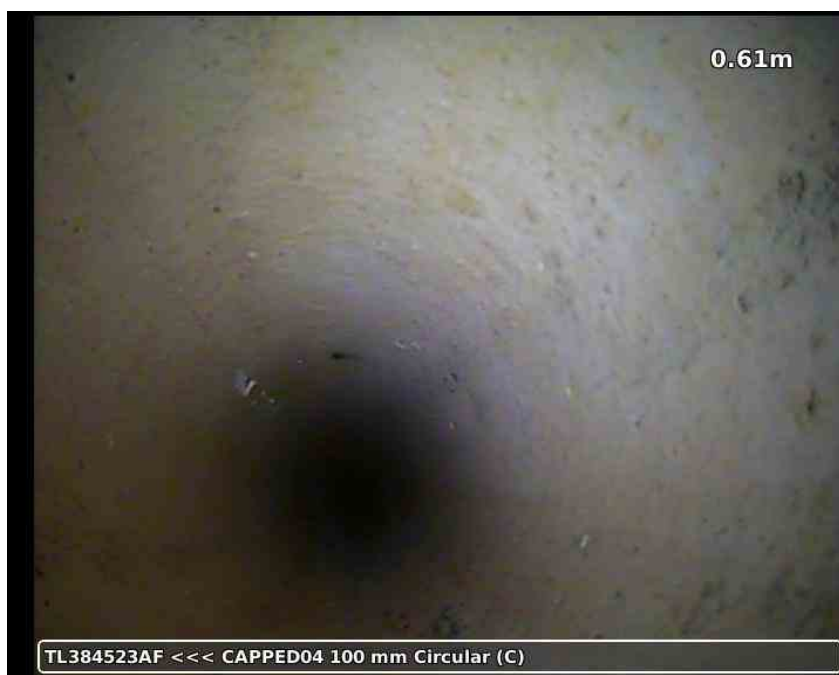
20210617-180144-snap0003.jpg, 00:00:35, 0.61 m
Fracture, longitudinal, at 11 o'clock, S01

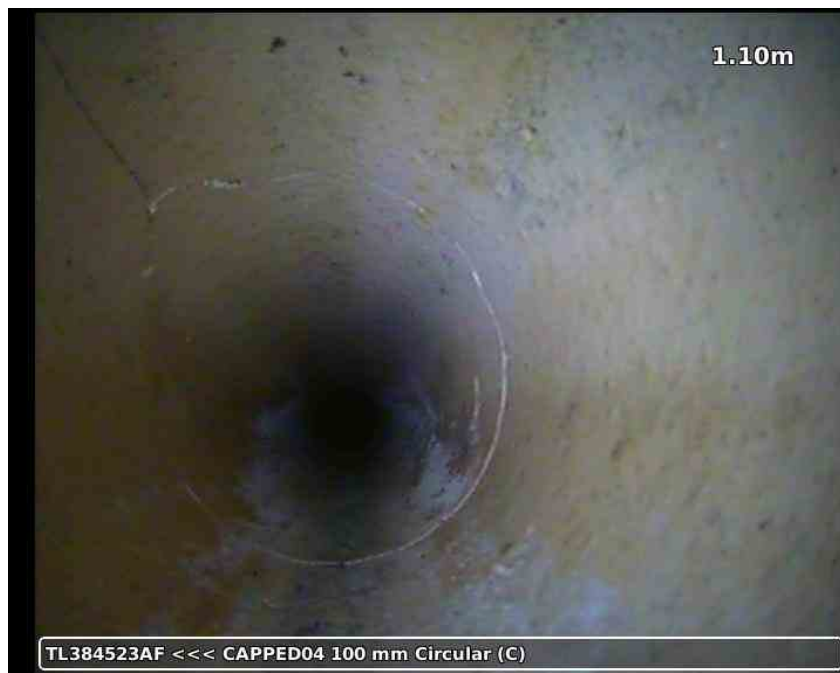
20210617-180144-snap0004.jpg, 00:00:50, 1.10 m
Fracture, circumferential, from 11 to 10 o'clock

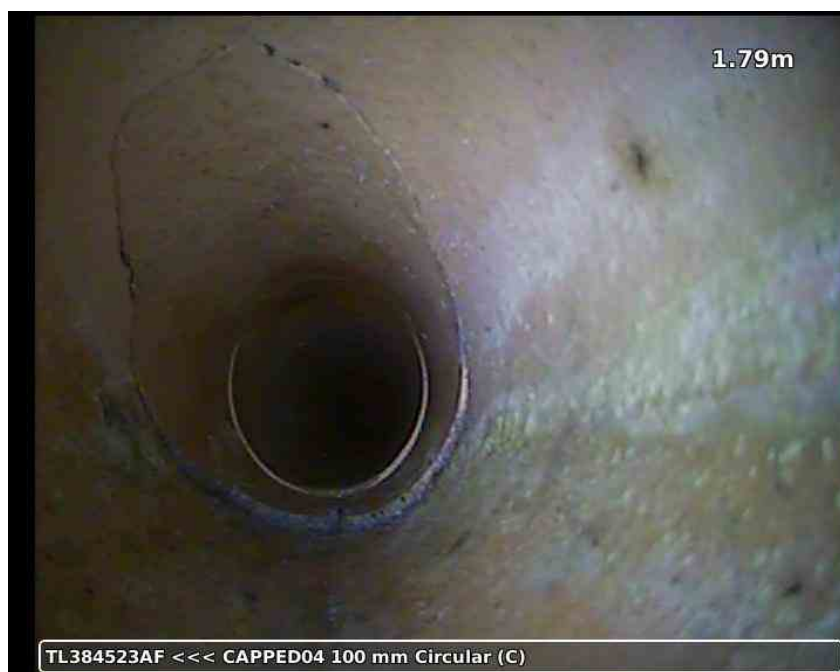
20210617-180144-snap0005.jpg, 00:01:11, 1.79 m
Fracture spiral, from 12 to 11 o'clock

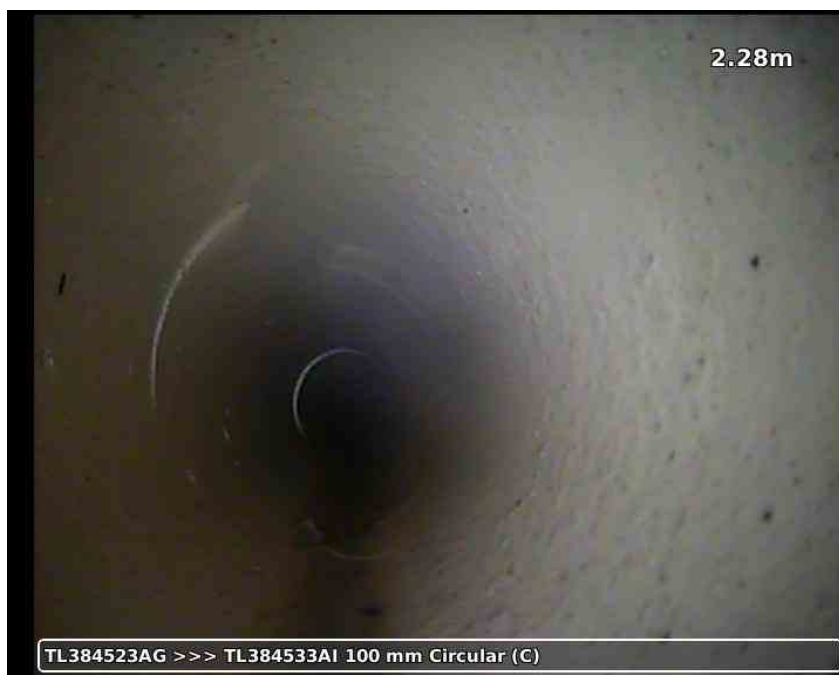
20210617-185600-snap0006.jpg, 00:01:02, 2.28 m
Fracture, longitudinal, at 11 o'clock

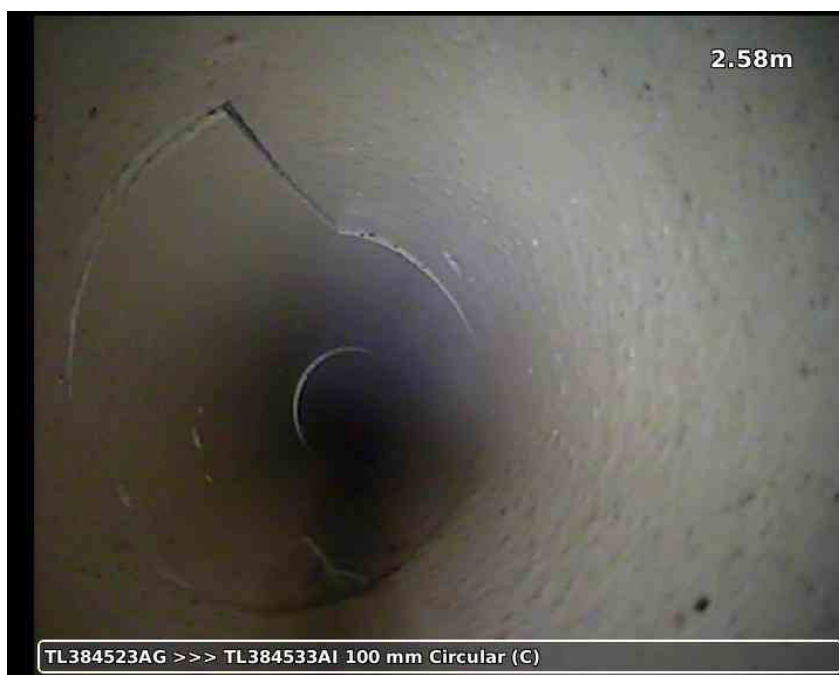
20210617-185600-snap0007.jpg, 00:01:12, 2.58 m
Fracture spiral, from 12 to 11 o'clock

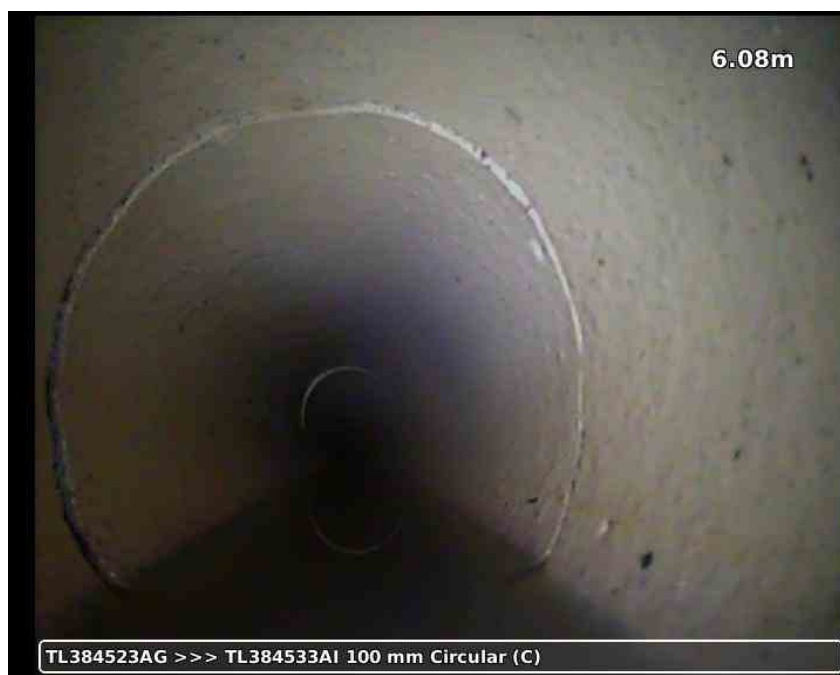
20210617-185600-snap0009.jpg, 00:02:01, 6.08 m
Fracture, circumferential, from 07 to 05 o'clock

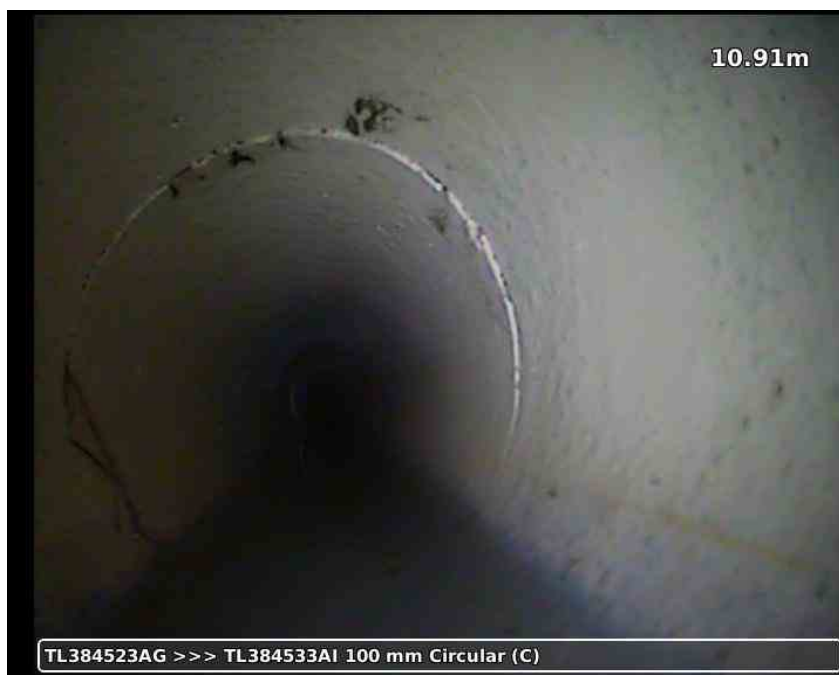
20210617-185600-snap0016.jpg, 00:03:14, 10.91 m
Fracture, circumferential, from 07 to 05 o'clock

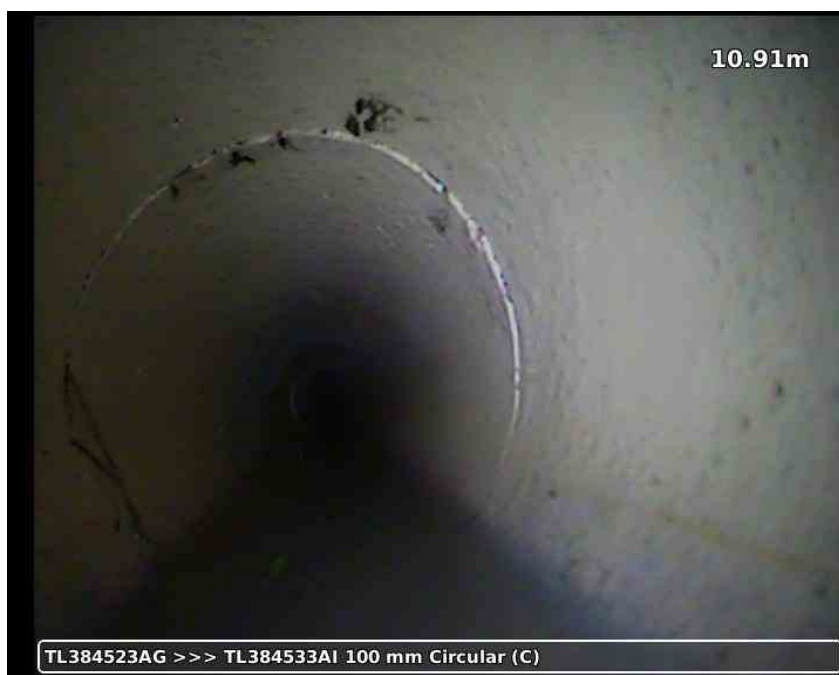
20210617-185600-snap0017.jpg, 00:03:18, 10.91 m
Roots, fine, ENTERING THROUGH FC

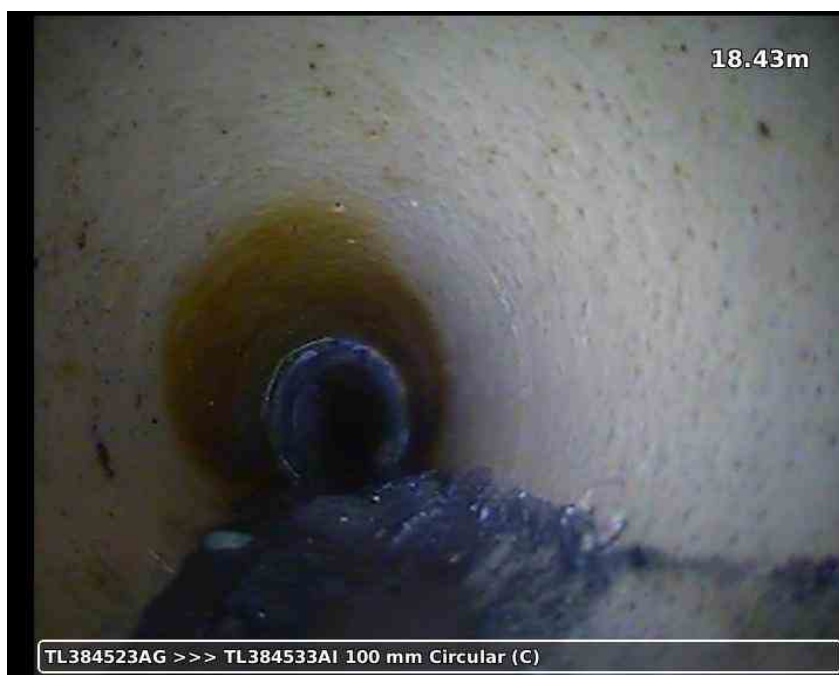
20210617-185600-snap0023.jpg, 00:04:41, 18.43 m
Crack, circumferential, from 07 to 05 o'clock
