TREE HEALTH & SAFETY SURVEY & ARBORICULTURAL REPORT

**Several locations
The Parish of Melbourn
South Cambridgeshire**

Job ref	Report Version	Author	Checked	Date
ATS0451	V1	IL	IL	September 2021

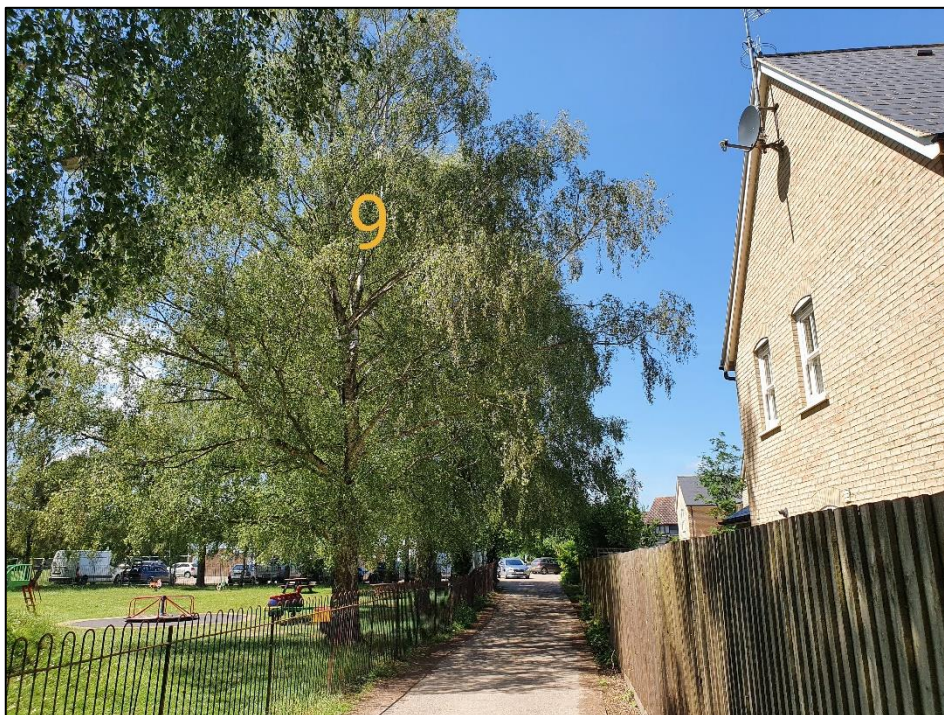
- Below: Tree 9 (Birch) – Over-extended limbs growing towards houses

- 5.1 All trees were inspected. They are generally in excellent health and condition.
- 5.2 Side branches of Birch trees numbered 9 and 11 are over-extending to the north, towards the houses. Over-extended branches can begin to subside (droop excessively), which can lead to failure. Remedial tree surgery is recommended at Chapter 3.

Tree number	Map number / name	Species	Site	Tree surgery	Priority
9	INSET 2 The Moor play area	Birch	The Moor play area	Shorten over extended limbs on north side of crown (growing towards houses) by approximately 4 metres	2
11	INSET 2 The Moor play area	Birch	The Moor play area	Shorten over extended limbs on north side of crown (growing towards houses) by approximately 4 metres	2
64	Royston Road	Lombardy Poplar	Royston Road	Remove dead wood	2

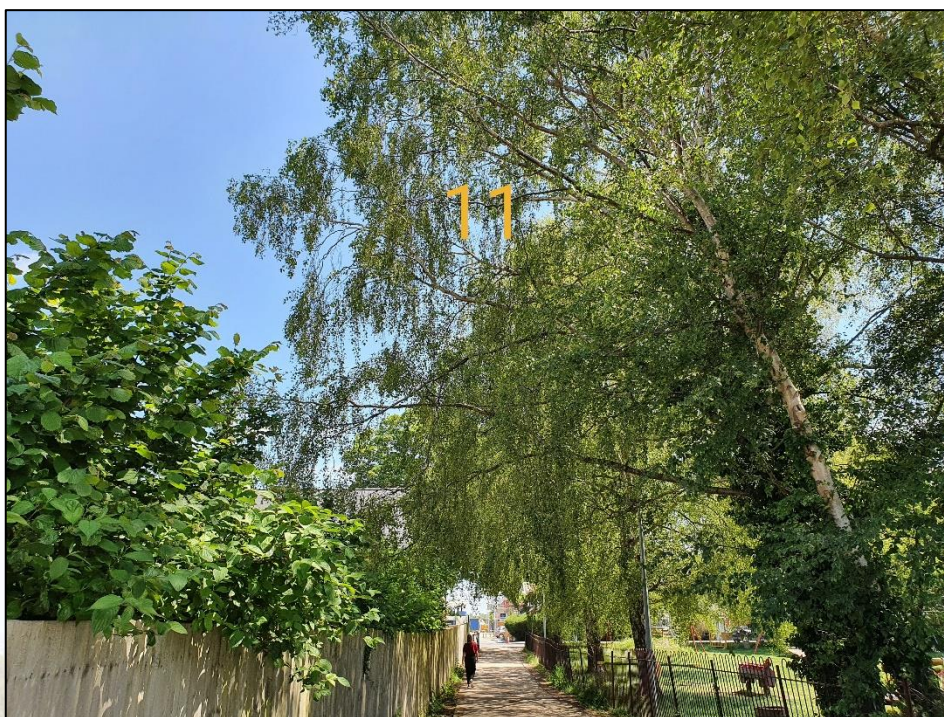
- Below: Tree 11 (Birch) – Over-extended limbs growing towards houses

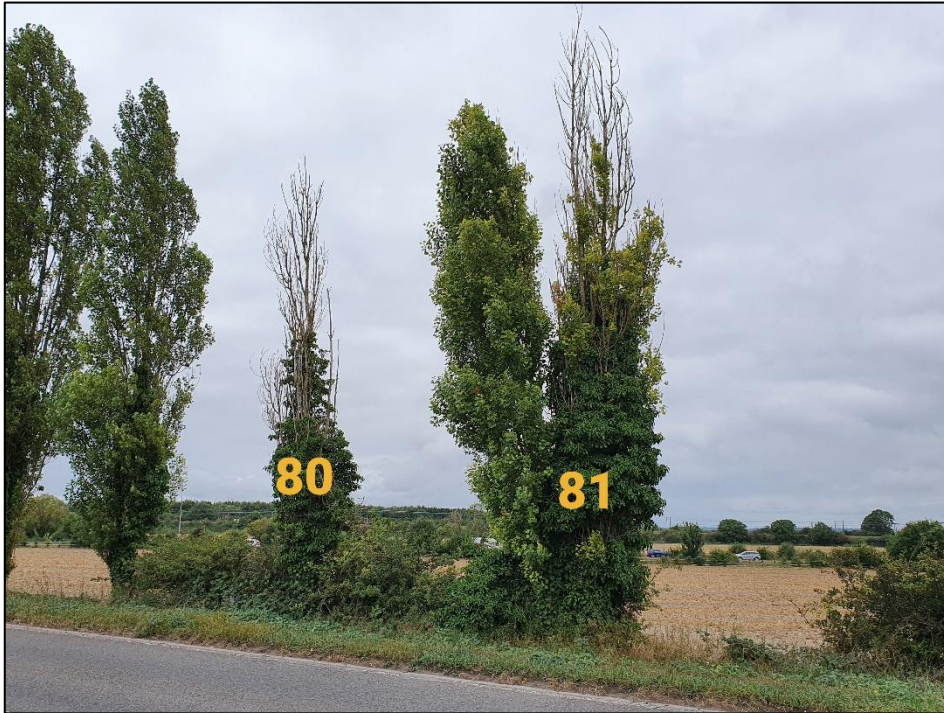
- Below: Trees 80 & 81 (Poplar) – Tree 80 is dead. Tree 81 is partially dead and has a precarious ‘subsiding’ stem leaning over the road

80	Royston Road	Lombardy Poplar	Royston Road	Fell to ground level	2
81	Royston Road	Lombardy Poplar	Royston Road	Fell to ground level	2
82	Royston Road	Lombardy Poplar	Royston Road	Remove dead wood	2
85	Royston Road	Lombardy Poplar	Royston Road	Fell to ground level	2
86	Royston Road	Lombardy Poplar	Royston Road	Fell to ground level	2
90	Royston Road	Lombardy Poplar	Royston Road	Fell to ground level	2

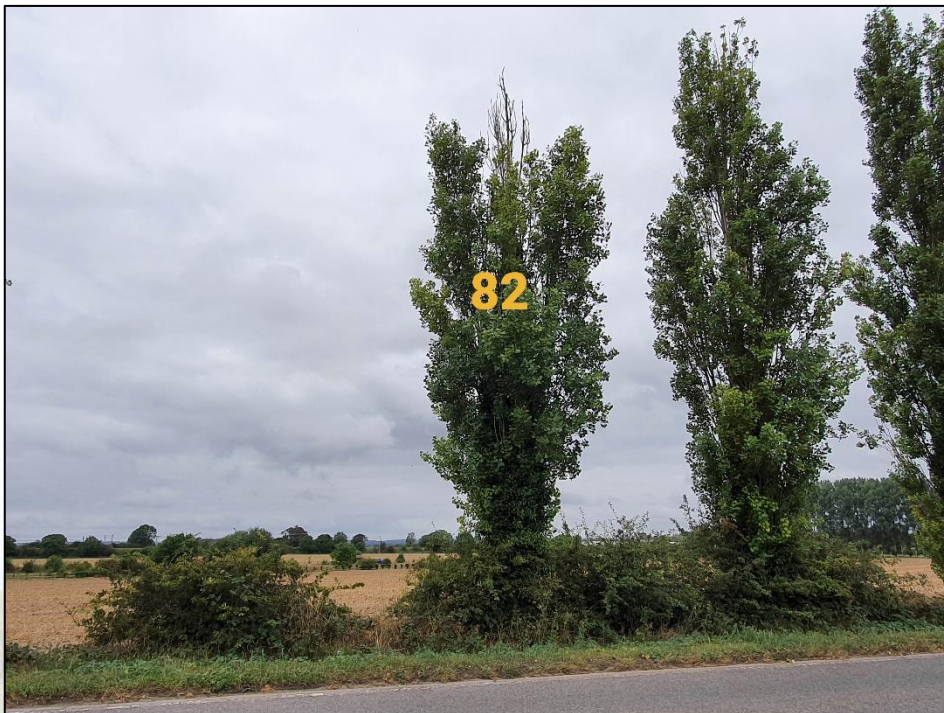
- Below: Tree 82 (Poplar) – Dieback in upper crown

Site name: Royston Road, Melbourn, Cambs Surveyor: Ian Lorman			Date of survey: 31 August 2021 Conditions: Clear / dry / still					
Tree number	Species	Height estim (m)	Stem Diam (s) estim (mm) No. of	Crown spread Ave rad estim (m)	Life stage	Observations; structural / physiological condition and any tree work recommendations	Priority / urgency of work	Zone value
78	Lombardy Poplar	14	400	2.5	Mature	Crown - Good, Stem - Fair, Basal Area - Fair No action Dense Ivy on trunk	0	1
79	Lombardy Poplar	12	300	2	Mature	Crown - Good, Stem - Fair, Basal Area - Fair No action Dense Ivy on trunk	0	1
80	Lombardy Poplar	10	300	1	Early-mature	Dead Fell	2	1
81	Lombardy Poplar	10	300	2.5	Mature	Crown - Poor, Stem - Fair, Basal Area - Fair Fell Considerable dieback in top of crown. Subsiding co-dominant leader in southwest leaning towards road with risk of snapping out	2	1
82	Lombardy Poplar	12	300	2	Mature	Crown - Fair, Stem - Fair, Basal Area - Fair Remove dead wood Dieback in upper crown. Dense Ivy on trunk	2	1

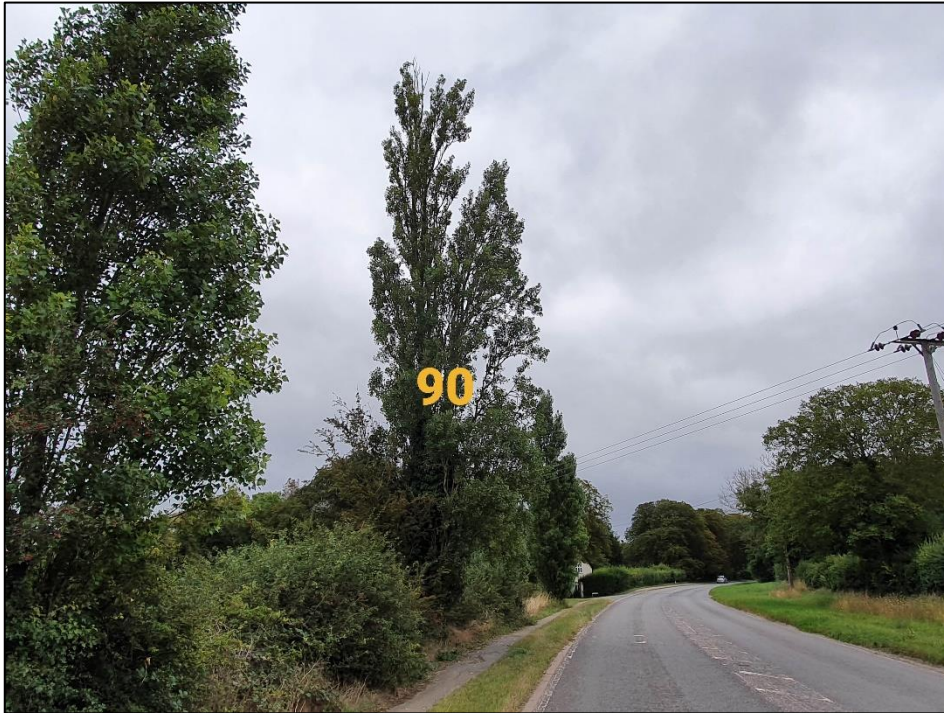
- Below: Tree 90 (Poplar) – Dying back and large ‘subsiding’ stem leaning over the road

90	Lombardy Poplar	15	400	4	Mature	Crown - Fair, Stem - Fair, Basal Area - Fair Fell Dieback in top and moderate dead wood throughout. Dense Ivy on trunk. Large subsiding co-dominant leader on south east side leaning towards road with risk of snapping out	2	1
91	Lombardy Poplar	6	125	0.5	Mature	Crown - Poor, Stem - Fair, Basal Area - Fair No action Stunted. Dense Ivy on trunk	0	1
92	Lombardy Poplar	14	400	3	Mature	Crown - Good, Stem - Fair, Basal Area - Fair No action Dense Ivy on trunk	0	1
