2 Brief

- 2.1 This report was requested by Melbourn Parish Council on 22nd April 2021. The tree survey was conducted on 14th June 2021 (all sites except Royston Road) and 31st August 2021 (Royston Road only). I am instructed to undertake a health & safety tree survey at several sites across the Parish to identify structural defects in trees and to make recommendations for tree surgery operations to eliminate a risk, or mitigate a risk to an acceptable level, proportionate to the nature and the location of the trees. Trees have been plotted on an Ordnance Survey base map using Geographical Positioning System (GPS) to a level of accuracy that is sufficient to identify the location of the trees, typically +/- 2 metres.

3 Summary of findings and recommendations

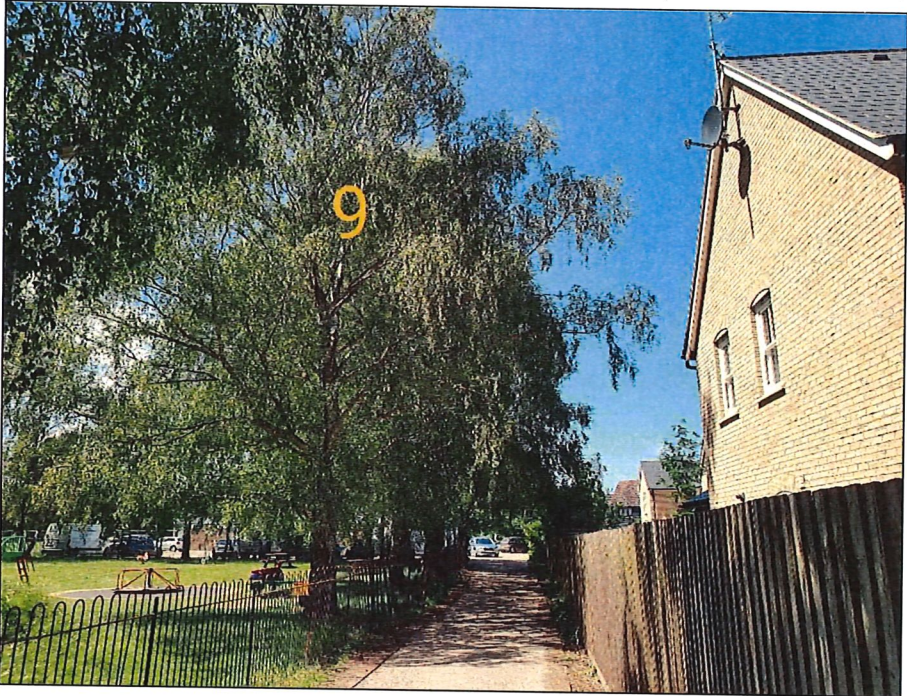
- Below: Tree 9 (Birch) – Over-extended limbs growing towards houses

Tree number	Map number / name	Species	Site	Tree surgery	Priority
9	INSET 2 The Moor play area	Birch	The Moor play area	Shorten over extended limbs on north side of crown (growing towards houses) by approximately 4 metres	2
11	INSET 2 The Moor play area	Birch	The Moor play area	Shorten over extended limbs on north side of crown (growing towards houses) by approximately 4 metres	2
64	Royston Road	Lombardy Poplar	Royston Road	Remove dead wood	2

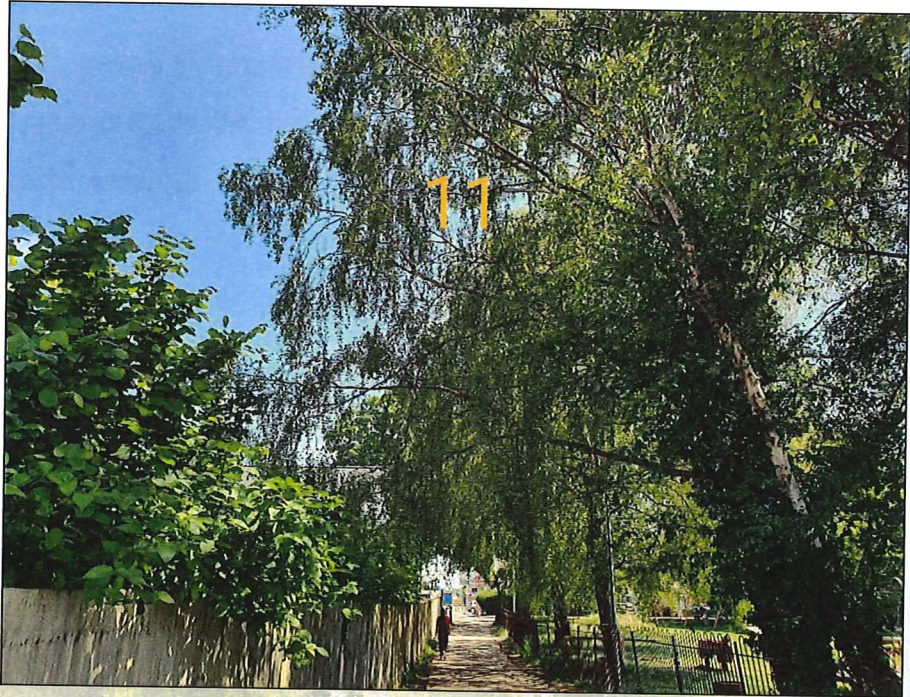
- Below: Tree 11 (Birch) – Over-extended limbs growing towards houses

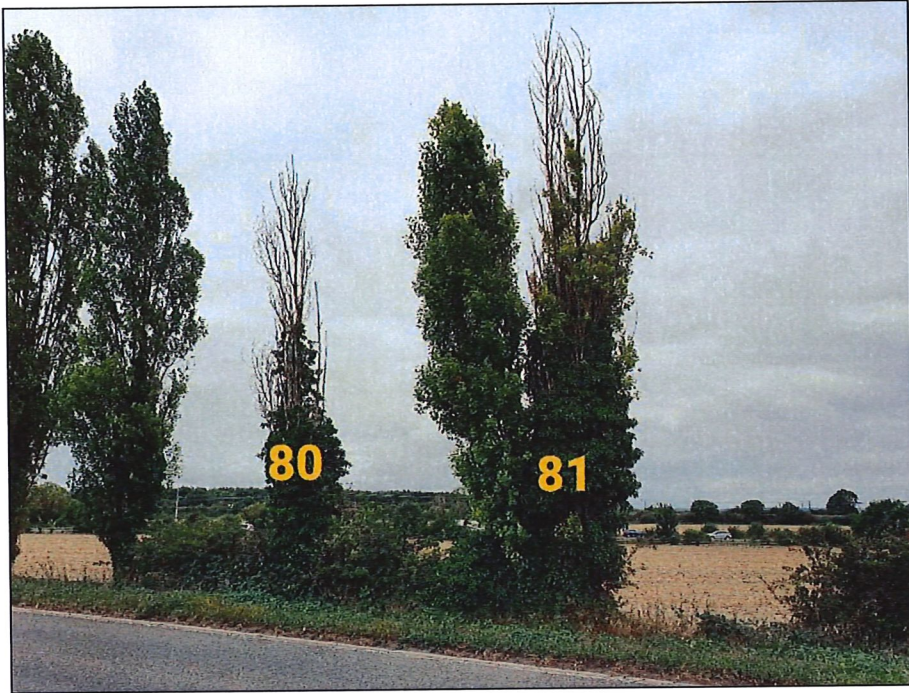
- Below: Trees 80 & 81 (Poplar) – Tree 80 is dead. Tree 81 is partially dead and has a precarious ‘subsiding’ stem leaning over the road

80	Royston Road	Lombardy Poplar	Royston Road	Fell to ground level	2
81	Royston Road	Lombardy Poplar	Royston Road	Fell to ground level	2
82	Royston Road	Lombardy Poplar	Royston Road	Remove dead wood	2
85	Royston Road	Lombardy Poplar	Royston Road	Fell to ground level	2
86	Royston Road	Lombardy Poplar	Royston Road	Fell to ground level	2
90	Royston Road	Lombardy Poplar	Royston Road	Fell to ground level	2

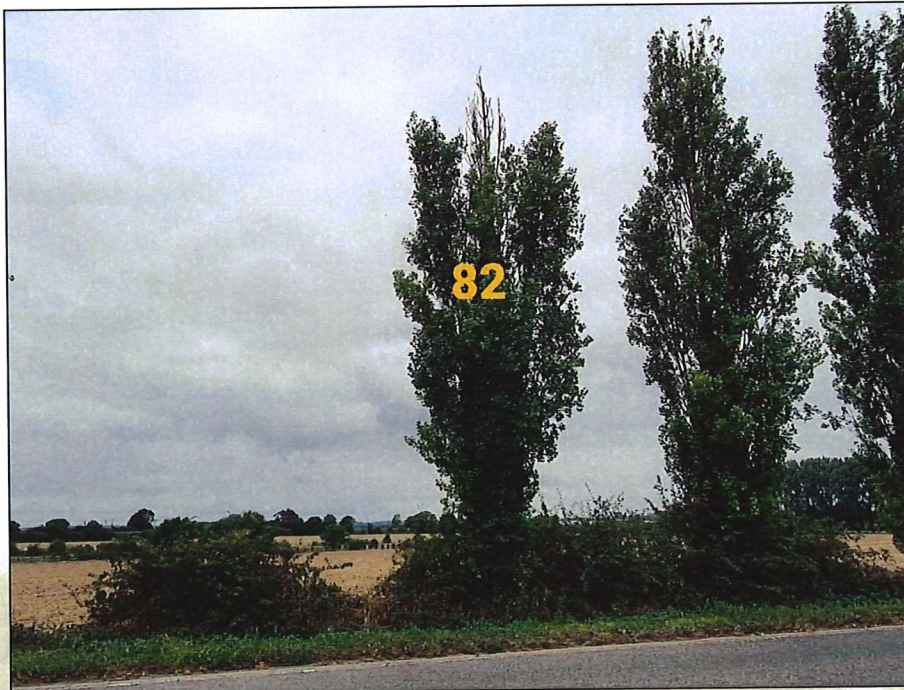
- Below: Tree 82 (Poplar) – Dieback in upper crown

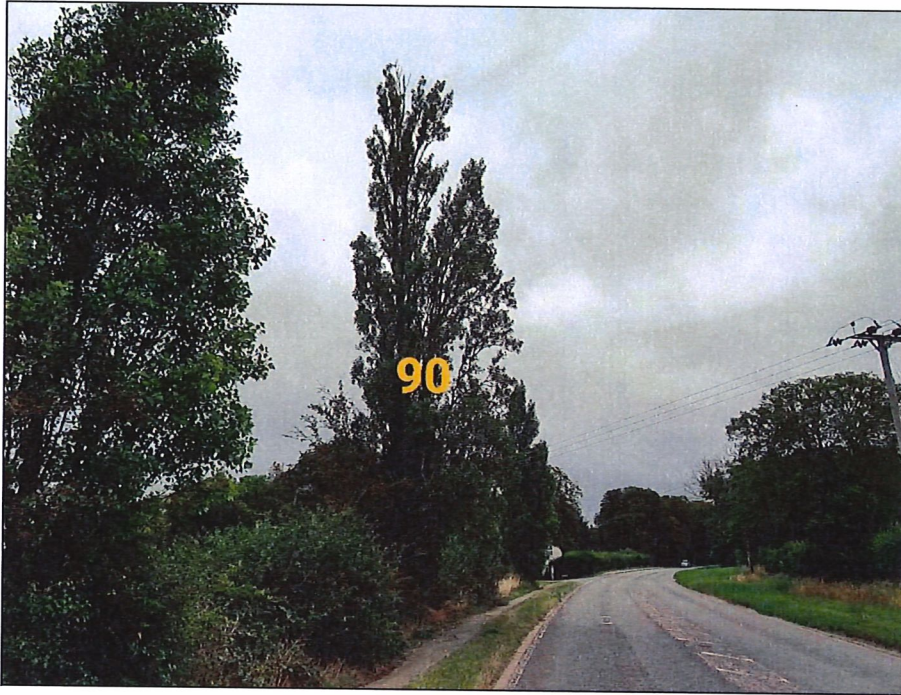
- Below: Tree 90 (Poplar) – Dying back and large ‘subsiding’ stem leaning over the road

90	Lombardy Poplar	15	400	4	Mature	Crown - Fair, Stem - Fair, Basal Area - Fair Fell Dieback in top and moderate dead wood throughout. Dense Ivy on trunk. Large subsiding co-dominant leader on south east side leaning towards road with risk of snapping out	2	1
91	Lombardy Poplar	6	125	0.5	Mature	Crown - Poor, Stem - Fair, Basal Area - Fair No action Stunted. Dense Ivy on trunk	0	1
92	Lombardy Poplar	14	400	3	Mature	Crown - Good, Stem - Fair, Basal Area - Fair No action Dense Ivy on trunk	0	1
