Post Installation Report

The Moor Play Area

Land East of the Moor, Melbourn, Royston, SG8 6ED

Inspection Ref: 1552746

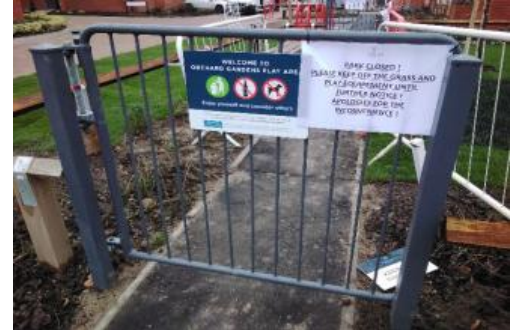
Item: Gate - Self Closing
Manufacturer: Not Identified
Surface Type: Tarmac
Item Quantity: 1
Equipment Compliance: N/A
Surface Area Compliance: N/A

This item is satisfactory - no work required -

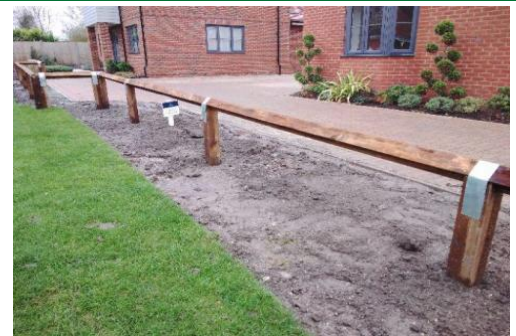
Item: Fencing - Post & Rail
Manufacturer: Not Identified
Surface Type: N/A
Item Quantity: 1
Equipment Compliance: N/A
Surface Area Compliance: N/A

The corner sections have not been secured - Refer to the contractor

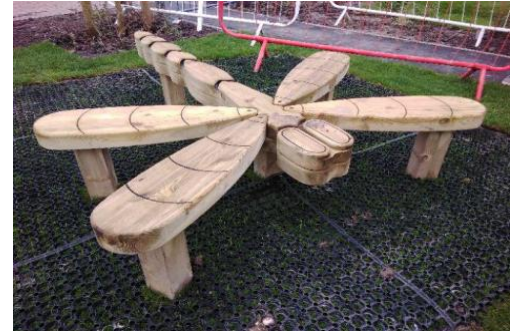
Item: Wetpour Animal
Manufacturer: Hand Made Places
Surface Type: Grass Matrix Tiles
Item Quantity: 1
Equipment Compliance: No
Surface Area Compliance: Yes

The tree forms a hard object within the falling space of the equipment in contravention of the requirements of BS EN 1176 Part 1 (Distance required 1.50m / Provided 1.02m) - Refer to the contractor / designer

The planting forms a hard object within the falling space of the equipment in contravention of the requirements of BS EN 1176 Part 1 (Distance required 1.50m / Provided 0.92m) - Refer to the contractor / designer

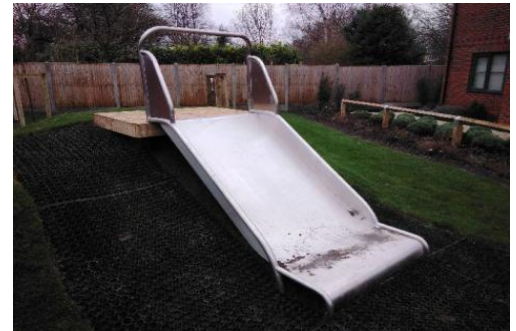
Item: Embankment Slide
Manufacturer: KBT
Surface Type: Grass Matrix Tiles
Item Quantity: 1
Equipment Compliance: Yes
Surface Area Compliance: Yes

The edges of the grass mat surface have not been installed in accordance with the API Code of Practice - Tuck in edges of grass mat to remove trip hazards

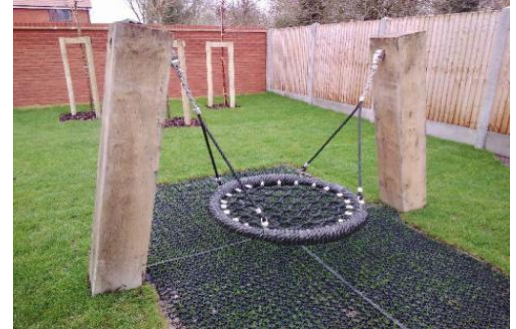
Item: Mini Basket Swing
Manufacturer: Playequip
Surface Type: Grass Matrix Tiles
Item Quantity: 1
Equipment Compliance: No
Surface Area Compliance: Yes

The seat clearance from finished surface level to the underside of the seat is too low at 60mm when measured in its most onerous position and does not meet the requirements of BS EN 1176 Part 2 - Install seats to a minimum height of 400mm for Group Swing Seats

Swings of this design should have a secondary safety device fitted to prevent collapse of the seat in the event of a joint failure to meet the requirements of BS EN 1176 Part 2. NOTE - this is due to the pivot height being marginally over 1.30m (1.35m) as this requirement is not valid for pivots under 1.30m - No action given the risk assessment

The seats are too close to the frame as defined in BS EN 1176 Part 2; (Required 608mm / Provided 390mm) - Refer to the manufacturer

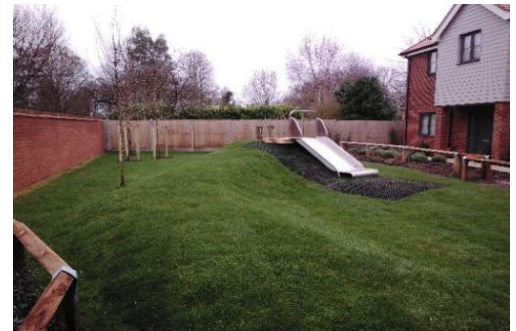
Item: Site General
Manufacturer: Owner/Operator
Surface Type: N/A
Item Quantity: 1
Equipment Compliance: N/A
Surface Area Compliance: N/A

There is the potential for users to impact the tree during falls from the mound - Refer to the designer

There is a 300mm gap between gate and fence - Refer to the contractor / designer

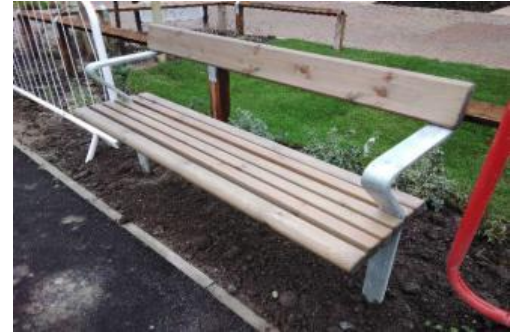
Item: Bench
Manufacturer: Not Identified
Surface Type: Soil
Item Quantity: 1
Equipment Compliance: N/A
Surface Area Compliance: N/A

This item is satisfactory - no work required -

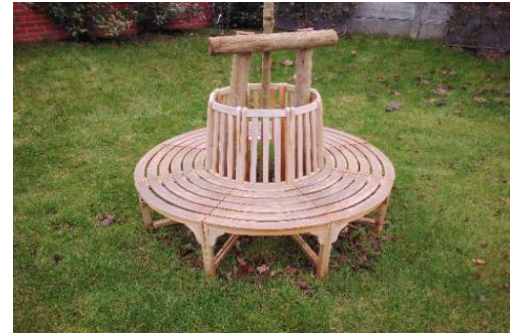
Item: Bench
Manufacturer: Not Identified
Surface Type: Grass
Item Quantity: 1
Equipment Compliance: N/A
Surface Area Compliance: N/A

The bench tops have not been secured into position -
 Secure

The bench is not securely fixed to the surface - Secure the
 bench to the ground

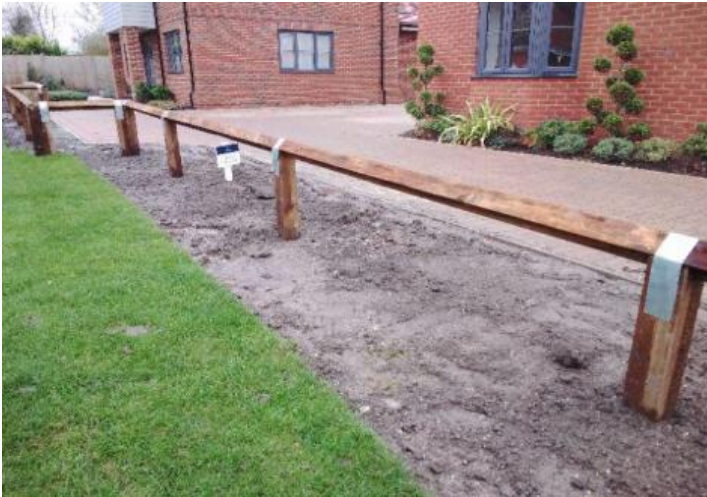
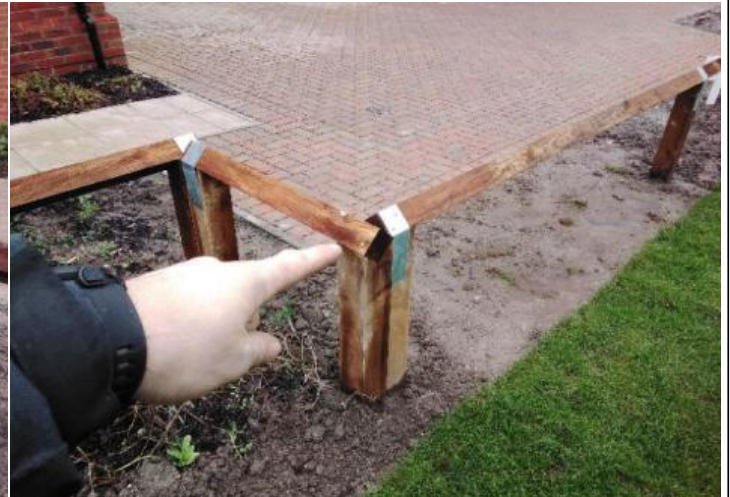
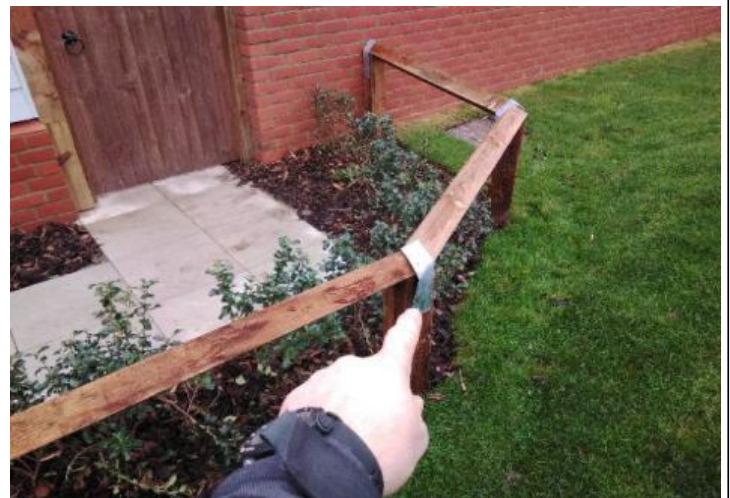
Item: Fences - Fencing - Post & Rail
Manufacturer: Not Identified

Finding: The corner sections have not been secured

Action: Refer to the contractor

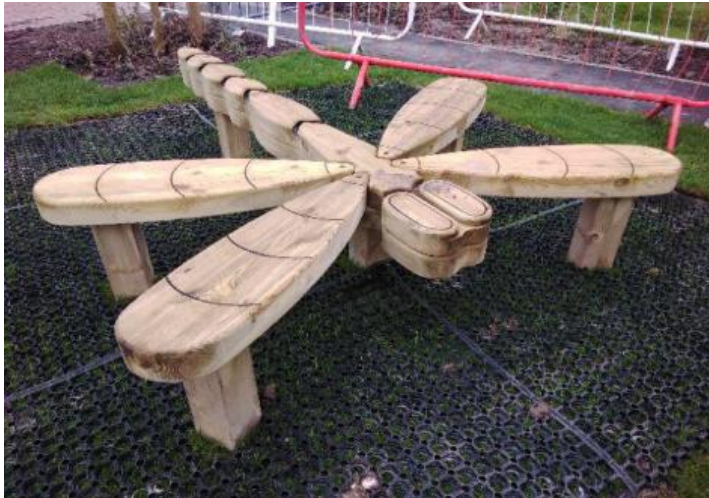
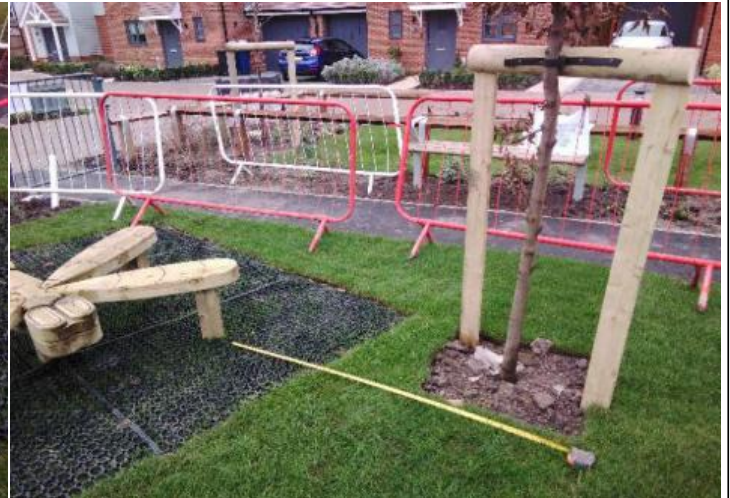
Item: Other - Wetpour Animal
Manufacturer: Hand Made Places

Finding: The tree forms a hard object within the falling space of the equipment in contravention of the requirements of BS EN 1176 Part 1 (Distance required 1.50m / Provided 1.02m)

Action: Refer to the contractor / designer

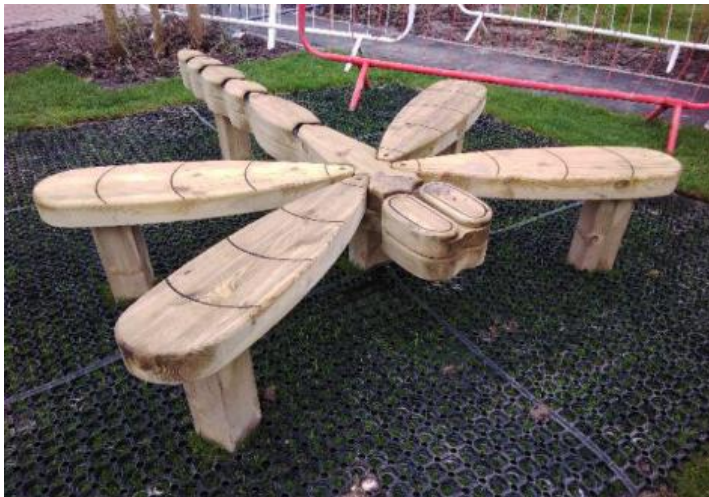
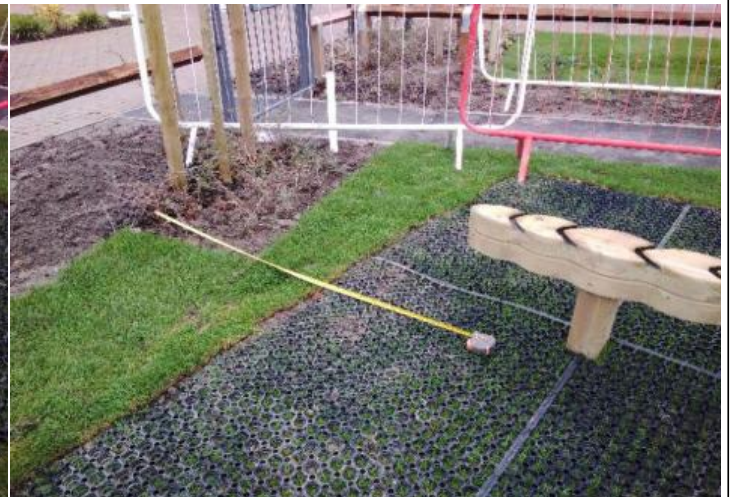
Item: Other - Wetpour Animal
Manufacturer: Hand Made Places

Finding: The planting forms a hard object within the falling space of the equipment in contravention of the requirements of BS EN 1176 Part 1 (Distance required 1.50m / Provided 0.92m)

Action: Refer to the contractor / designer

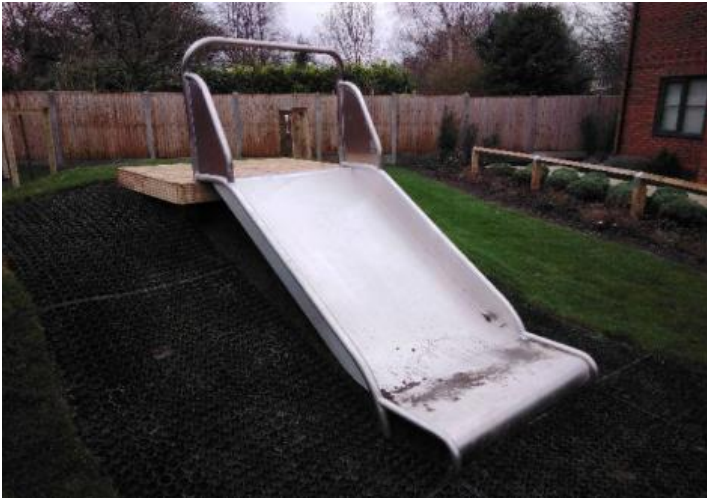
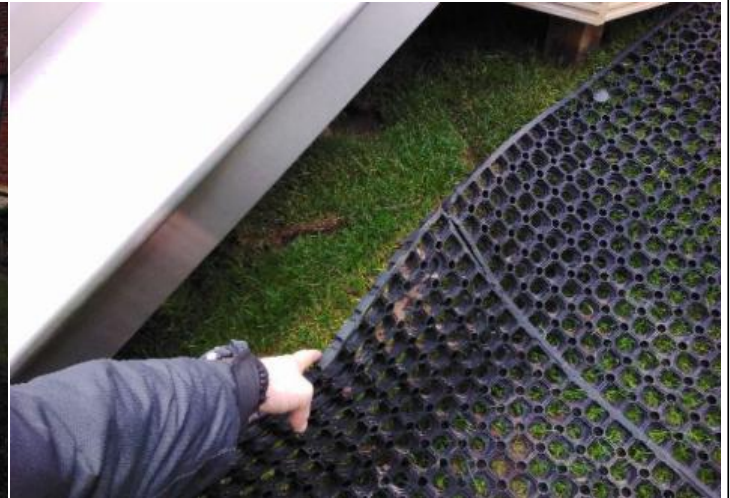
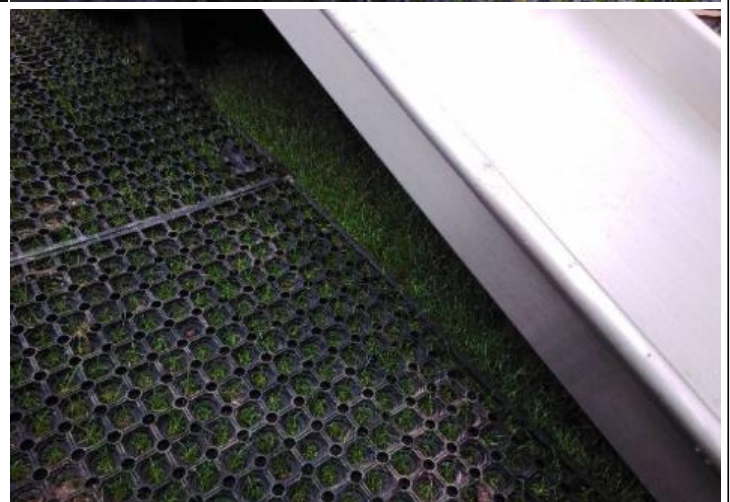
Item: Other - Embankment Slide
Manufacturer: KBT

Finding: The edges of the grass mat surface have not been installed in accordance with the API Code of Practice
Action: Tuck in edges of grass mat to remove trip hazards

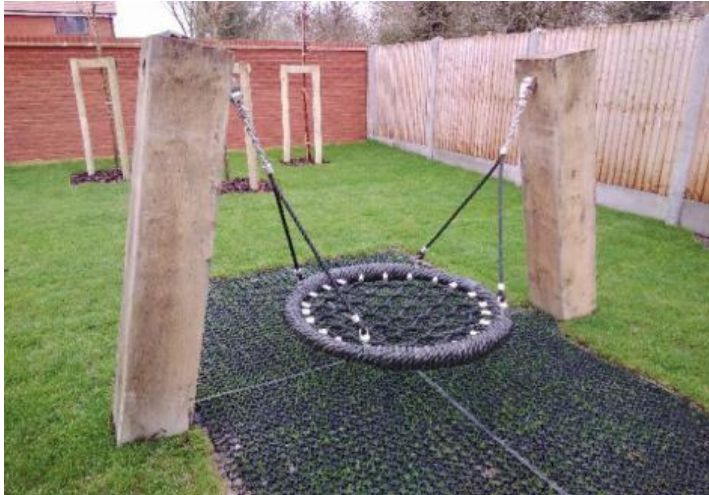
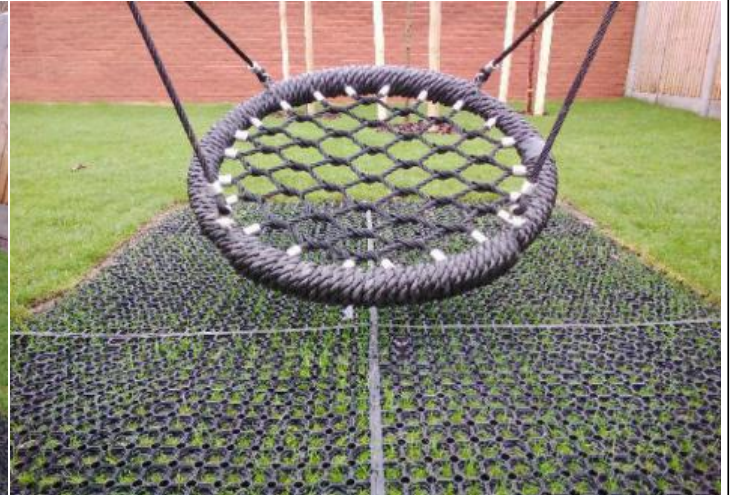
Item: Swings - Mini Basket Swing
Manufacturer: Playequip

Finding: The seat clearance from finished surface level to the underside of the seat is too low at 60mm when measured in its most onerous position and does not meet the requirements of BS EN 1176 Part 2

Action: Install seats to a minimum height of 400mm for Group Swing Seats

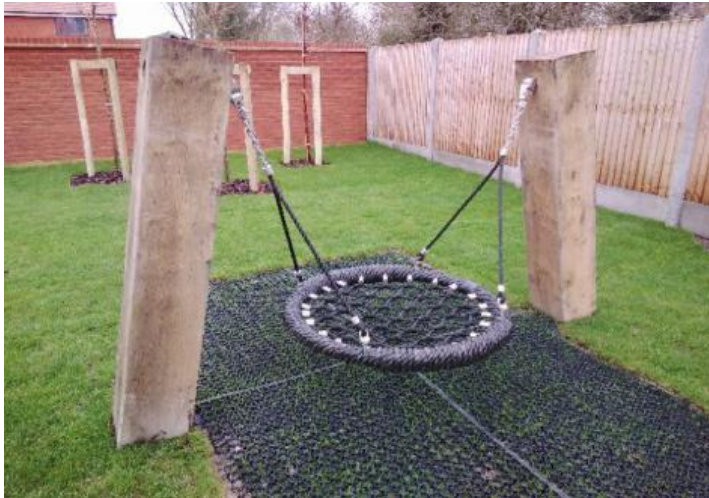
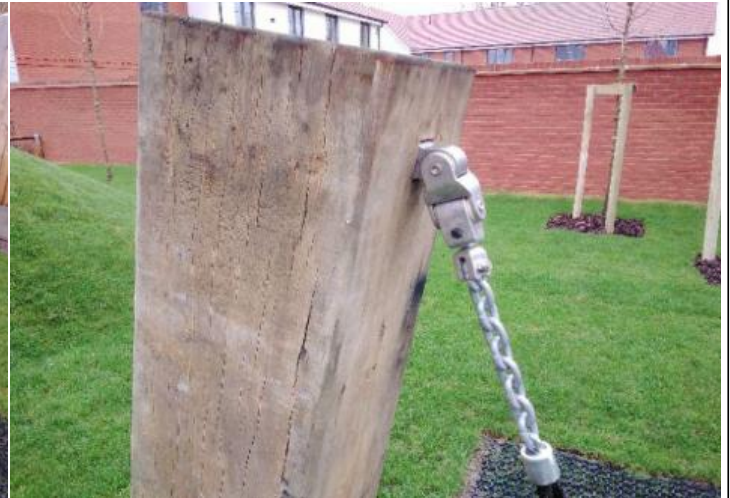
Item: Swings - Mini Basket Swing
Manufacturer: Playequip

Finding: Swings of this design should have a secondary safety device fitted to prevent collapse of the seat in the event of a joint failure to meet the requirements of BS EN 1176 Part 2. NOTE - this is due to the pivot height being marginally over 1.30m (1.35m) as this requirement is not valid for pivots under 1.30m

Action: No action given the risk assessment

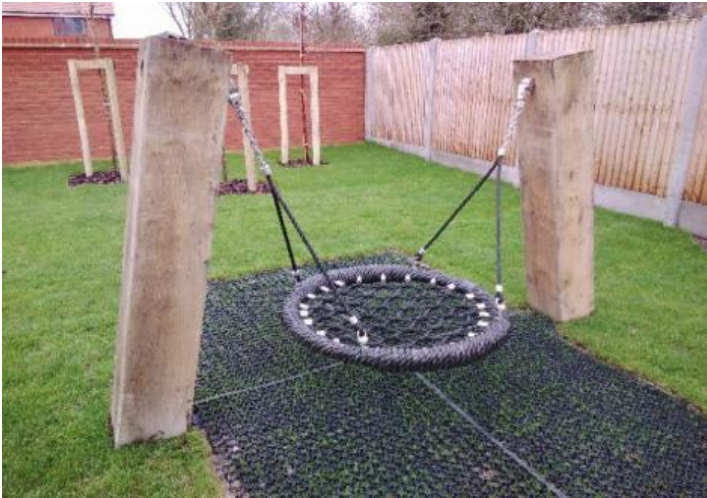
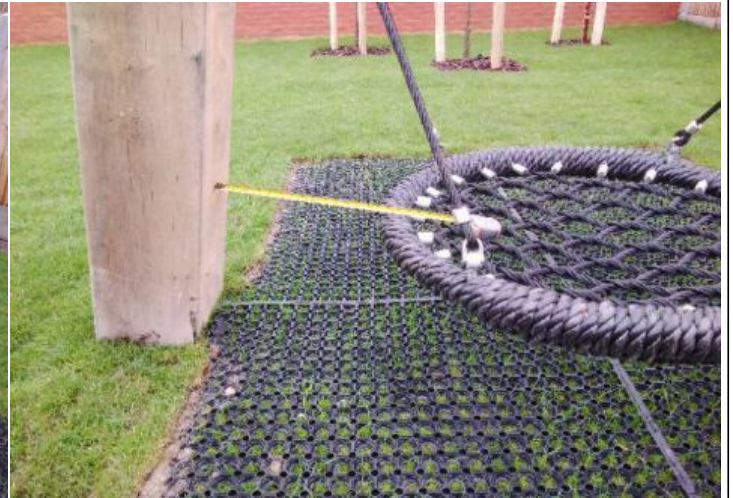
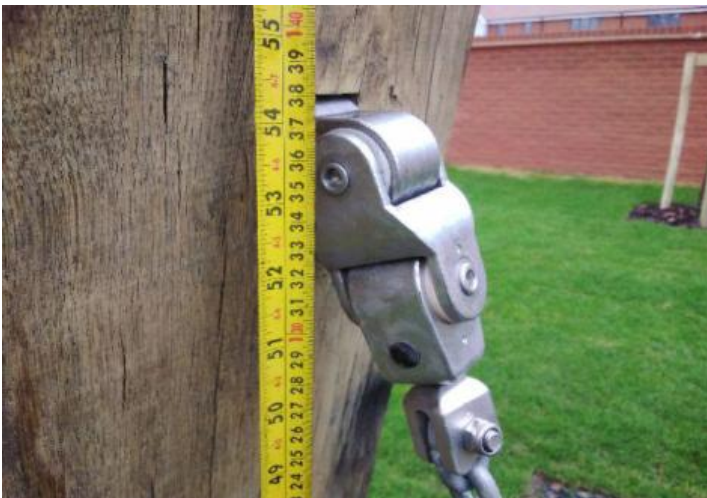
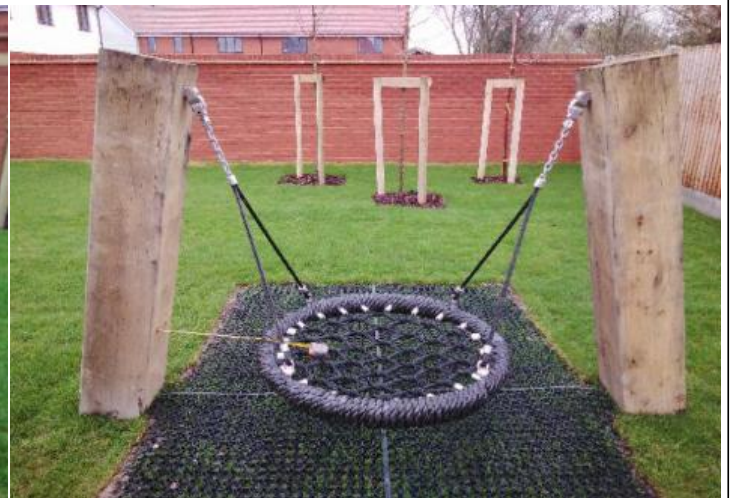
Item: Swings - Mini Basket Swing
Manufacturer: Playequip

Finding: The seats are too close to the frame as defined in BS EN 1176 Part 2; (Required 608mm / Provided 390mm)

Action: Refer to the manufacturer

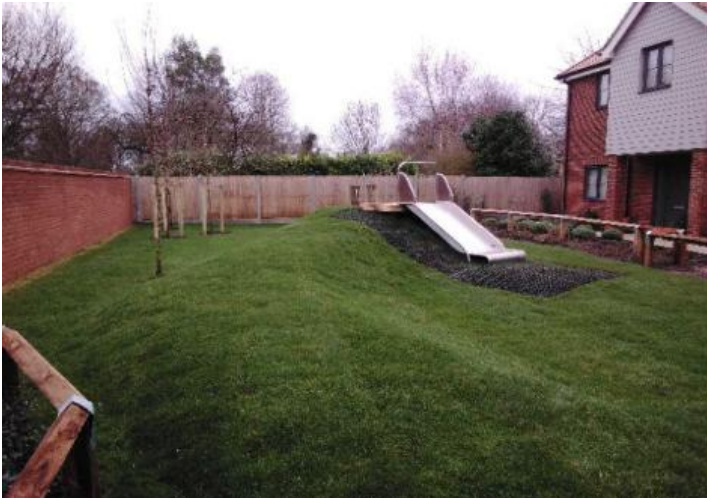
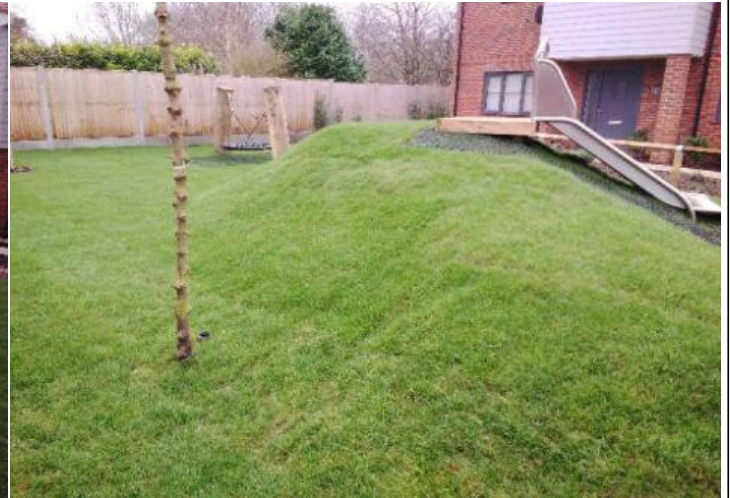
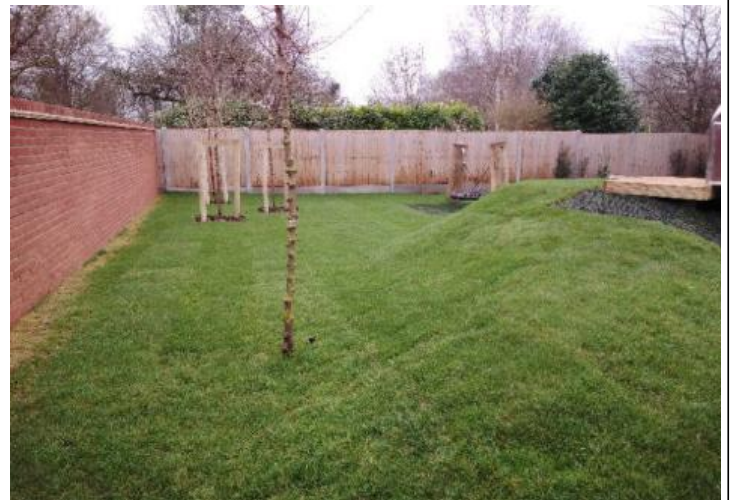
Item: Ancillary Items - Site General
Manufacturer: Owner/Operator

Finding: There is the potential for users to impact the tree during falls from the mound

Action: Refer to the designer

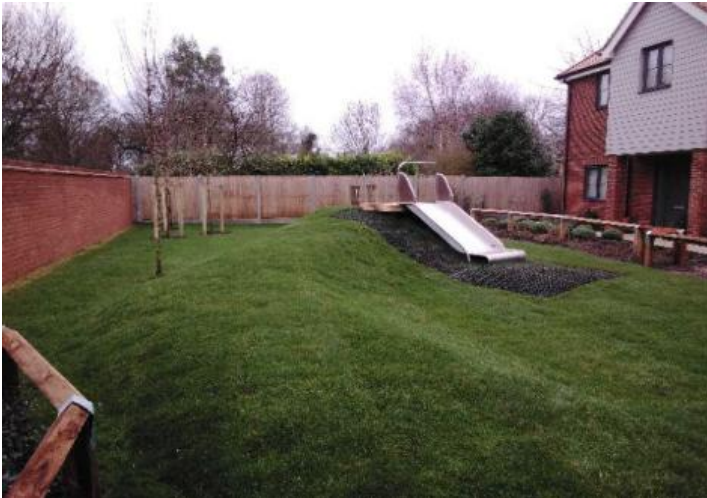
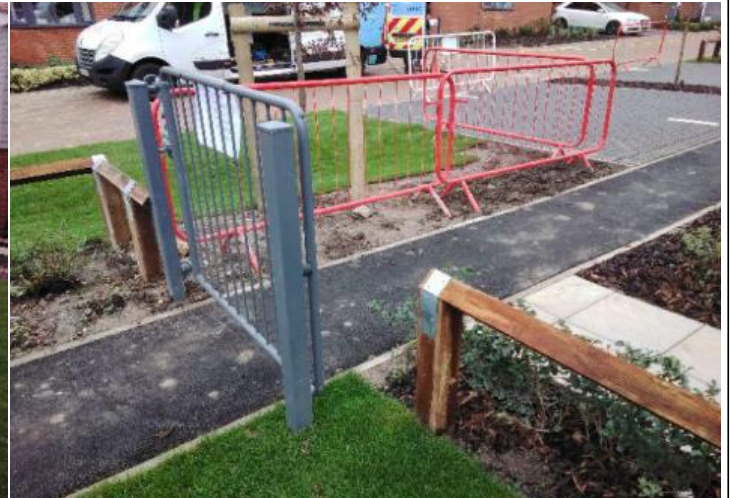
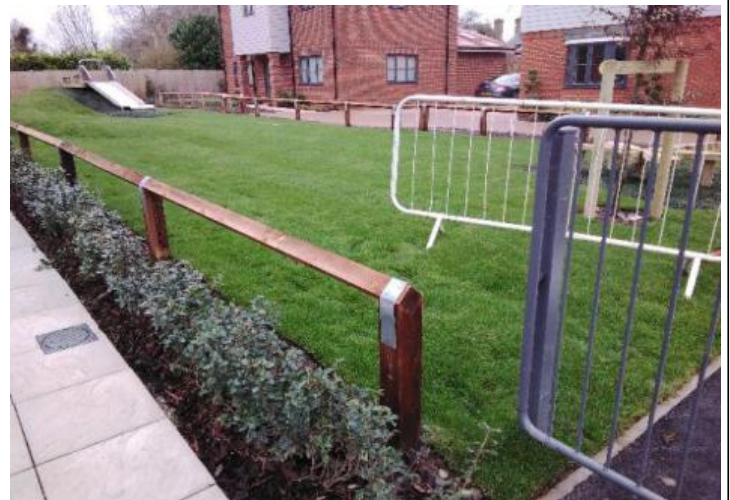
Item: Ancillary Items - Site General
Manufacturer: Owner/Operator

Finding: There is a 300mm gap between gate and fence

Action: Refer to the contractor / designer

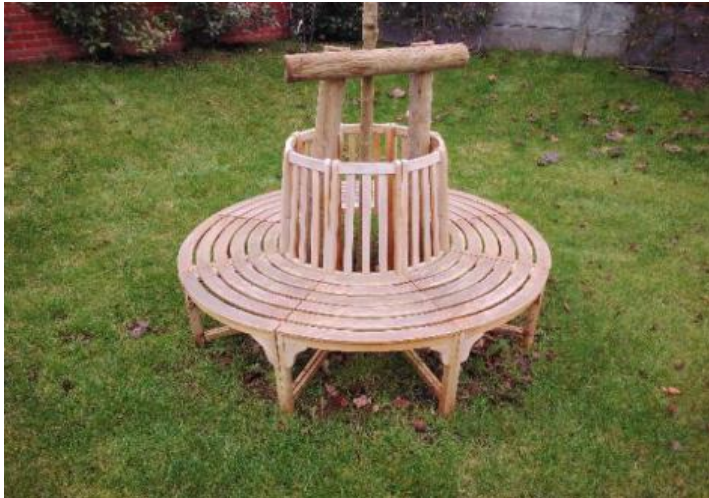
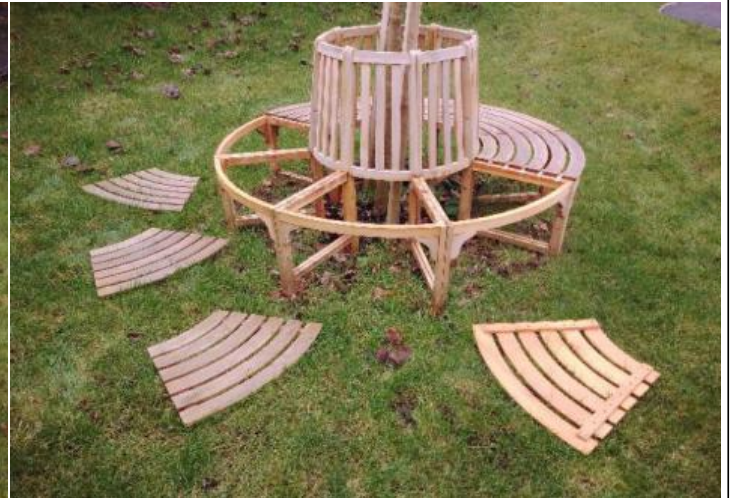
Item: Ancillary Items - Bench
Manufacturer: Not Identified

Finding: The bench tops have not been secured into position

Action: Secure

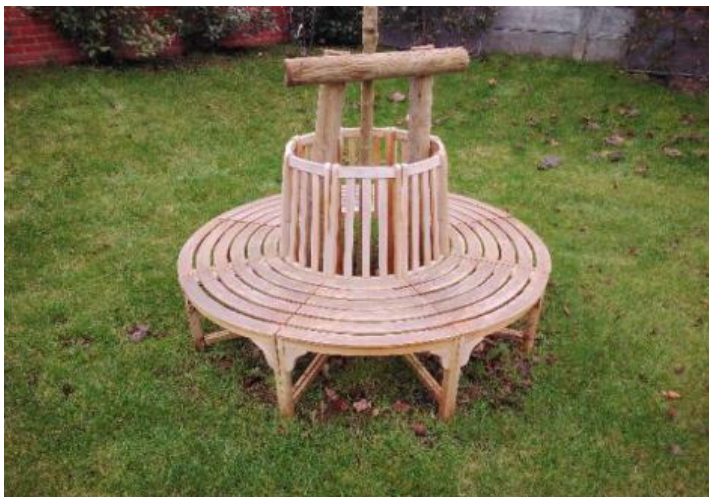
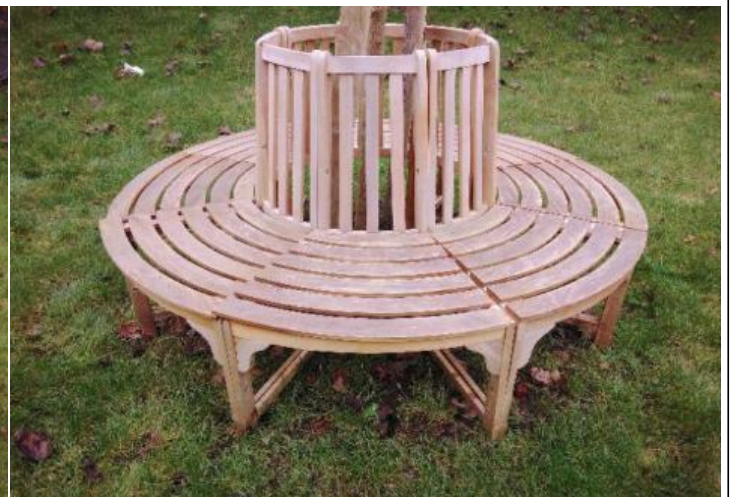
Item: Ancillary Items - Bench
Manufacturer: Not Identified

Finding: The bench is not securely fixed to the surface

Action: Secure the bench to the ground
