# Safety Inspection Report

## Clear Crescent Play Area

Melbourn Parish Council

26 April 2022

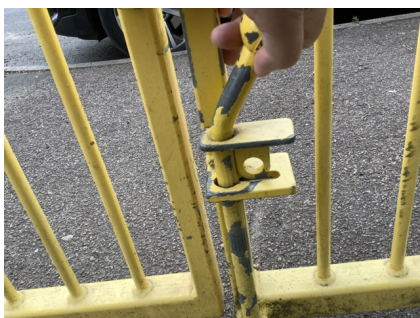
The item is unlocked.

The maintenance gate is not locked and could be opened by the public.

Lock.

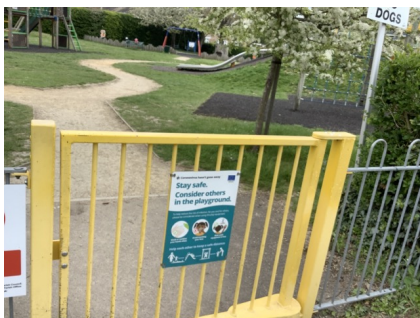
Dog ban & ownership signs recommended.

Operator signs should be installed at each entrance with the correct information on them, operator's name and contact number etc. please see link attached. [www.rospa.com/Play-Safety/Advice/Signs.aspx](http://www.rospa.com/Play-Safety/Advice/Signs.aspx)

See <https://www.rospa.com/en/Play-Safety/Advice/Signs>

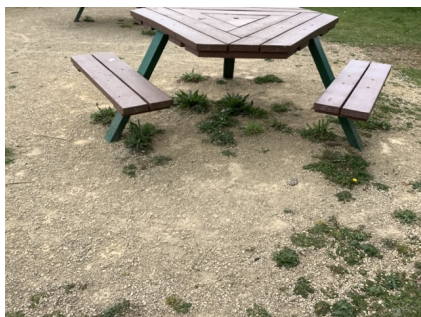
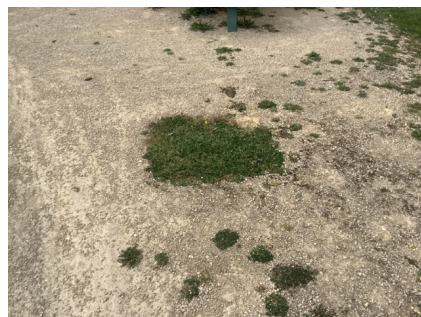
Surface has unintended grass, moss or weeds.

Grass and weeds growing inside pathway. Remove.

Remove.

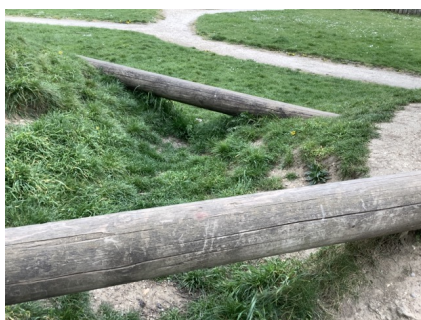
The timber components are slippery.

Log balance beams slippery when wet.

Remove slipperiness. Consider adding surface texture.

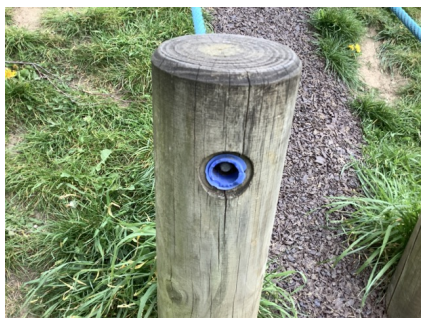
Bolt cap damaged.

Replace.

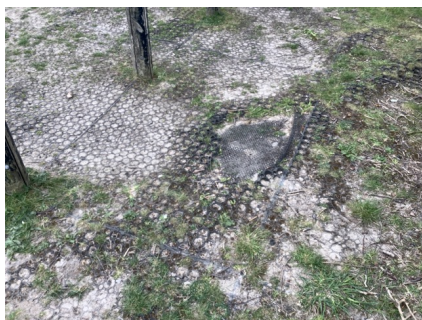
Surface needs repair.

Grass mats are damaged - replace.

Replace.

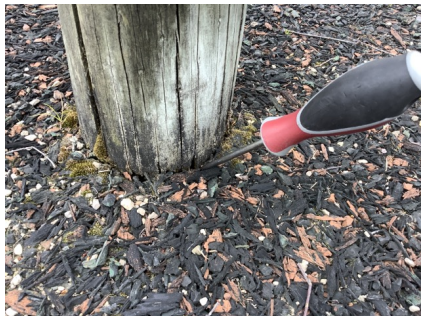
There is decay to timber components which may affect structural integrity. We do not recommend replacing rotten supports with timber posts which are directly set in the ground due to the increased problem of timber rot, especially in posts in contact with the ground.

One post is showing signs of softening and decay at ground level - monitor.

Read the notes for further action.

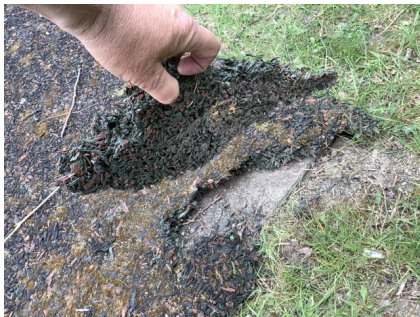
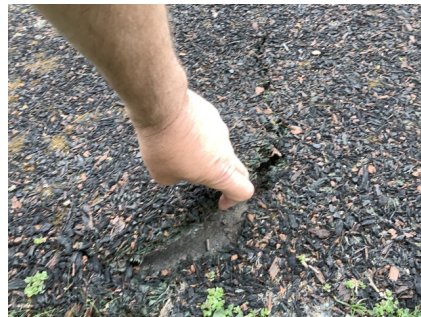
The surface is cracking.

The surfacing has cracked.

Repair.

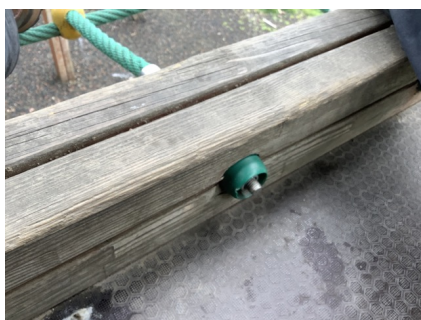
Cap missing.

Cap plug missing exposing the thread - replace.

Replace.

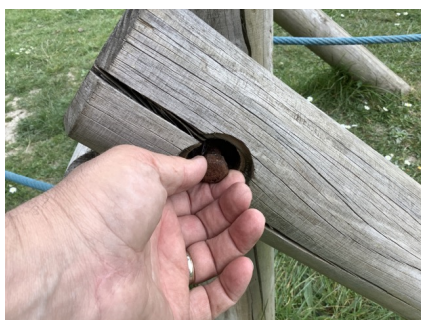
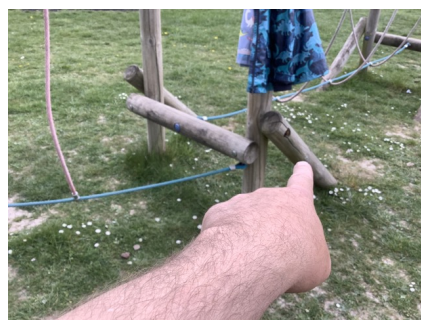
Bolt(s) loose.

Burma bridge bolt loose.

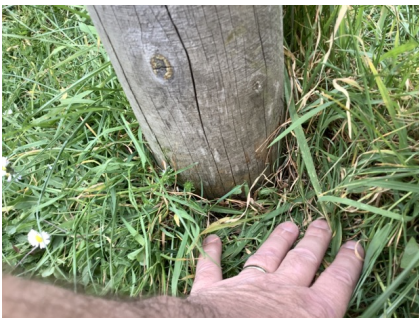
Strimmer damage to supports is likely to accelerate timber rot.

Prevent further damage.

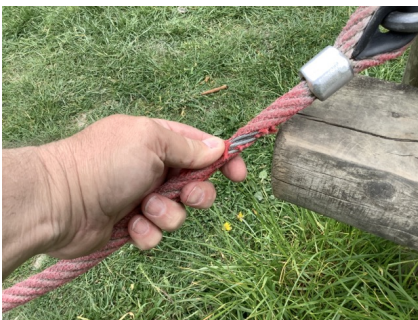
The rope is rubbing on the balance beam and wearing down to the wire - monitor for broken wires and replace if found.

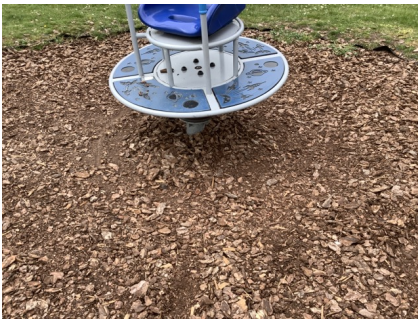
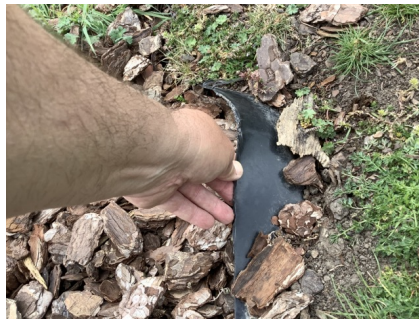
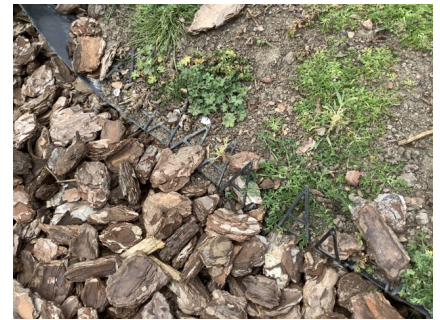
Surface needs repair.

The surfacing has worn away exposing and damaging the liner beneath. Grass & weeds have grown inside. The plastic edging strips are sharp - the whole area requires immediate repairs and alterations. Bark requires topping up.

Repair.

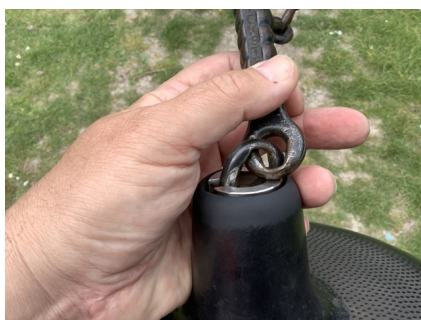
Chains links worn.

Chain link and seat connector worn.

Replace the worn parts.

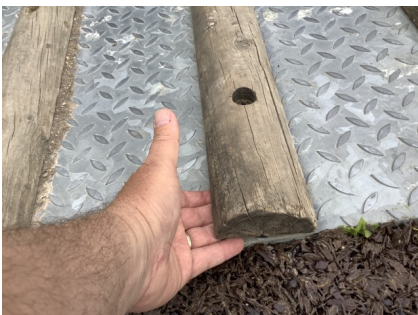
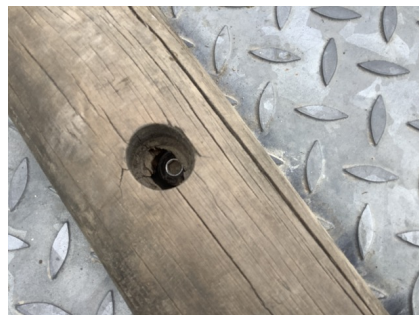
Fixtures loose or missing.

Log rung loose to the ramp. Secure.

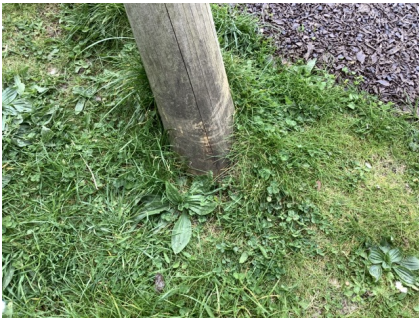
Strimmer damage to supports is likely to accelerate timber rot.

Prevent further damage.

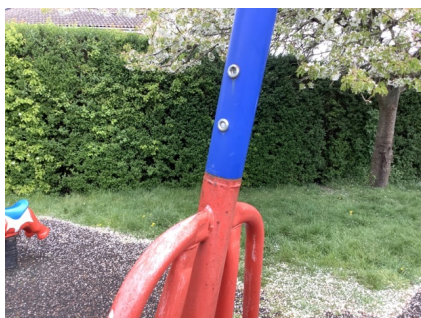
Wicksteed recommend that during routine inspections the area on the swing where the side frames meet the vertical support be checked for any cracks. In the event of cracks being found then remove the seats and contact Wicksteed for further advice.

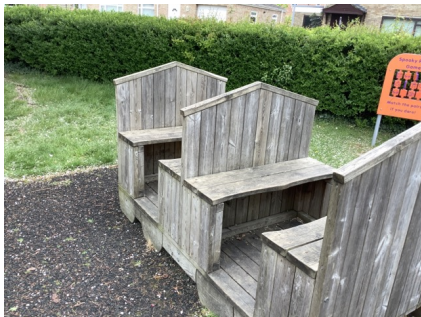
Fixtures loose or missing.

Seat rest panels loose - secure.

Tighten/replace.

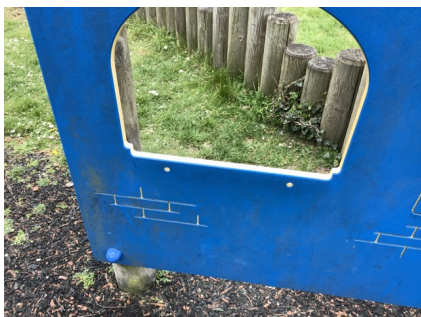
Item has some parts missing.

Shop shelf missing.

Replace the missing parts.

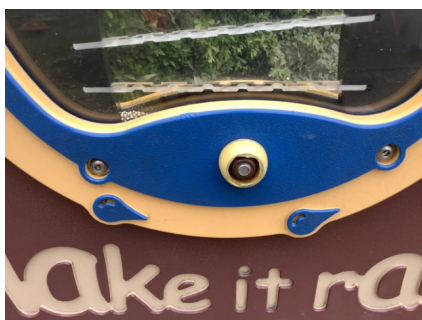
Bolt cap damaged.

Replace.
