TREE HEALTH & SAFETY SURVEY & ARBORICULTURAL REPORT

Site at:
Orchard Road Cemetery
Melbourn
South Cambridgeshire

Job ref	Report Version	Author	Checked	Date
ATS0510	V1	IL	IL	September 2022

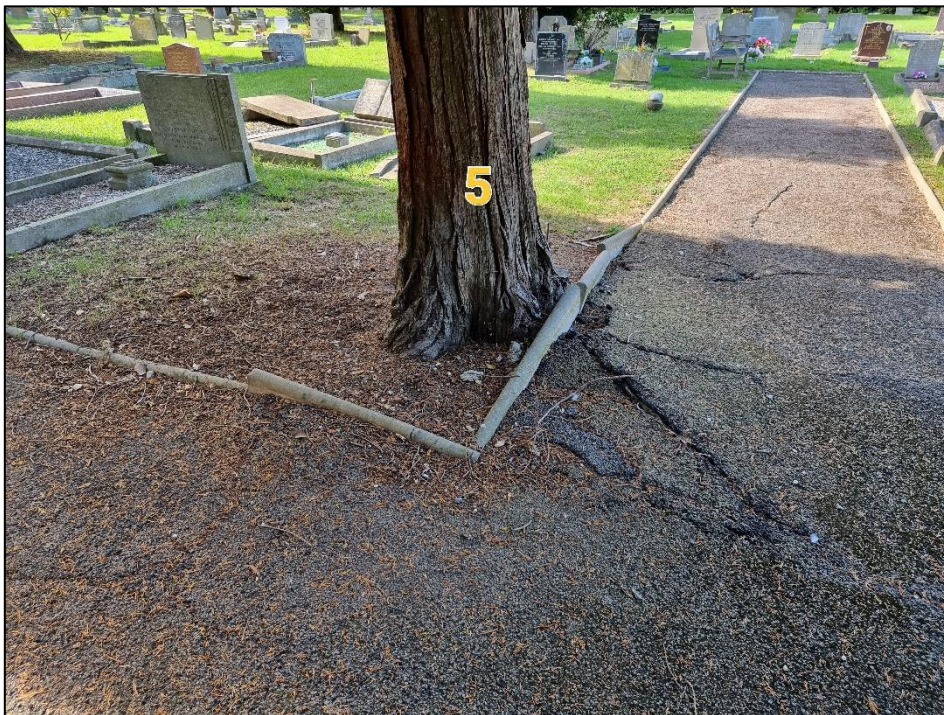
- Below: Tree 5 (Cypress) – Root damage to footpath

Site name: Orchard Road Cemetery, Melbourn Surveyor: Ian Lorman			Date of survey: 14 th September 2022 Conditions: Clear / dry / still					
Tree number	Species	Height estim (m)	Stem Diam (s) estim (mm) No. of	Crown spread Ave rad estim (m)	Life stage	Observations; structural / physiological condition and any tree work recommendations	Priority / urgency of work	Zone value
1	Irish Yew	7.5	300	2.5	Mature	Crown - Good, Stem - Good, Basal Area - Good No action No notable defects	0	2
2	Common Holly	6	200 175	5	Mature	Crown - Good, Stem - Good, Basal Area - Good No action Twin stem from base	0	2
3	Lawson's Cypress	11	500	5	Mature	Crown - Good, Stem - Good, Basal Area - Good No action No notable defects	0	2
4	Lawson's Cypress	12	550	6	Mature	Crown - Good, Stem - Good, Basal Area - Good No action No notable defects	0	2
5	Lawson's Cypress	11	500	4	Mature	Crown - Good, Stem - Good, Basal Area - Good No action Causing significant damage to footpath	0	2

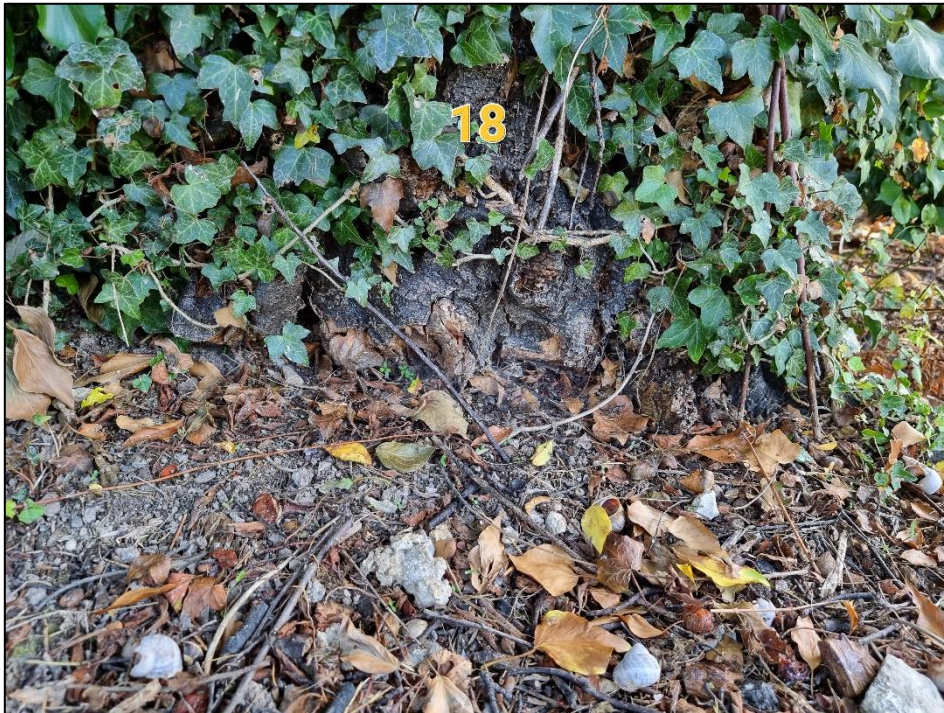
- Below: Tree 18 (Myrobalan Plum) – Decay at base

Tree number	Species	Tree surgery	Priority
13	Cypress	Sever Ivy	3
16	Birch	Sever Ivy	3
18	Plum	Fell	2
38	Cherry	Shorten branches overhanging road by 3 metres	2
40	Sycamore	Crown reduce back to previous points at 12 metres height	3
41	Sycamore	Crown reduce back to previous points at 12 metres height	3

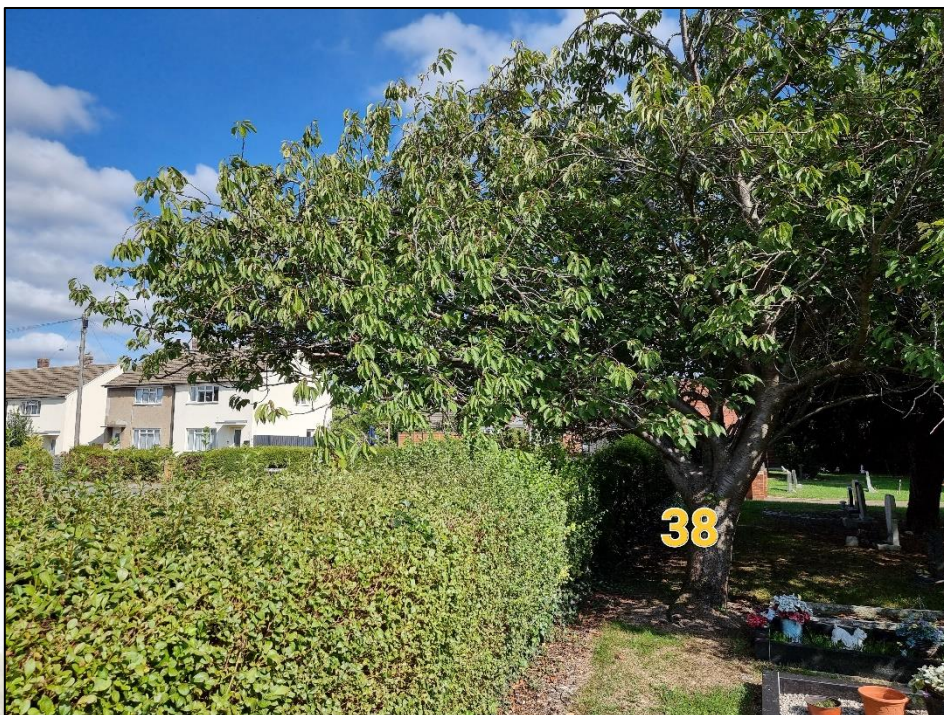
- Below: Tree 38 (Cherry) – Branches over-extended over road

37	Lawson's Cypress	10	600	7	Mature	Crown - Good, Stem - Good, Basal Area - Good No action Divides into multiple stems at 1.5 metres above ground level	0	2
38	Wild Cherry	7.5	450	9	Mature	Crown - Good, Stem - Good, Basal Area - Good Shorten branches overhanging road by 3 metres Excessively extended horizontal branches on northwest side projecting over highway	2	1
