the **play inspection** company

Annual Inspection

Melbourn Parish Council

The Moor Play Area

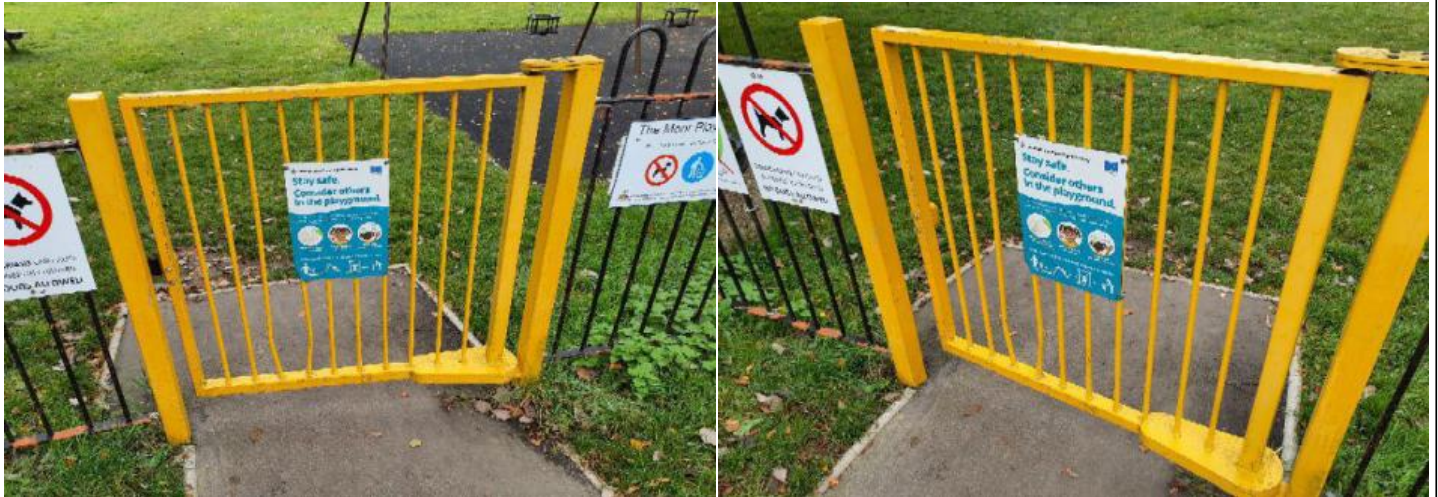
Item: Gates - Gate - Self Closing
Manufacturer: I.A.E. Fencing

Finding: The gate is closing too quickly (less than 4 seconds)

Action: Take corrective action to ensure that the gate closes in 4-8 seconds

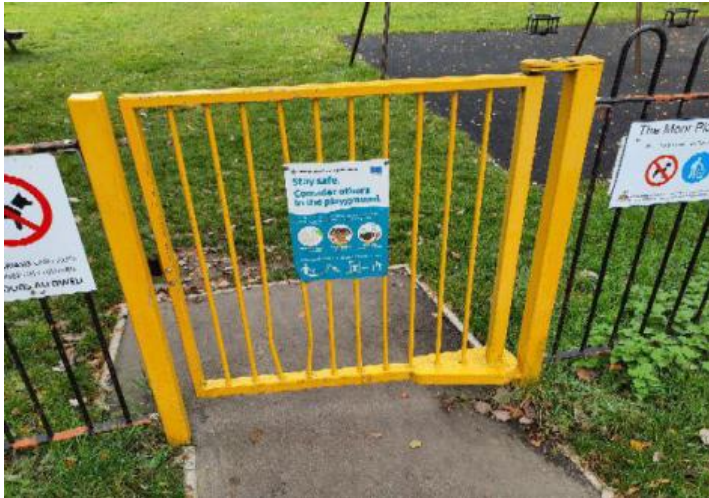
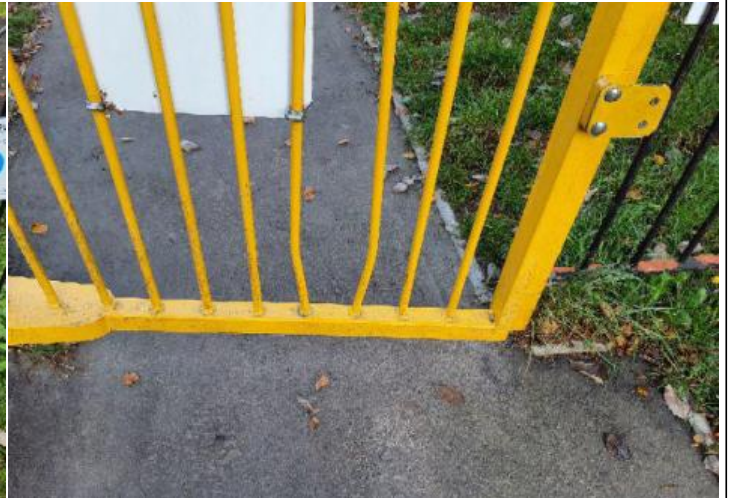
Item: Gates - Gate - Self Closing
Manufacturer: I.A.E. Fencing

Finding: There is some damage to the item

Action: Monitor for any further deterioration and repair as required

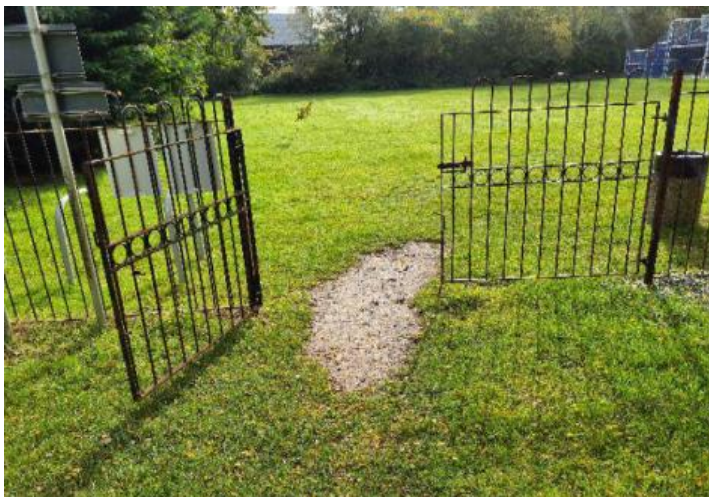
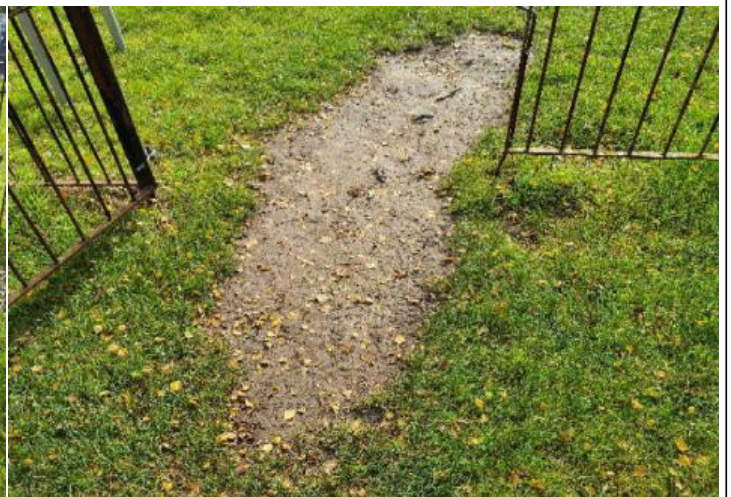
Item: Gates - Gate - Maintenance
Manufacturer: Not Identified

Finding: The surface has eroded in some areas and may be slippery in wet conditions

Action: Reinstate the surface

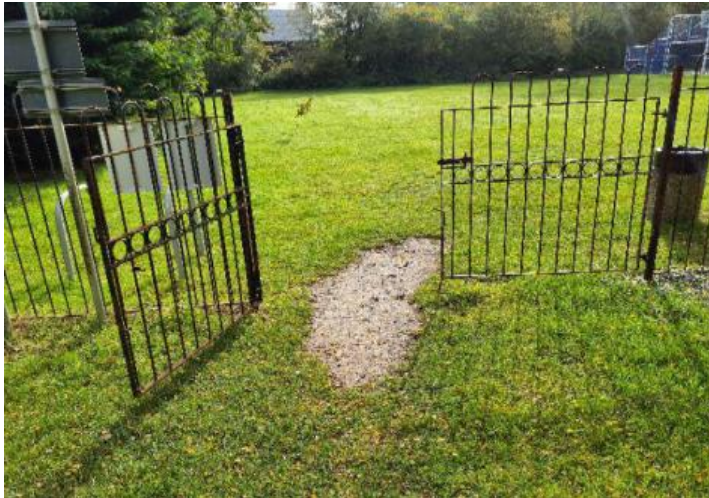
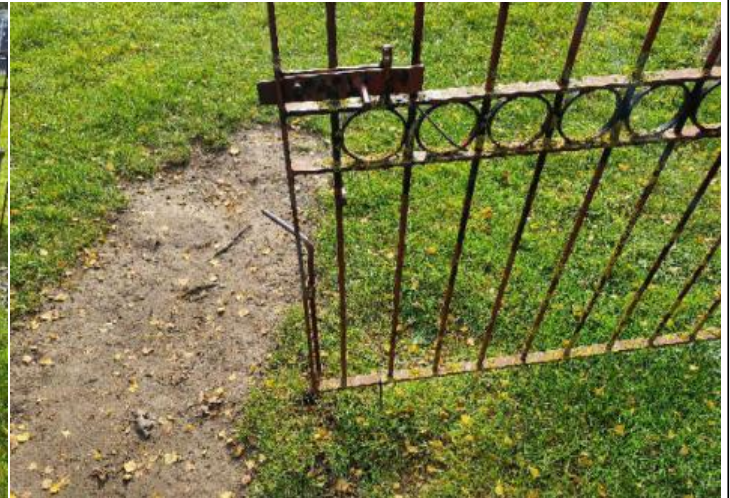
Item: Gates - Gate - Maintenance
Manufacturer: Not Identified

Finding: There is no padlock on the maintenance gate

Action: Provide a padlock to secure the gate

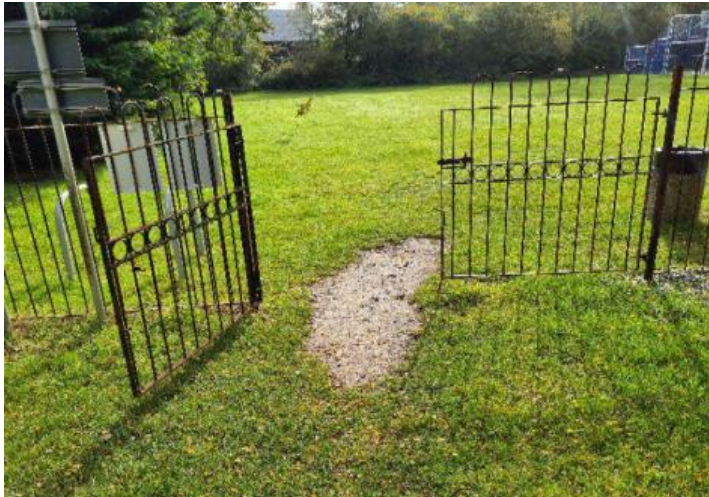
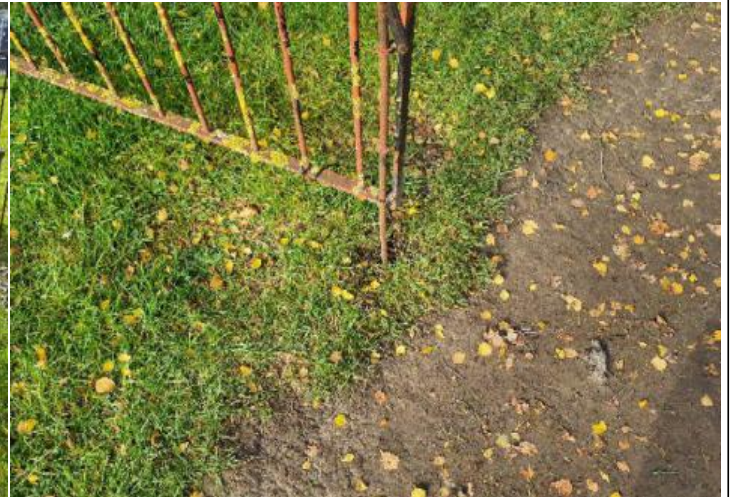
Item: Gates - Gate - Maintenance
Manufacturer: Not Identified

Finding: The gate has no drop bolt sleeves and/or drop bolts fitted

Action: Provide drop bolt sleeves and/or drop bolts

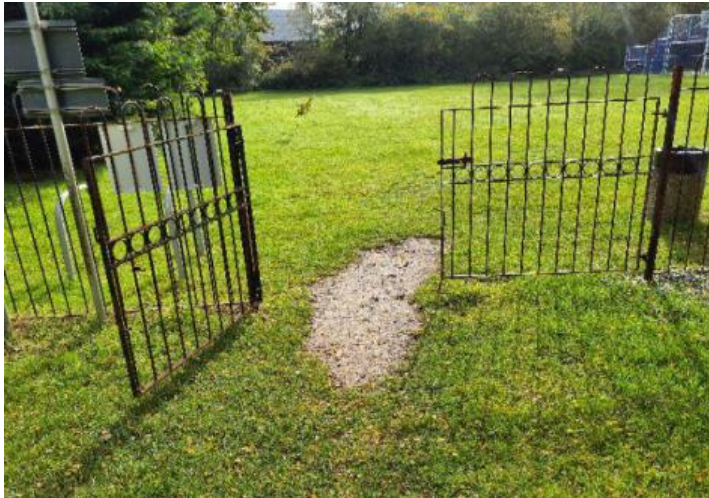
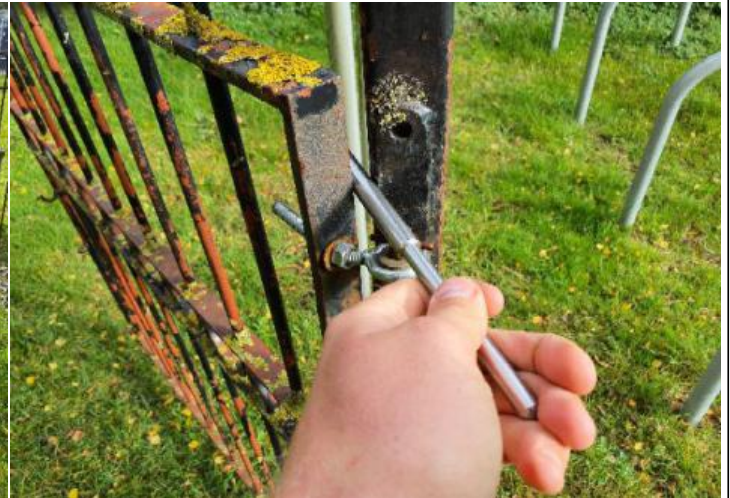
Item: Gates - Gate - Maintenance
Manufacturer: Not Identified

Finding: There are openings that are less than 12mm that could trap or crush fingers

Action: Provide a 12mm gap throughout full range of motion at both sides of gate

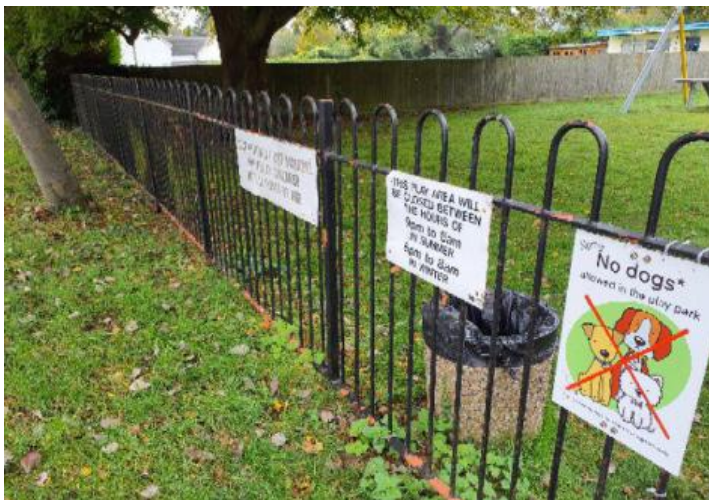
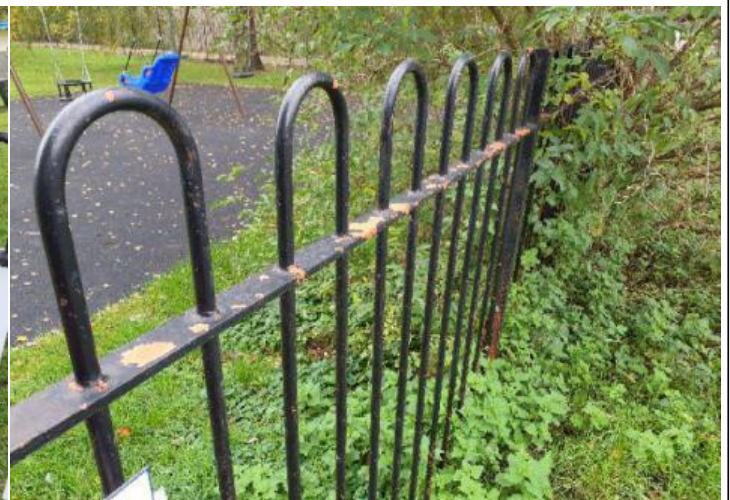
Item: Fences - Fence - Bow Top
Manufacturer: Not Identified

Finding: The paint is flaking off the metalwork

Action: Rub down and re-paint

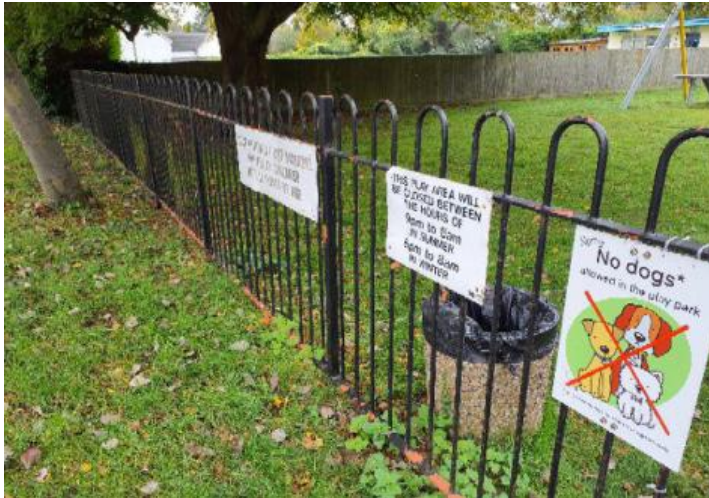
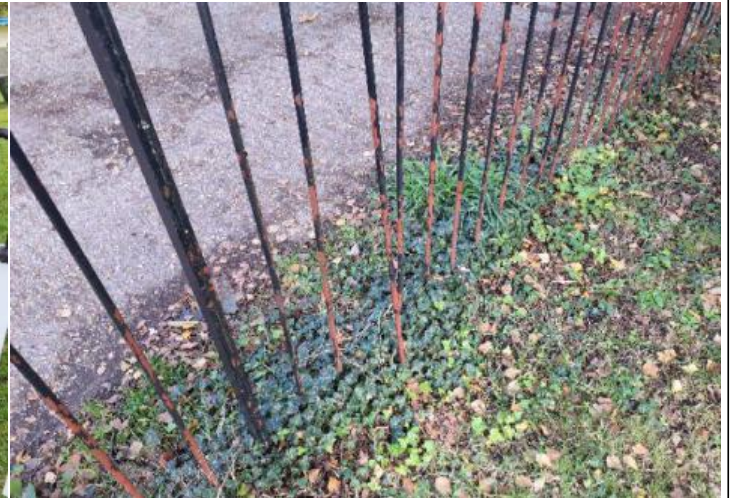
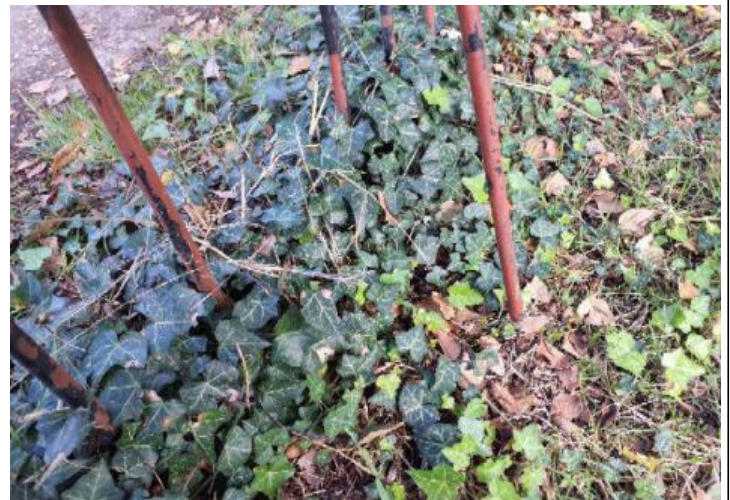
Item: Fences - Fence - Bow Top
Manufacturer: Not Identified

Finding: The fence is damaged in places

Action: Repair or replace all affected sections

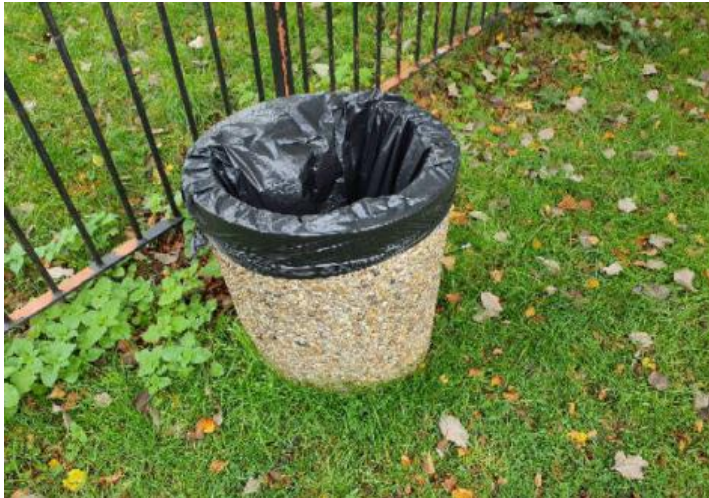
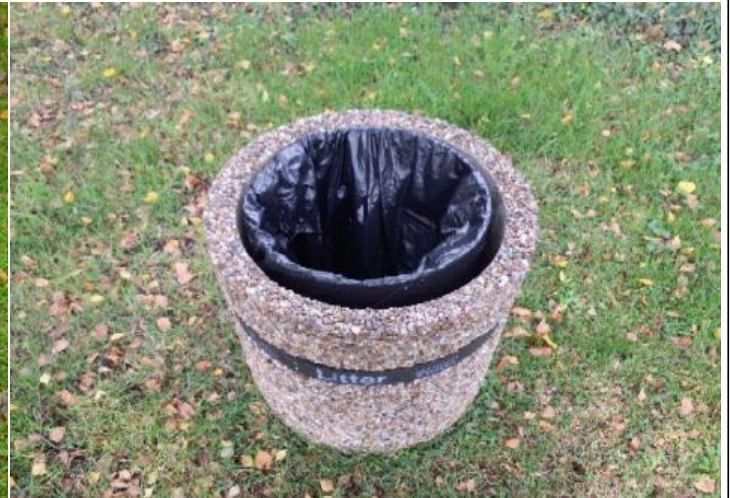
Item: Ancillary Items - Litter Bin
Manufacturer: Not Identified

Finding: The liner of the litter bin is not secured

Action: Ensure the lid/door is kept locked and the liner secured

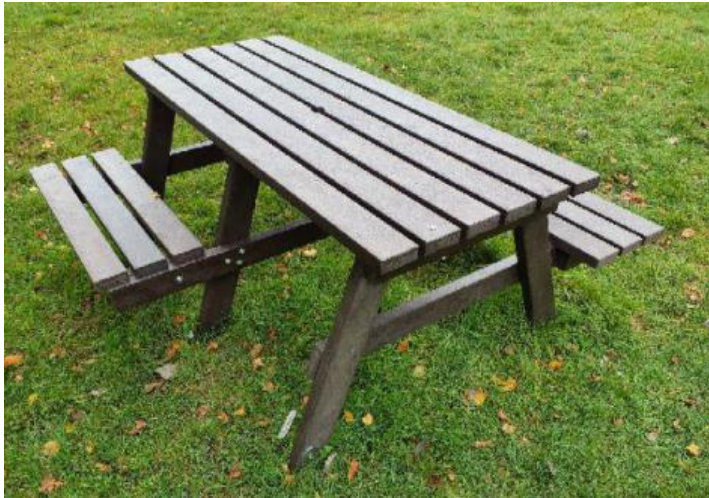
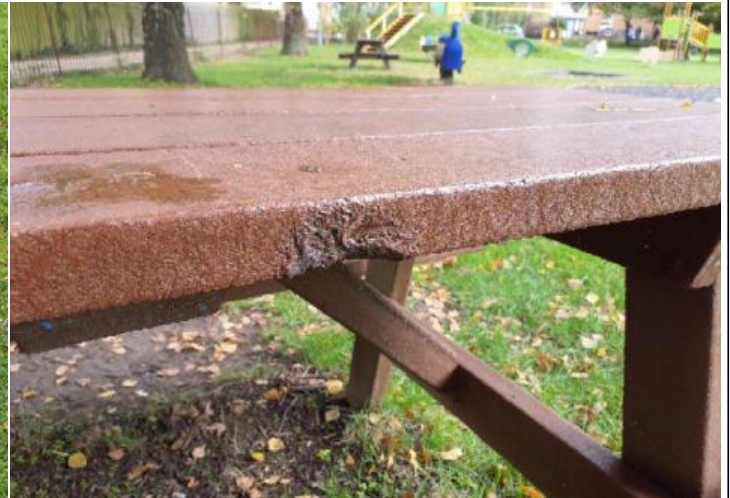
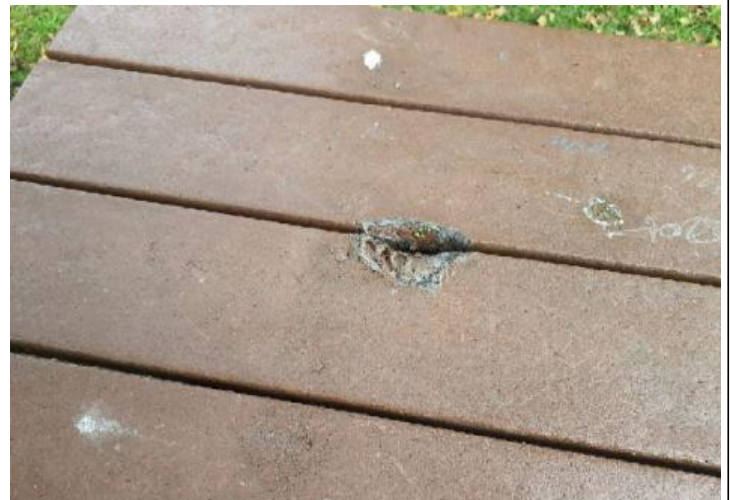
Item: Ancillary Items - Picnic Table
Manufacturer: Not Identified

Finding: There is some evidence of fire damage to the item **Action:** Monitor for any further deterioration and repair as required

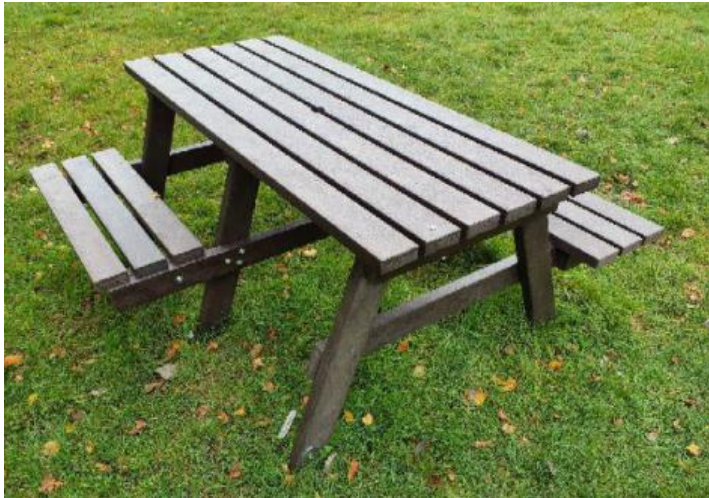
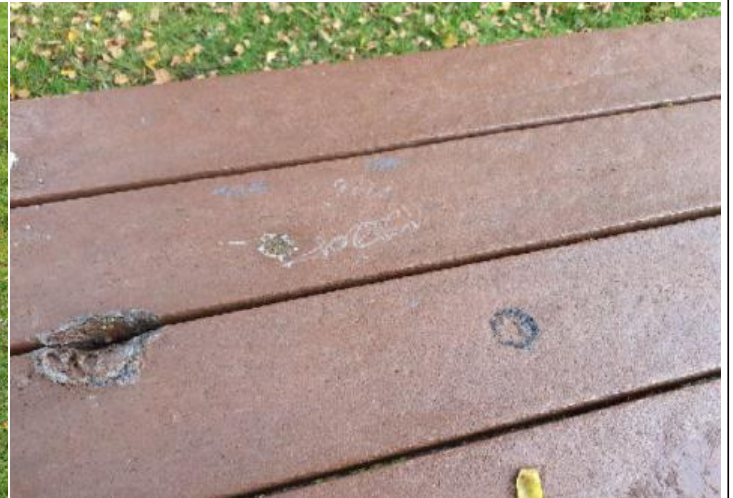
Item: Ancillary Items - Picnic Table
Manufacturer: Not Identified

Finding: There is some graffiti present

Action: Remove the graffiti

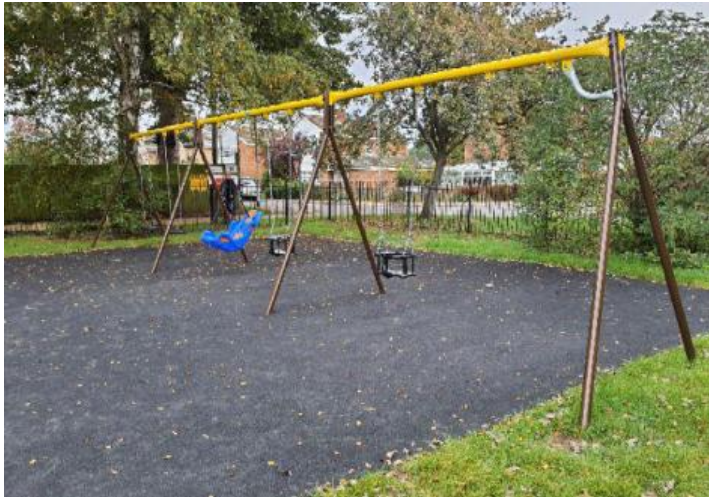
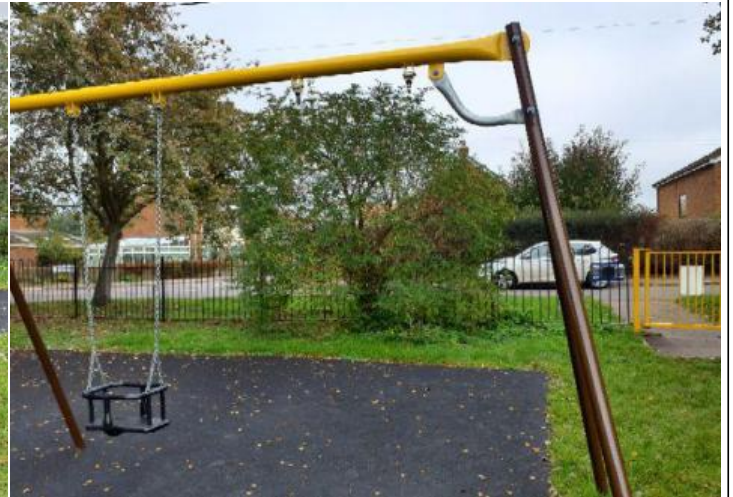
Item: Swings - 3 Bay Swing
Manufacturer: Hags

Finding: The seat(s) and suspension were missing at the time of inspection and the inspector was unable to make a full compliance assessment

Action: Replace missing seat(s) and suspension

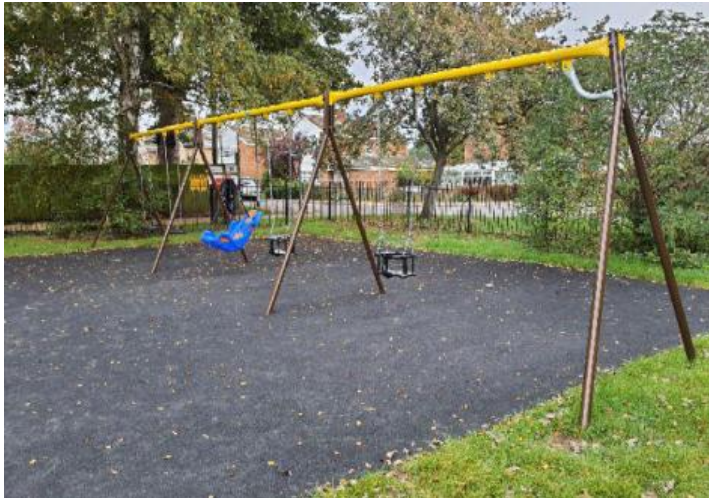
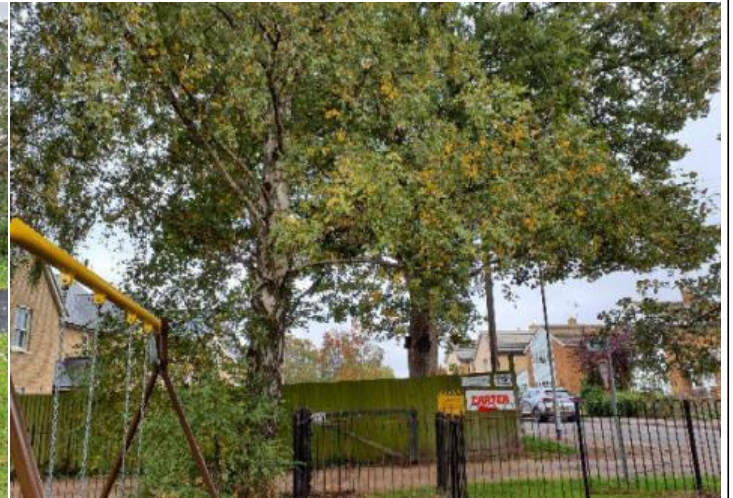
Item: Swings - 3 Bay Swing
Manufacturer: Hags

Finding: The tree canopy overhangs the equipment and is less than 2.0m away

Action: Lift tree canopy to ensure a minimum clearance of 2.0m from the equipment

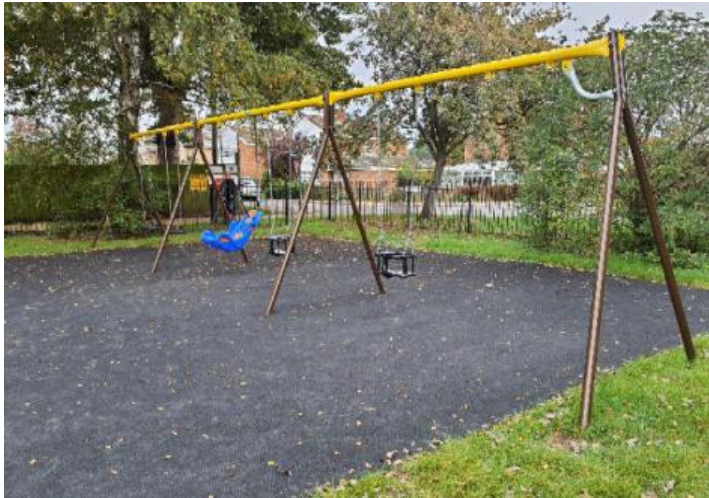
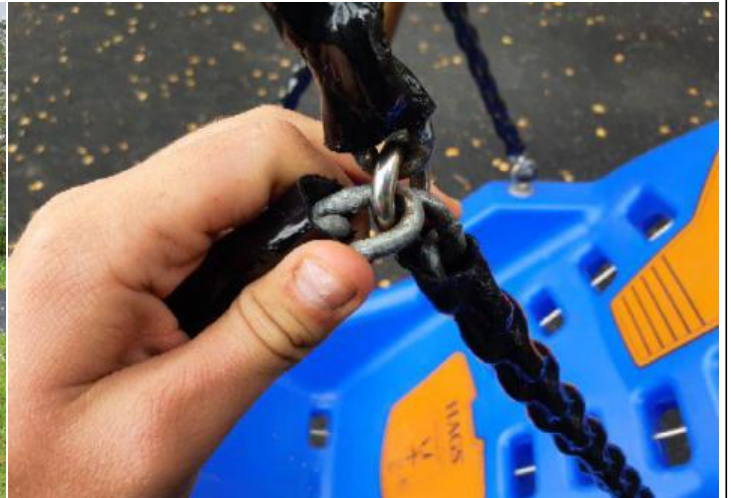
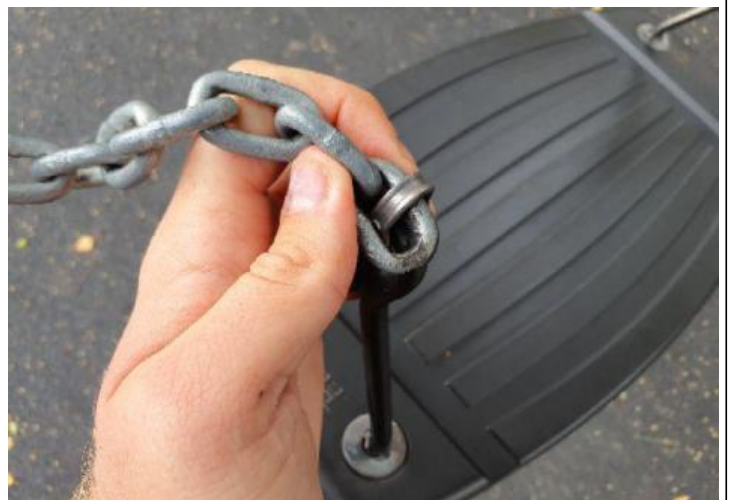
Item: Swings - 3 Bay Swing
Manufacturer: Hags

Finding: There is some notable evidence of chain wear

Action: Monitor for any further deterioration and replace when 40% worn

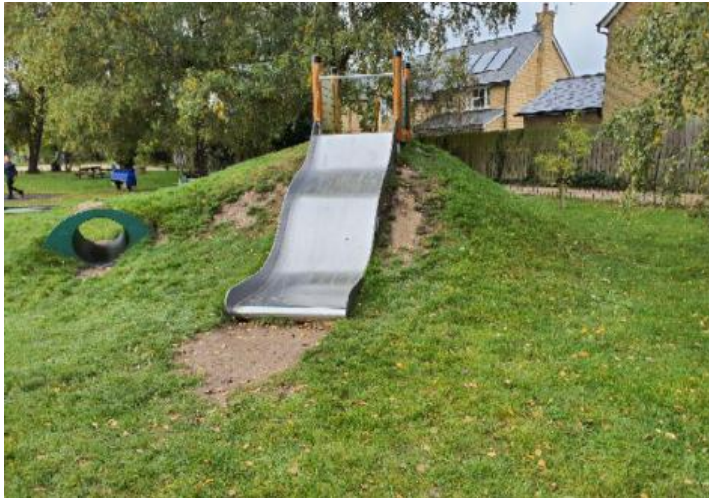
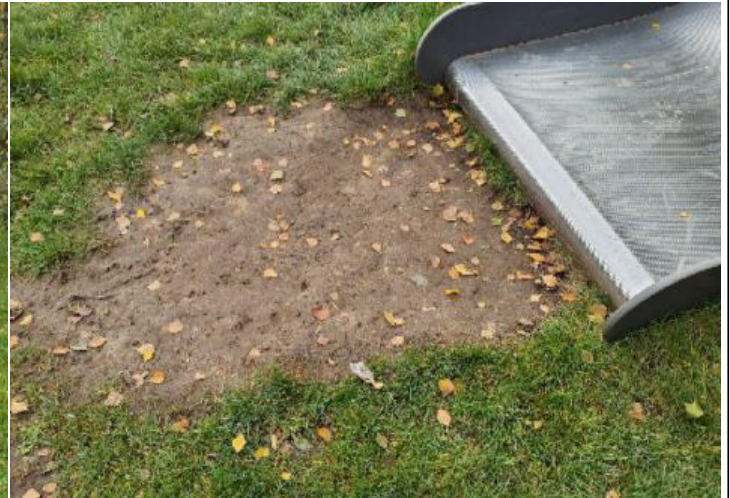
Item: Other - Embankment Slide
Manufacturer: Hags

Finding: The grass has eroded within the impact area of the equipment and may not provide the necessary impact attenuating properties for the equipment fall height; the surface may also be slippery in wet weather
Action: Reinstate the grass or provide an all weather surface

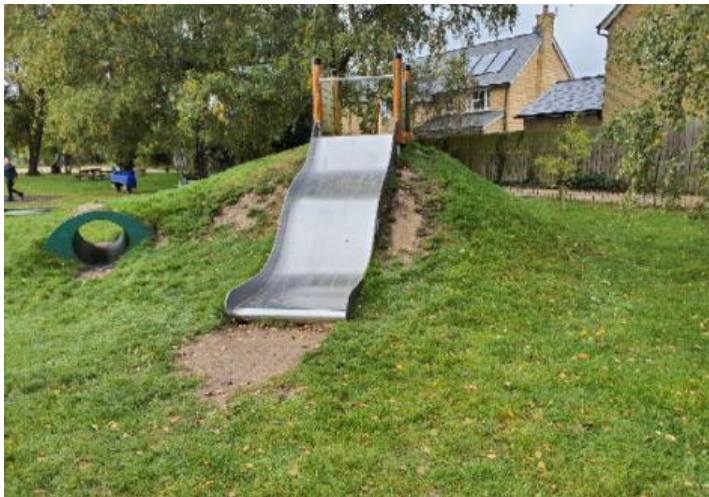
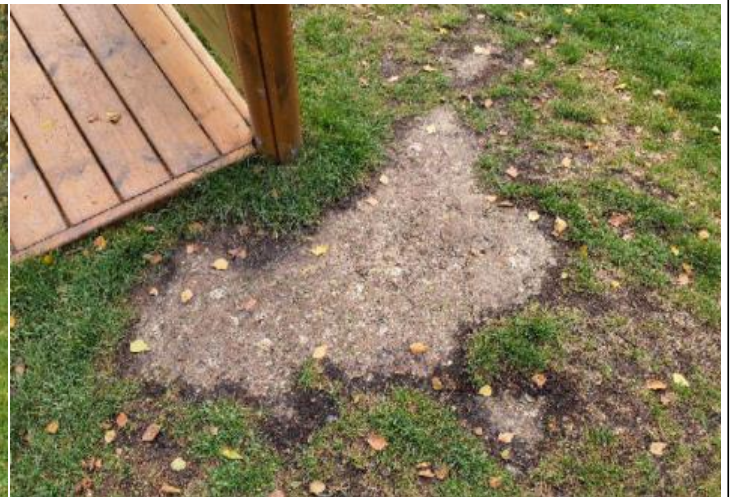
Item: Other - Embankment Slide
Manufacturer: Hags

Finding: The surface has eroded in some areas and may be slippery in wet conditions
Action: Reinstate the surface

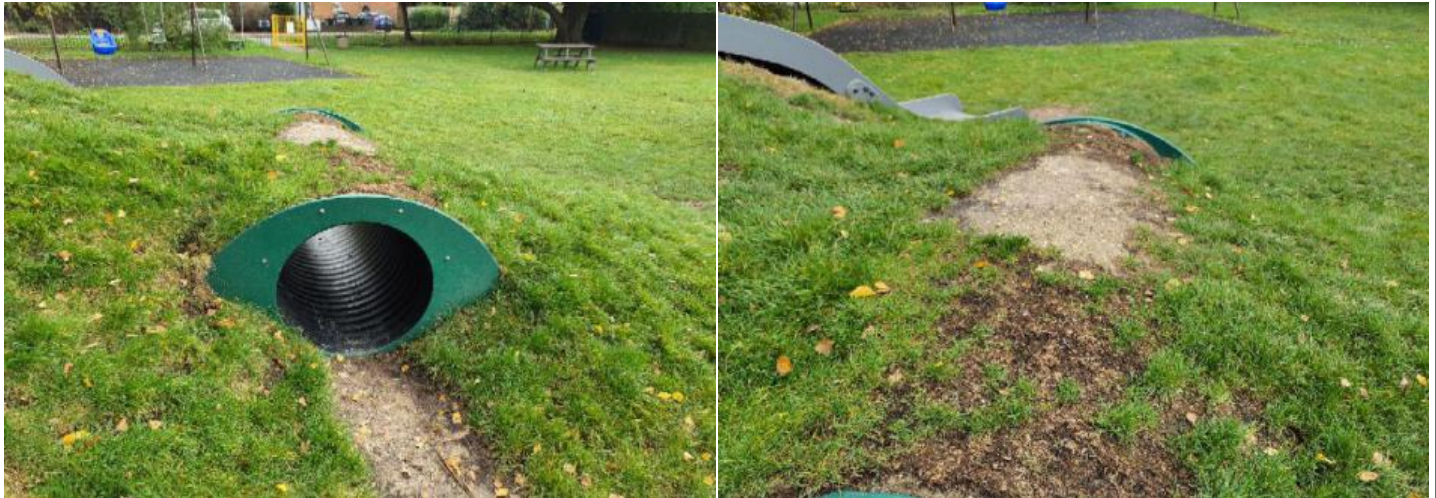
Item:	Other - Tunnel Mound	Risk Level:	L - Low Risk
Manufacturer:	Hags	Surface:	Grass

Finding: The surface has eroded in some areas and may be slippery in wet conditions
Action: Reinststate the surface

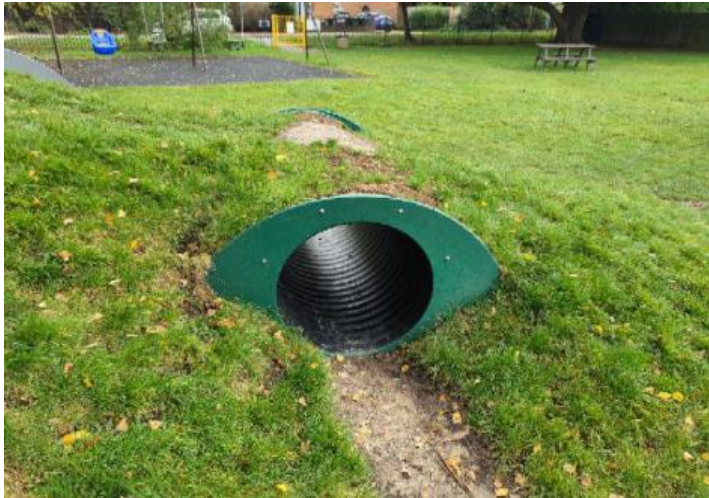
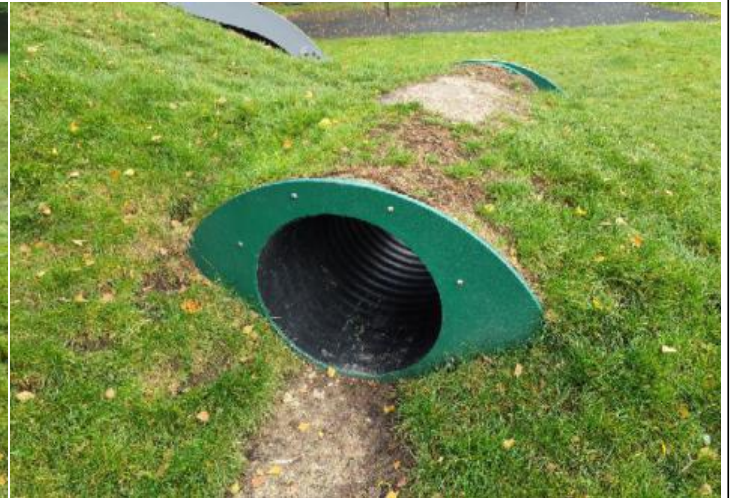
Item: Other - Tunnel Mound
Manufacturer: Hags

Finding: This design / configuration of tunnel mound is well established and has been successfully included in large quantities of playgrounds throughout the UK. Whilst the design does not fully meet the requirements of BS EN 1176 with regards to falls in excess of 600mm over the edge of the tunnel to the surface below, it has been risk assessed as fit for purpose in this regard and no changes are recommended to the design unless otherwise stated in additional findings

Action: Monitor - No remedial work recommended

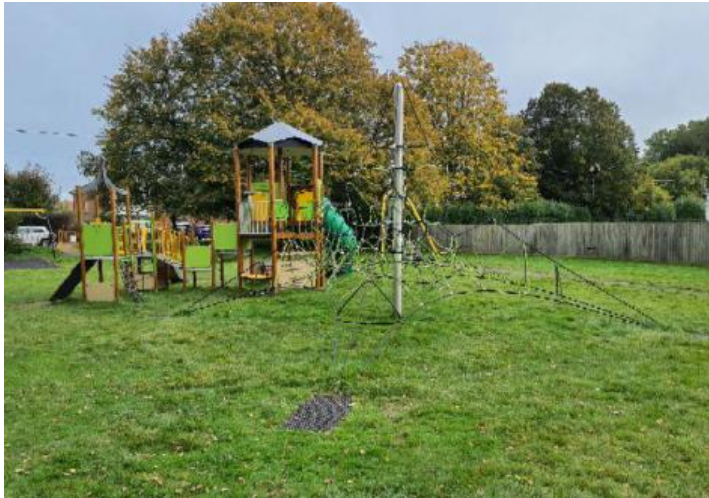
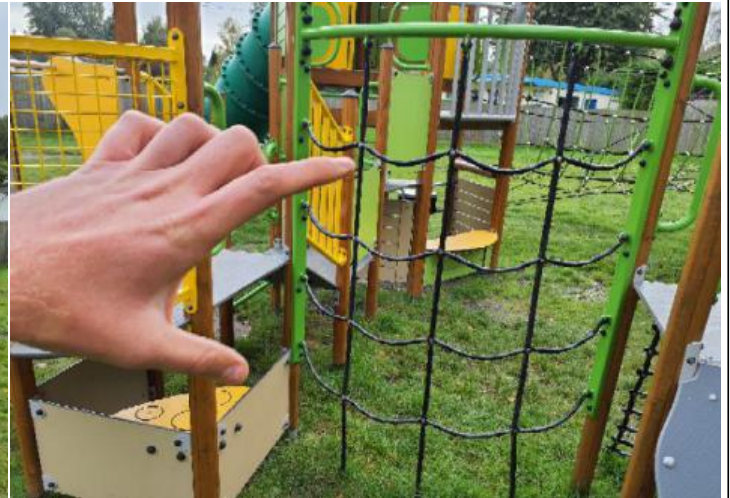
Item: Activity Equipment - Multi Play (Junior)
Manufacturer: Hags

Finding: There are falls in excess of 600mm between adjacent components on the structure, in contravention of the recommendations set out in BS EN 1176 Part 1; 4.2.8.4

Action: Monitor - No remedial work recommended

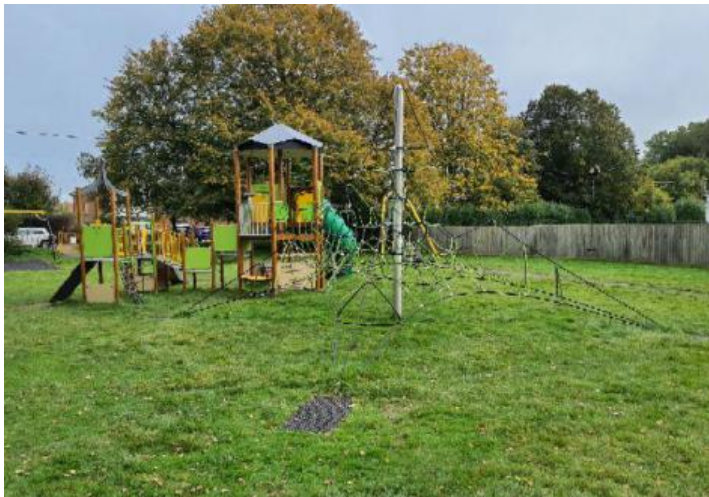
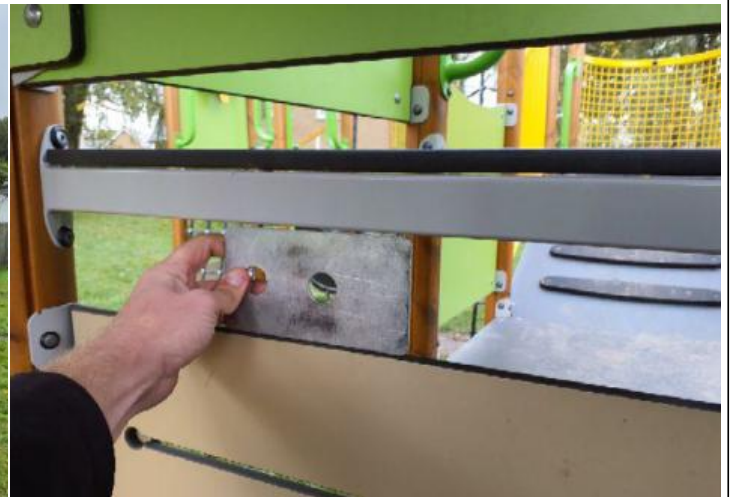
Item: Activity Equipment - Multi Play (Junior)
Manufacturer: Hags

Finding: The item fails to meet the requirements of BS EN 1176 Part 1 4.2.7.2 head and neck entrapment in the barriers and/or steps

Action: Monitor - No remedial work recommended

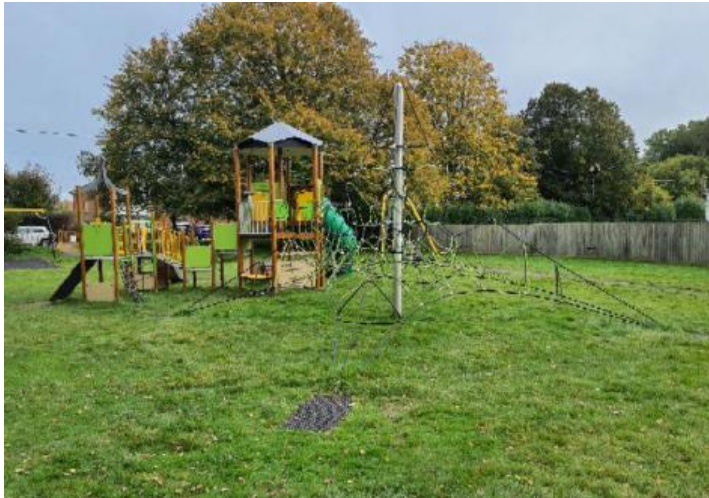
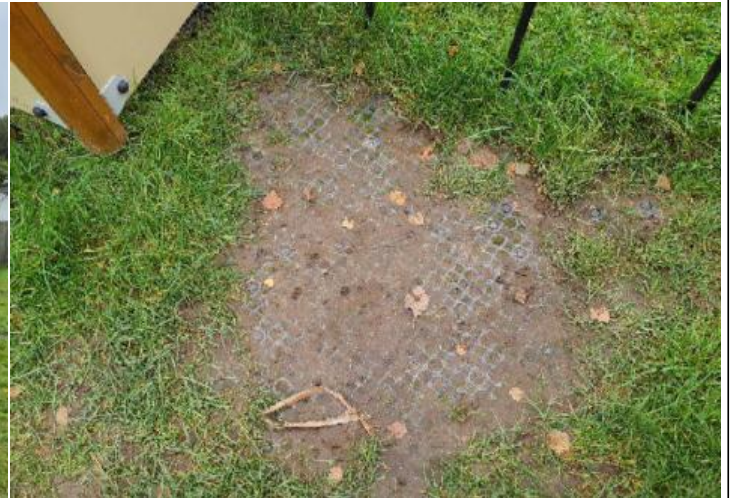
Item: Activity Equipment - Multi Play (Junior)
Manufacturer: Hags

Finding: The grass mats are silted up and the soil is compacted; this may have an effect on the impact absorbing properties of the surface

Action: Consider HIC testing impact absorbing properties to ensure the correct surface qualities are maintained for the equipment and replace as required

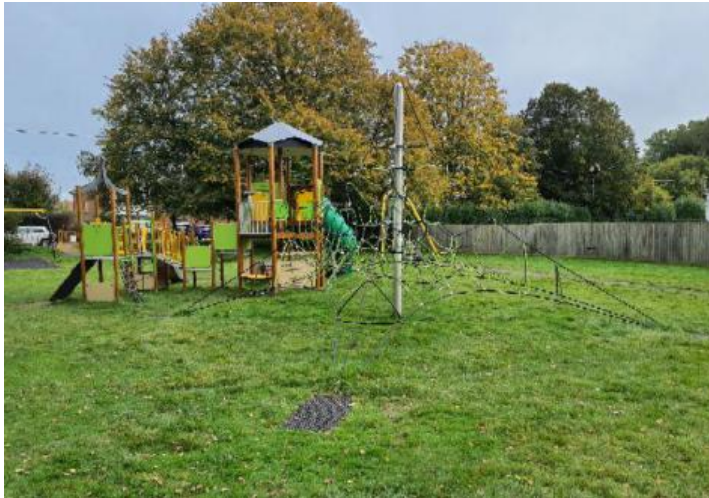
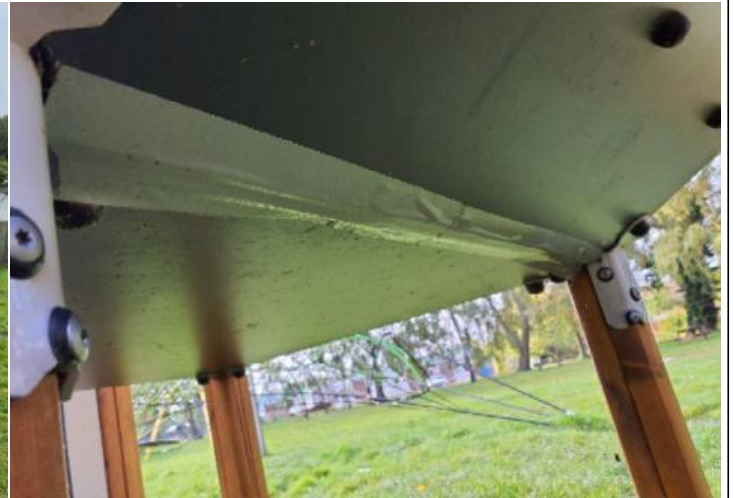
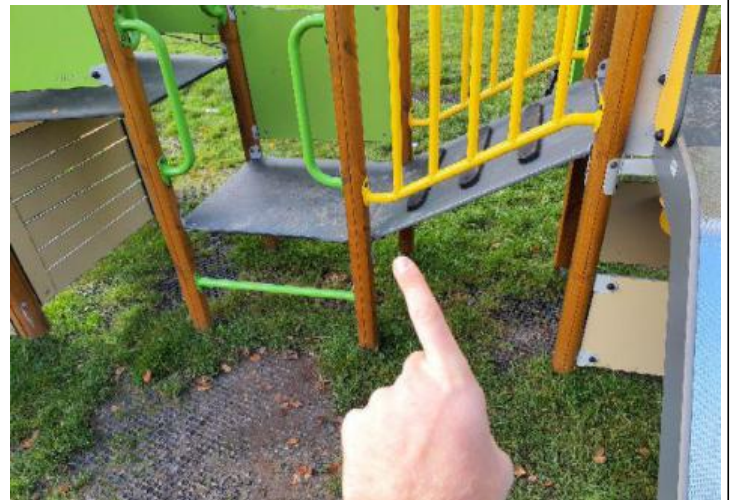
Item: Activity Equipment - Multi Play (Junior)
Manufacturer: Hags

Finding: The item has been taped and we are unable to fully assess the condition of the item

Action: Repair or replace as required

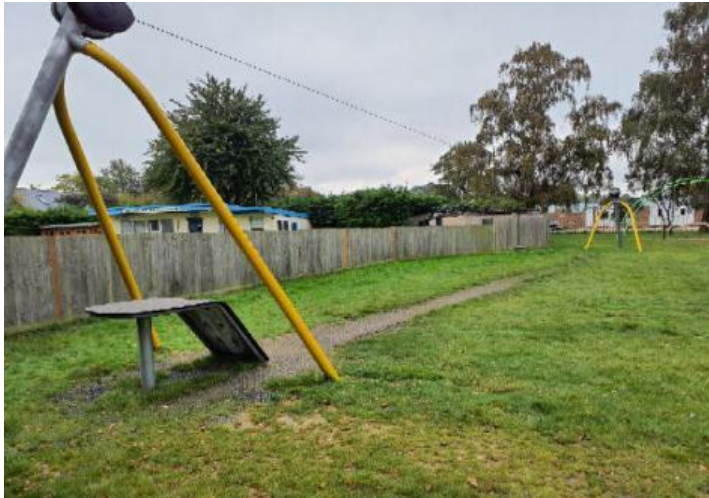
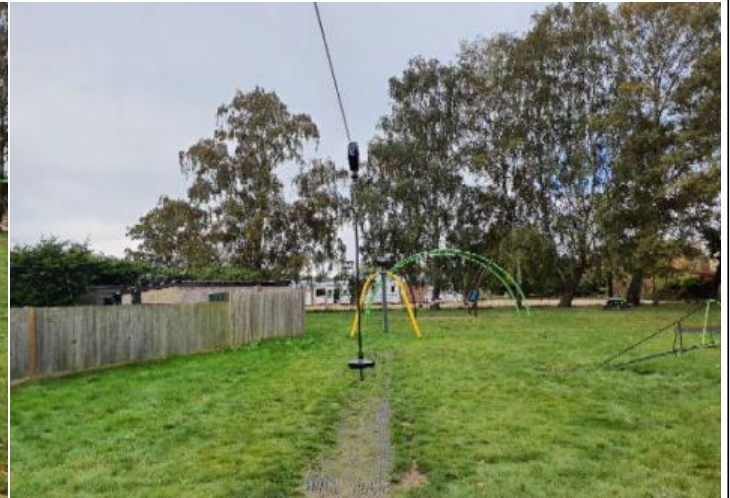
Item: Other - Cable Runway
Manufacturer: Hags

Finding: We have completed a visual inspection of the suspension links, cable and fixing points from ground level, however it is not possible to fully inspect these areas without either hiring equipment to gain access or removing the cable and suspension and inspecting at ground level. We recommend that the main cable and fixing security is thoroughly inspected at least in accordance with the manufacturers recommendations to check for wear, damage, security or internal rusting; this will help to ensure the continued safe use of the equipment

Action: Inspect in accordance with the manufacturers recommendations

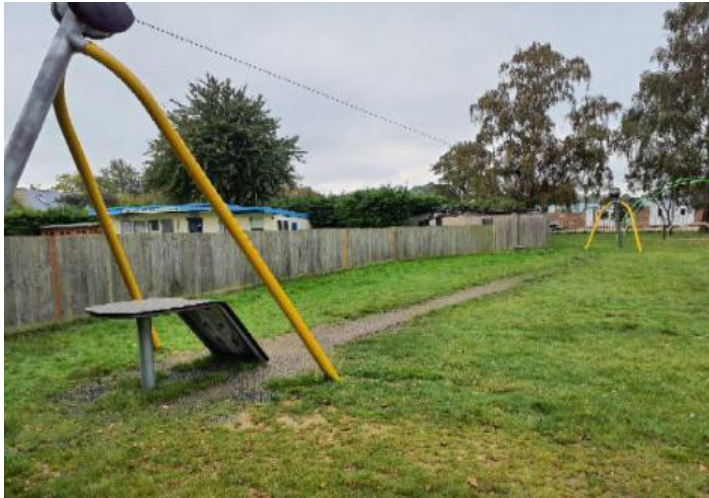
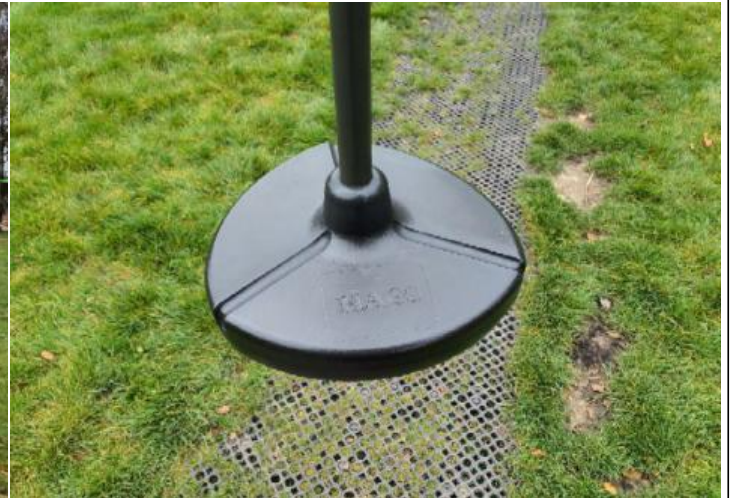
Item: Other - Cable Runway
Manufacturer: Hags

Finding: The seat connection cannot be inspected without dismantling the seat

Action: Dismantle the seat to inspect the seat connection for wear

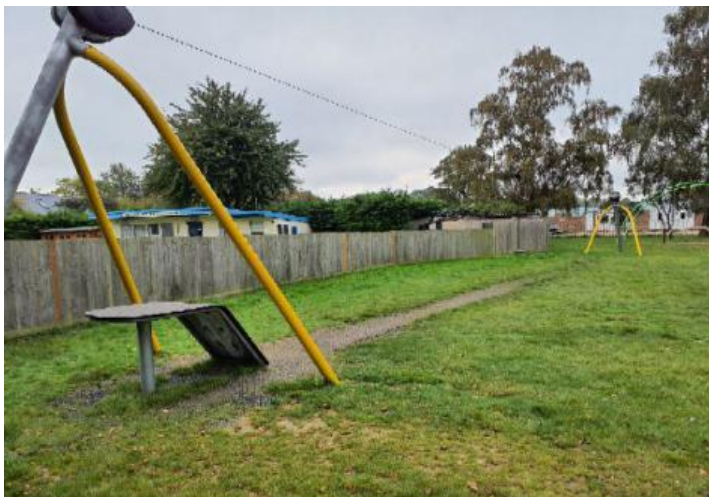
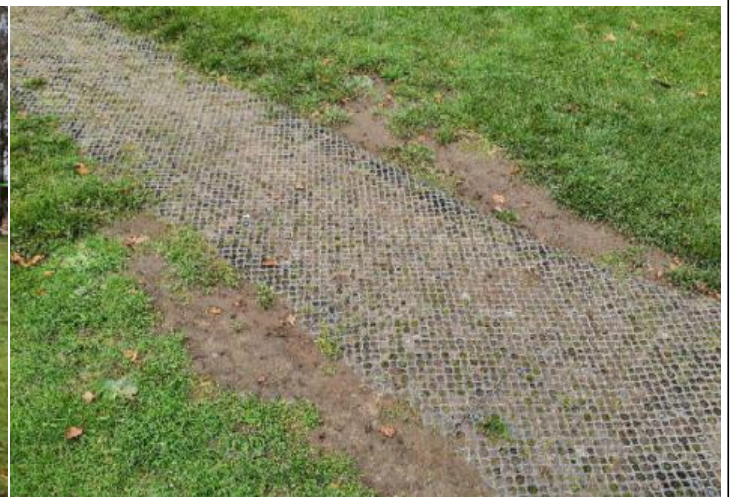
Item: Other - Cable Runway
Manufacturer: Hags

Finding: The grass has eroded within the impact area of the equipment and may not provide the necessary impact attenuating properties for the equipment fall height; the surface may also be slippery in wet weather

Action: Reinstate the grass or provide an all weather surface

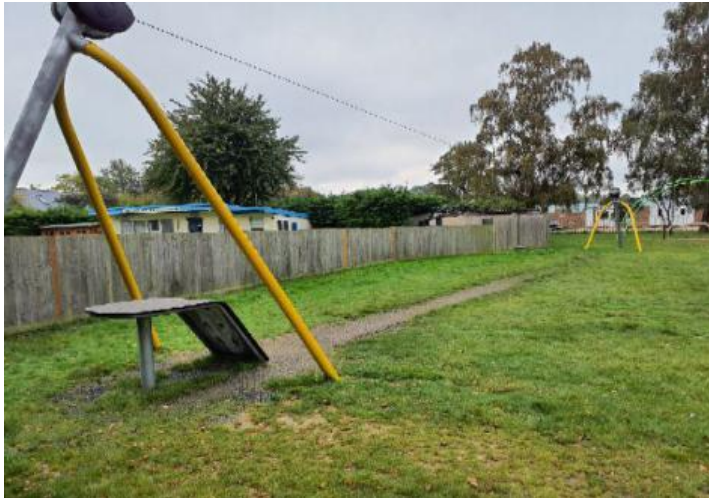
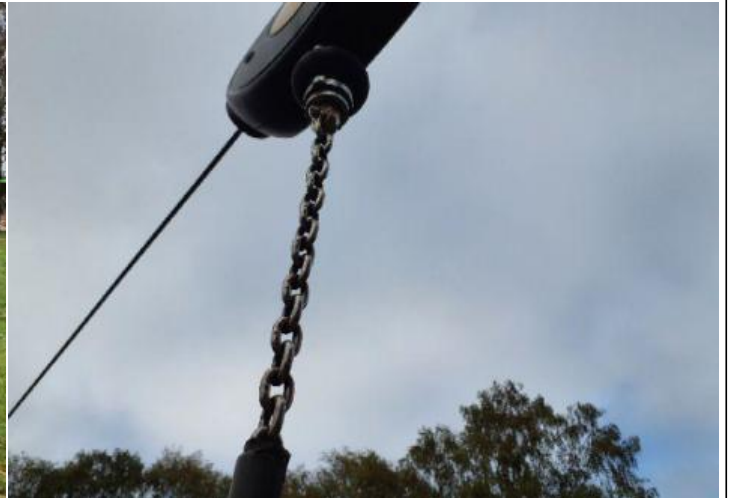
Item: Other - Cable Runway
Manufacturer: Hags

Finding: There is some notable evidence of chain wear

Action: Monitor for any further deterioration and replace when 40% worn

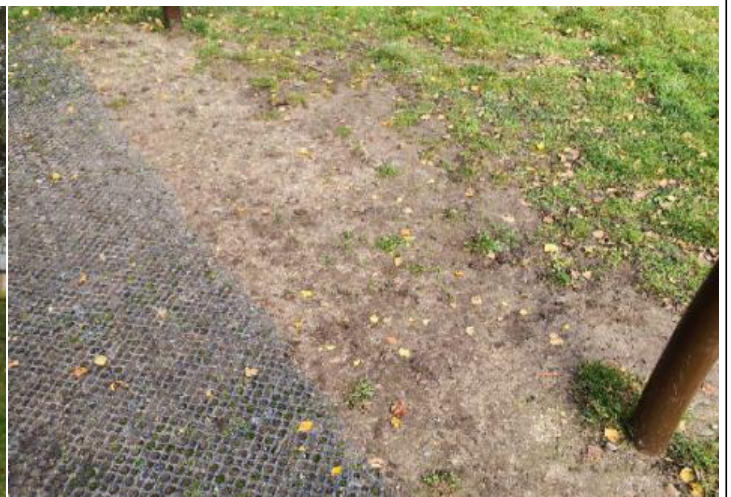
Item: Swings - Giant Rope Swing
Manufacturer: Hags

Finding: The grass has eroded within the impact area of the equipment and may not provide the necessary impact attenuating properties for the equipment fall height; the surface may also be slippery in wet weather

Action: Reinstate the grass or provide an all weather surface

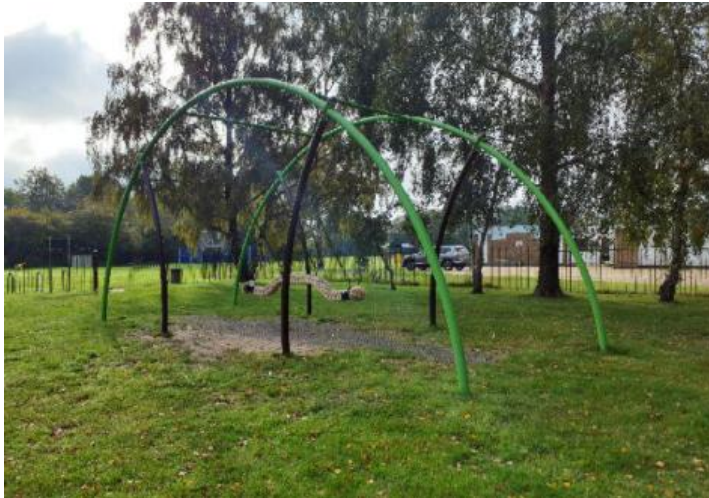
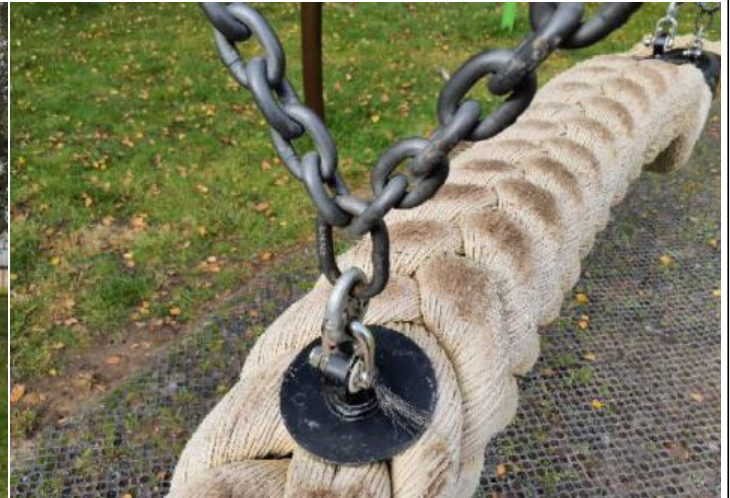
Item: Swings - Giant Rope Swing
Manufacturer: Hags

Finding: There is some notable evidence of chain wear

Action: Monitor for any further deterioration and replace when 40% worn
