the **play inspection** company

Annual Inspection

Melbourn Parish Council

The Moor Play Area

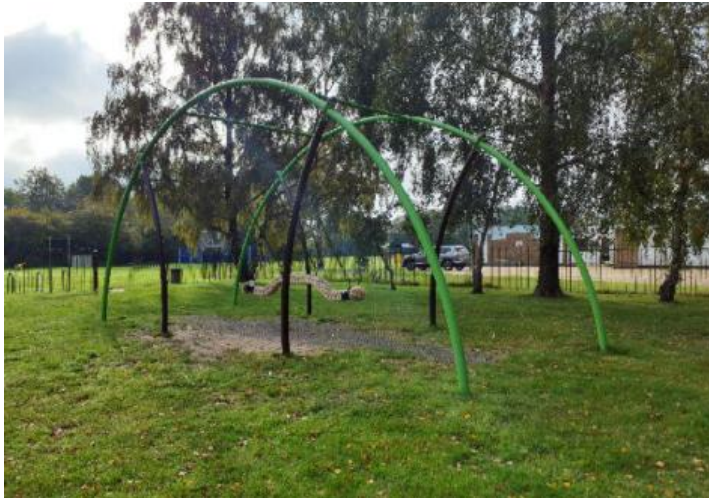
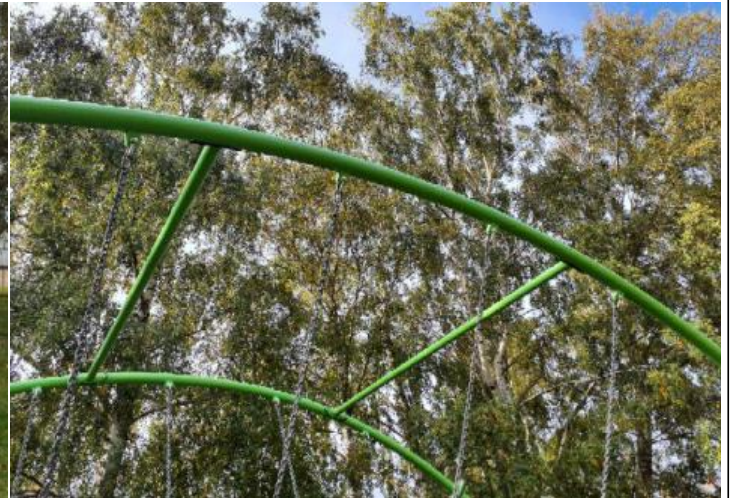
Item: Swings - Giant Rope Swing
Manufacturer: Hags

Finding: The fixings or components for this item were in excess of 2.5m above the standing surface and could not be fully accessed by the inspector. We have completed a visual inspection of the fixings from ground level but a maintenance inspection should be undertaken to assess the condition, security and wear of the components at intervals in accordance with the manufacturers recommendations.

Action: Inspect in accordance with the manufacturers recommendations

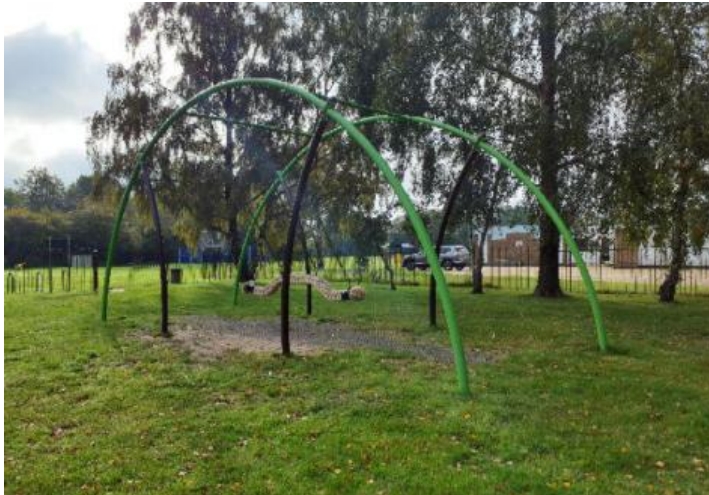
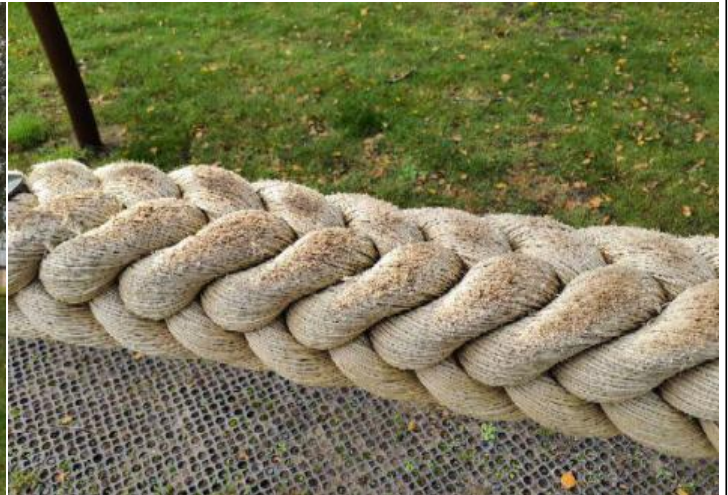
Item: Swings - Giant Rope Swing
Manufacturer: Hags

Finding: The seat has minor damage or wear

Action: Monitor for any further deterioration and replace as required

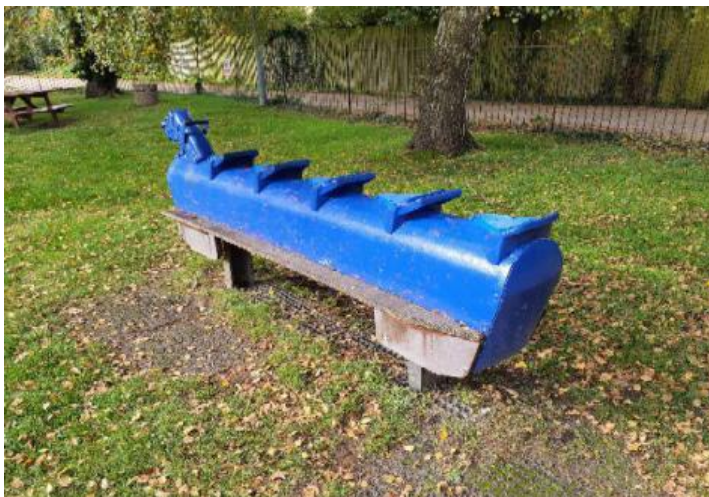
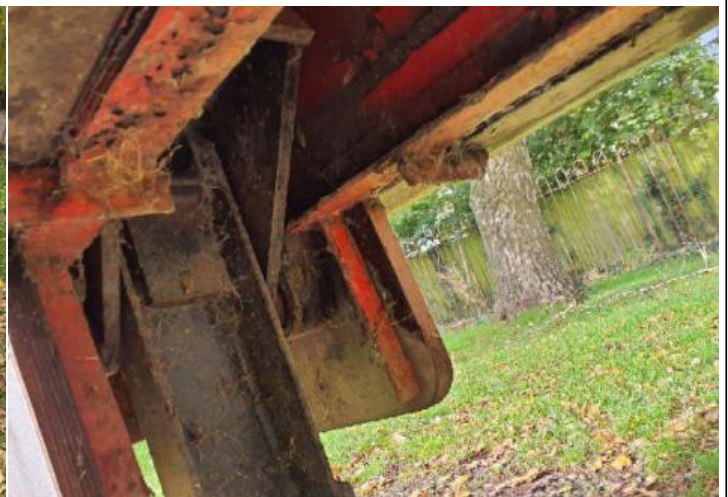
Item: Rocking Equipment - Rocking Horse
Manufacturer: Not Identified

Finding: There is no gaiter protection for accessible moving parts (possible shear trap) as recommended in BS EN 1176 Part 1; 4.2.6 Moving Parts

Action: Monitor - No remedial work recommended

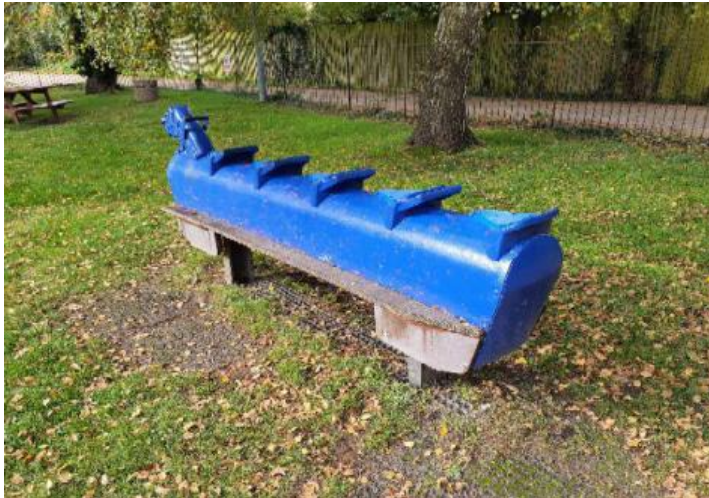
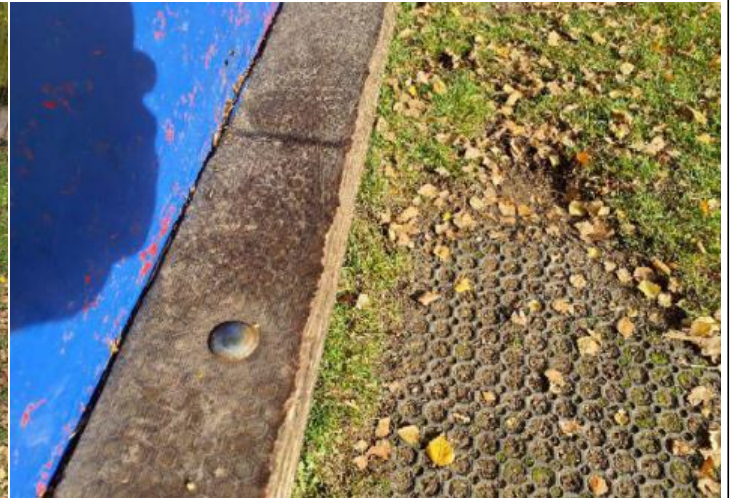
Item: Rocking Equipment - Rocking Horse
Manufacturer: Not Identified

Finding: Parts of the timber are rough or splintered

Action: Remove all rough or sharp edges

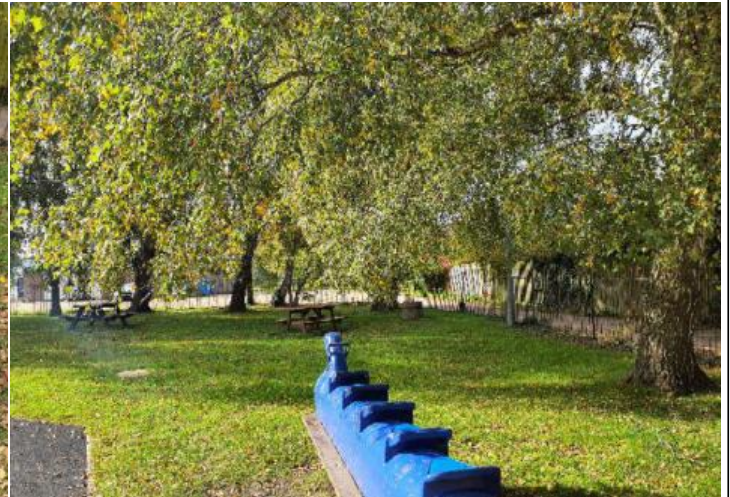
Item: Rocking Equipment - Rocking Horse
Manufacturer: Not Identified

Finding: The tree canopy overhangs the equipment and is less than 2.0m away

Action: Lift tree canopy to ensure a minimum clearance of 2.0m from the equipment

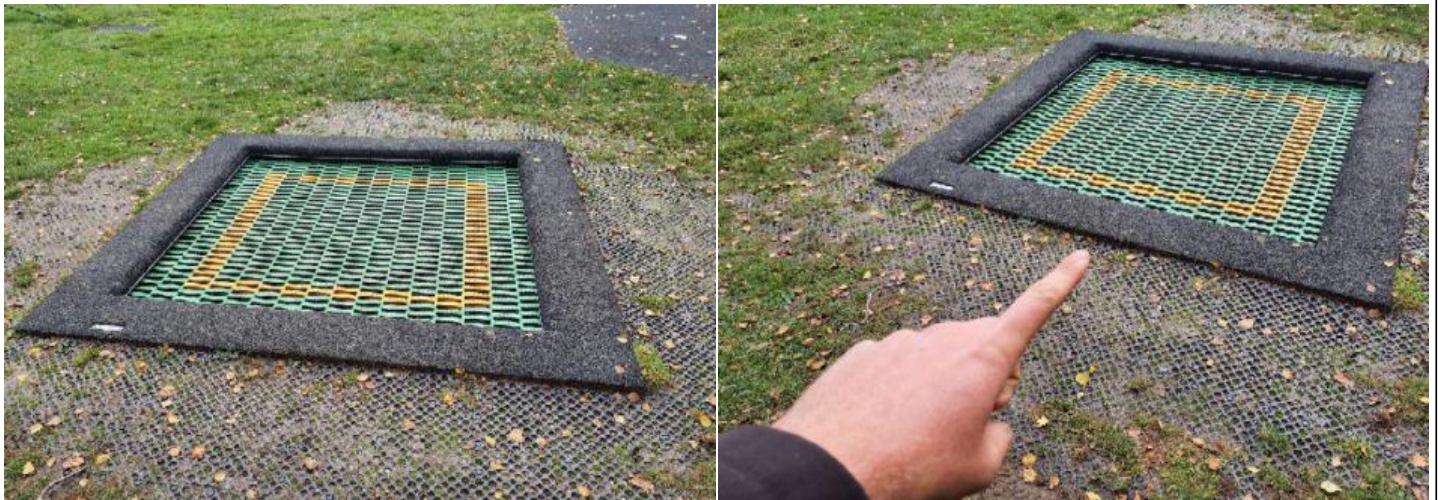
Item: Other - Bouncing Facility
Manufacturer: 1 Move
Risk Level: L - Low Risk
Surface: Grass Matrix Tiles

Finding: There are trip hazards at the edges of the surface
Action: Reinstate surrounding surface levels to remove the trip points

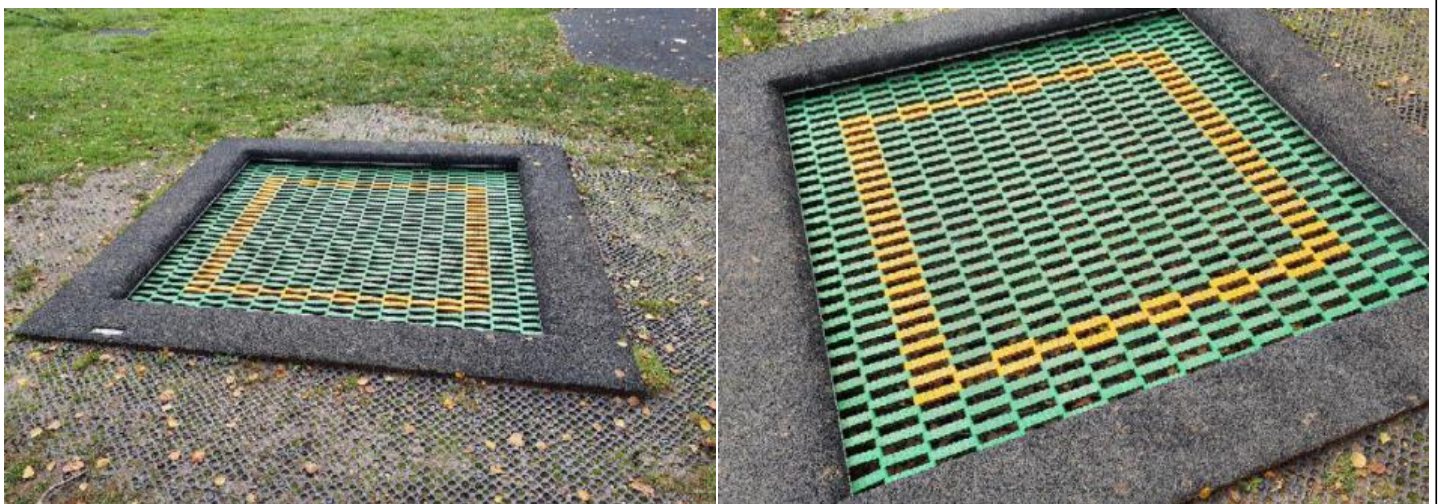
Item: Other - Bouncing Facility
Manufacturer: 1 Move
Risk Level: N - Risk Assessment not Undertaken
Surface: Grass Matrix Tiles

Finding: On site visits it is not possible to test the ground clearance of the Bouncing Facility bed as specified in BS EN 1176; ensure that the clearance between the Bouncing Facility Bed and the ground underneath is in accordance with the manufacturers recommendations (recorded nominal depth at time of inspection 390 mm measured unloaded).
Action: Refer to the manufacturers recommendations
