Operational Inspection

Melbourn Parish Council

The Moor Play Area
The Moor, Royston, Cambridgeshire, SG8 6ED

Inspection Ref: 2256362

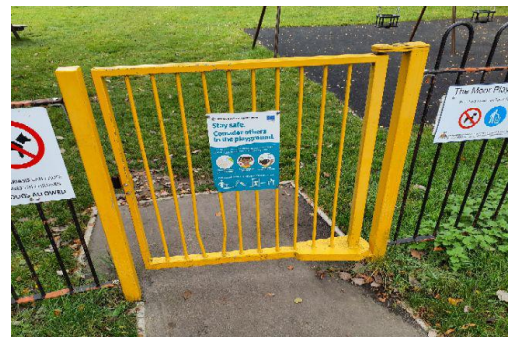
Finding 1
 The gate is closing too quickly (less than 4 seconds) and fails to close all the way - Take corrective action to ensure that the gate closes in 4-8 seconds

Finding 2
 The item has been damaged - Monitor for any further deterioration and replace as required

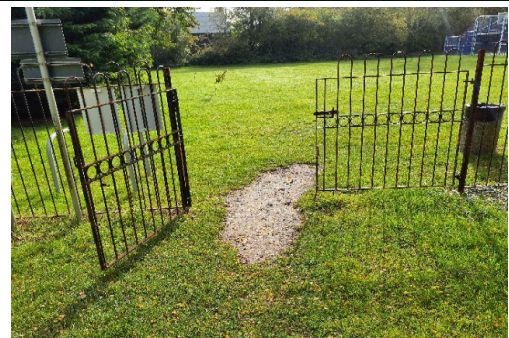
Finding 1
 There is no padlock on the maintenance gate - Provide a padlock to secure the gate

Finding 2
 Fixings are damaged and/or have sharp edges - Repair or replace as required

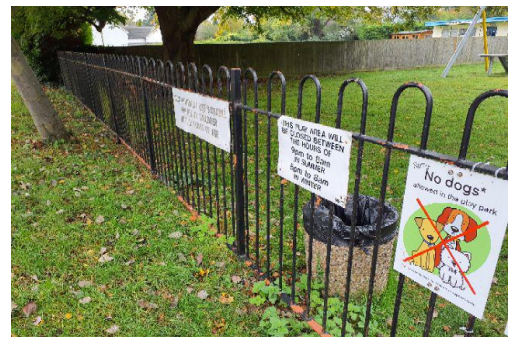
<p>Finding 1</p> <p>There is some damage to the fence sections - Monitor for any further deterioration and repair as required</p>	<p>Finding 2</p> <p>There is some damage to the fence sections - Monitor for any further deterioration and repair as required</p>
--	--

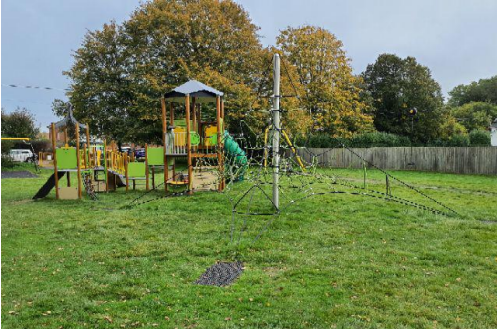
Finding 1	Finding 2
Gaps have been taped! - Na	Filler has been used to fill gaps - Monitor
Finding 3	Finding 4
The grass mats are silted up, the soil is compacted and the area will become very slippery when the soil is wet. - Reinstate as required	There is/are bolt cap covers missing or damaged on the item - Replace missing or damaged bolt cap covers

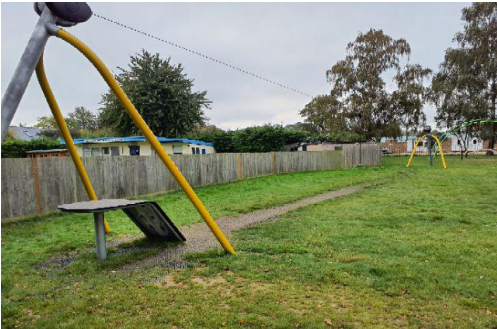
Finding 1	Finding 2
The dampening spring or tyre is damaged or broken on the item - Replace spring or tyre	The loose fill safety surfacing has become compacted - Rake and fork over to aerate the surface

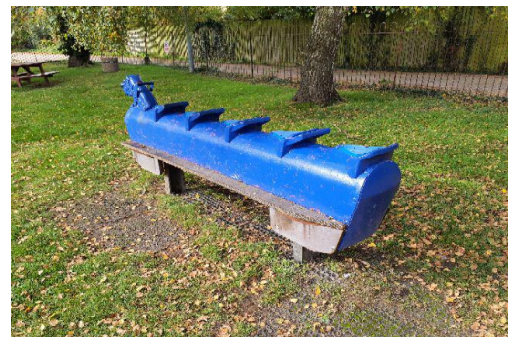
The timber has a number of splits/shakes or air cracks and this may affect the stability or allow water ingress which will accelerate the rotting process - Monitor to ensure the splits do not cross through fixing points of the structure and/or cause any instability

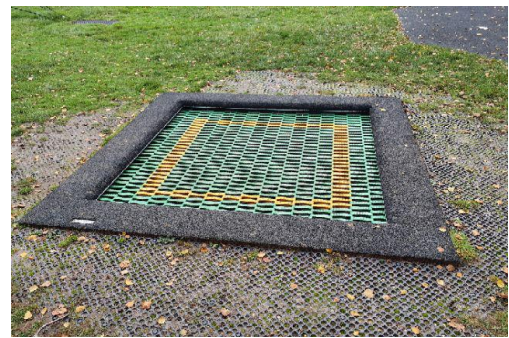
Finding 1
 There are trip hazards at the edges of the surface 8lm - Reinstate surrounding surface levels to remove the trip points

Finding 2
 The grass mats are silted up, the soil is compacted and the area will become very slippery when the soil is wet. - Reinstate as required

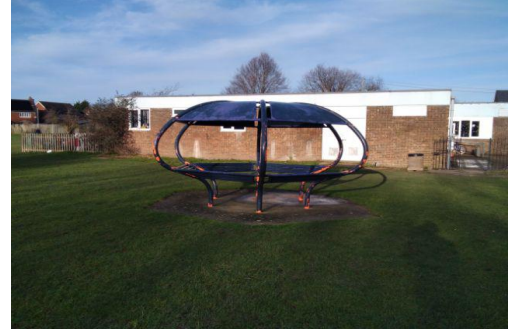
The paintwork on this item has been damaged or worn exposing the metal underneath which is rusting - Treat any rusting components and repaint

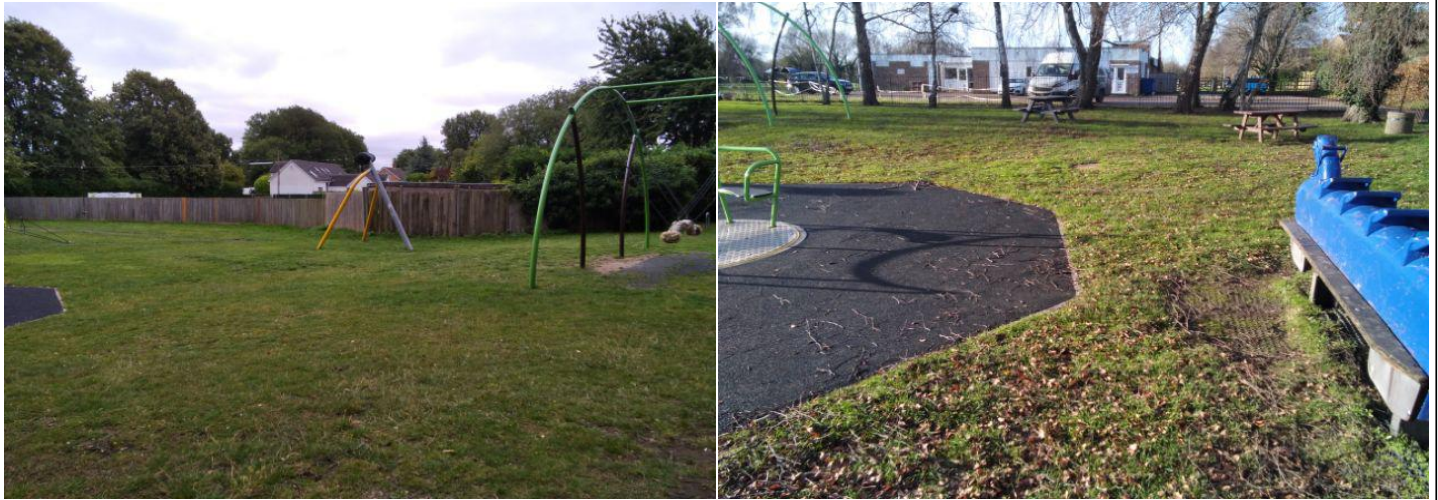
Finding: There is some tree debris on the surfacing

Action: Remove and maintain

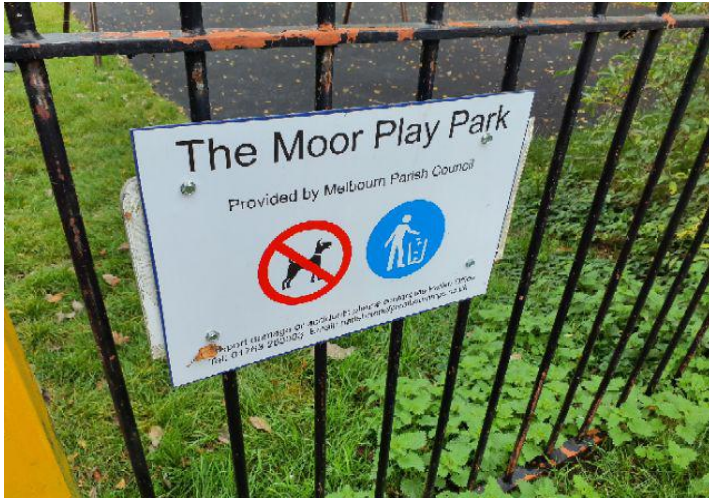
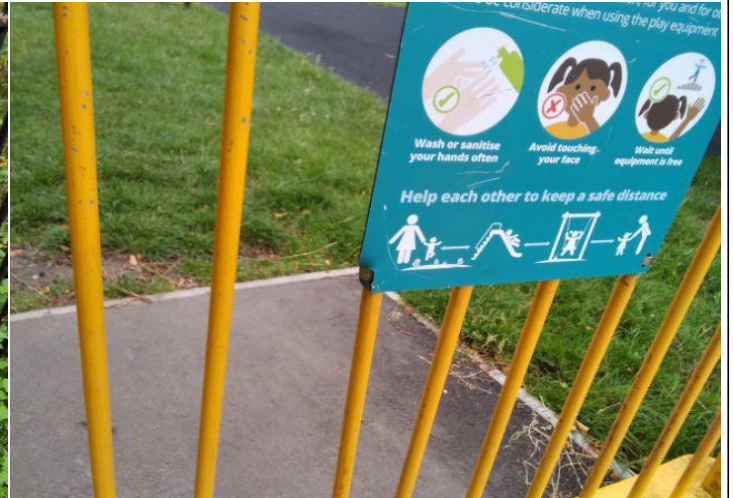
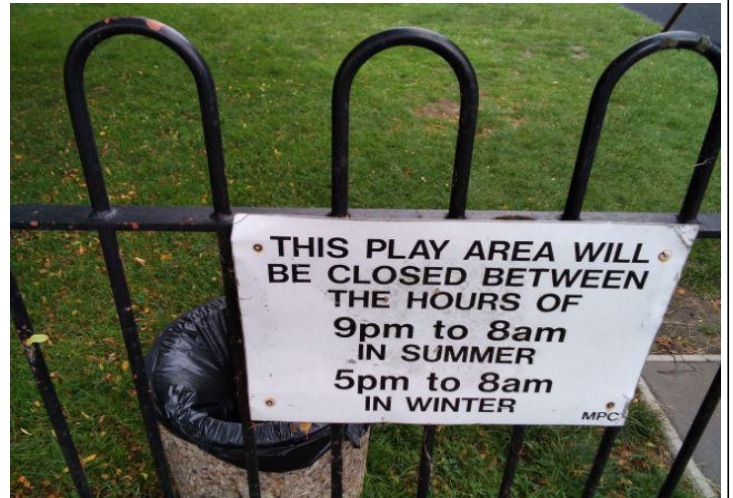
Finding: The item has been damaged

Action: Monitor for any further deterioration and replace as required

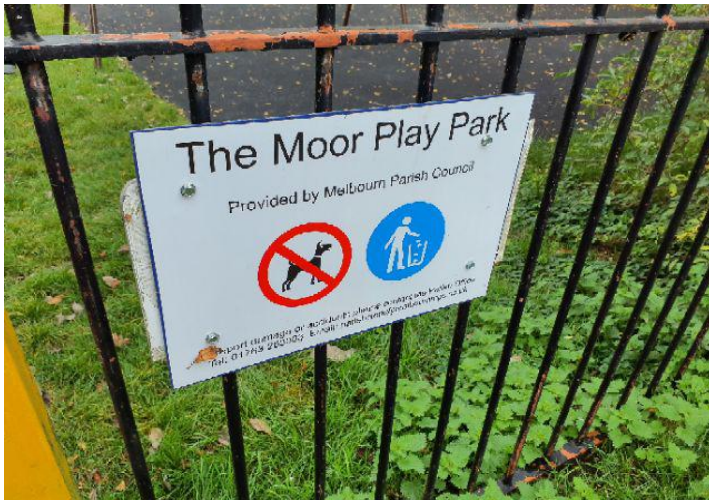
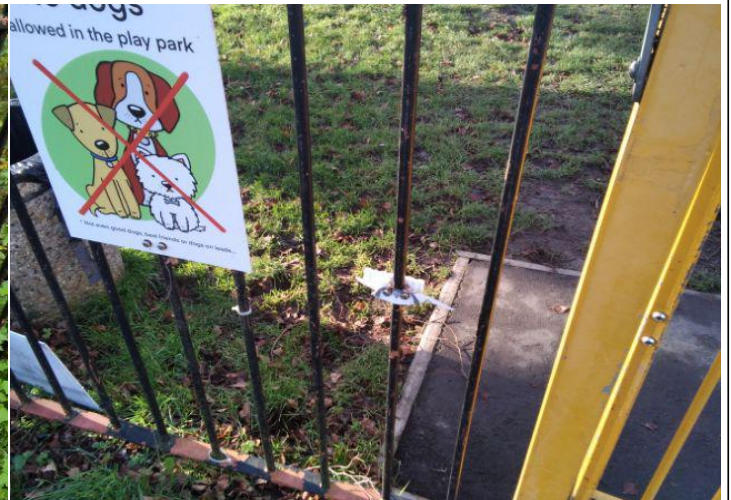
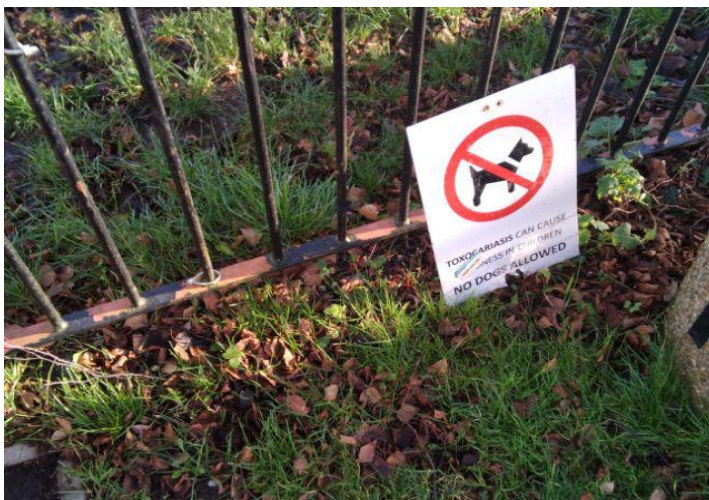
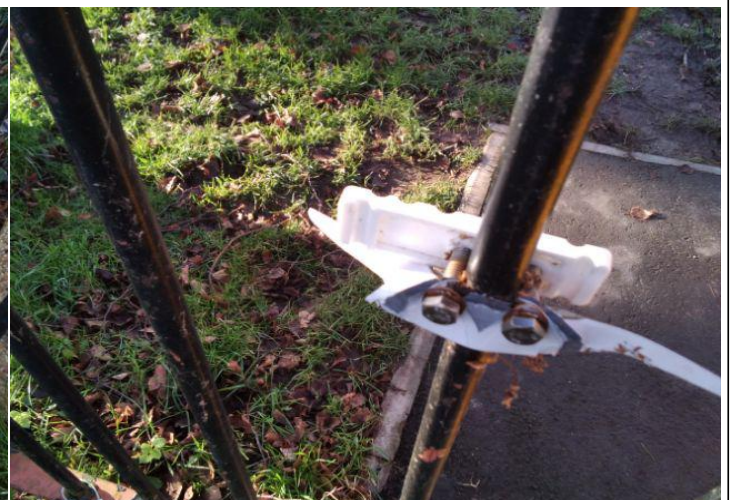
Finding: The item has been severely damaged leaving sharp edges to remaining fixings

Action: Replace item

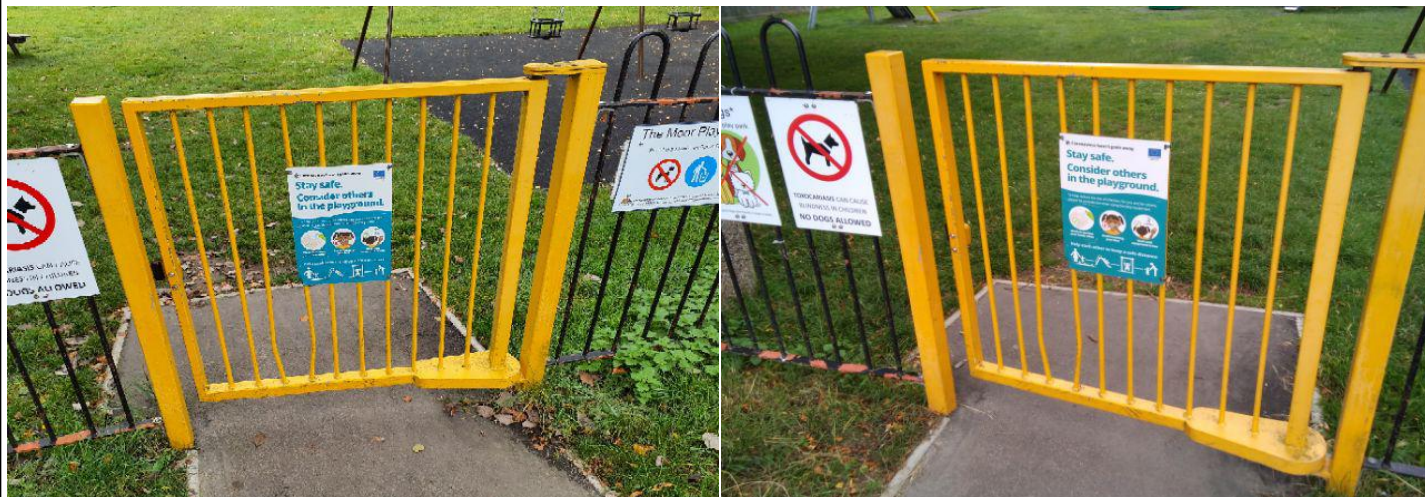
Finding: The gate is closing too quickly (less than 4 seconds) and fails to close all the way
Action: Take corrective action to ensure that the gate closes in 4-8 seconds

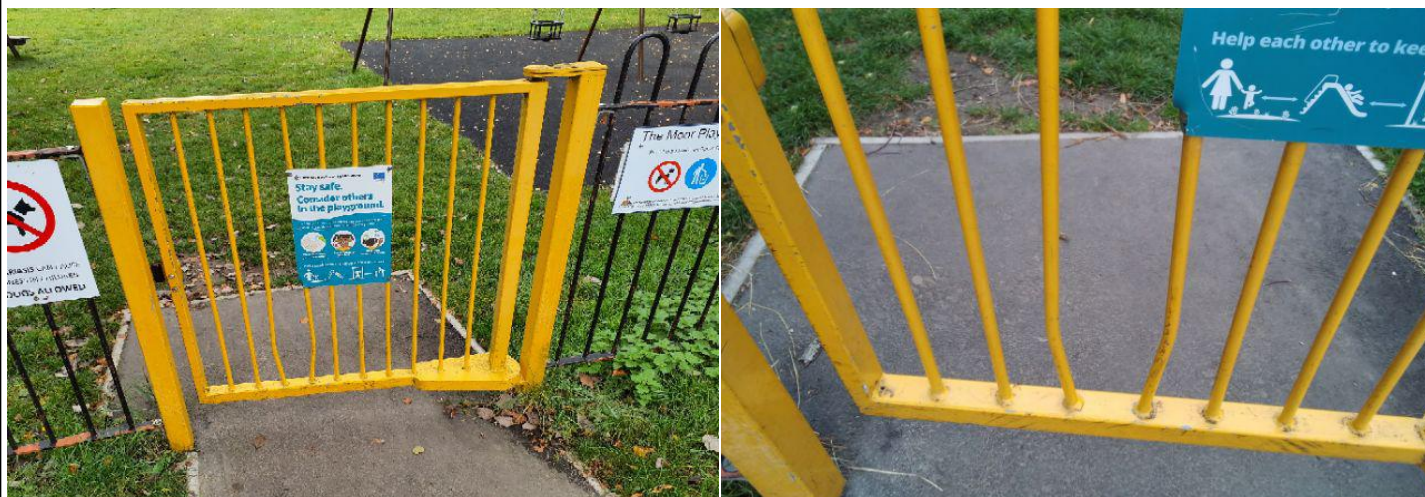
Finding: The item has been damaged
Action: Monitor for any further deterioration and replace as required

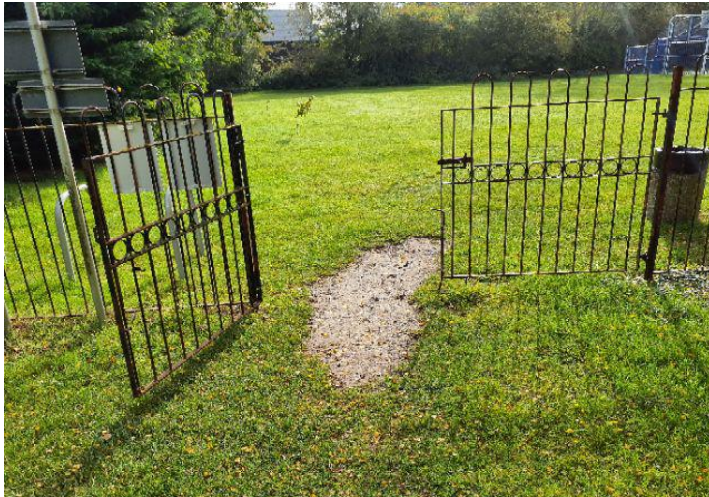
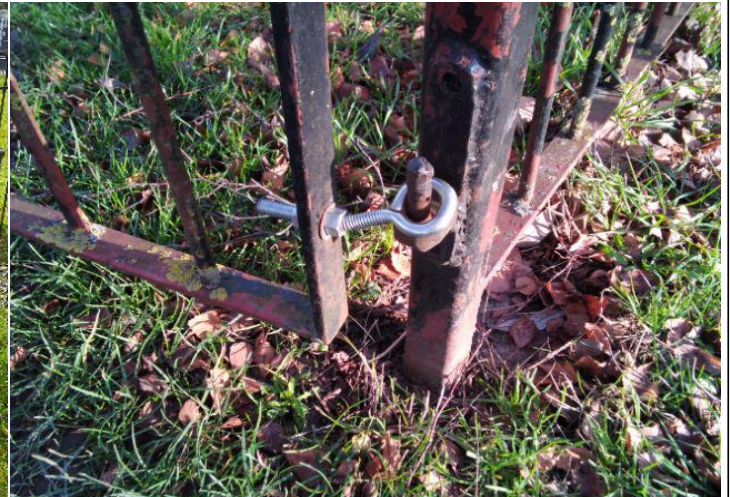
Finding: Fixings are damaged and/or have sharp edges

Action: Repair or replace as required

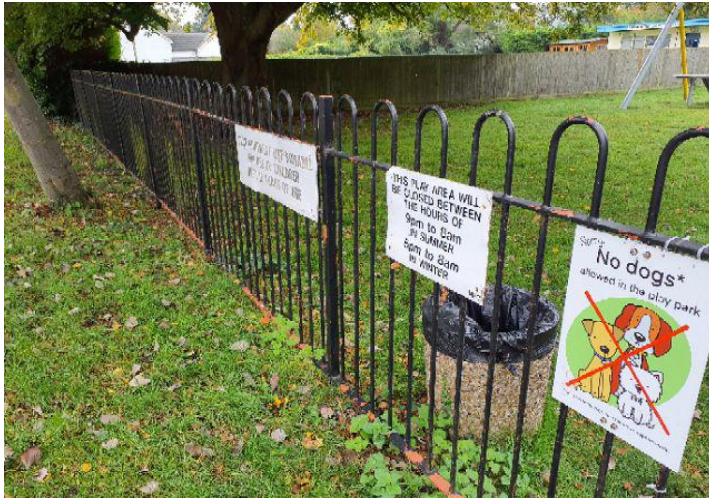
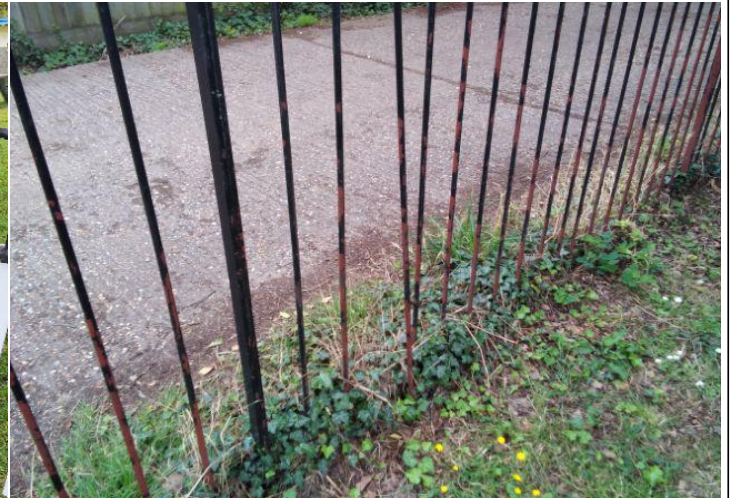
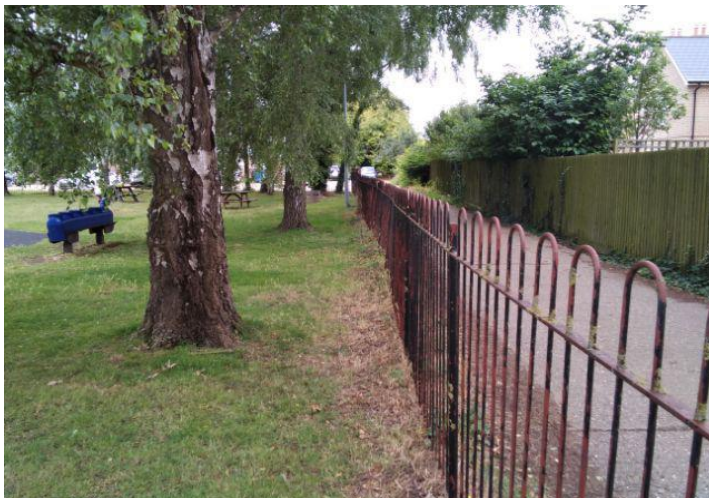
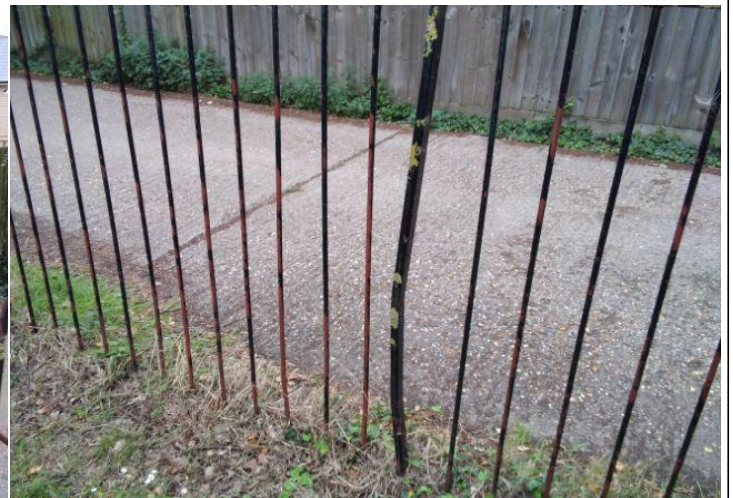
Finding: There is some damage to the fence sections

Action: Monitor for any further deterioration and repair as required

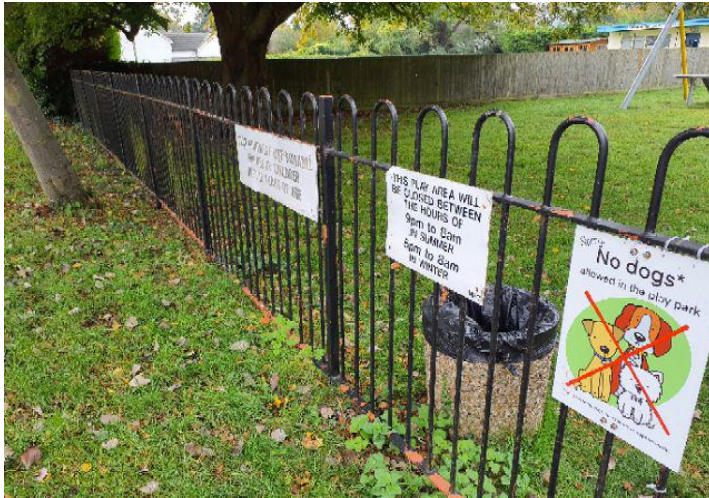
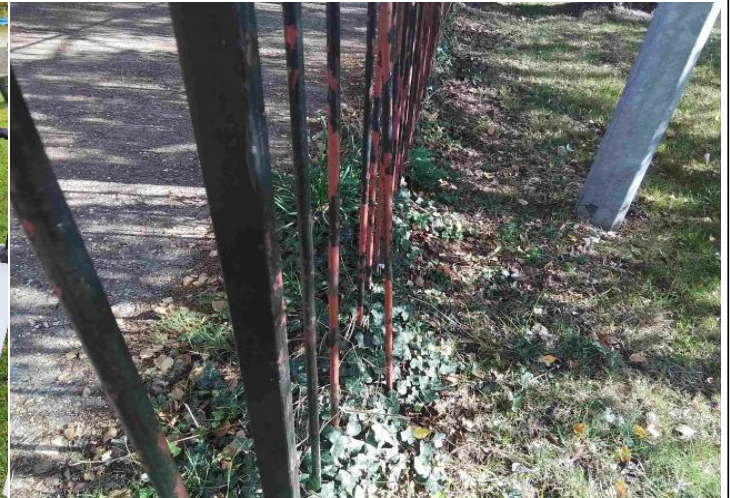
Finding: There is some damage to the fence sections

Action: Monitor for any further deterioration and repair as required

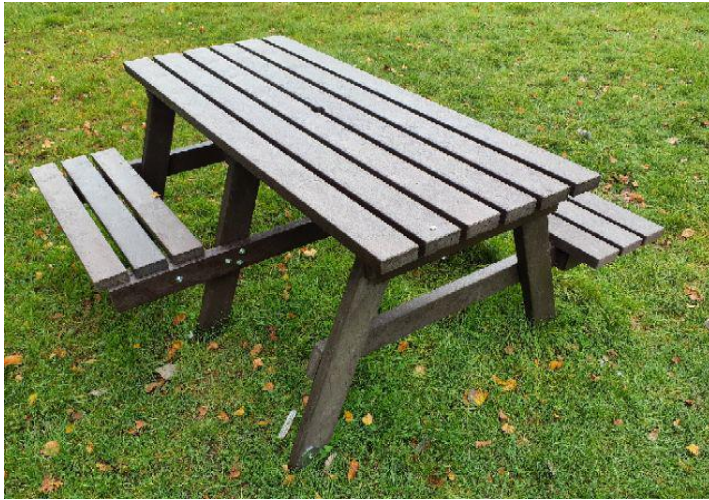
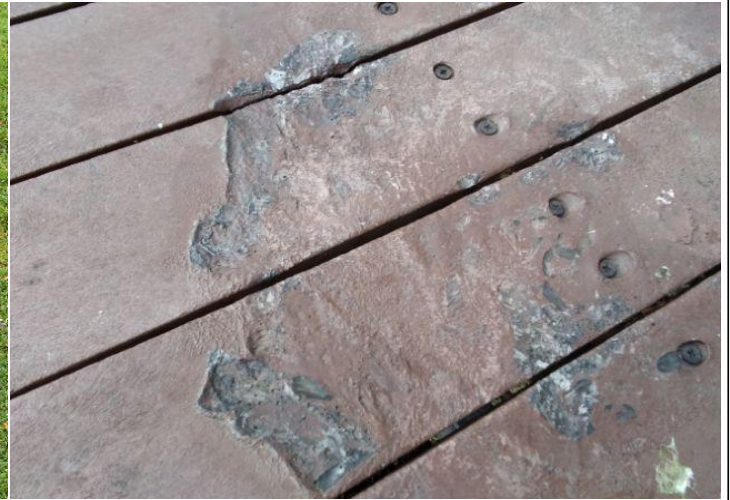
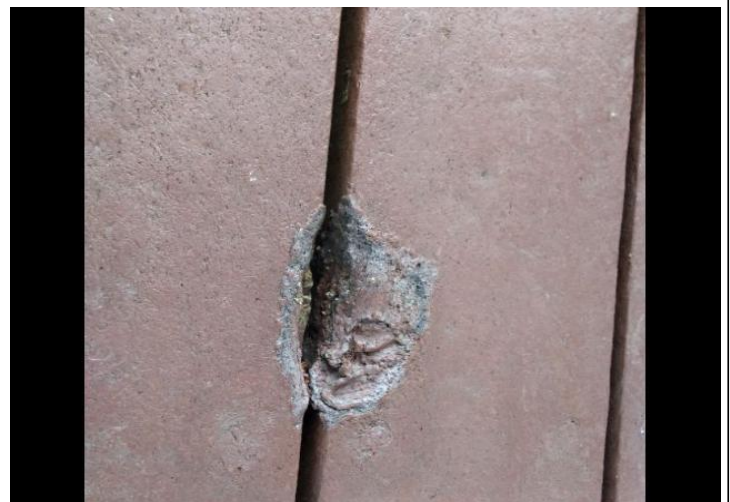
Finding: There is some evidence of fire damage to the item **Action:** Monitor for any further deterioration and repair as required

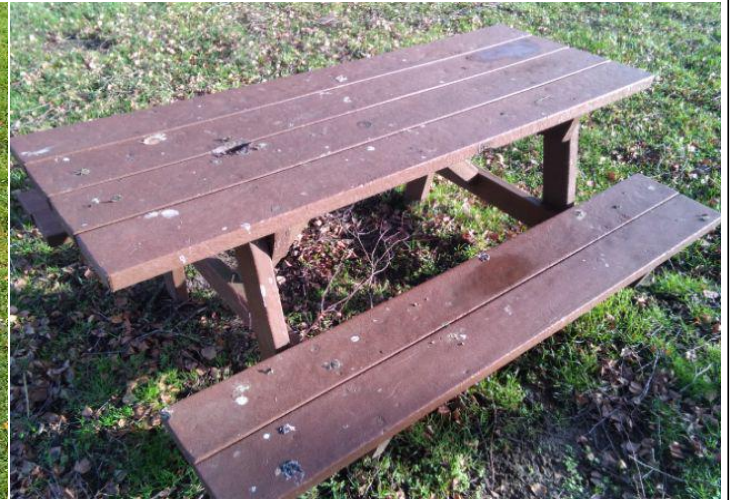
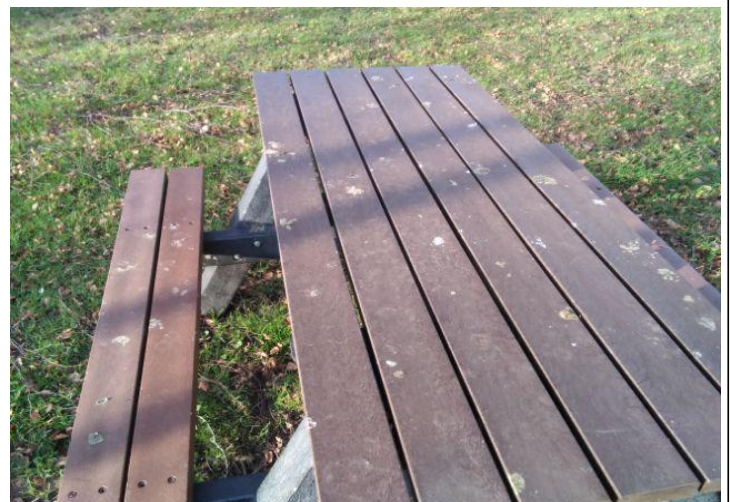
Finding: There is excrement on site

Action: Clean and maintain area

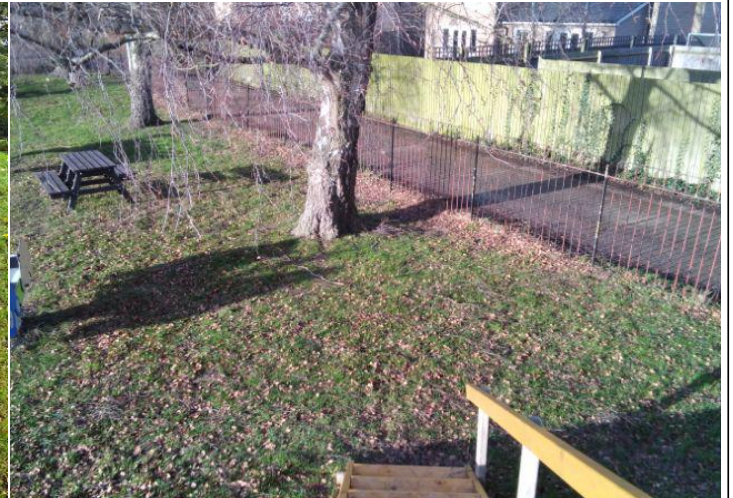
Finding: The tree canopy overhangs the equipment and is less than 2.0m away

Action: Lift tree canopy to ensure a minimum clearance of 2.0m from the equipment

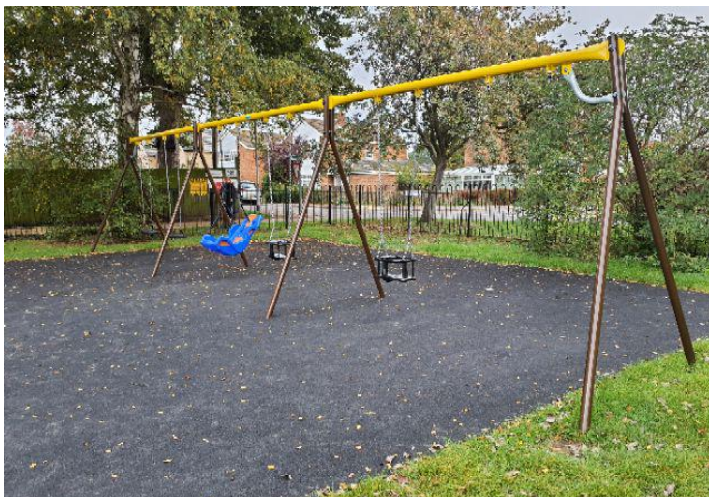
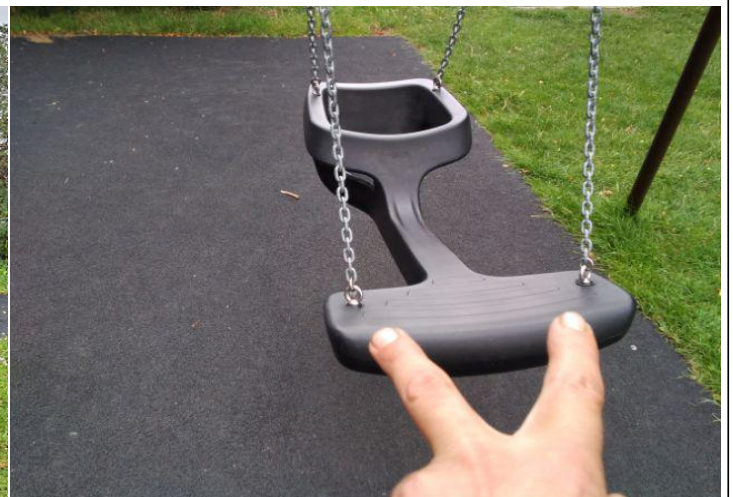
Finding: A number of fixing(s) have worked loose

Action: Secure all loose fixings

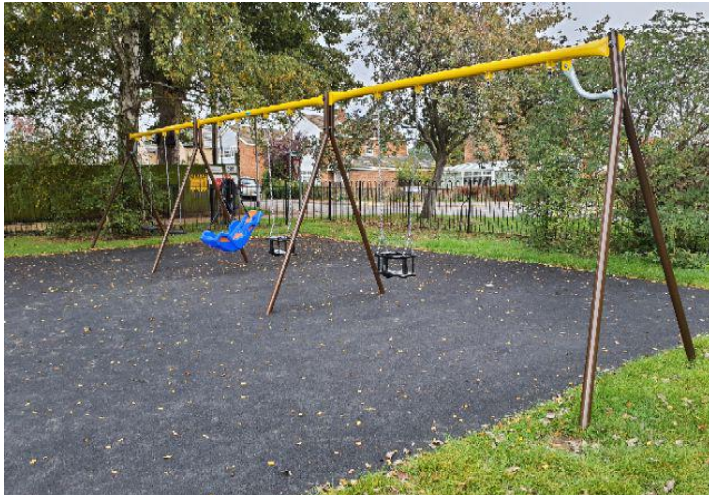
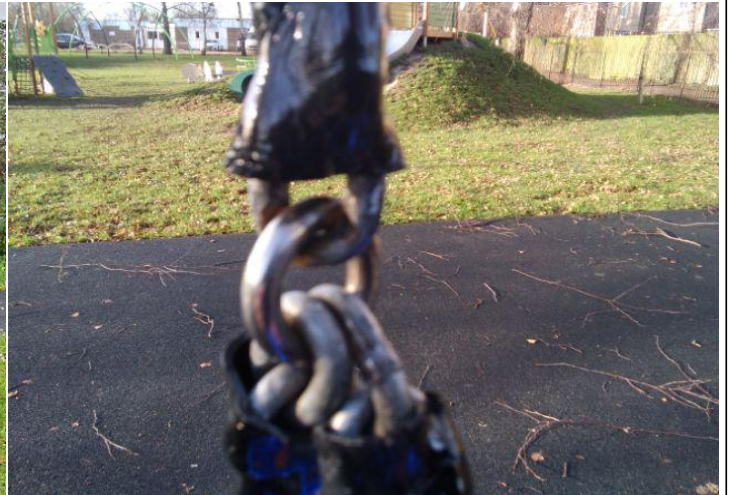
Finding: There is some notable evidence of chain wear

Action: Monitor for any further deterioration and replace when 40% worn

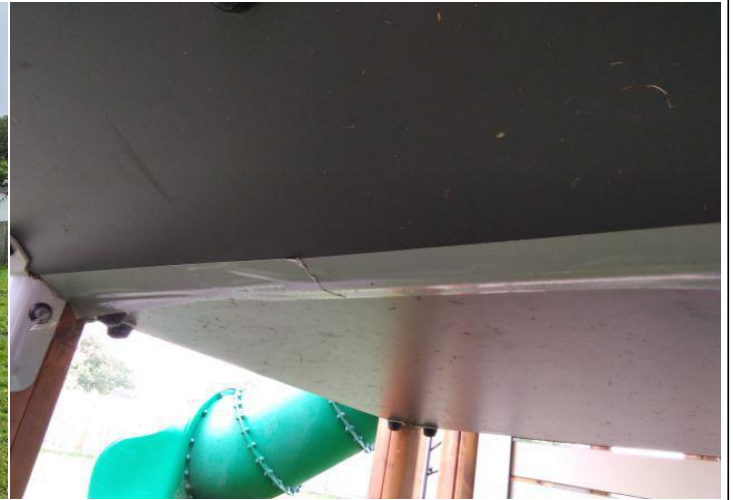
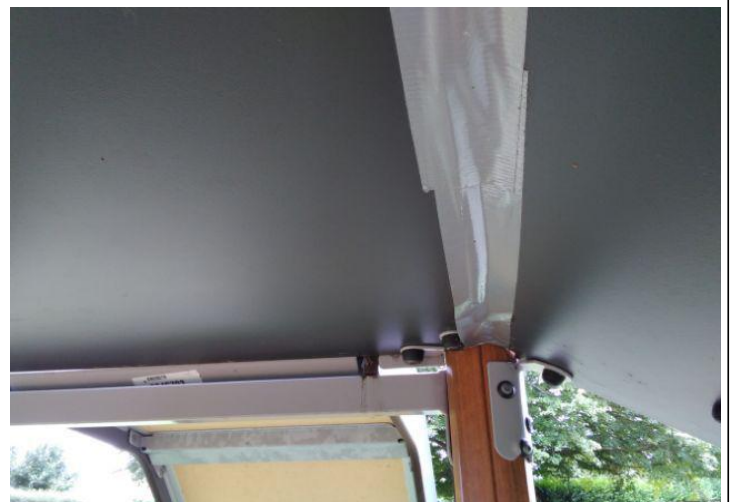
Finding: Gaps have been taped!

Action: Na

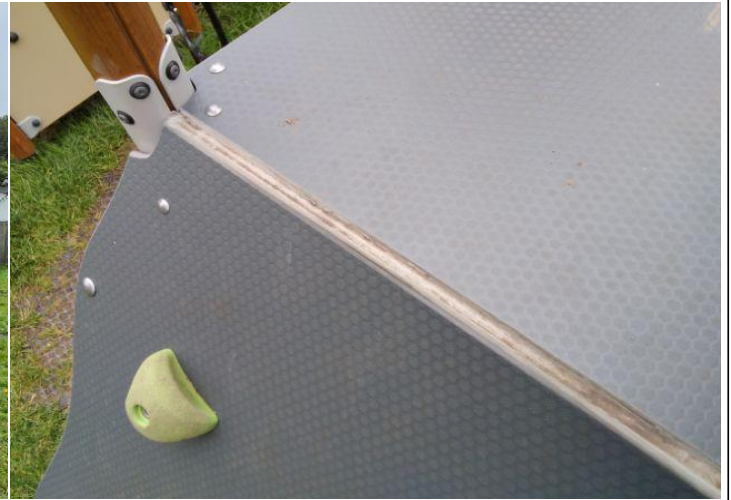
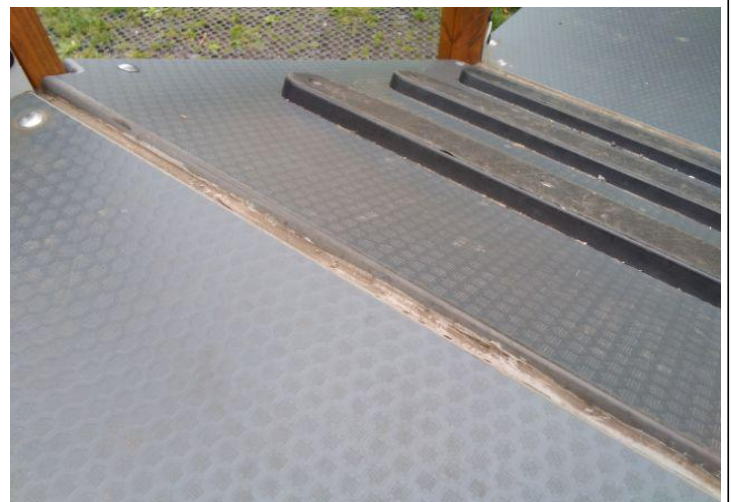
Finding: Filler has been used to fill gaps

Action: Monitor

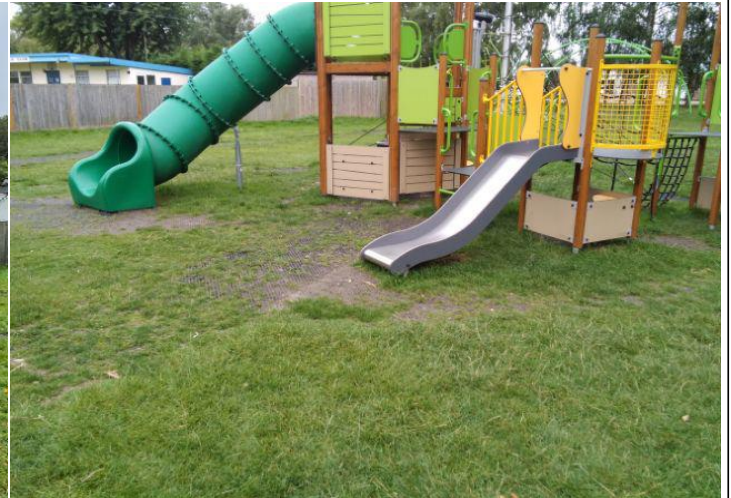
Finding: The grass mats are silted up, the soil is compacted and the area will become very slippery when the soil is wet. **Action:** Reinstate as required

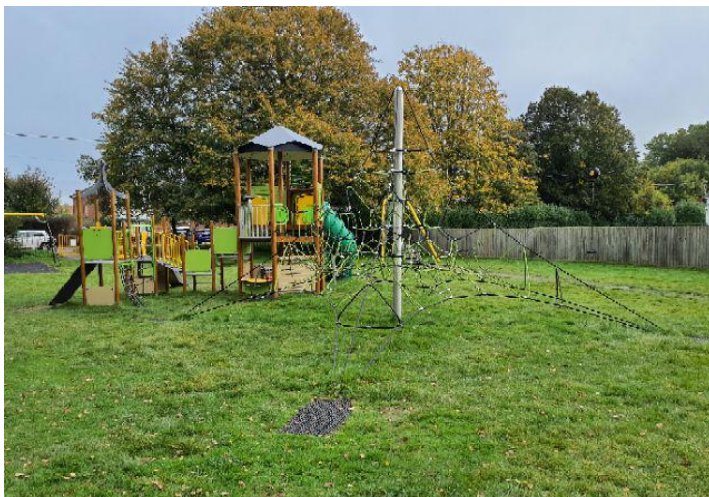
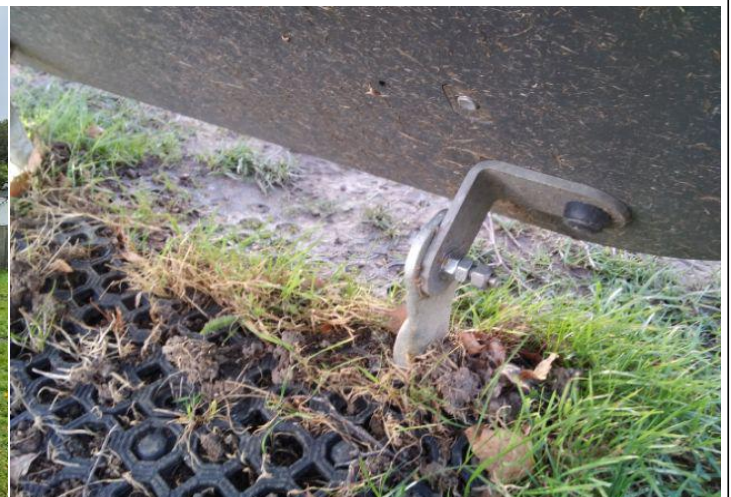
Finding: There is/are bolt cap covers missing or damaged on the item **Action:** Replace missing or damaged bolt cap covers

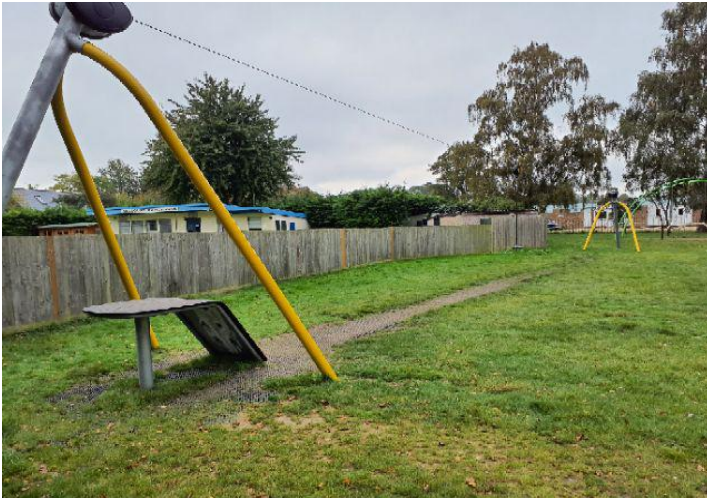
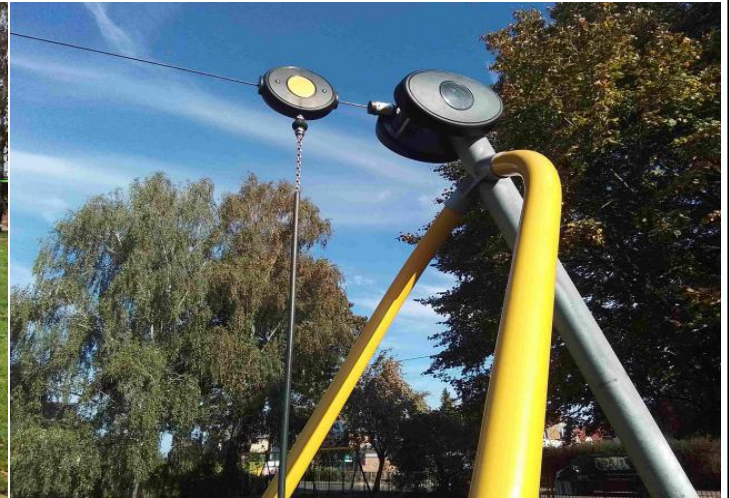
Finding: The dampening spring or tyre is damaged or broken on the item

Action: Replace spring or tyre

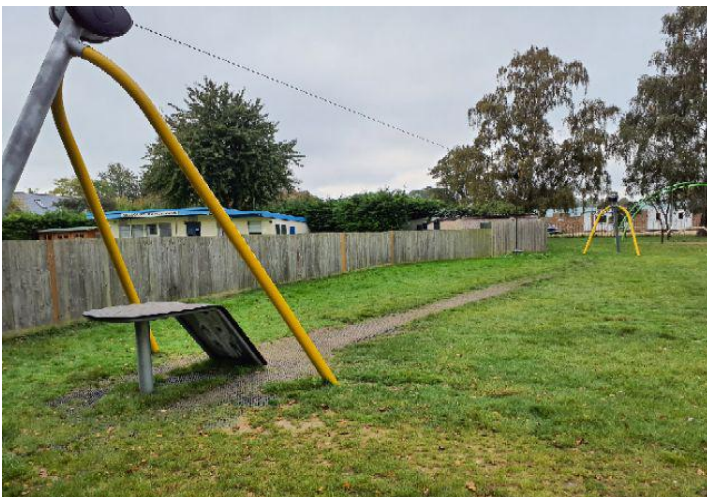
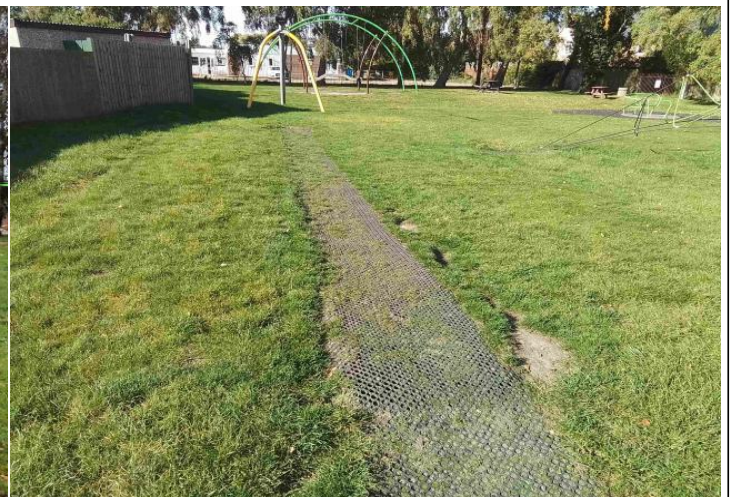
Finding: The loose fill safety surfacing has become compacted

Action: Rake and fork over to aerate the surface

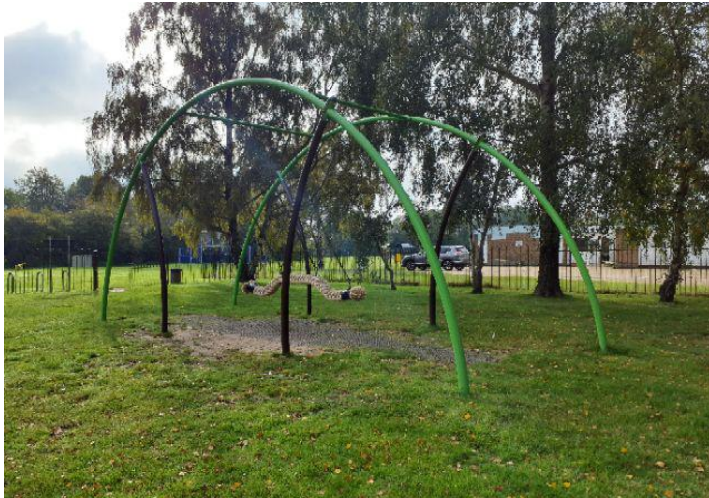
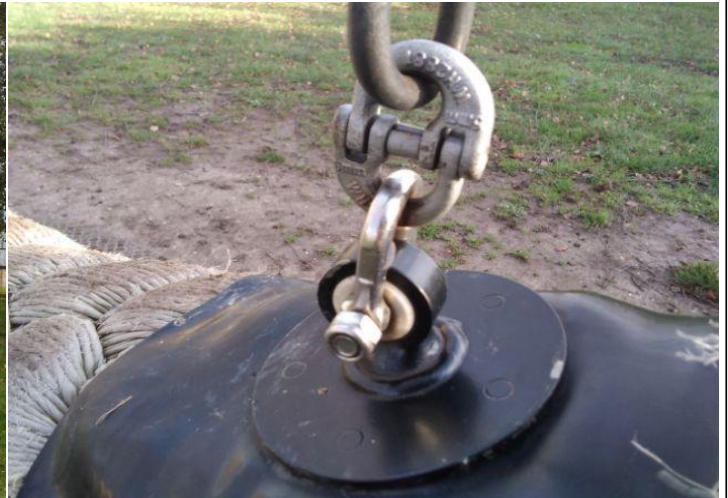
Finding: There is some wear to the shackles x 4 quick links **Action:** Monitor for any further deterioration and replace when 40% worn

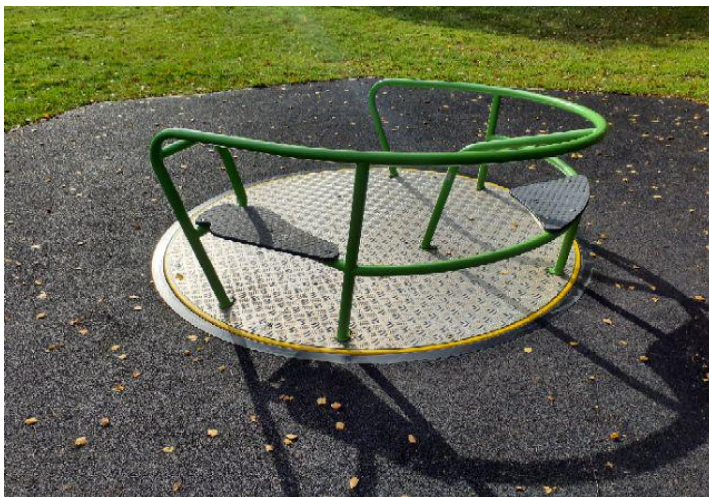
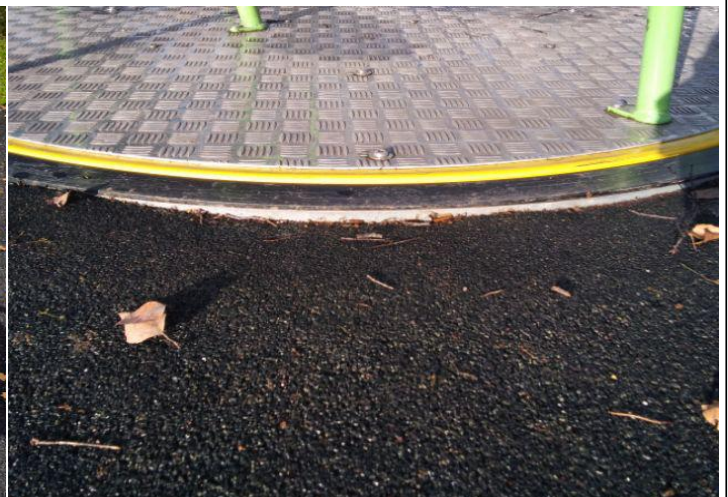
Finding: Wet pour sinking at edge causing trip hazard 2 Im **Action:** Monitor repair

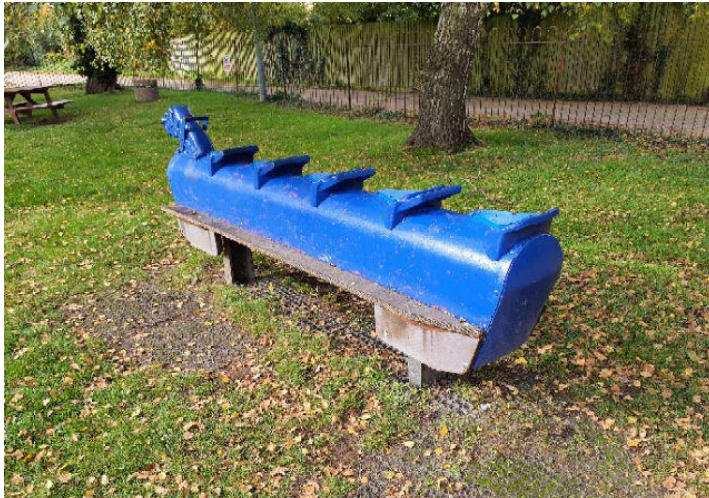
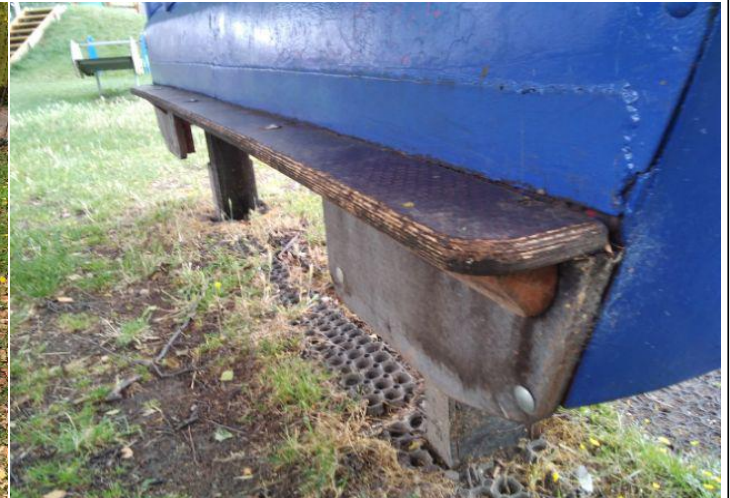
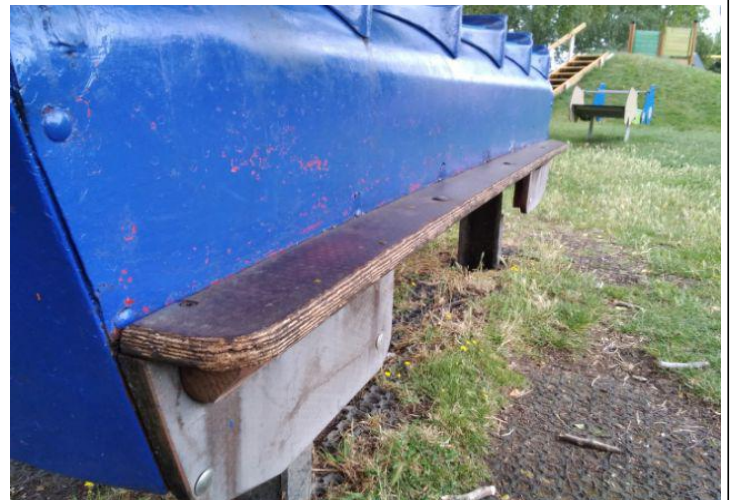
Finding: The timber has a number of splits/shakes or air cracks and this may affect the stability or allow water ingress which will accelerate the rotting process

Action: Monitor to ensure the splits do not cross through fixing points of the structure and/or cause any instability

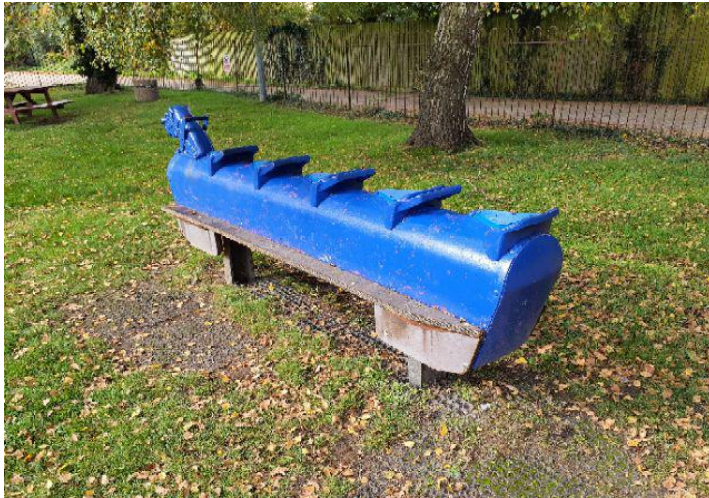
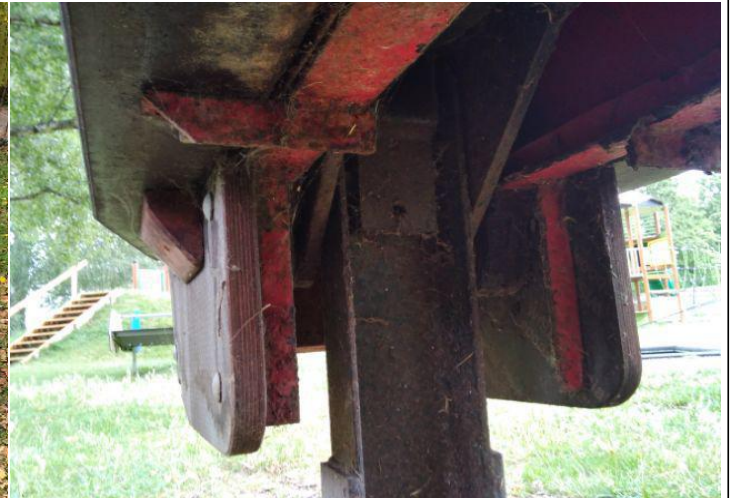
Finding: The bearing is showing signs of wear

Action: Monitor for any further deterioration and replace as required

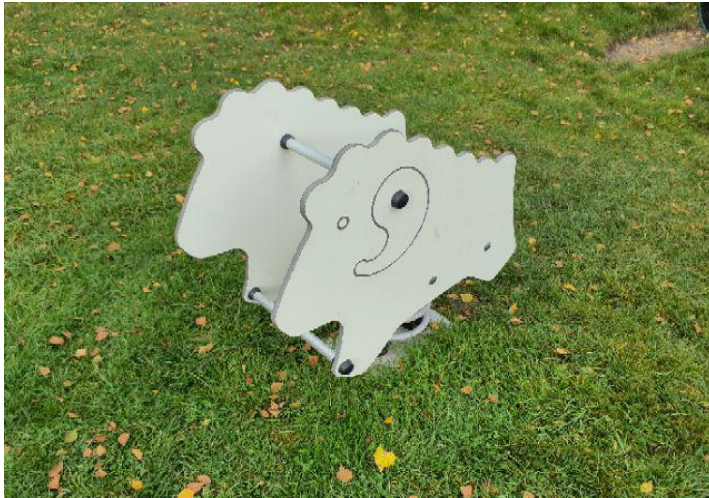
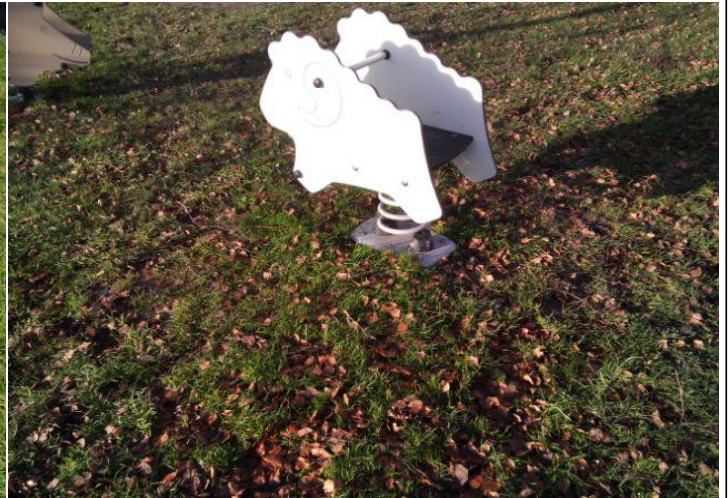
Finding: The grass mats are silted up and the soil is compacted; this may have an effect on the impact absorbing properties of the surface

Action: Consider HIC testing impact absorbing properties to ensure the correct surface qualities are maintained for the equipment and replace as required

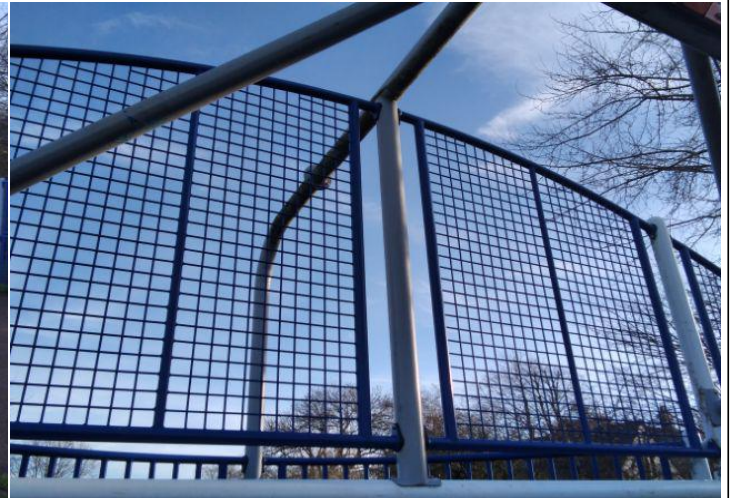
Finding: There is algae or moss on the surface of the equipment

Action: Clean and treat appropriately

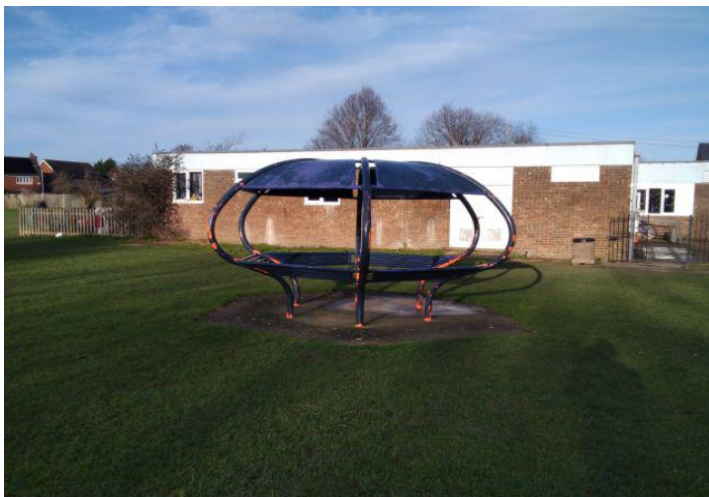
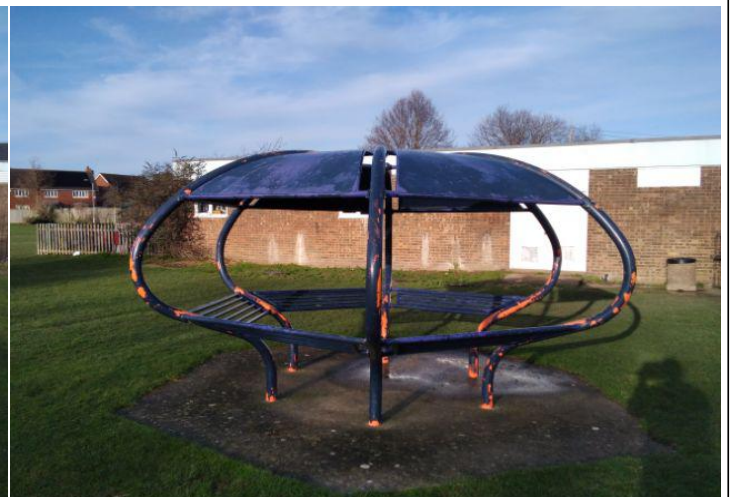
Finding: The paintwork on this item has been damaged or worn exposing the metal underneath which is rusting

Action: Treat any rusting components and repaint
