Operational Inspection

Melbourn Parish Council

The Moor Play Area
The Moor, Royston, Cambridgeshire, SG8 6ED

Inspection Ref: 2256362

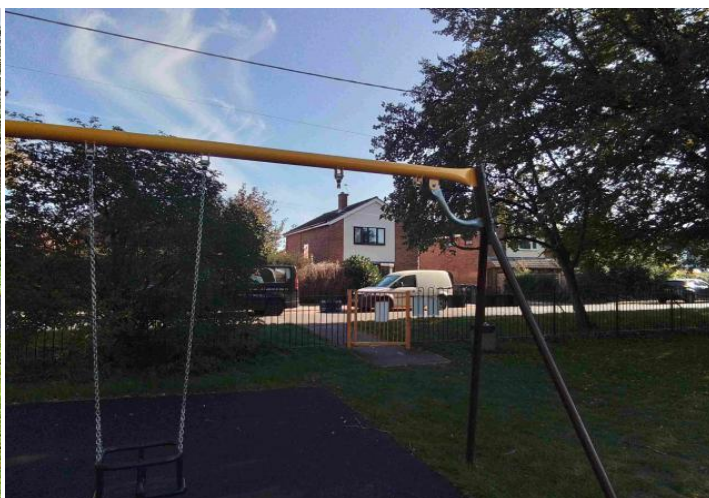
Finding: The end seat has gone and requires replacing

Action: Replace damaged seat

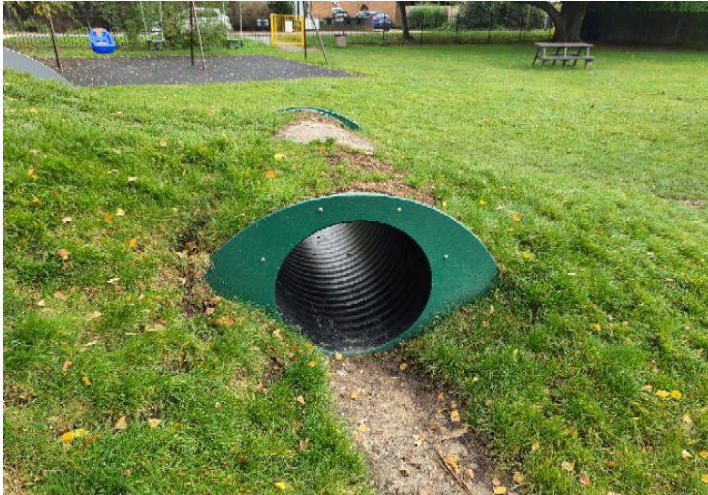
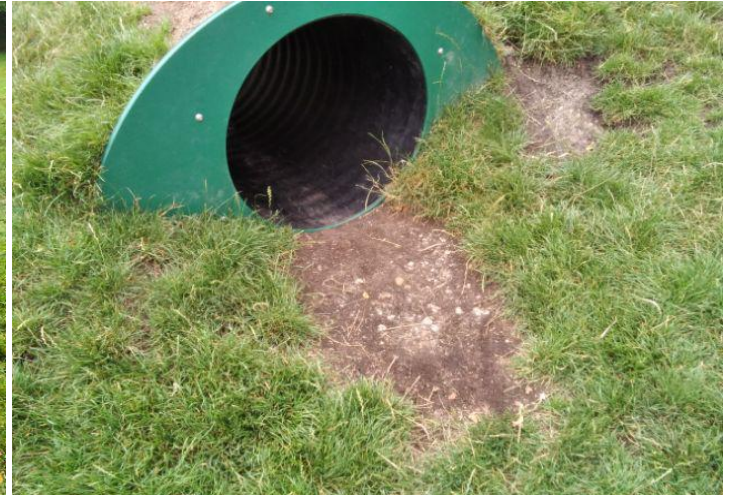
Finding: The safety surface under or around this unit has been damaged

Action: Monitor for any further deterioration and repair as required

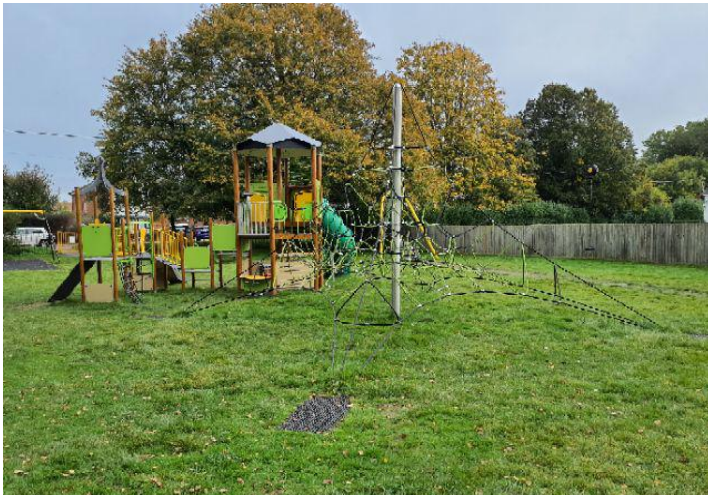
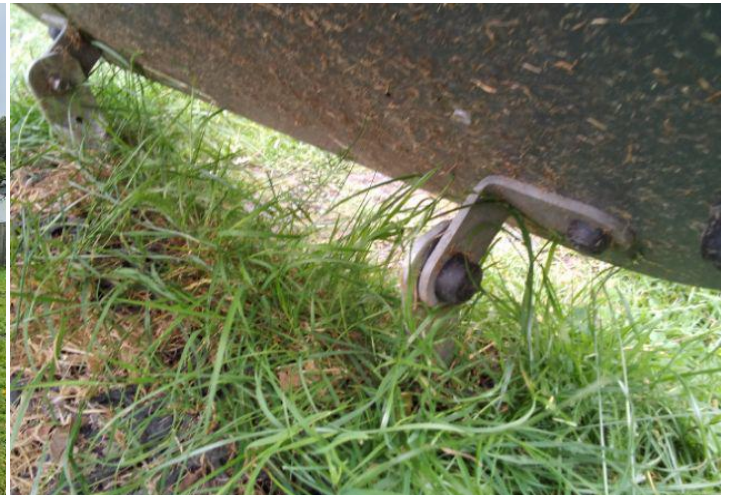
Finding: A number of fixing(s) have worked loose

Action: Secure all loose fixings
