QUOTATION

EXPERT
ACCESS
SOLUTIONS

Site Reference Melbourn Community Hub SG8 6DZ
30 High Street
Melbourn
SG8 6DZ

Door Location: 3no. Auto Swing Doors – Main Entrance Outer (Asset 440328277), Main Entrance Inner (Asset 440328278), Rear Exit (Asset 440328279)

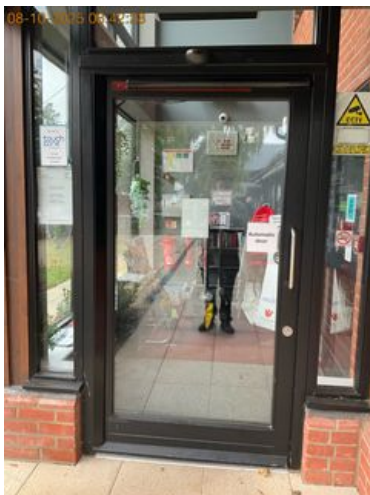
Before

Door Location	Main Entrance Outer	Asset No	440328277
Door Type	Assets

Insufficient safety devices fitted on opening edge. Additional on door safety sensor to be fitted into existing housing to prove full door width coverage. Finger guard fitted too high from floor level. Finger guard requires removing, bottom lip of door to be cut with multi tool and then finger guard refitted back on door, lower to floor.

*Main Entrance Outer 440328277: Safety device insufficient on opening edge. Additional safety sensor module to be fitted into existing on-door sensor housing to prove full door width coverage. Finger guard fitted too high from floor level. Finger guard requires removing, bottom lip of door to be cut with multi tool and then finger guard refitted back on door, lower to floor.

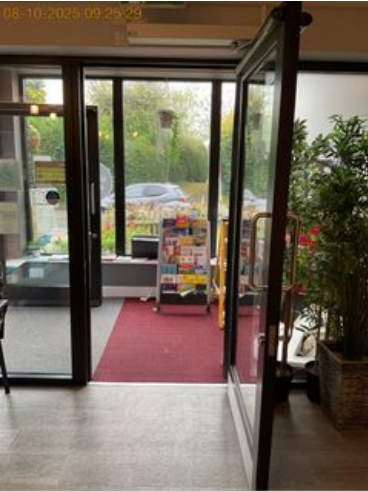
Before

Door Location	Main Entrance Inner	Asset No	440328278
Door Type	Assets

Insufficient safety devices fitted on opening edge. Requires new housing and additional sensor fitting to opening edge to provide full door width coverage. Finger guard fitted too high from floor level. Finger guard requires refitting lower to floor.

*Main Entrance Inner 440328278: Safety device insufficient on opening edge. Requires new housing therefore a replacement sensor fitting to opening edge to provide full door width coverage. Finger guard fitted too high from floor level. Finger guard requires refitting lower to floor.

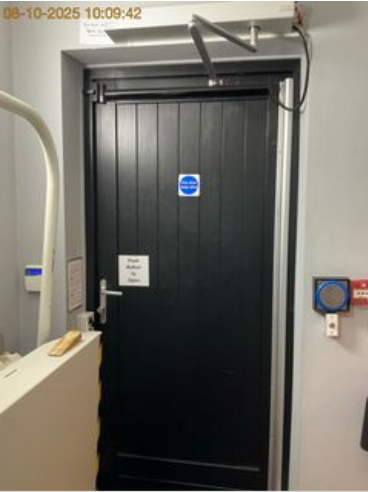
Before

Door Location	Rear Exit	Asset No	440328279
Door Type	Assets

Insufficient safety devices fitted on opening edge. Requires new sensor to be fitted into existing housing on the opening edge to provide full door width coverage. Finger guard fitted too high from floor level. Finger guard requires refitting lower to floor.

*Rear exit 440328279: Safety device insufficient on opening edge. Additional safety sensor module to be fitted into existing on-door sensor housing to prove full door width coverage. Finger guard fitted too high from floor level. Finger guard requires refitting lower to floor.
