# Safety Inspection Report

Annual Inspection

## Clear Crescent Play Area

Melbourn Parish Council

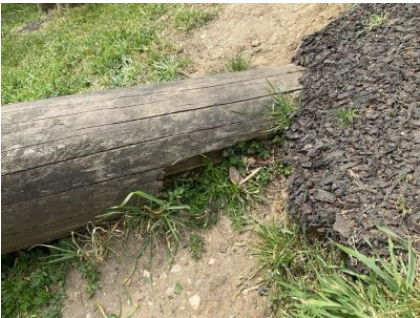
Timber is decayed.

Log adjacent to the rope balance has started to decay.

Replace affected parts.

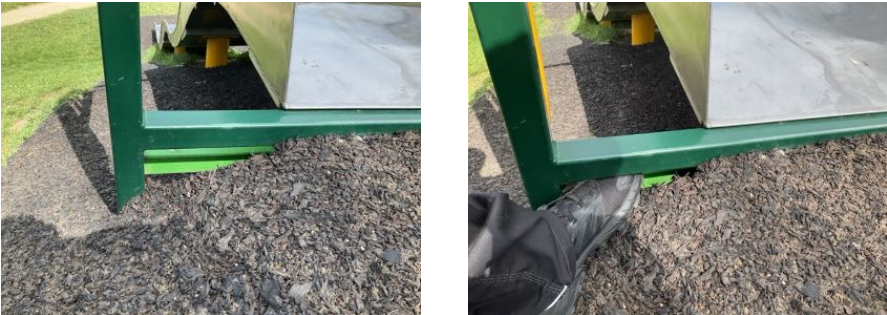
1. Ground erosion present.
2. Loose in ground.

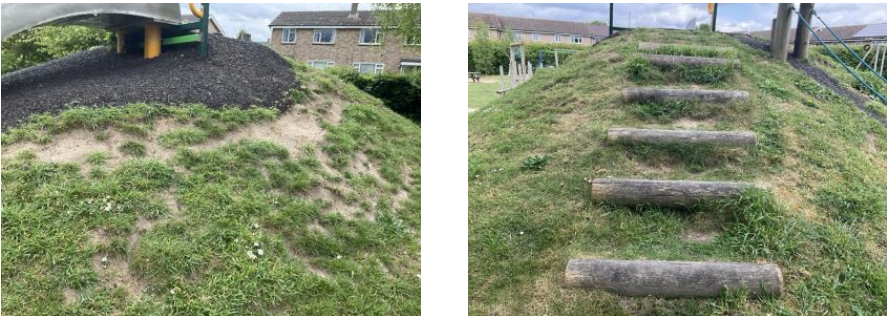
Loose in ground.

Logs have slight movement and could cause trips and falls. Secure.

Repair.

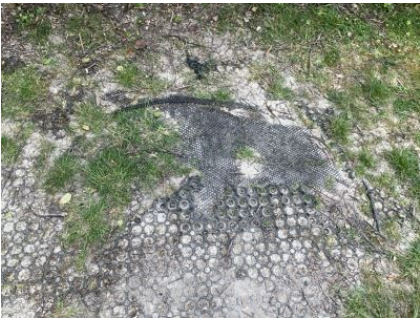
Surface needs repair.

Grass mats are damaged and lifting. Replace.

Replace.

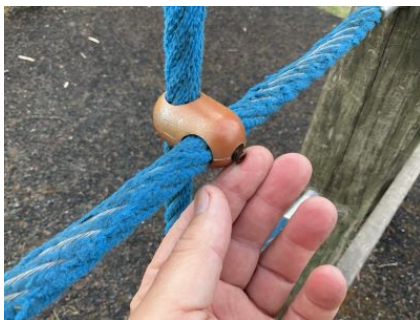
Fixtures loose or missing.

Net connectors are very loose to the posts. Remove fittings to check for corrosion and replace if found and then secure the net.

Loose and projecting rope screws. Secure.

Ladder fixings missing. Replace.

Cap/s are missing allowing water ingress into the frame and fixtures. Replace.

Read the notes for further action., Tighten/replace.

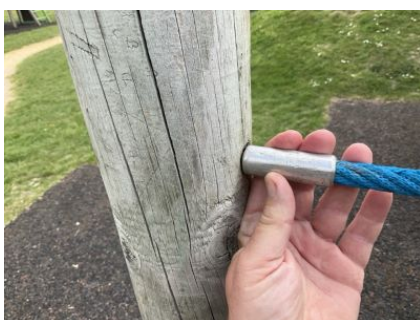
Fixtures loose or missing.

Rope connectors are loose.

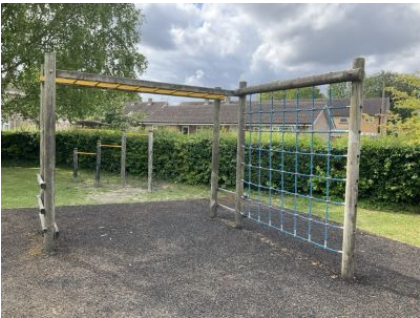
This equipment relies on one post for its stability. Special attention should be paid to maintenance (e.g. by monitoring degradation) and if necessary decommissioning the item before the end of its operating life. This is a requirement of the British Standard.

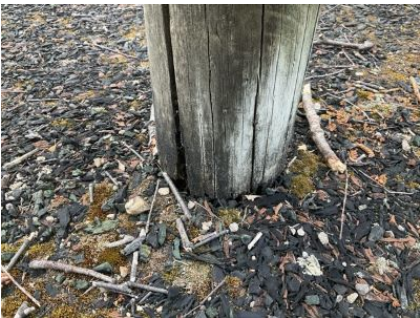
There is decay to timber components which may affect structural integrity. We do not recommend replacing rotten supports with timber posts which are directly set in the ground due to the increased problem of timber rot, especially in posts in contact with the ground.

Posts are showing signs of softening and decay at ground level. Monitor and replace when necessary.

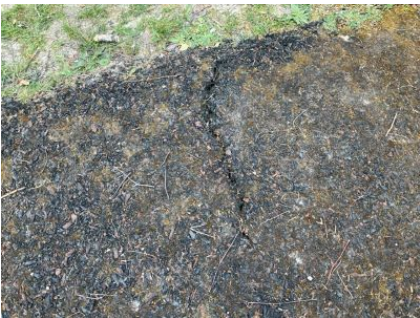
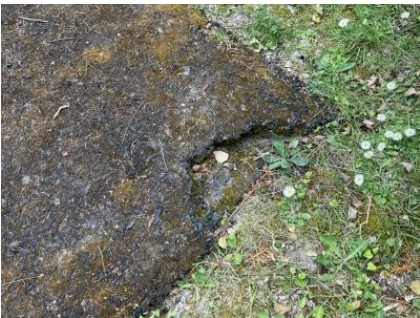
The surface is cracking.

The surfacing is cracking and damaged.  
Surface/the equipment are algae covered, creating a slippery surface when wet.

Repair., Read the notes for further action.

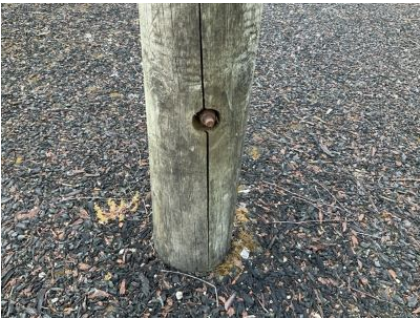
Cap missing.

Replace.

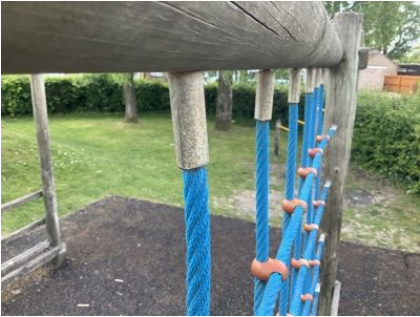
Periodically disconnect the rope net connectors to check for corrosion to the bolt fittings and replace if found, as corrosion and collapse has been know to occur to similar connectors.

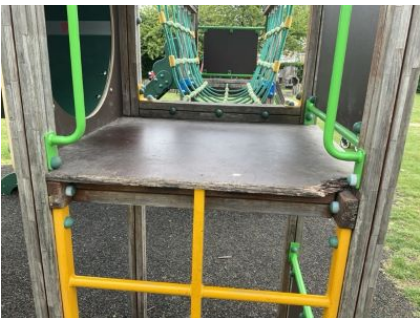
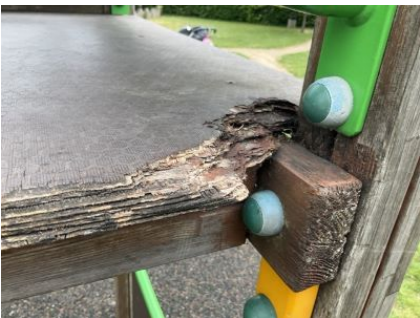
There is wear on the platform.

Replace.

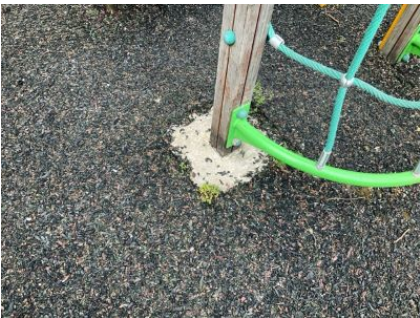
The foundations should be designed such that they do not present a hazard (tripping, impact). Care should be taken to ensure that foundations are not exposed as a result of erosion.

Square section missing around one post. Replace.

Repair., Eliminate the hazard.

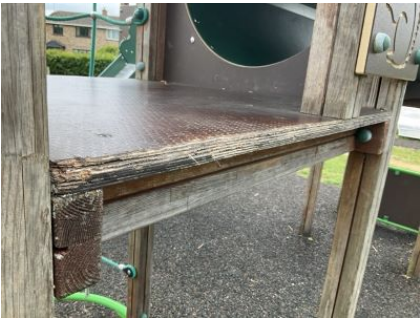
Laminate damaged.

Platform laminates around edges. Repair/replace.

Rub down and treat damaged edges., Read the notes for further action.

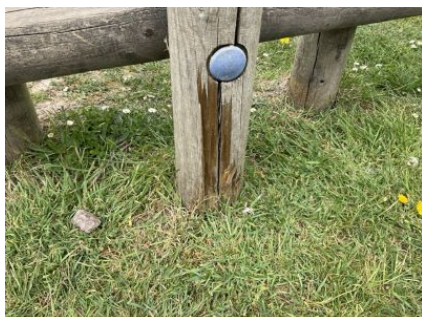
Strimmer damage is present on posts, allowing water to enter and timbers to soften. It can also remove the protective envelope around the timber. Prevent further damage and check timbers for decay throughout the year.

Monitor all timber items for decay throughout the year due to softening. Replace affected parts if found/necessary.

Prevent further damage., Read the notes for further action.

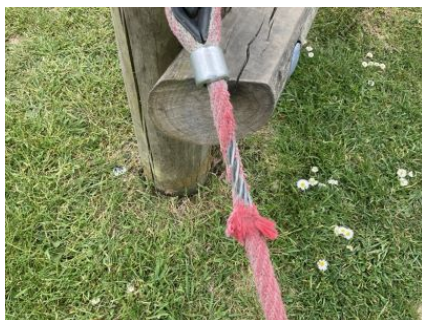
The rope is rubbing on the balance beam and wearing down to the wire. Monitor for broken wires and replace if found.

Read the notes for further action., Replace.

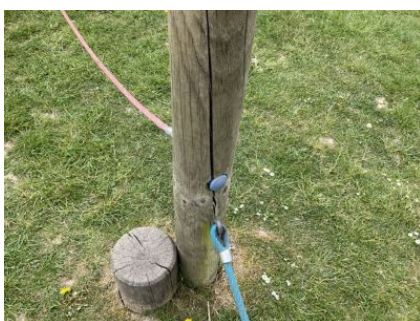
Bolt(s) loose.

Bridge cross beam loose.

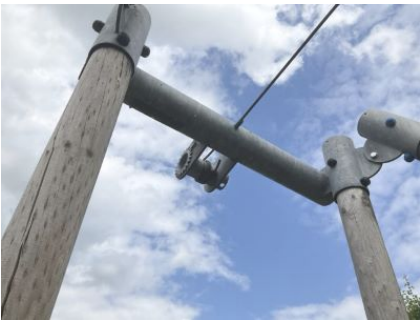
Cables have been known to fail under load due to wear and corrosion. This is generally where the cable enters into a tube, top bar, sleeve or similar, where the wire is in contact and wears and frays over time, but can happen anywhere on the cable. It is important to inspect any hidden parts at least annually. Damaged cables require replacement. This cannot be determined during an annual inspection, and is excluded from our inspection. This can lead to a high risk if no action is taken. Refer to the manufacturer's instructions to ensure the correct check is carried out.

Conduct an appropriate dismantling inspection according to the manufacturer's instructions, and at least annually. The trolley mechanism can be checked at the same time.

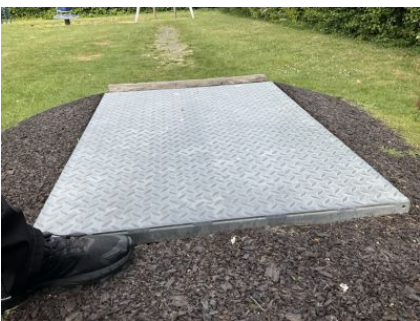
Trip around the platform.

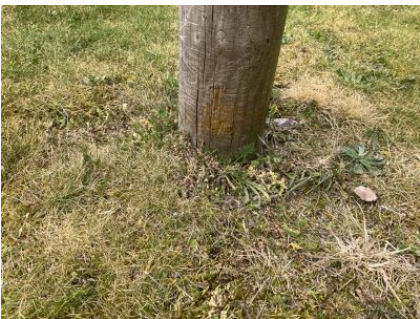
Strimmer damage is present on posts, allowing water to enter and timbers to soften. It can also remove the protective envelope around the timber. Prevent further damage and check timbers for decay throughout the year.

Prevent further damage.

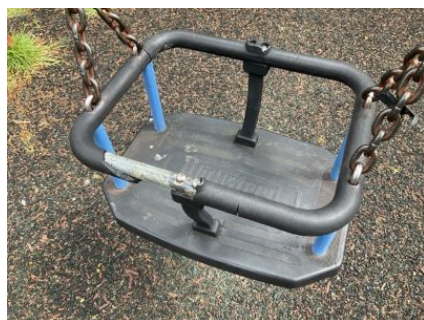
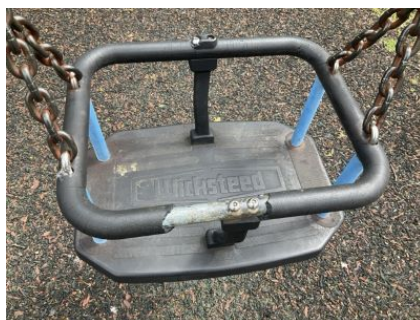
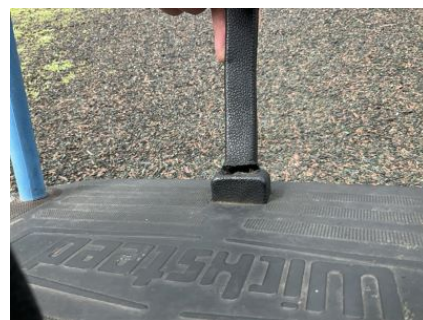
There is wear to the top of the cradle(s) leaving exposed metal.

Replace both seats in the near future, as frames are almost exposed.

Replace the seats for cradles if available.
