ASBESTOS MANAGEMENT SURVEY FOR ASBESTOS CONTAINING MATERIALS AT:

| <b>SITE ADDRESS:</b> | Grays Allotment Site<br>Melbourn<br>Royston<br>The Moor |
| <b>SURVEY REFERENCE</b> | CAR/2026/280 |

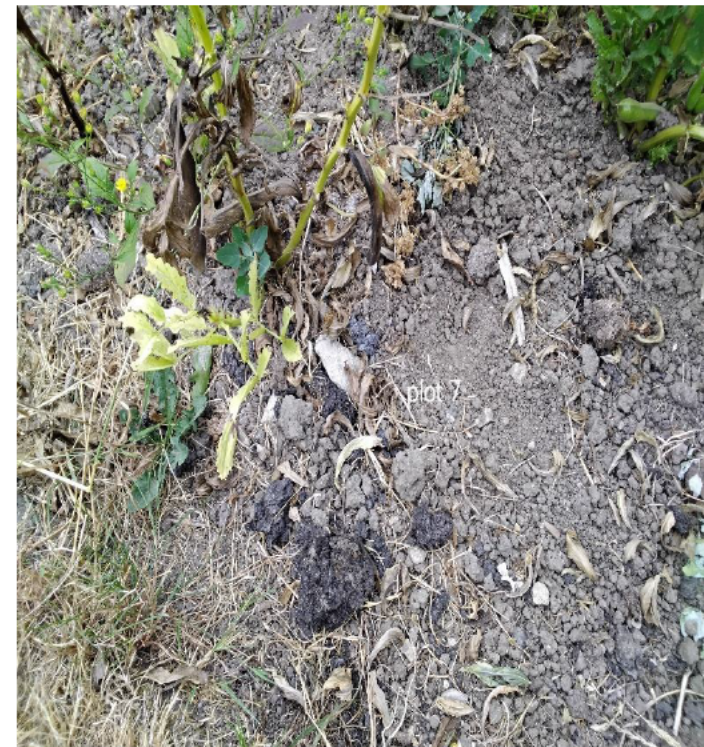
| Area, Floor, Room, Product: | Plot 7: Debris on floor | Treatment | Asbestos cement |

| Date: | 23.7.26 | Product type | Asbestos cement |
| Survey type: | Management | Damage | Medium damage |
| Location id | 1 | Asbestos type | Chrysotile |
| Material comments | Asbestos cement debris | Material risk band | Low risk |
| Quantity | | Priority risk score | 2 |

| Action | Remove | Material risk score | 2 |

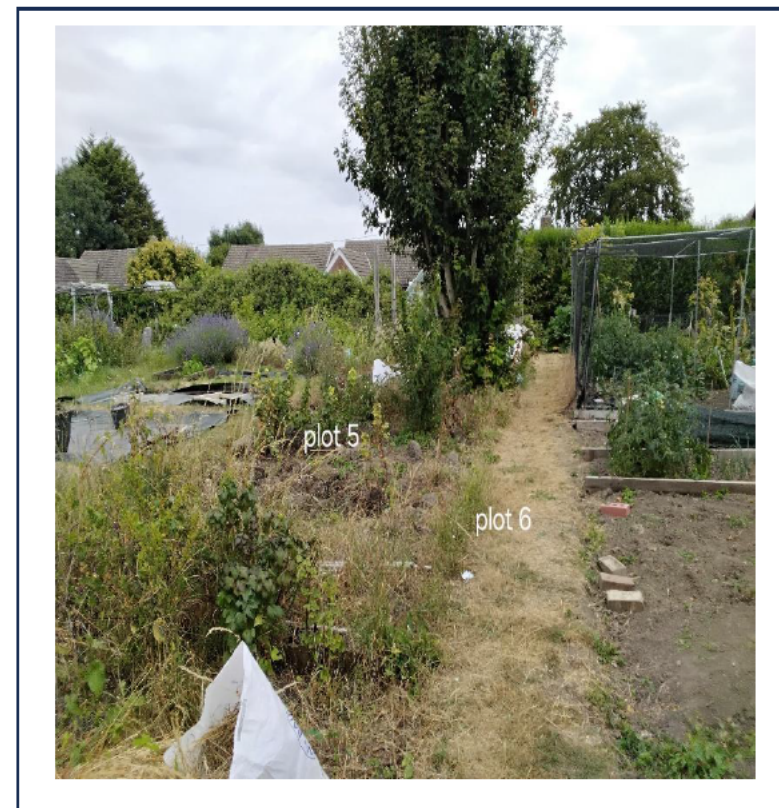
| Area, Floor, Room, Product: | Plot 5 and 6 | Treatment | No asbestos detected |

| Material comments | No asbestos detected | Material risk band | 0 |

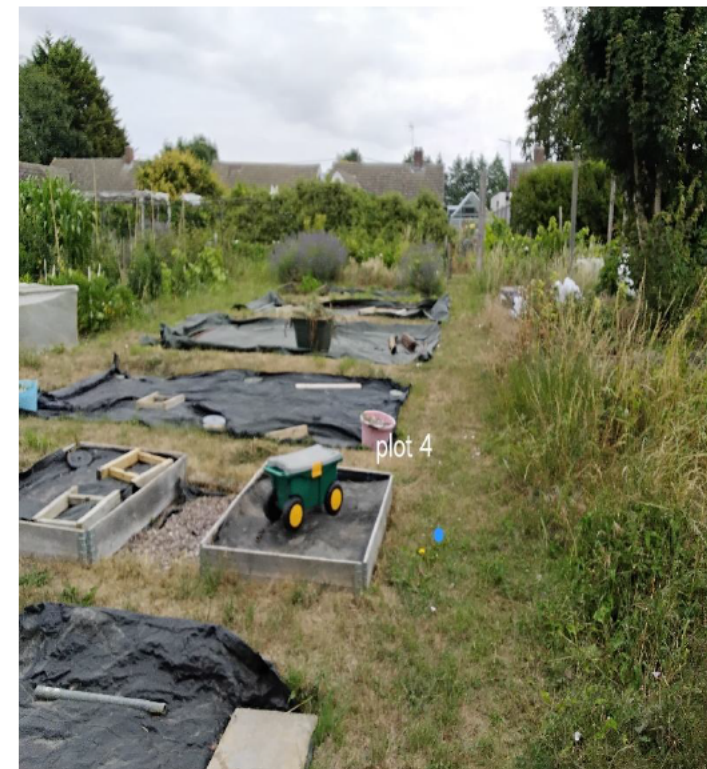
| Area, Floor, Room, Product: | Plot 4 | Treatment | No asbestos detected |

| Material comments | No asbestos detected | Material risk band | 0 |

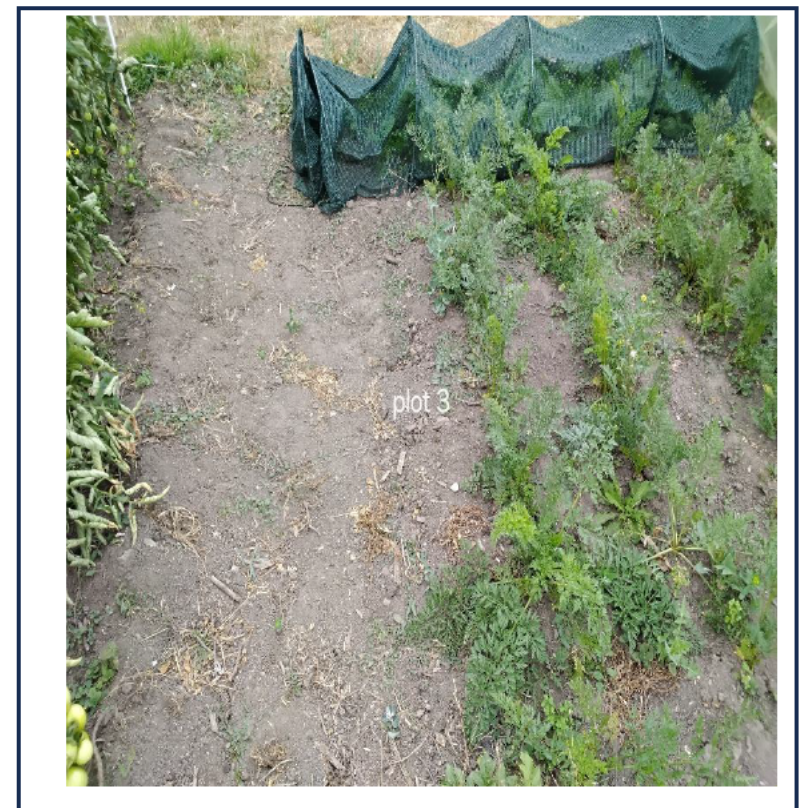
| Area, Floor, Room, Product: | Plot 3: debris | Treatment | NADIS |

| Material comments | No asbestos detected in sample | Material risk band | 0 |

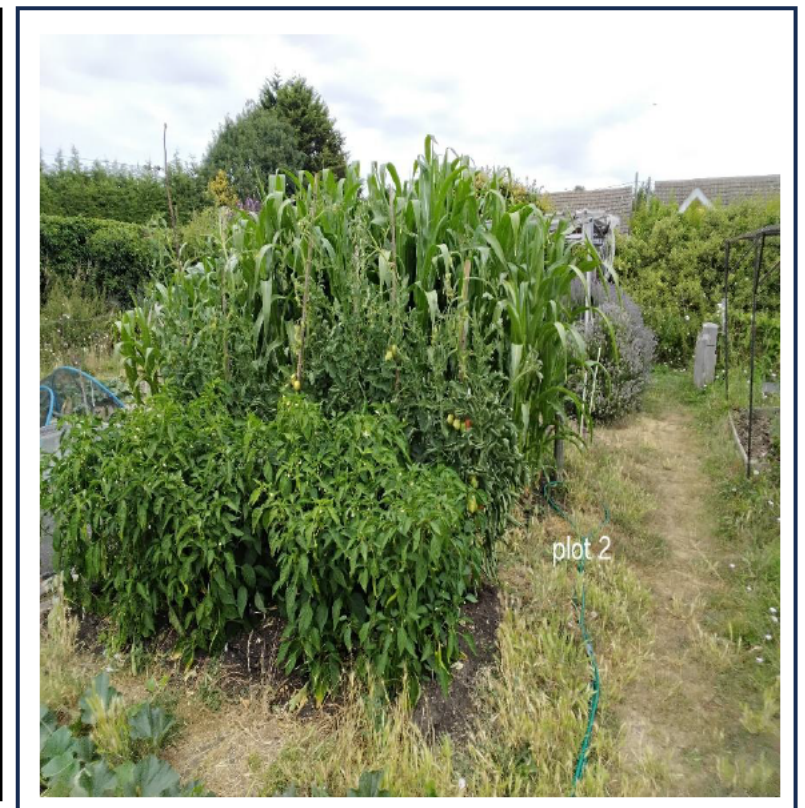
| Area, Floor, Room, Product: | Plot 2 | Treatment | No asbestos detected |

| Material comments | No asbestos detected | Material risk band | 0 |

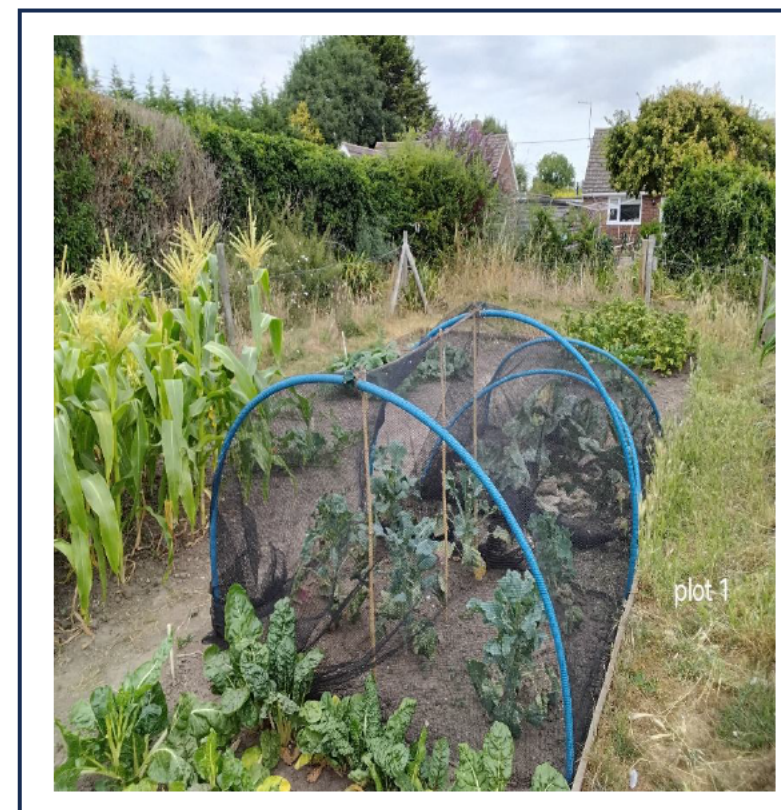
| Area, Floor, Room, Product: | Plot 1 | Treatment | No asbestos detected |

| Material comments | No asbestos detected | Material risk band | 0 |
