ASBESTOS MANAGEMENT SURVEY FOR ASBESTOS CONTAINING MATERIALS AT:

| <b>SITE ADDRESS:</b> | The Moor Allotment Site<br>Melbourn<br>Royston |
| <b>SURVEY DATE</b> | 23.7.26 |
| <b>SURVEY REFERENCE</b> | CAR/2026/279 |

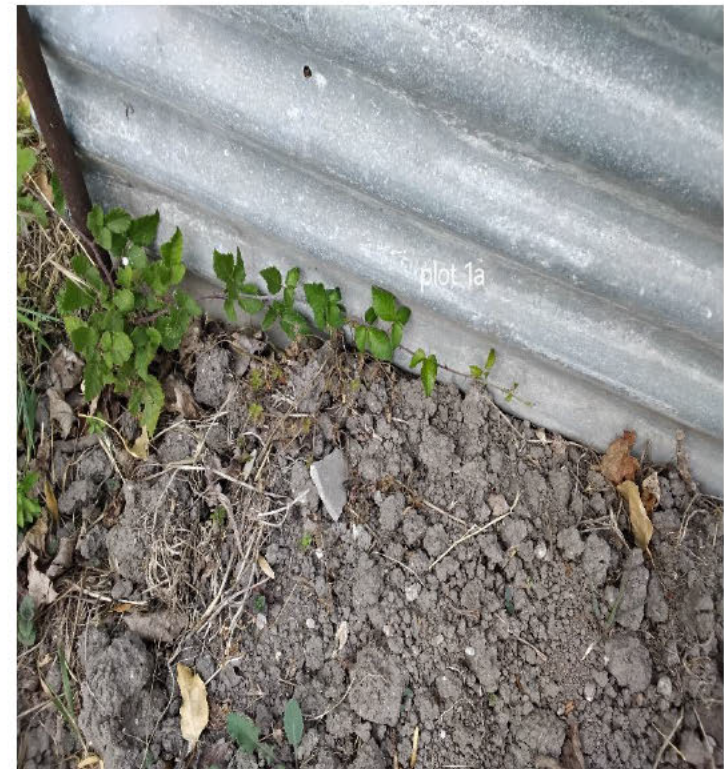
| Location id | 1 | Asbestos type | Chrysotile<br>Amosite |

| Survey type: | Management | Damage | Medium damage |
| Area, Floor, Room, Product: | Plot 1A/1B:<br>Various debris throughout plot | Treatment | Asbestos cement |
| Material comments | Asbestos cement debris | Material risk band | Low risk |

| Action | Remove | Material risk score | 2 |

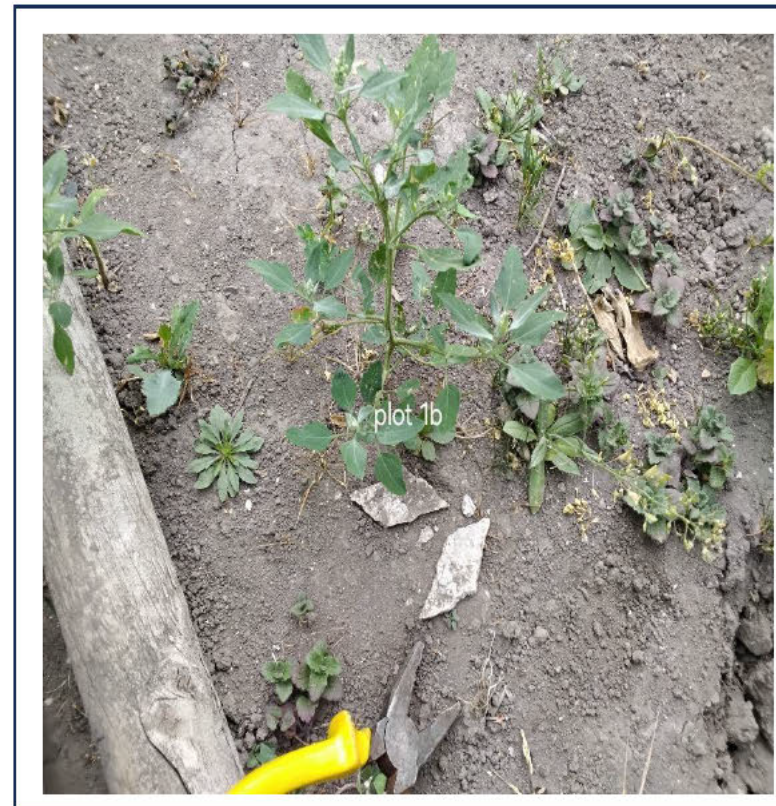
| Location id | 1 | Asbestos type | Chrysotile<br>Amosite |

| Survey type: | Management | Damage | Medium damage |
| Area, Floor, Room, Product: | Plot 1A/1B: Various debris throughout plot | Treatment | Asbestos cement |
| Material comments | Asbestos cement debris | Material risk band | Low risk |

| Action | Remove | Material risk score | 2 |

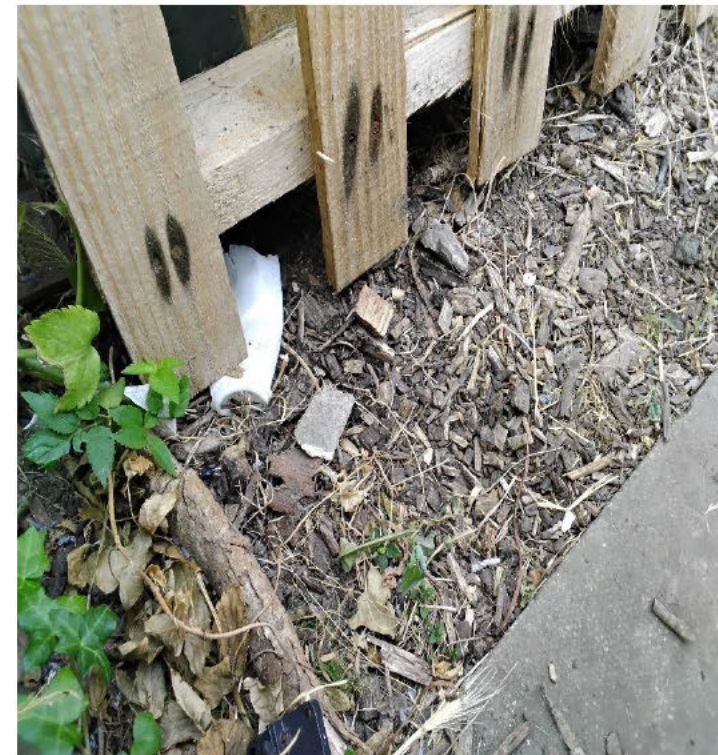
| Location id | 2 | Asbestos type | Chrysotile<br>Amosite |

| Survey type: | Management | Damage | Medium damage |
| Area, Floor, Room, Product: | Plot 1 – 10: Various debris T/O plots | Treatment | Asbestos cement |
| Material comments | Asbestos cement debris | Material risk band | Low risk |

| Action | Remove | Material risk score | 2 |

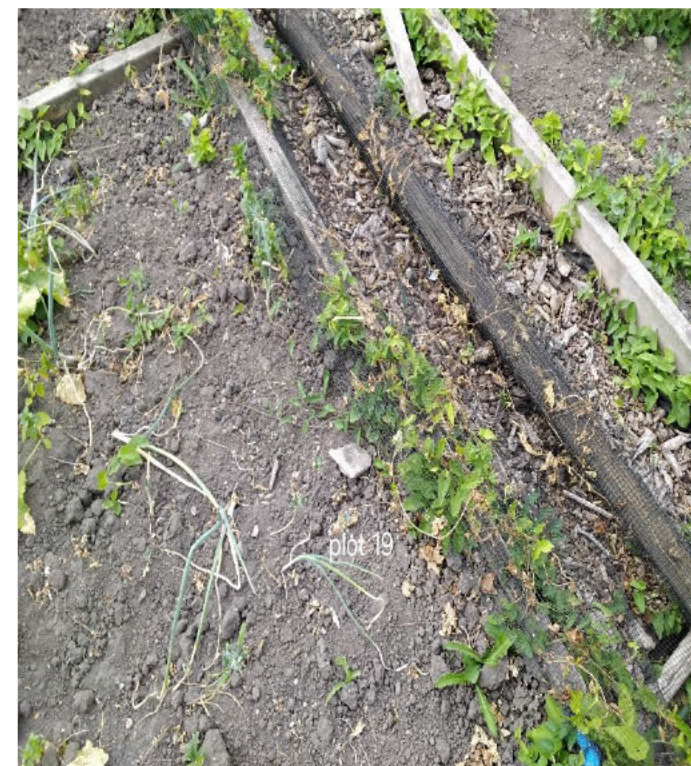
| Location id | 3 | Asbestos type | Chrysotile<br>Amosite |

| Area, Floor, Room, Product: | Plot 11-23: Various debris T/O plots | Treatment | Asbestos cement |
| Material comments | Asbestos cement debris | Material risk band | Low risk |
| Quantity | Specific photo took on plot 19 | Priority risk score | 2 |

| Action | Remove | Material risk score | 2 |

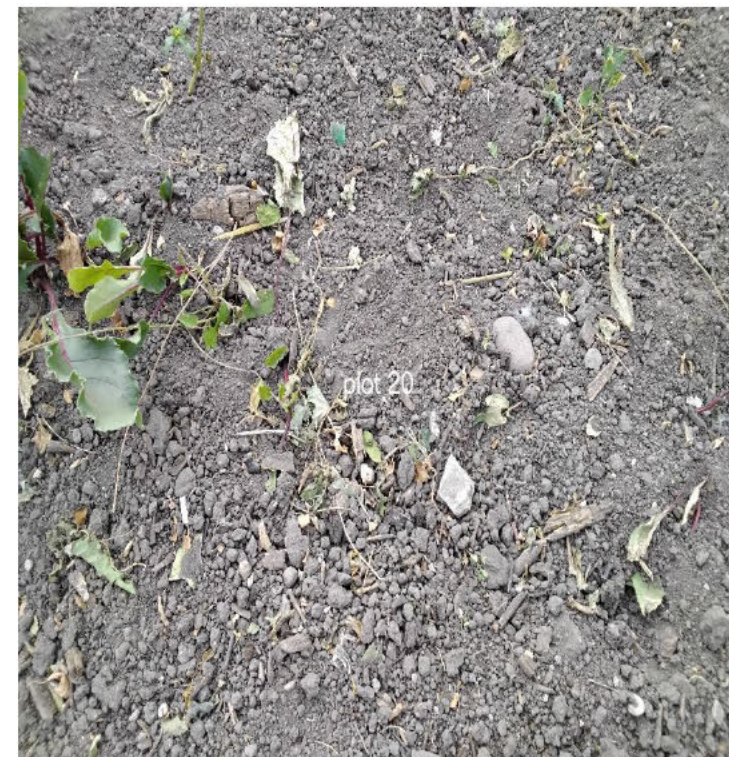
| Location id | 4 | Asbestos type | Chrysotile<br>Amosite |

| Area, Floor, Room, Product: | Plot 11-23: Various debris T/O plots | Treatment | Asbestos cement |
| Material comments | Asbestos cement debris | Material risk band | Low risk |
| Quantity | Specific photo took on plot 20 | Priority risk score | 2 |

| Action | Remove | Material risk score | 2 |

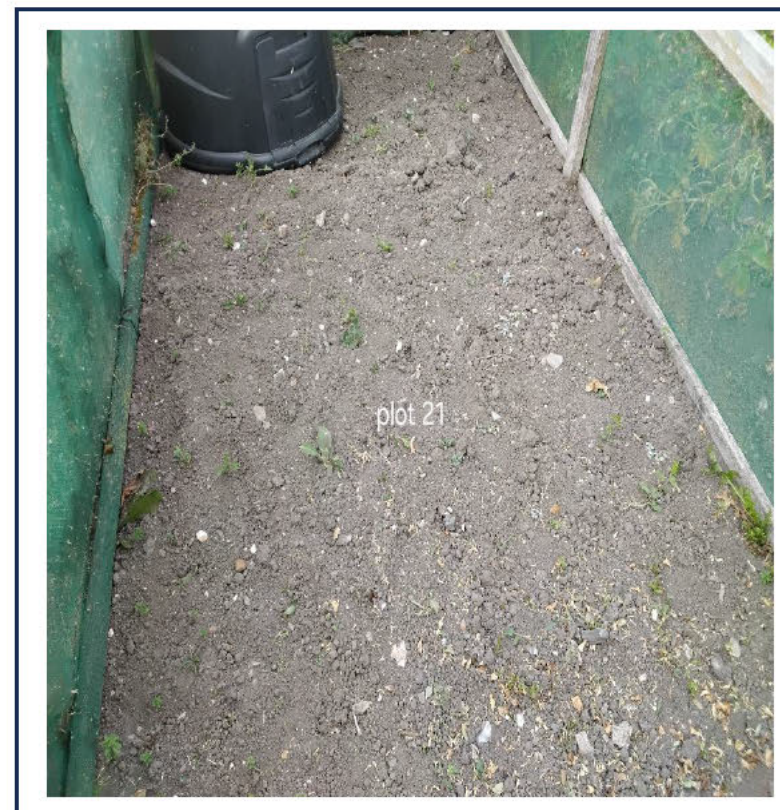
| Location id | 5 | Asbestos type | Chrysotile<br>Amosite |

| Area, Floor, Room, Product: | Plot 11-23: Various debris T/O plots | Treatment | Asbestos cement |
| Material comments | Asbestos cement debris | Material risk band | Low risk |
| Quantity | Specific photo took on plot 21 | Priority risk score | 2 |

| Action | Remove | Material risk score | 2 |

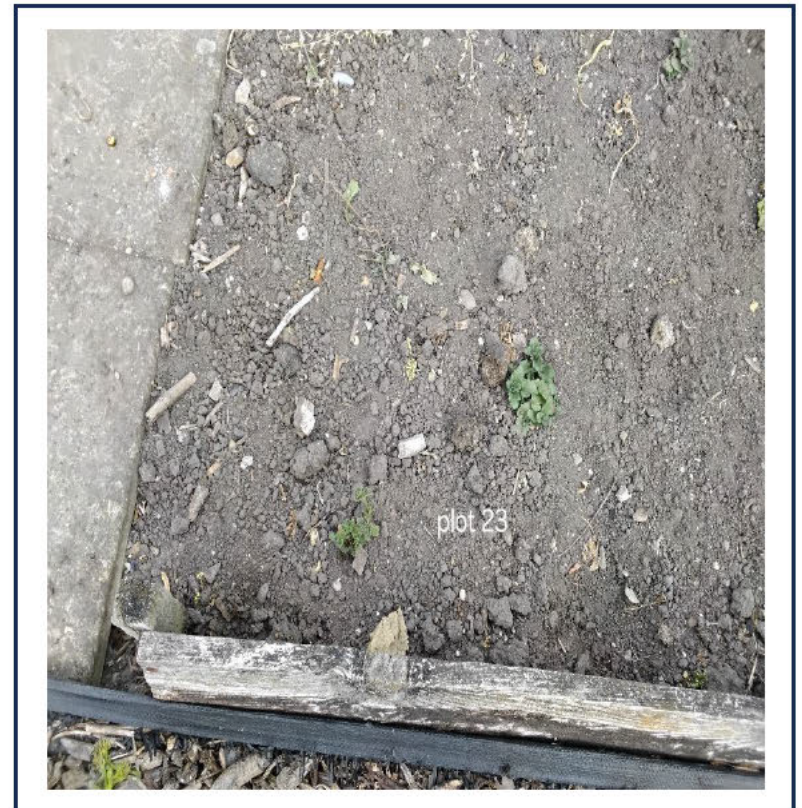
| Location id | 6 | Asbestos type | Chrysotile<br>Amosite |

| Area, Floor, Room, Product: | Plot 11-23: Various debris T/O plots | Treatment | Asbestos cement |
| Material comments | Asbestos cement debris | Material risk band | Low risk |
| Quantity | Specific photo took on plot 23 | Priority risk score | 2 |

| Action | Remove | Material risk score | 2 |

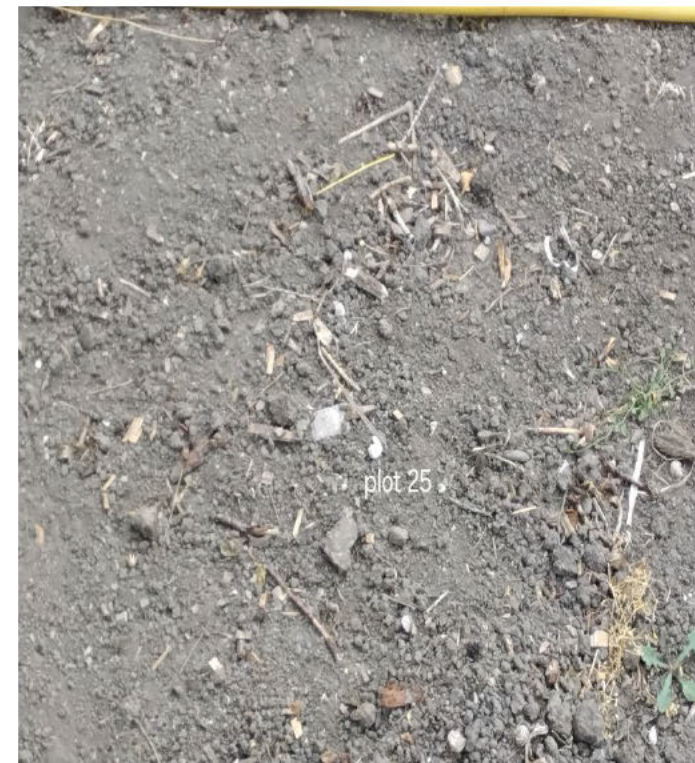
| Location id | 7 | Asbestos type | Chrysotile<br>Amosite |

| Area, Floor, Room, Product: | Plot 24-44: Various debris T/O plots | Treatment | Asbestos cement |
| Material comments | Asbestos cement debris | Material risk band | Low risk |
| Quantity | Specific photo took on plot 25 | Priority risk score | 2 |

| Action | Remove | Material risk score | 2 |

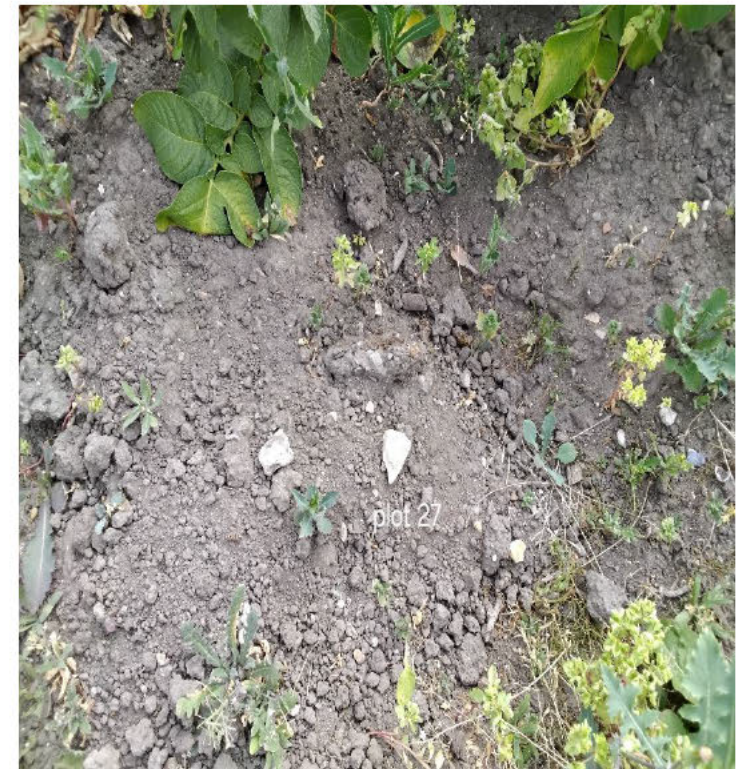
| Location id | 8 | Asbestos type | Chrysotile<br>Amosite |

| Area, Floor, Room, Product: | Plot 24-44: Various debris T/O plots | Treatment | Asbestos cement |
| Material comments | Asbestos cement debris | Material risk band | Low risk |
| Quantity | Specific photo took on plot 27 | Priority risk score | 2 |

| Action | Remove | Material risk score | 2 |

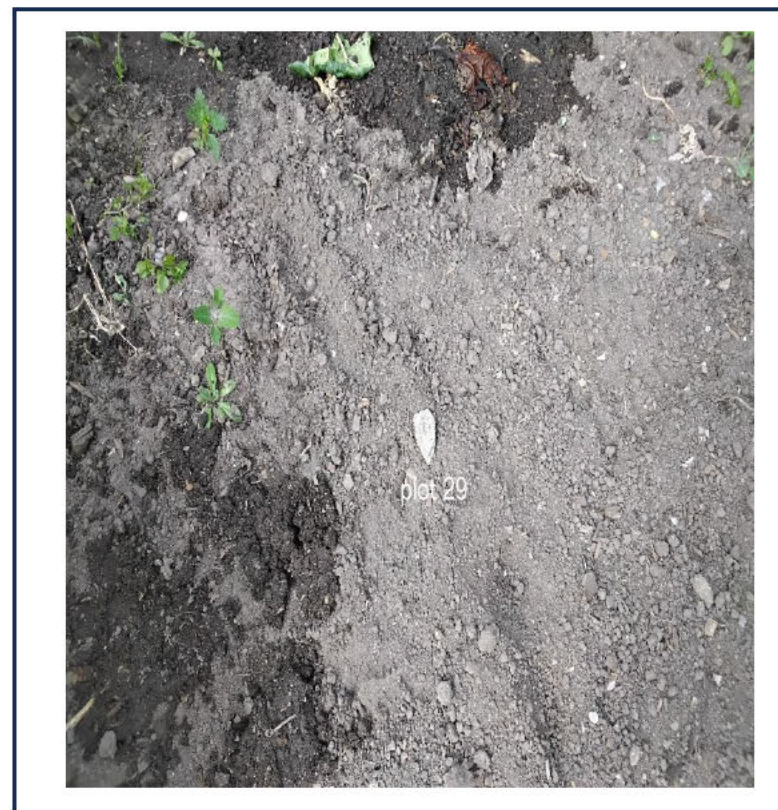
| Location id | 9 | Asbestos type | Chrysotile<br>Amosite |

| Area, Floor, Room, Product: | Plot 24-44: Various debris T/O plots | Treatment | Asbestos cement |
| Material comments | Asbestos cement debris | Material risk band | Low risk |
| Quantity | Specific photo took on plot 29 | Priority risk score | 2 |

| Action | Remove | Material risk score | 2 |

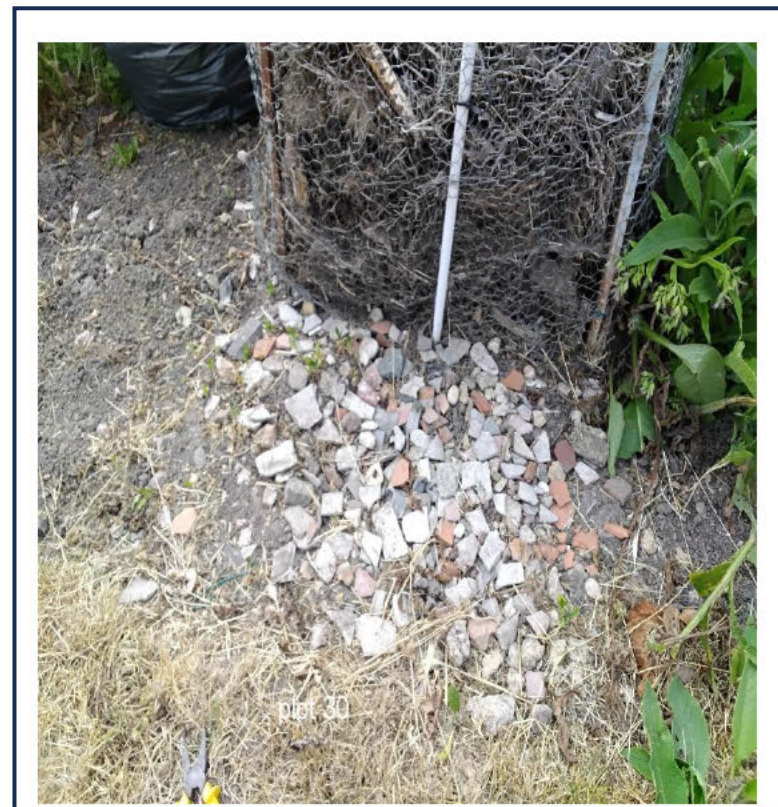
| Location id | 10 | Asbestos type | Chrysotile<br>Amosite |

| Area, Floor, Room, Product: | Plot 24-44: Various debris T/O plots | Treatment | Asbestos cement |
| Material comments | Asbestos cement debris | Material risk band | Medium risk |
| Quantity | Specific photo took on plot 30 | Priority risk score | 2 |

| Action | Remove | Material risk score | 2 |

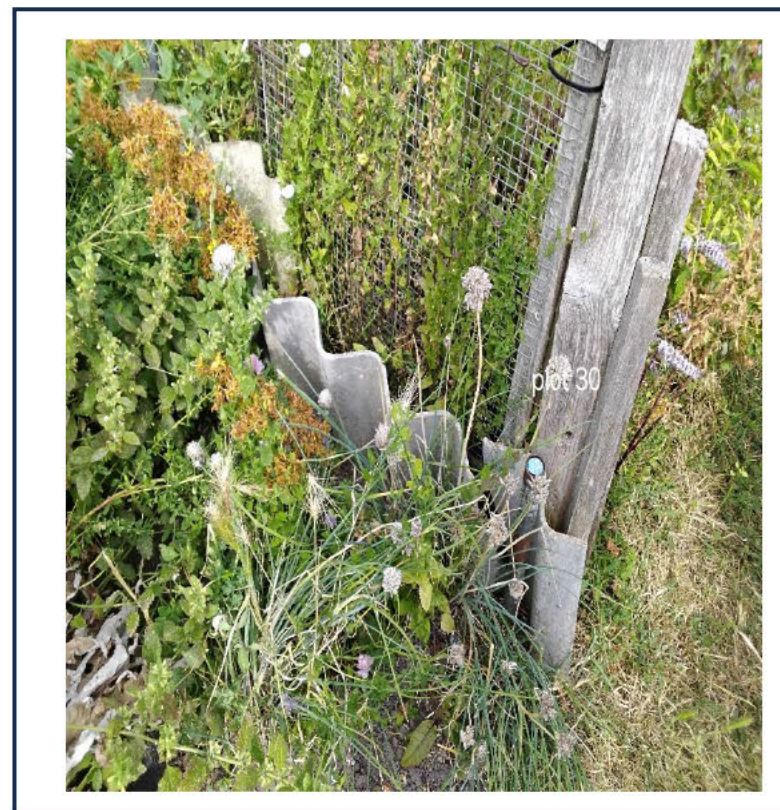
| Location id | 11 | Asbestos type | Chrysotile<br>Amosite |

| Area, Floor, Room, Product: | Plot 30: Asbestos cement fence panels | Treatment | Asbestos cement |
| Material comments | Asbestos cement sheeting | Material risk band | Low risk |
| Quantity | Specific photo took on plot 30 | Priority risk score | 2 |

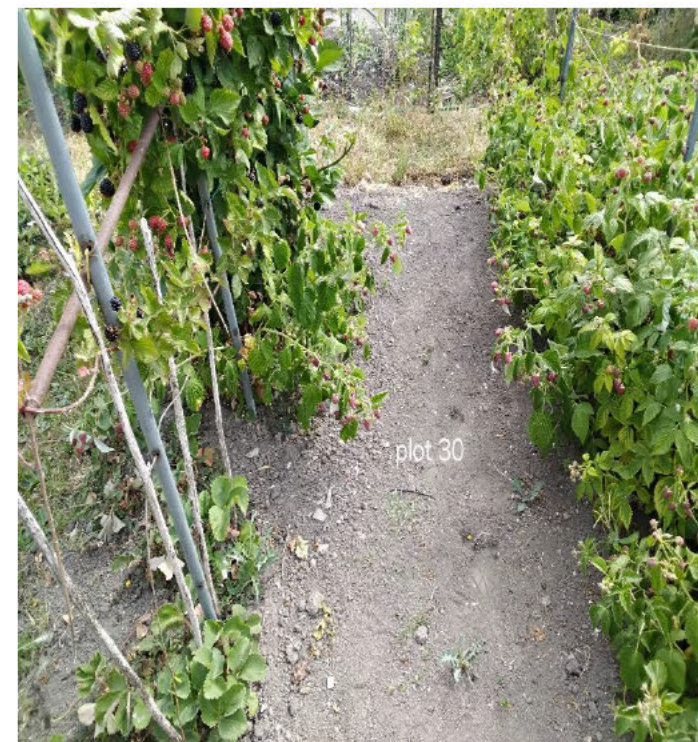
| Material comments | Asbestos cement debris | Material risk band | Low risk |
| Quantity | Specific photo took on plot 30 | Priority risk score | 2 |

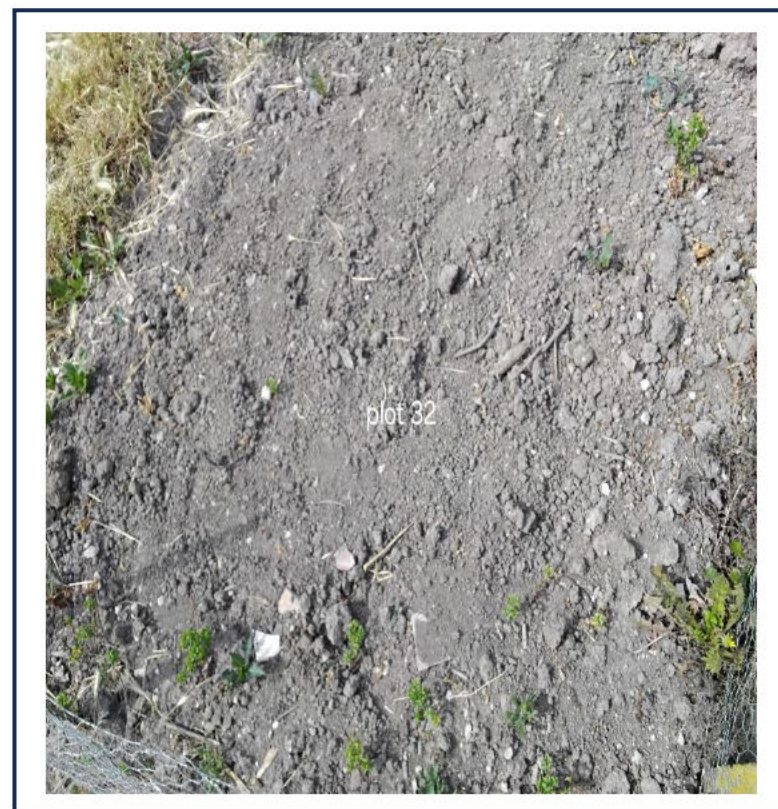
| Material comments | Asbestos cement debris | Material risk band | Low risk |
| Quantity | Specific photo took on plot 32 | Priority risk score | 2 |

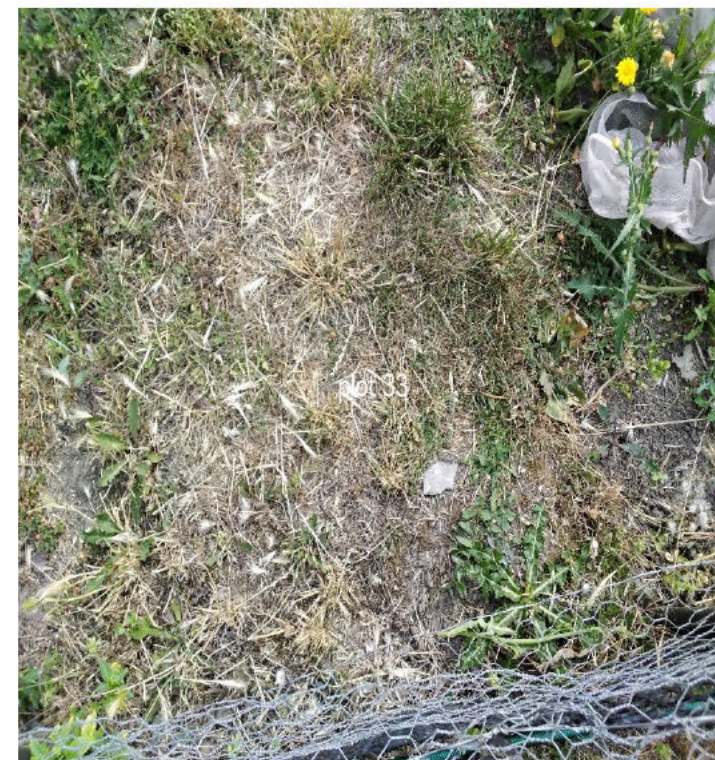
| Material comments | Asbestos cement debris | Material risk band | Low risk |
| Quantity | Specific photo took on plot 33 | Priority risk score | 2 |

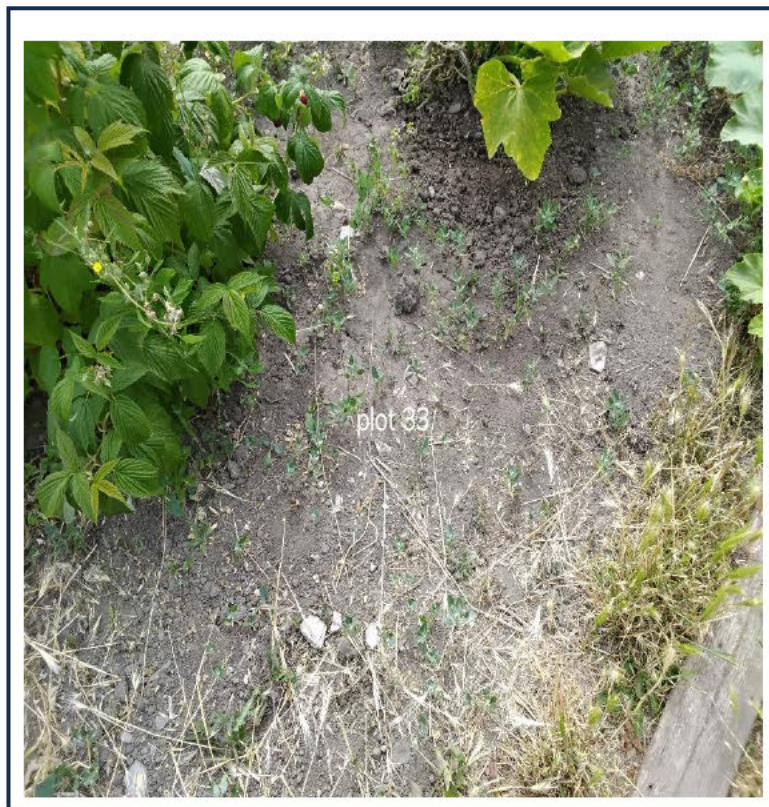
| Material comments | Asbestos cement debris | Material risk band | Low risk |
| Quantity | Specific photo took on plot 33 | Priority risk score | 2 |

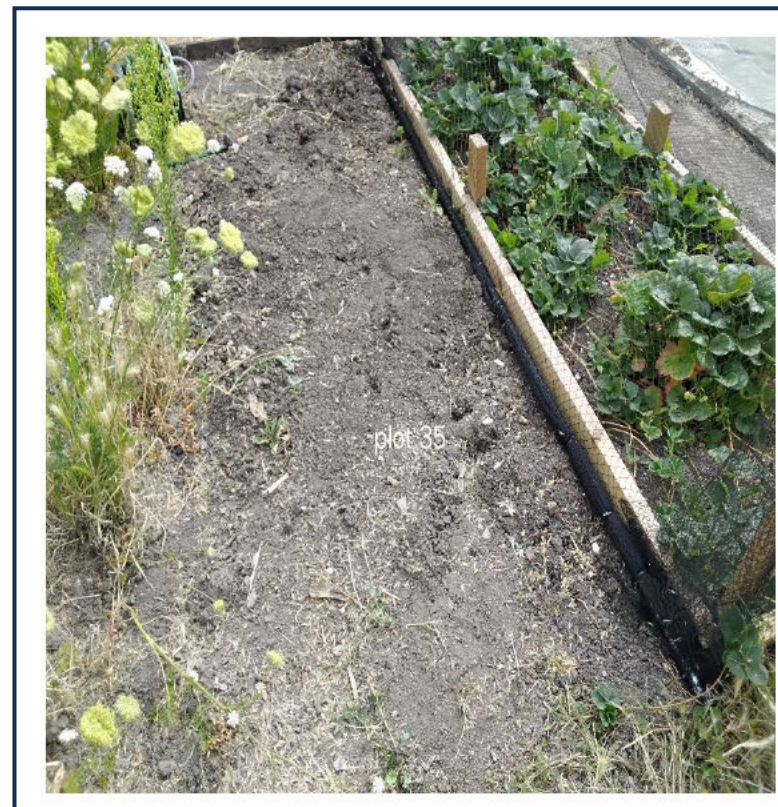
| Material comments | Asbestos cement debris | Material risk band | Low risk |
| Quantity | Specific photo took on plot 35 | Priority risk score | 2 |

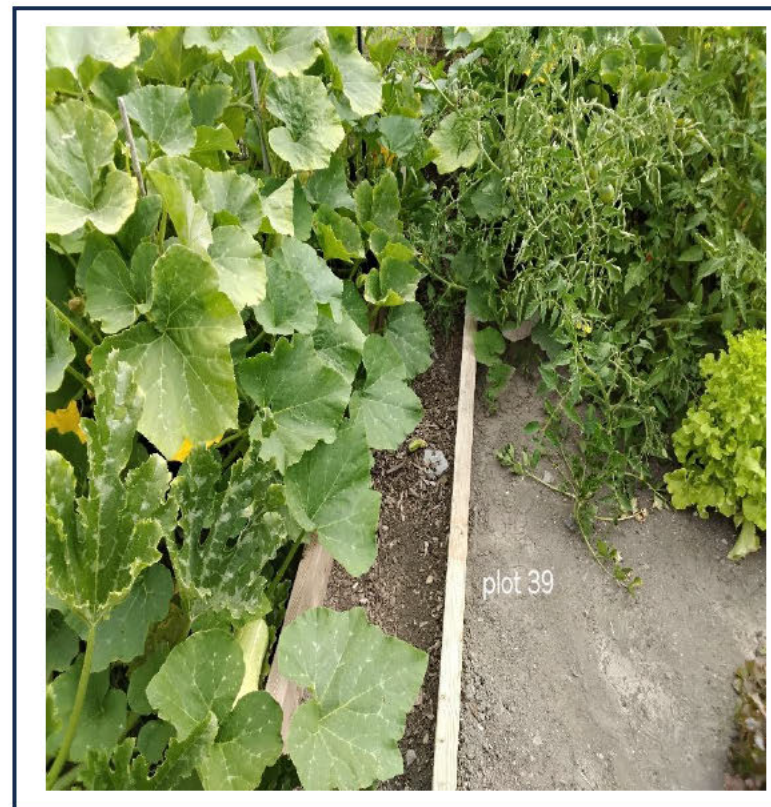
| Material comments | Asbestos cement debris | Material risk band | Low risk |
| Quantity | Specific photo took on plot 39 | Priority risk score | 2 |

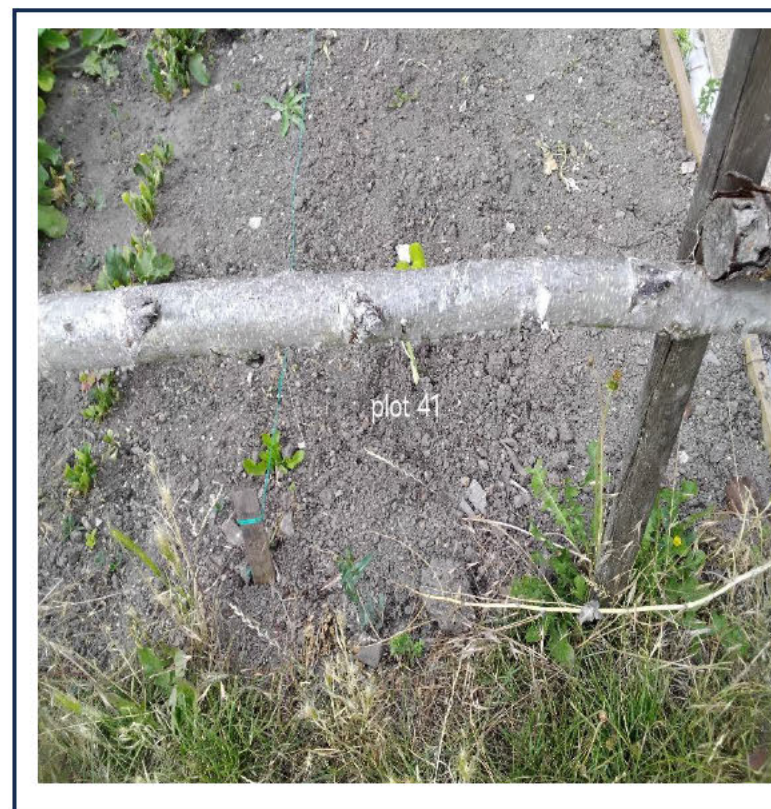
| Material comments | Asbestos cement debris | Material risk band | Low risk |
| Quantity | Specific photo took on plot 41 | Priority risk score | 2 |

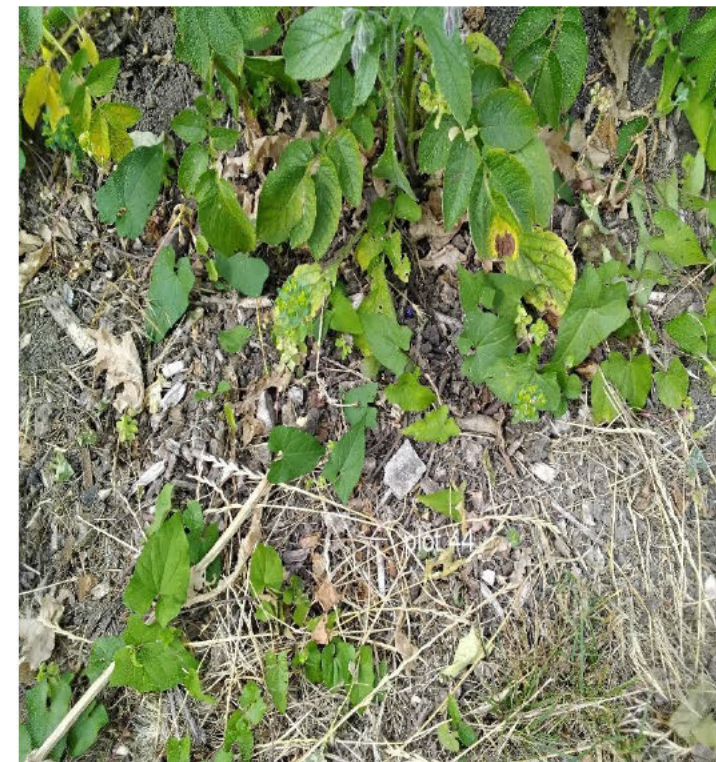
| Material comments | Asbestos cement debris | Material risk band | Low risk |
| Quantity | Specific photo took on plot 44 | Priority risk score | 2 |
