MELBOURN PARISH COUNCIL - MAINTENANCE COMMITTEE

A meeting of this Committee was held on Thursday, 16 May 2019 at Melbourn Community Pavilion, The Moor, Melbourn at 09:00

Safety Inspection Report

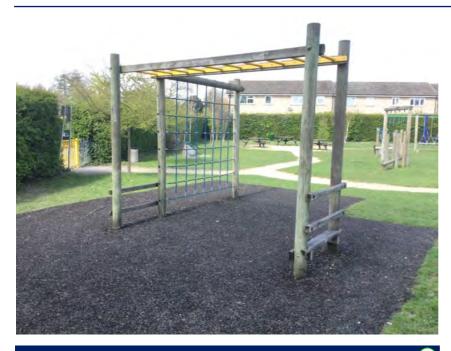
Climber - Net & Ladder

Cap missing.

Item has some parts missing.

One rung and two hand holds missing - replace.

Replace.

Replace the missing parts.

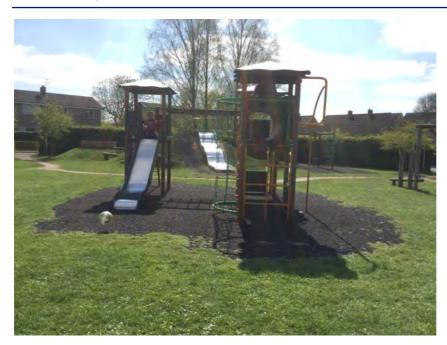
Multiplay - Junior

Two burn marks inside the tunnel - monitor.

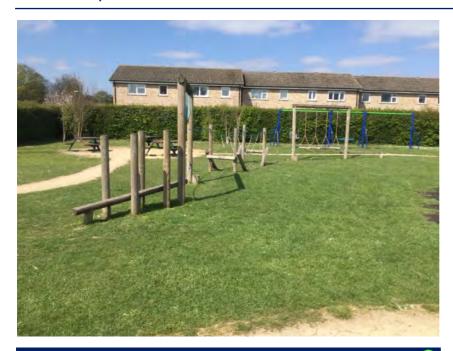
Agility Trail - 7 Element

Strimmer damage to supports is likely to accelerate timber rot.

Rope Burma Bridge post has split and damaged - repair.

The rope is rubbing on the balance beam and wearing down to the wire - monitor for broken wires and replace if found.

Prevent further damage.

Repair.

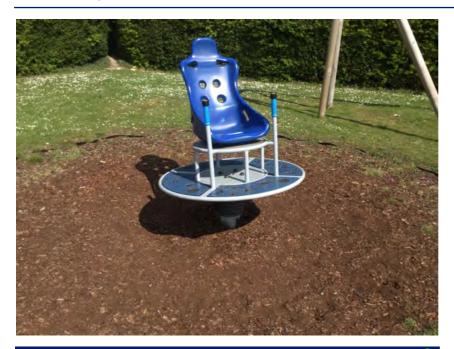
Rocker / Rotator - Chair - Space Rocket

The seat has water inside its frame - contact the manufacturer for their recommendations.

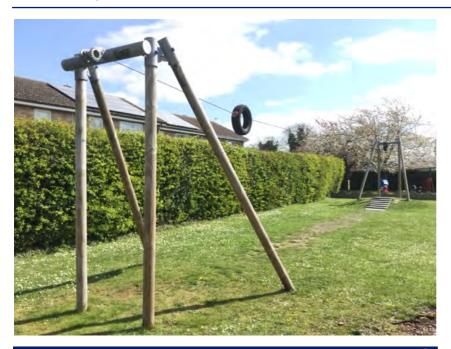
Cableway

Chains links worn.

Where the cable enters into a tube, top bar or similar it is not possible to determine its condition, therefore this is excluded from our inspection. It is vital that the operator arranges to dismantle the unit to inspect the full length of the cable for any corrosion, wear or damage.

Strimmer damage to supports is likely to accelerate timber rot.

Replace the worn parts.

Remove worn links.

Prevent further damage.

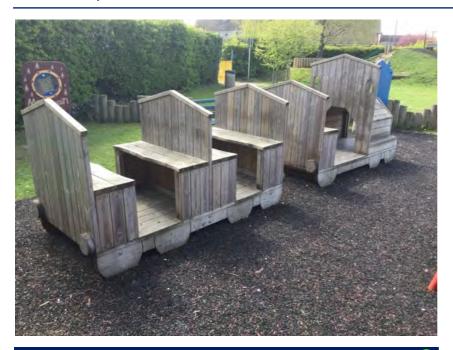
Play Train & Carriage - With Play Panel - Station

Fixtures loose or missing.

Exhaust loose to tunnel and seat rest panels loose - secure.

Tighten/replace.

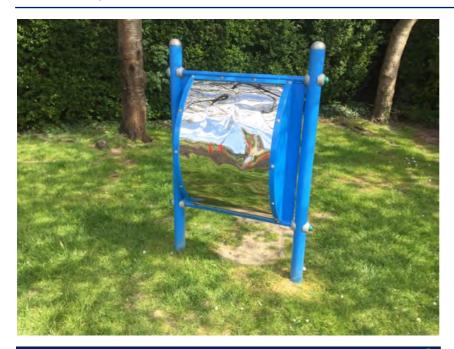
Play Panel - Mirror

Mirror bent - monitor for splits / cracks, if found replace.

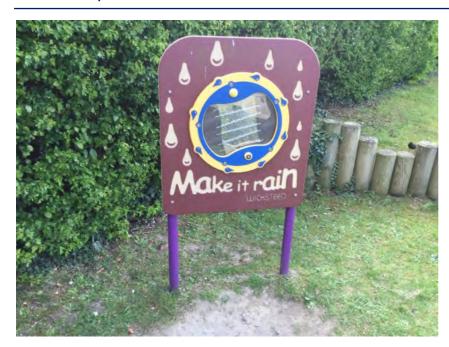
Play Panel - Make it Rain

Bolt cap damaged.

Replace.

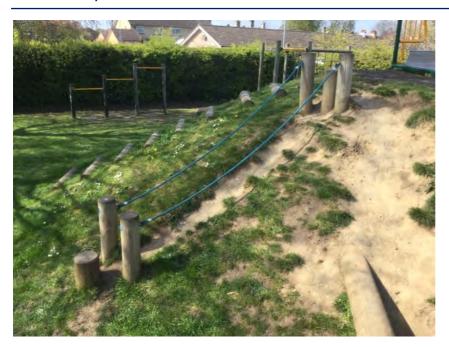
Rope Balance - Embankment

Bolt cap damaged.

Foundations exposed - reinstate mound.

Replace.

Repair the worn areas.

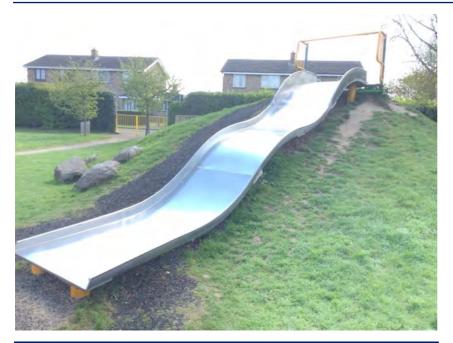
Slide - Embankment - With Log Steps

Surface needs repair.

Worn ground areas.

Repair.

Build up ground levels to remove trip hazard.

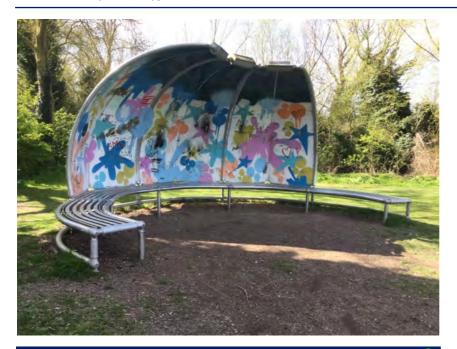
Shelters x 2

Bolt is missing.

Replace.

Repair.
