### **MELBOURN PARISH COUNCIL - MAINTENANCE COMMITTEE**

# A meeting of the Maintenance Committee held on Thursday, 20 May 2021 at 09:30 at All Saints Community Hall, Station Road, Melbourn SG8 6DX

# **Safety Inspection Report**

Date of inspection: 21 April 2021
Inspector: David Owen

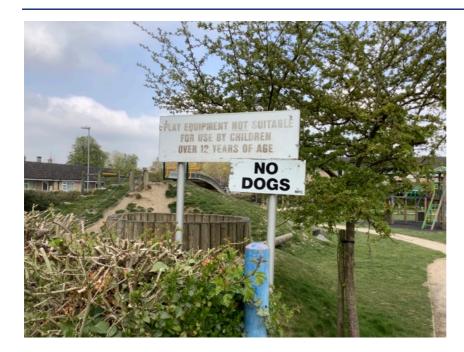
# Signage

Dog ban & ownership signs recommended.

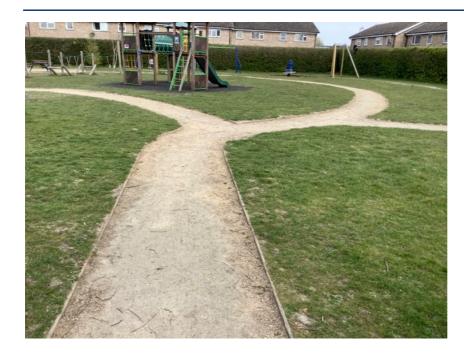
# **Pathways**

Surface is wearing.

Surface wearing and creating a trip point around the edgings.

Repair.

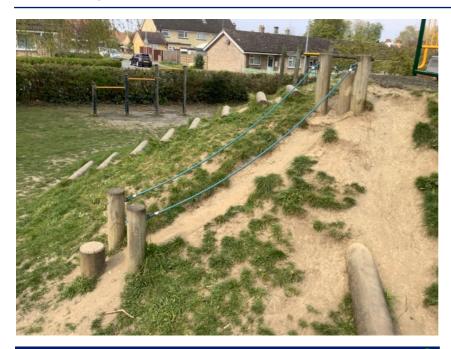
# **Rope Balance - Embankment**

Bolt cap damaged.

Replace.

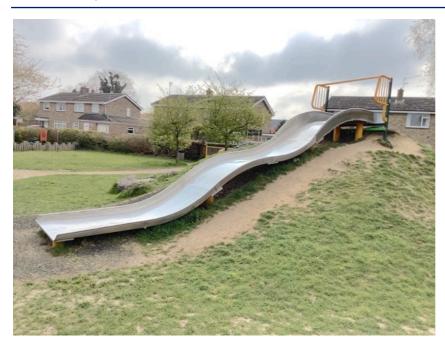
# **Slide - Embankment - With Log Steps**

Surface needs repair.

Timber is decayed.

Top log is decayed through and loose in the ground and could lead to a fall - replace.

Repair.

Replace affected parts.
