MELBOURN PARISH COUNCIL - MAINTENANCE COMMITTEE
(District of South Cambridgeshire)

A meeting of the Maintenance Committee held on Thursday 17 August at 09:30
in the Austen Room, Community Hub, 30 High Street, Melbourn SG8 6DZ

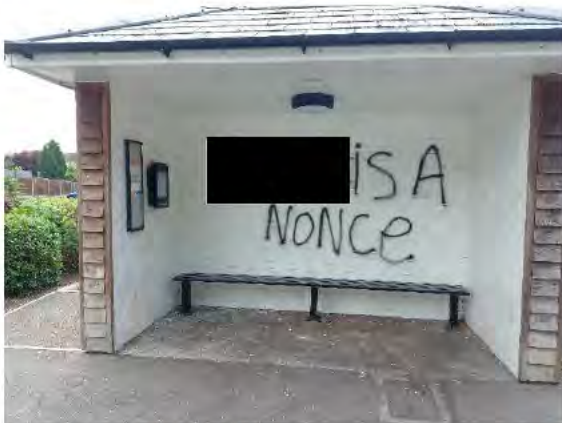
High Street Bus Stop
///chins.tripods.oasis

- [REDACTED] called to report defamatory graffiti, written about [REDACTED] on the High Street and Vicarage Close bus stops.
- Wardens responded by painting over the graffiti on the bus stop and cleaning the word 'nonce' from the Vicarage Close stop (due to not having sufficient chemicals to remove it all).
- Parish Office reported criminal damage via Cambridgeshire Police website - [REDACTED]
- [REDACTED] visited the Parish Office and shared the name of suspect as [REDACTED]
- Police upgrade report to criminal damage with crime reference number [REDACTED]

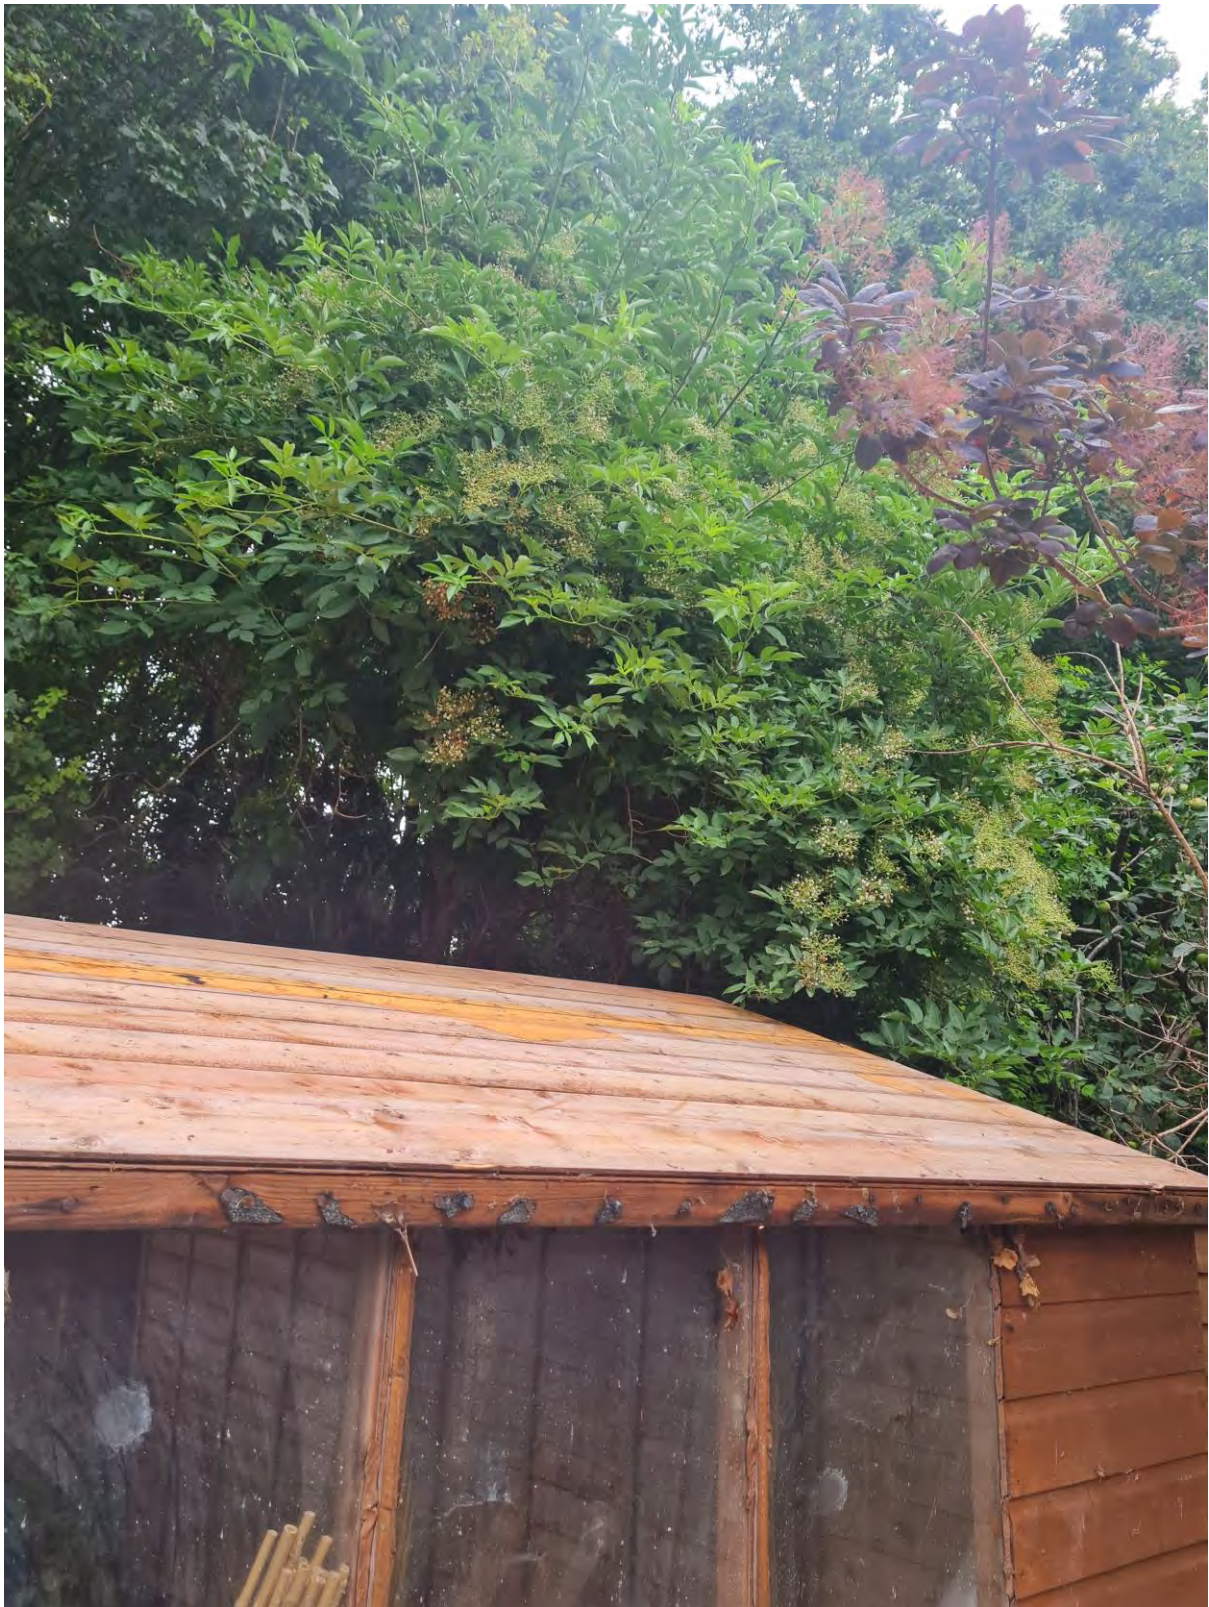
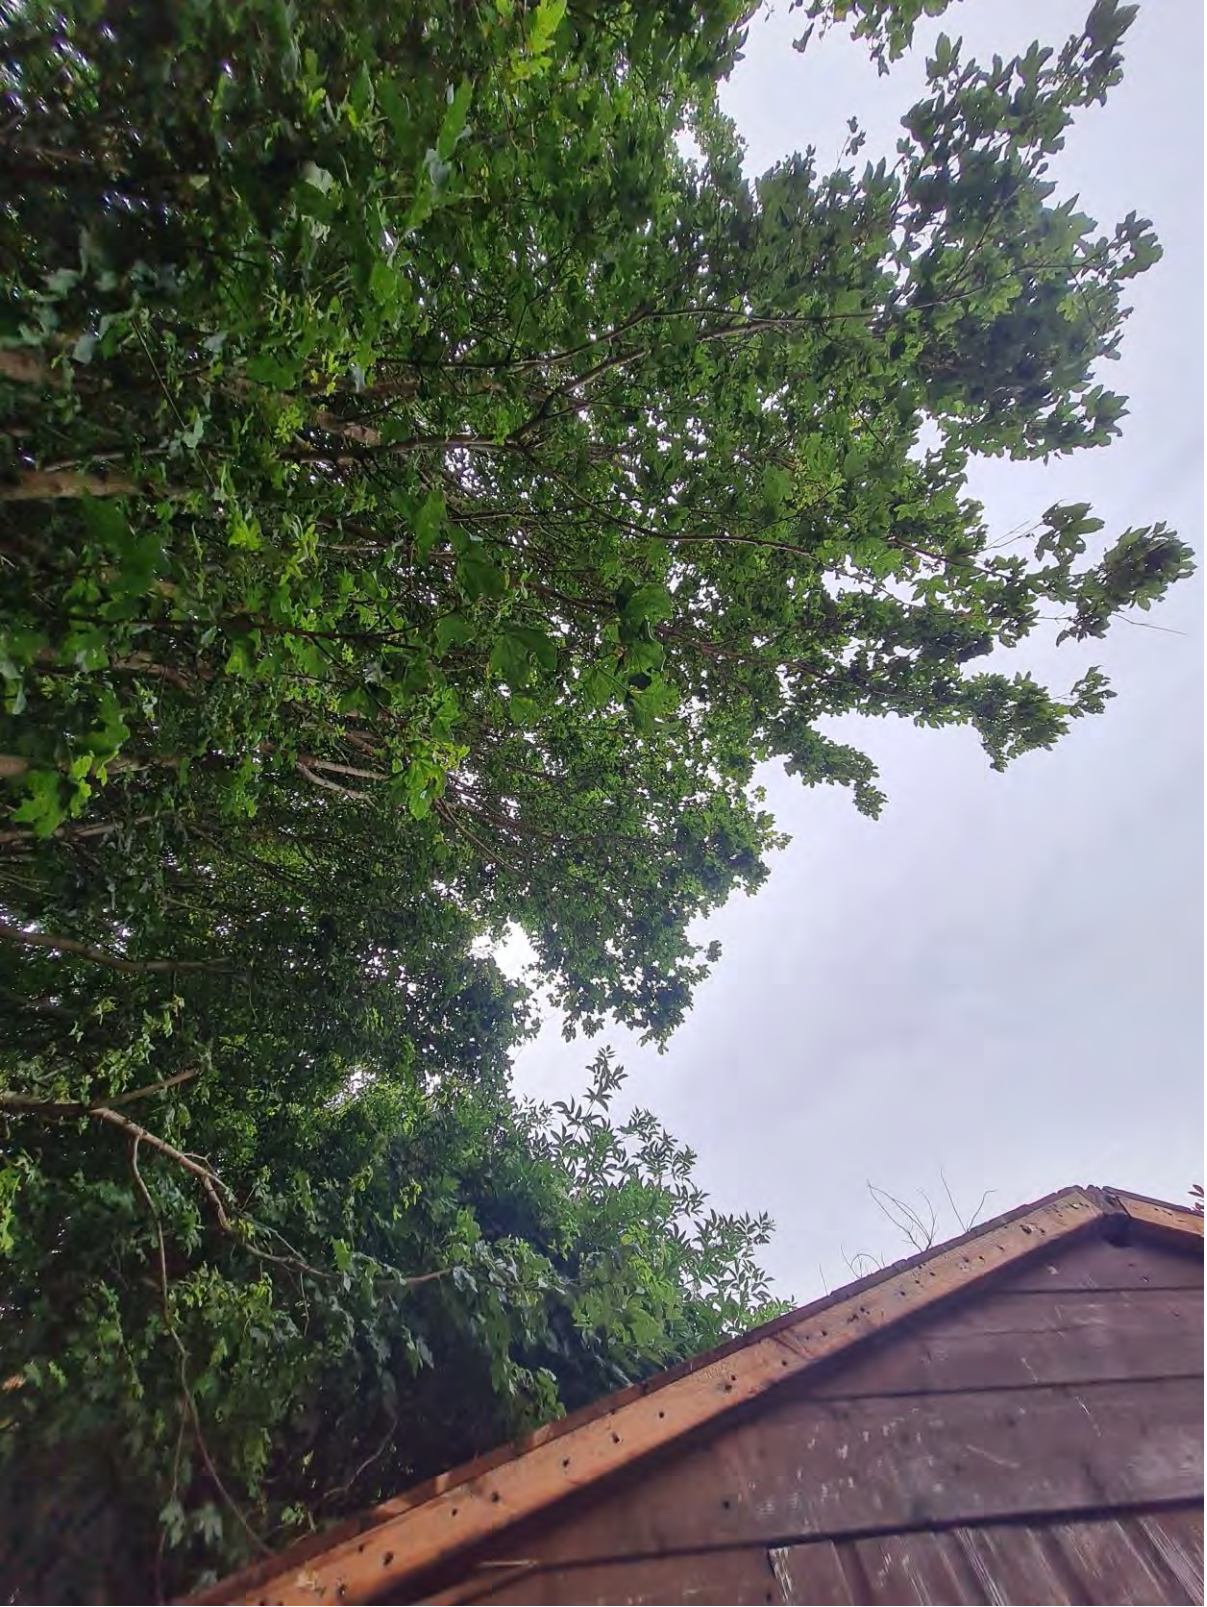
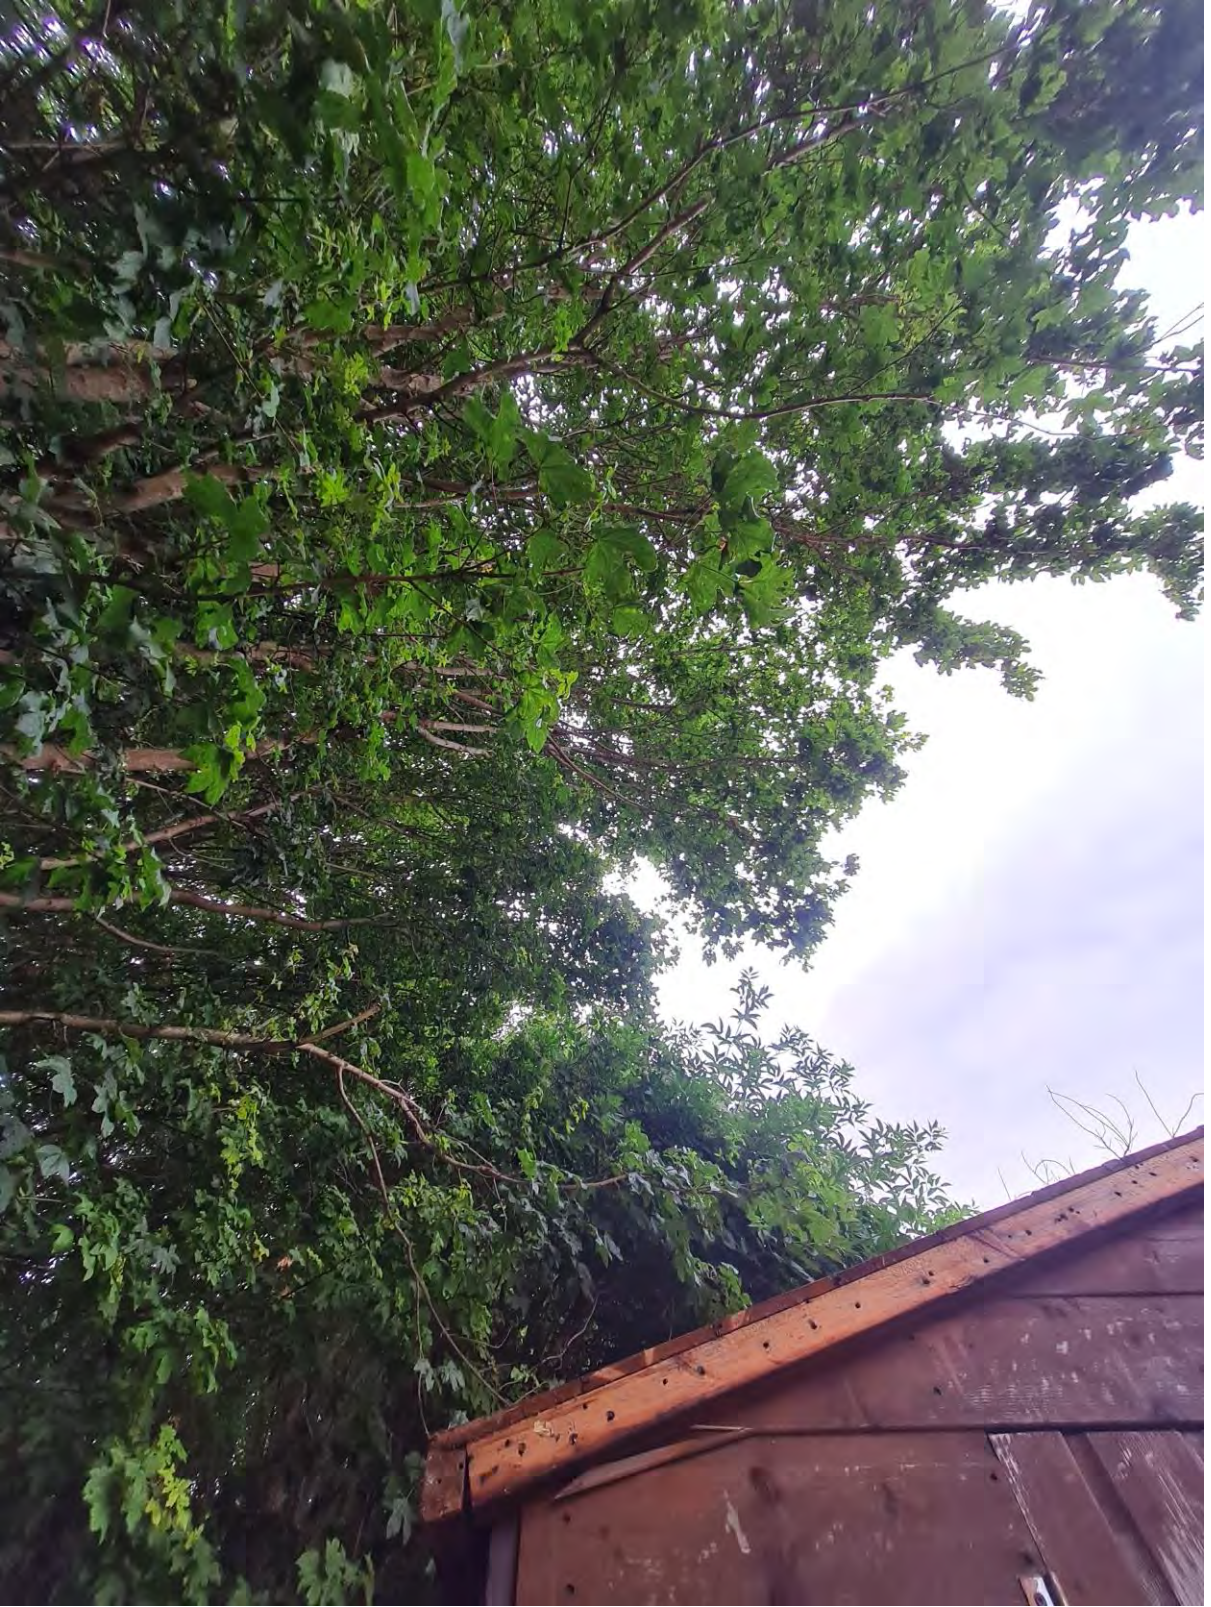
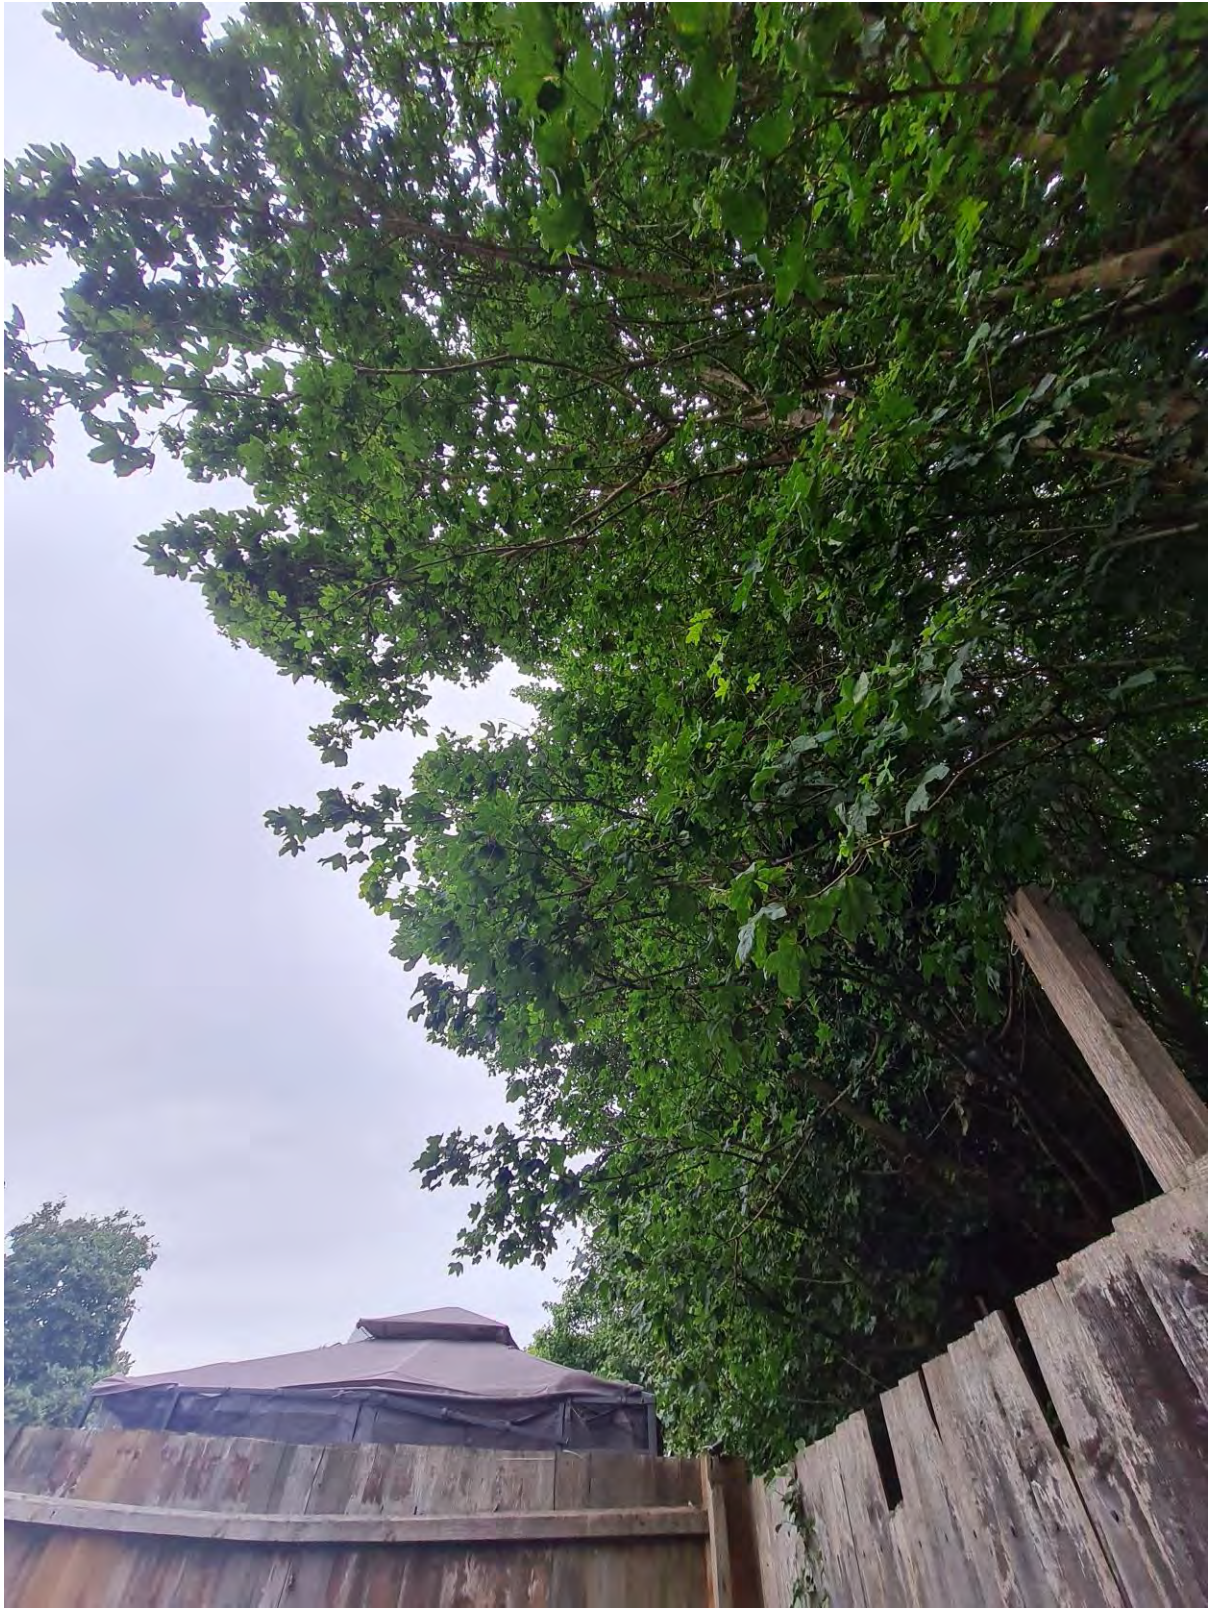
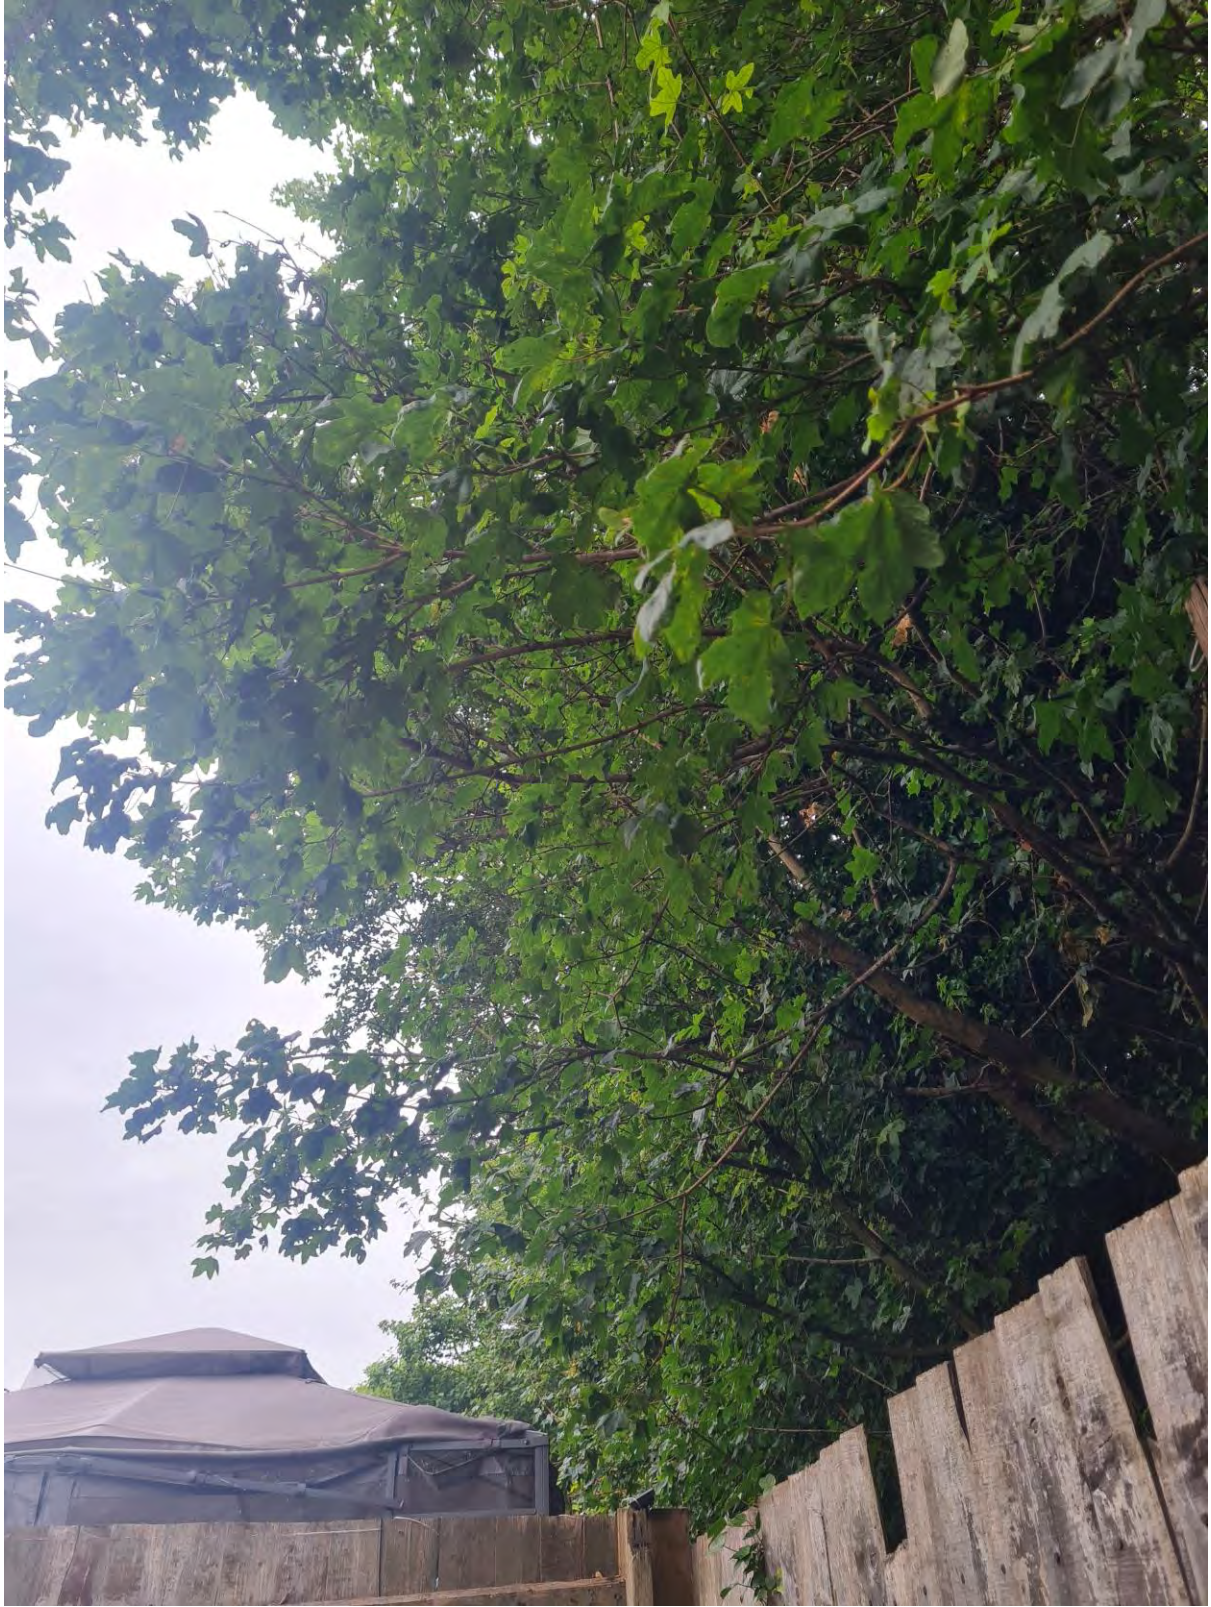
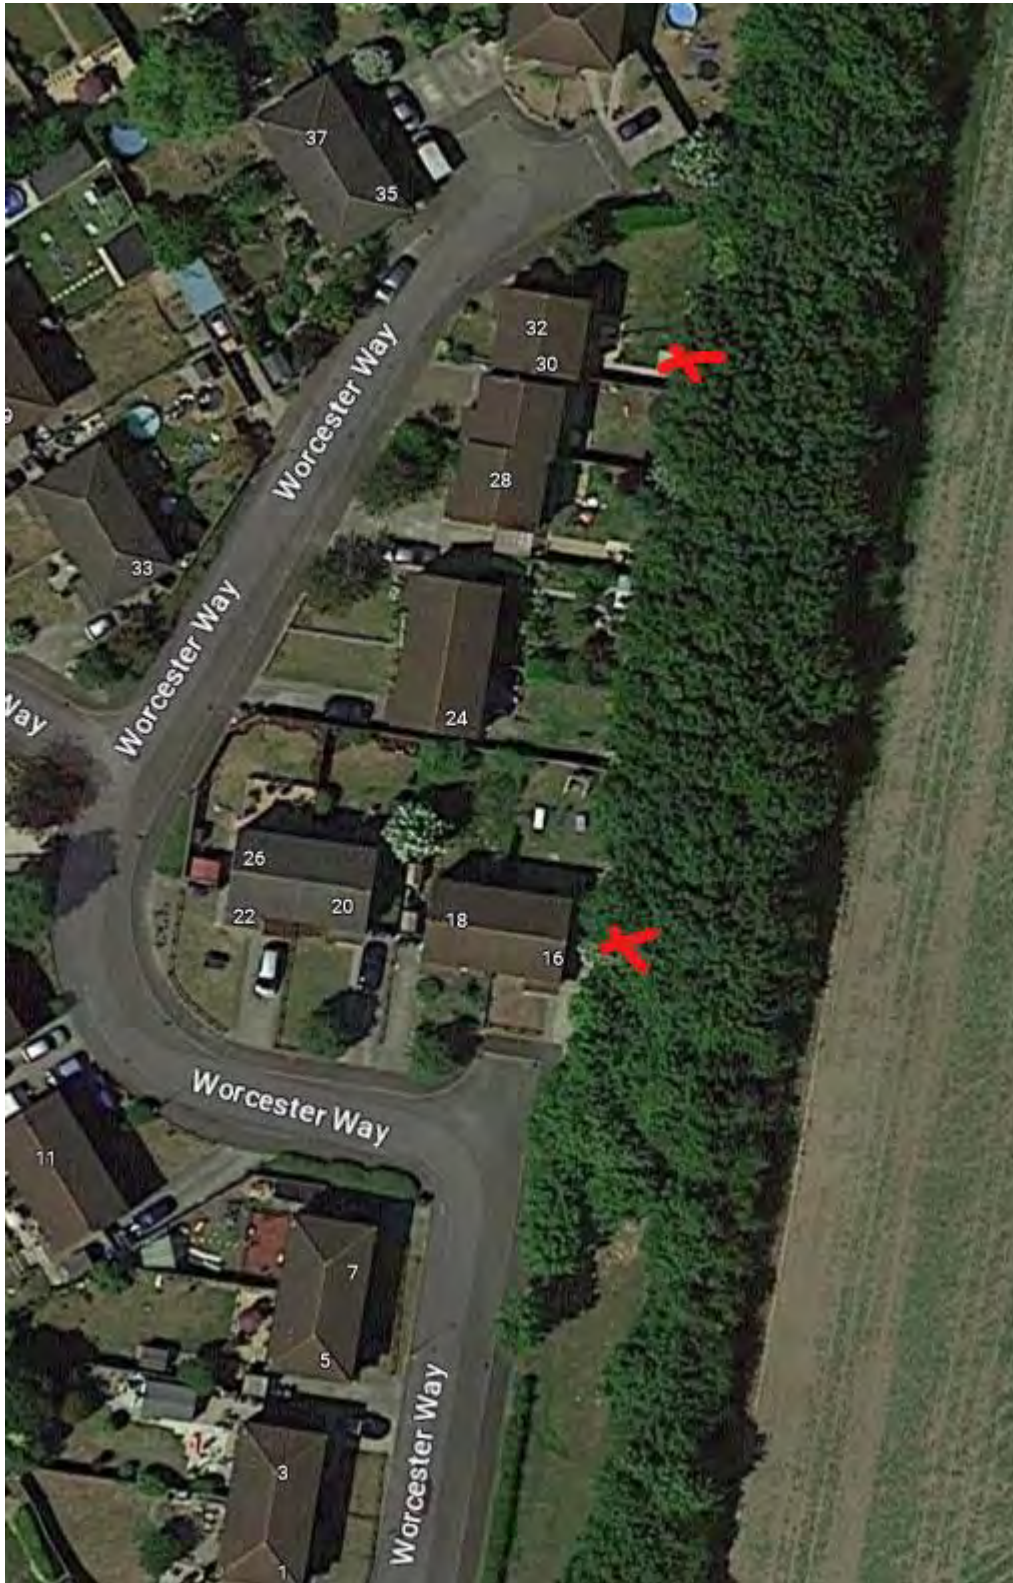
Images of trees at Worcester way

- a) To note actions from the ROSPA reports
 Actions were noted.
- b) To consider quotations to cut back to trees along the Worcester Way fence boundary
 Quote for the works was discussed. ACTION: Office to confirm/clarify the work stated on the quote and report back to committee.

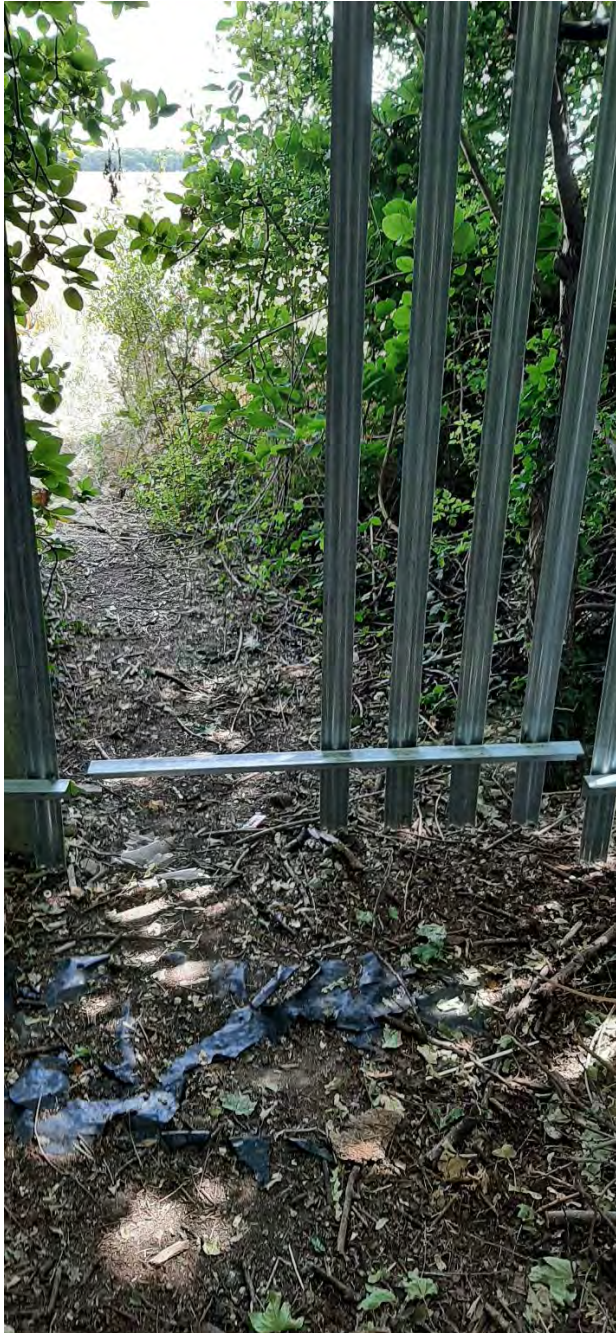
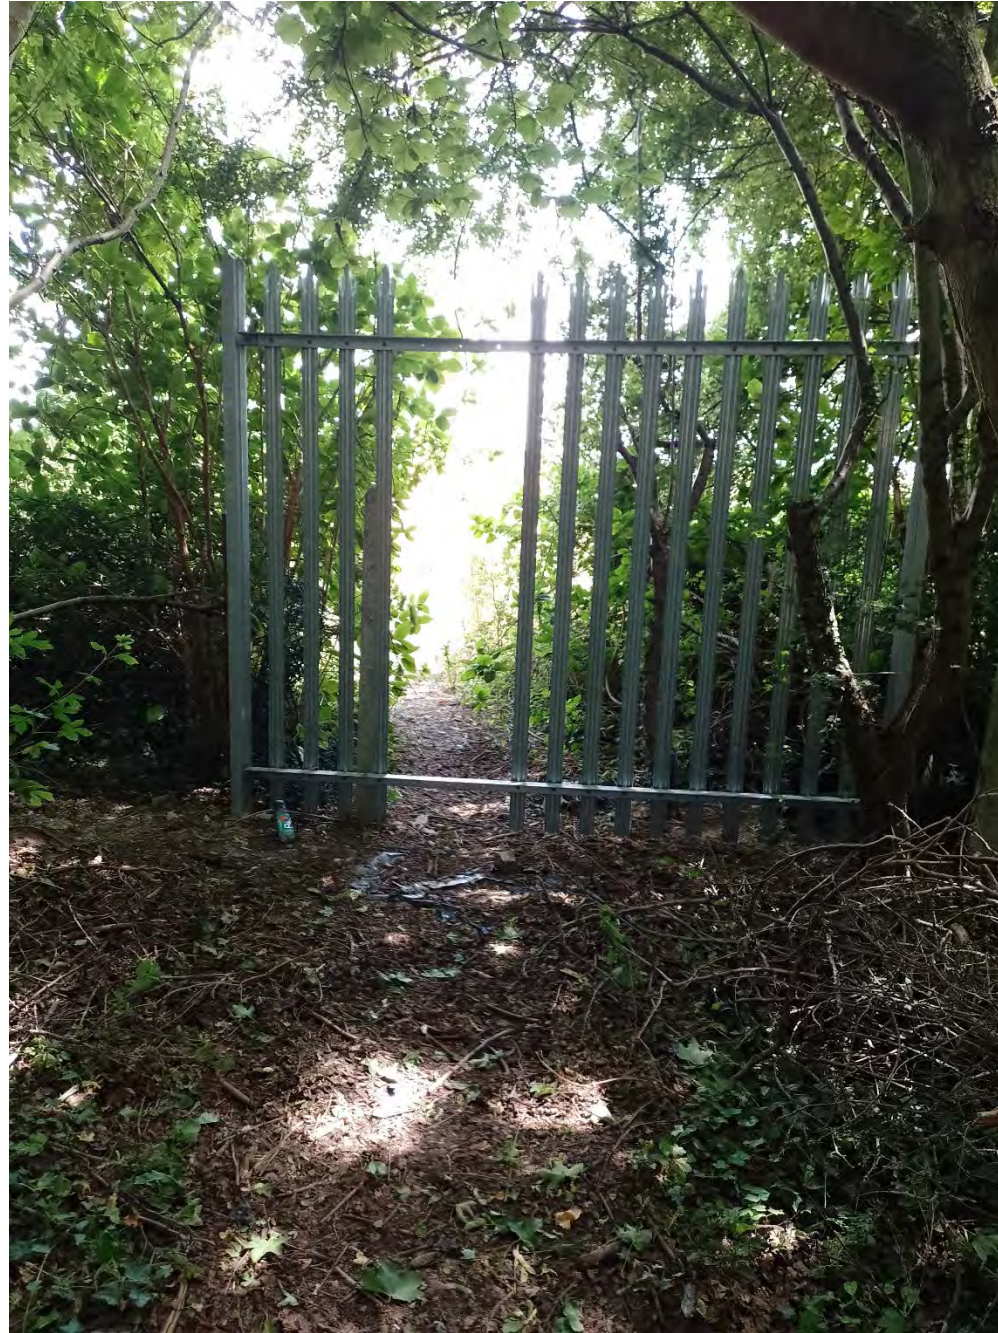
Damage to fences at Worcester Way

- c) To receive an update regarding the fencing works between Worcester Way and the private farm land
 Repeated vandalism to boundary fence. ACTION: Office to report damage to the Police.
 ACTION: Office to talk to County Farms re possible installation of a boulder deterrent etc.

Noted that bolts had been removed from new fencing for access, one section of fencing inadequate. Contractor has been contacted and will be reviewing works to properly secure existing fence and consider the need for extra fencing.

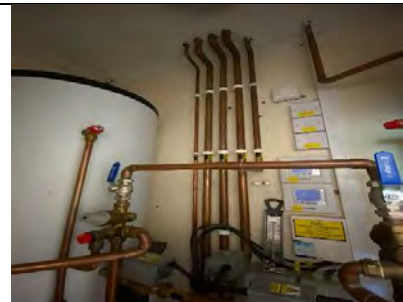
**HWSV 02
FAULTY EXPANSION VESSEL**

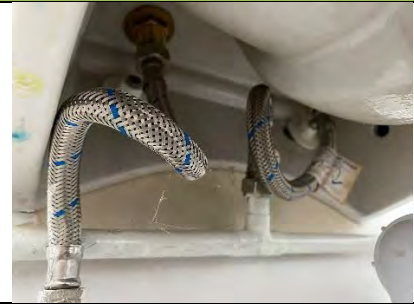
OLD AND TWISTED FLEXI HOSES

**AS THERE IS NO RETURN PUMP
EXISTING PIPEWORK COULD BE
FITTED WITH
DE-STRAT PUMPS SO THAT
LUKEWARM WATER DOES NOT
ACCUMULATE IN THE BASE OF THE
WATER HEATERS**
