Safety Inspection Report

Annual Inspection

Clear Crescent Play Area

22 April 2025

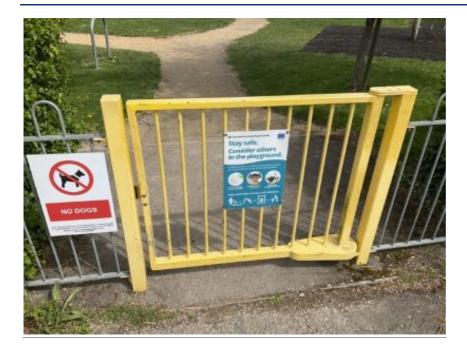
Gates

The item is unlocked.

The maintenance gate is not locked and could be opened by the public. Clean out the drop bolt socket and lock the gate.

Trip points on the surface.

Combination gate.

Lock.

Make level.

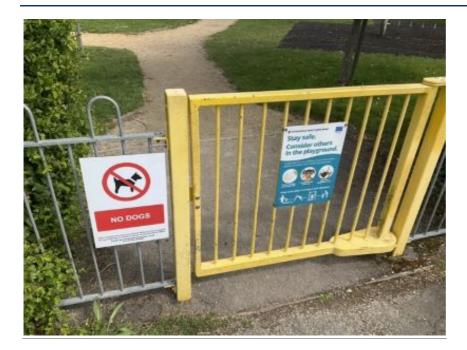
Signage

Sign is unreadable.

Projecting bolt thread.

Cut back unused bolt threads/install capping.

Modify.

Cut off and file down to remove sharp edges or use the correct length of bolt.

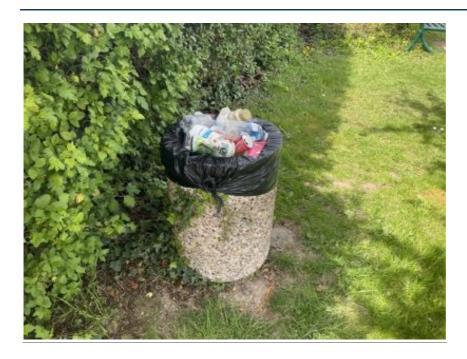
Litter Bins

Bin is full.

Empty the bin.

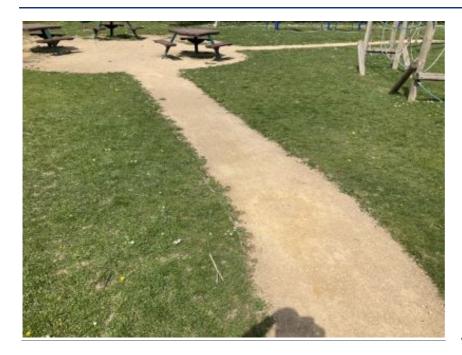
Pathways

Surface has unintended grass, moss or weeds.

Grass and weeds growing inside pathway. Remove.

Remove.

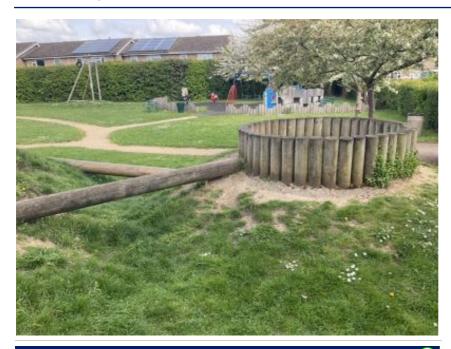
Log Stockade - With Balance Logs

The top of the beam should be made non-slip by the addition of surface textures or cross-cutting.

Log balance beams slippery when wet.

Overhanging tree branches are present.

Remove slipperiness. Consider adding surface texture.

Cut back.

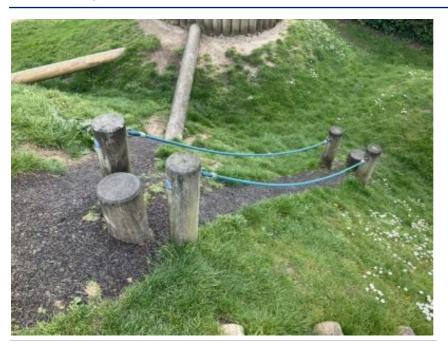
Rope Balance - Embankment

Fixtures loose or missing.

Replace damaged caps. Tighten loose eye bolts.

Tighten/replace.

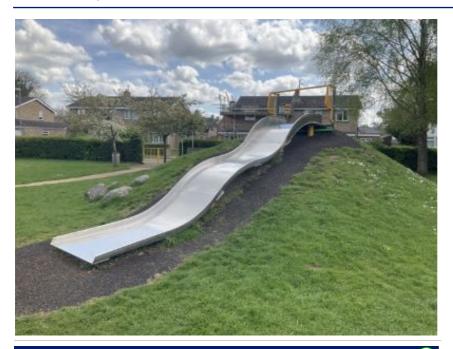
Slide - Embankment - With Log Steps

Ground erosion present.

Loose in ground.

Repair the worn areas.

Monitor.

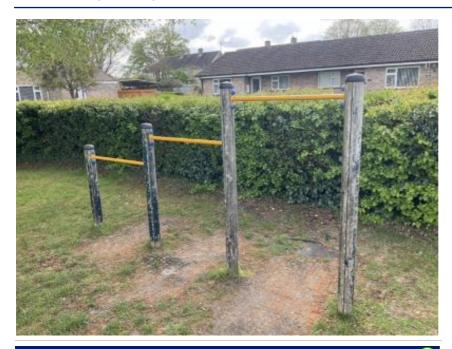
Agility Bars - 3 Tier

Surface needs repair.

Grass mats are damaged and lifting. Replace.

Bolt(s) loose.

Replace.

Tighten.

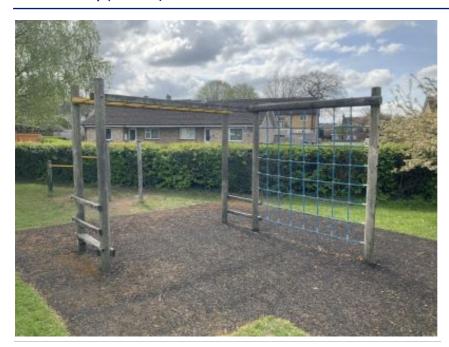
Climber - Net & Ladder

Fixtures loose or missing.

Net connectors are very loose to the posts. Remove fittings to check for corrosion and replace if found and then secure the net.

Loose and projecting rope screws. Secure.

Ladder fixings missing. Replace.

Cap/s are missing allowing water ingress into the frame and fixtures. Replace.

This equipment relies on one post for its stability. Special attention should be paid to maintenance (e.g. by monitoring degradation) and if necessary decommissioning the item before the end of its operating life. This is a requirement of the British Standard.

The surface is cracking.

The surfacing is cracking and damaged.

Surface/the equipment are algae covered, creating a slippery surface when wet.

There is decay to timber components which may affect structural integrity. We do not recommend replacing rotten supports with timber posts which are directly set in the ground due to the increased problem of timber rot, especially in posts in contact with the ground.

Posts are showing signs of softening and decay at ground level. Monitor and replace when necessary.

Item has some parts missing.

One rung and two hand holds missing. Replace.

Exposed metal rope core(s).

Replace net in the near future when wire is broken.

Overhead ladders and rings provide significant play value and benefits to children, and with it the risk of falling. Ensuring the surface remains in good condition will help to keep the correct balance between benefits and risk.

Read the notes for further action., Tighten/replace.

Consult with the manufacturer's guidance to determine suitable maintenance.

Repair., Read the notes for further action.

Read the notes for further action.

Replace the missing parts.

Replace the worn ropes.

The protective surface under all bars and rings must be kept in good condition.

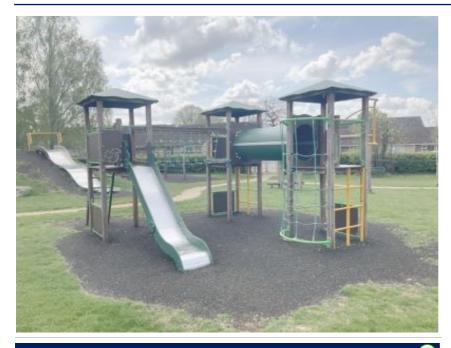
Multiplay - Junior

Laminate damaged.

Platform laminates around edges. Repair/replace. Replace highlighted platform laminate.

The foundations should be designed such that they do not present a hazard (tripping, impact). Care should be taken to ensure that foundations are not exposed as a result of erosion.

Square section missing around one post. Replace.

Bolt(s) loose.

Two burn marks inside the tunnel. Monitor.

Rub down and treat damaged edges., Read the notes for further action.

Repair., Eliminate the hazard.

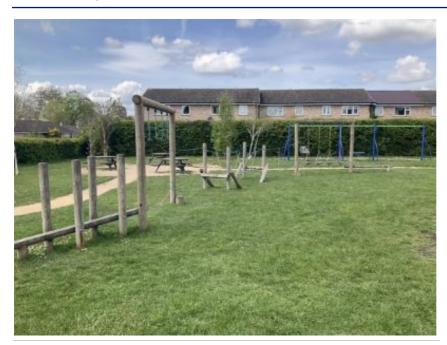
Agility Trail - 7 Element

This equipment relies on one post for its stability. Special attention should be paid to maintenance (e.g. by monitoring degradation) and if necessary decommissioning the item before the end of its operating life. This is a requirement of the British Standard.

Strimmer damage is present on posts, allowing water to enter and timbers to soften. It can also remove the protective envelope around the timber. Prevent further damage and check timbers for decay throughout the year.

Monitor all timber items for decay throughout the year due to softening. Replace affected parts if found/necessary.

The rope is rubbing on the balance beam and wearing down to the wire. Monitor for broken wires and replace if found.

Cap missing.

Prevent further damage., Read the notes for further action.

Read the notes for further action., Replace.

Replace.

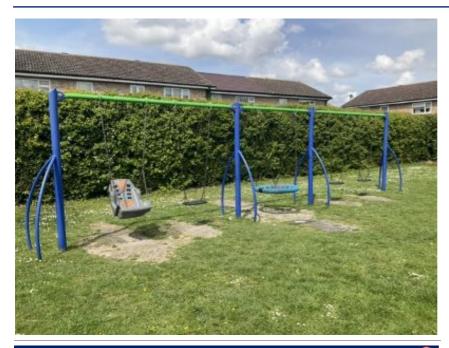
Swing - Mixed - 3 Bay 1 Accessible 1 Basket 3 Junior Seat (2300 mm)

- 1. Surface needs repair.
- 2. Swing seat rubber is deteriorating / degrading.
- 3. Moving parts require greasing.
- 4. Minor repairs are needed.

Surface needs repair.

Grass mats missing and loose.

Swing seat rubber is deteriorating / degrading.

Replace one junior seat due to exposed metal frame.

Minor repairs are needed.

Replace.

Monitor and replace when hard material is exposed., Replace when metal is exposed.

Repair.

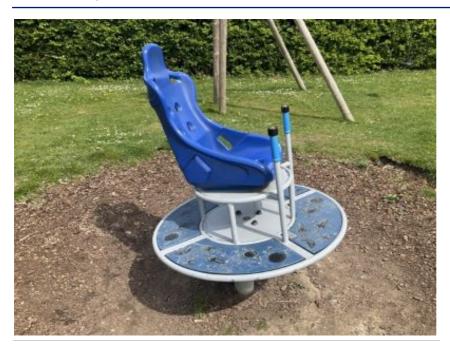
Rocker/Rotator - Chair - Space Rocket

Surface needs repair.

The surfacing has worn away exposing and damaging the liner beneath. Grass and weeds have grown inside. The plastic edging strips are sharp. The whole area requires immediate repairs and alterations. Bark requires topping up.

Repair.

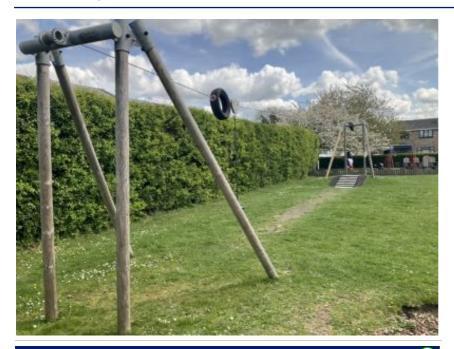
Cableway

Cables have been known to fail under load due to wear and corrosion. This is generally where the cable enters into a tube, top bar, sleeve or similar, where the wire is in contact and wears and frays over time, but can happen anywhere on the cable. It is important to inspect any hidden parts at least annually. Damaged cables require replacement. This cannot be determined during an annual inspection, and is excluded from our inspection. This can lead to a high risk if no action is taken. Refer to the manufacturer's instructions to ensure the correct check is carried out.

Item has some parts missing.

Traveller's plastic guard is missing.

Strimmer damage is present on posts, allowing water to enter and timbers to soften. It can also remove the protective envelope around the timber. Prevent further damage and check timbers for decay throughout the year.

Minor repairs are needed.

Loose ramp foot holds. Lifting matting.

Replace the missing parts.

Prevent further damage.

Repair., Replace.

Repair.

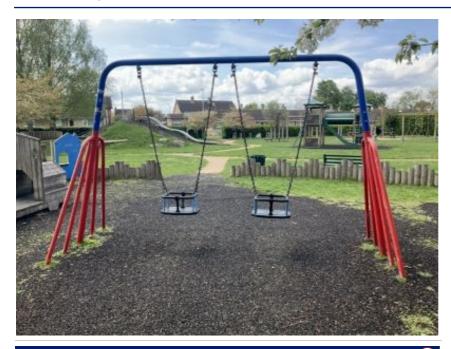
Swing - Toddler - 1 Bay 2 Seat (2300 mm)

- 1. Projecting bolt thread.
- 2. There is wear to the top of the cradle(s) leaving exposed metal.
- 3. Wicksteed recommend that during routine inspections the area on the swing where the side frames meet the vertical support be checked for any cracks. In the event of cracks being found then remove the seats and contact Wicksteed for further advice.

There is wear to the top of the cradle(s) leaving exposed metal.

Replace both seats in the near future as frames are almost exposed.

Wicksteed recommend that during routine inspections the area on the swing where the side frames meet the vertical support be checked for any cracks. In the event of cracks being found then remove the seats and contact Wicksteed for further advice.

Replace the seats for cradles if available.

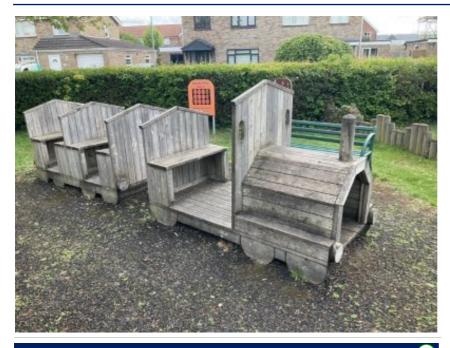
Play Train & Carriage

Fixtures loose or missing.

Tighten/replace.

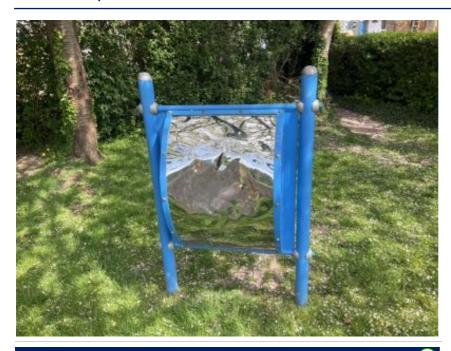
Play Panel - Mirror

Mirror bent. Monitor for splits/cracks, replace if found.
