Safety Inspection Report

Annual Inspection

Clear Crescent Play Area

Melbourn Parish Council

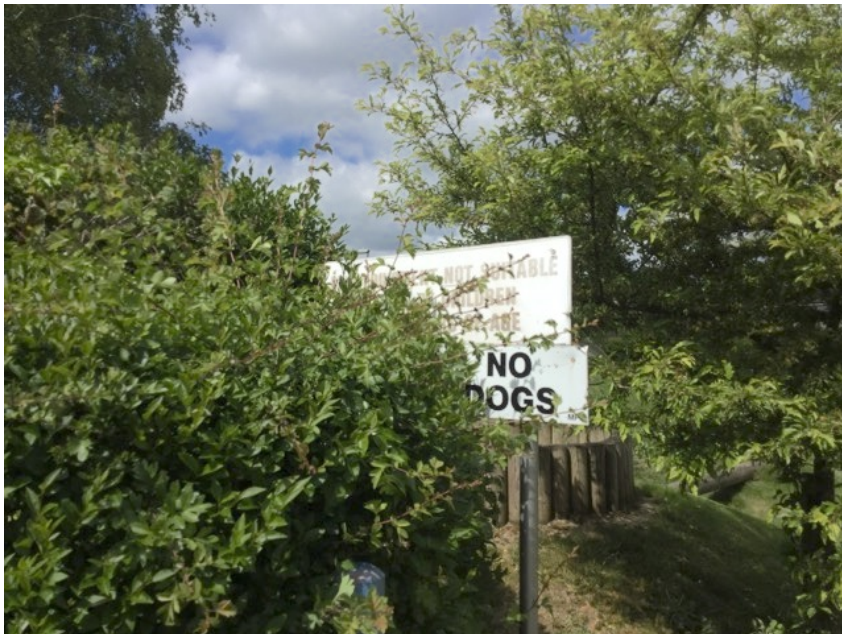
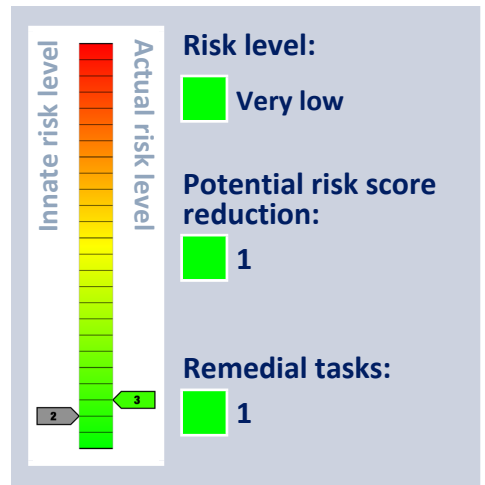
Signage

Vegetation obstructing sign or causing hazard.

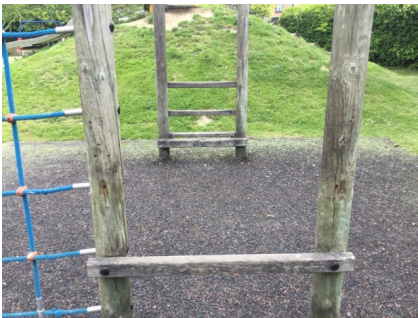
This equipment relies on one post for its stability. Special attention should be paid to maintenance (e.g. by monitoring degradation) and if necessary decommissioning the item before the end of its operating life.

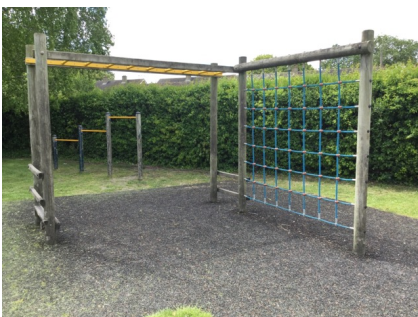
If possible, on angled or S-shaped bars, consideration should be given to level bars with firm grips and even spacings. The protective surface under all bars and rings must be kept in good condition.

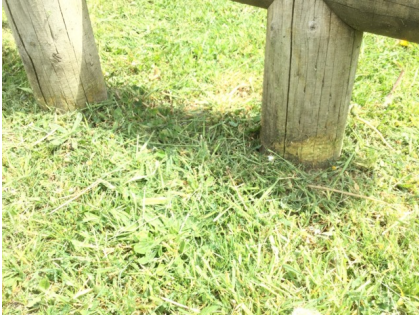
Timber is decayed.

Rope walk top bar is decayed from the inside out, hollowed - replace as soon as possible.

Replace affected parts.

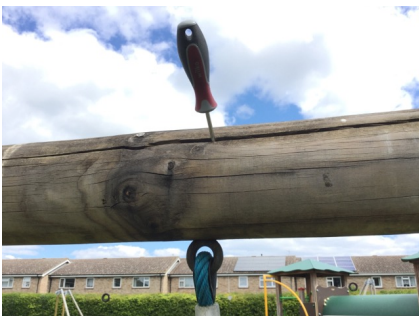
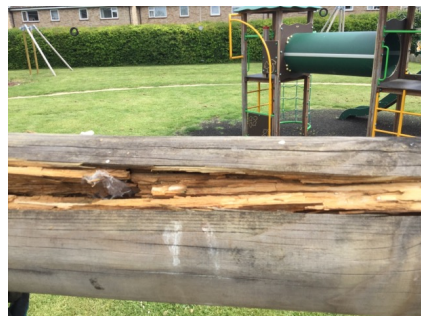
Rope Burma Bridge post has split and damaged - repair.

Repair.

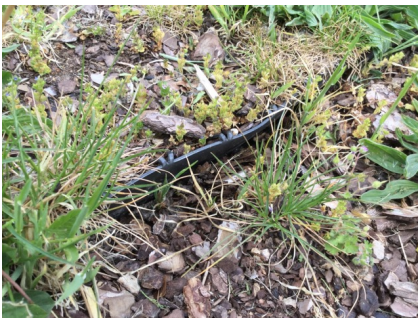
Surface needs repair.

The surfacing has worn away exposing and damaging the liner beneath. Grass & weeds have grown inside. The plastic edging strips are sharp. The whole area requires immediate repairs and alterations.

Repair.

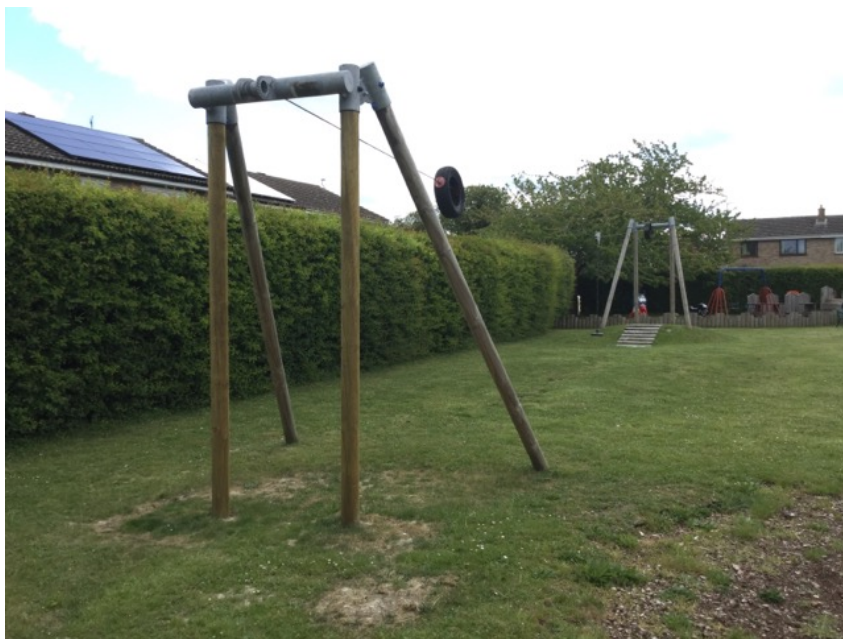
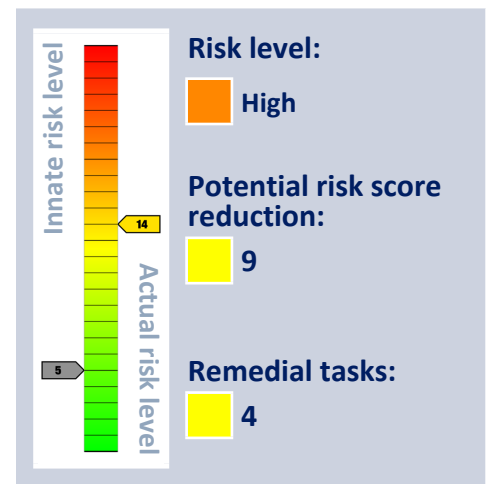
Cableway

Where the cable enters into a tube, top bar or similar it is not possible to determine its condition, therefore this is excluded from our inspection. It is vital that the operator arranges to dismantle the unit to inspect the full length of the cable for any corrosion, wear or damage.

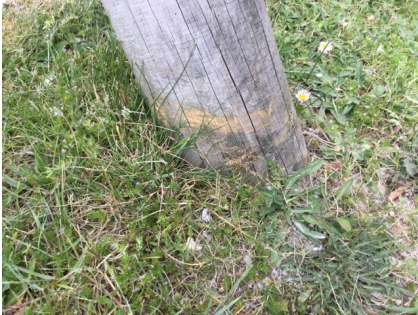
Timber is decayed.

End support leg decayed.

Replace affected parts.

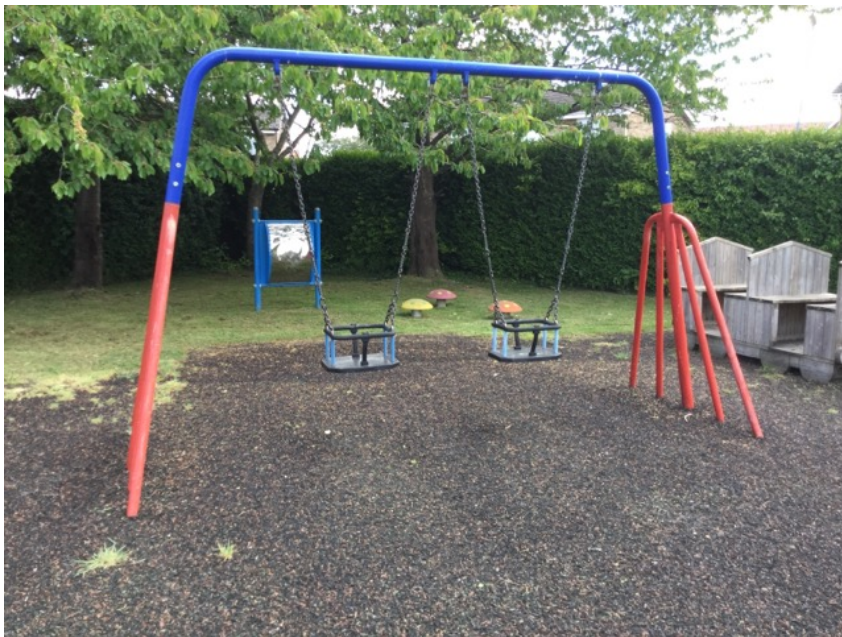
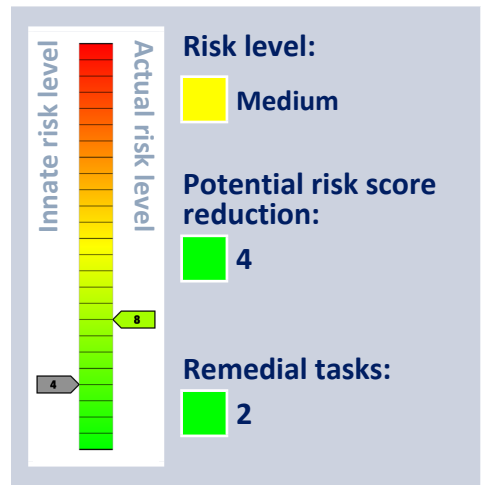
Swing - Toddler - 1 Bay 2 Seat (2300 mm)

Wicksteed recommend that during routine inspections the area on the swing where the side frames meet the vertical support be checked for any cracks. In the event of cracks being found then remove the seats and contact Wicksteed for further advice.

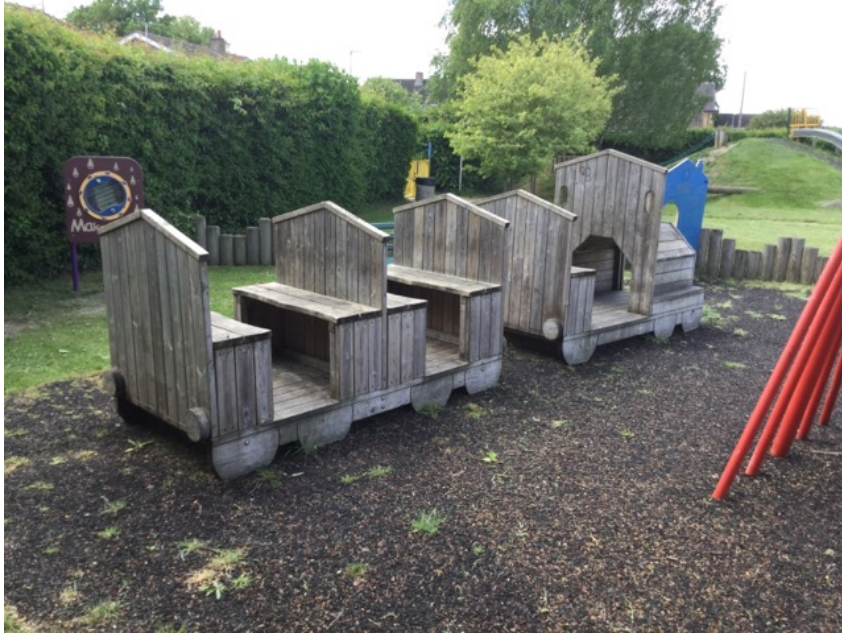
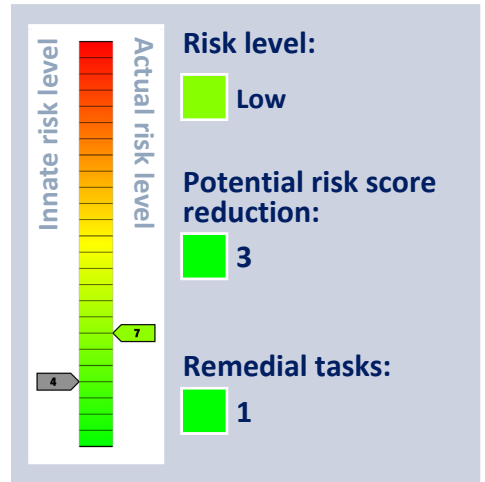
Play Train & Carriage - With Play Panel - Station

Fixtures loose or missing.

Exhaust loose to tunnel and seat rest panels loose - secure.

Tighten/replace.

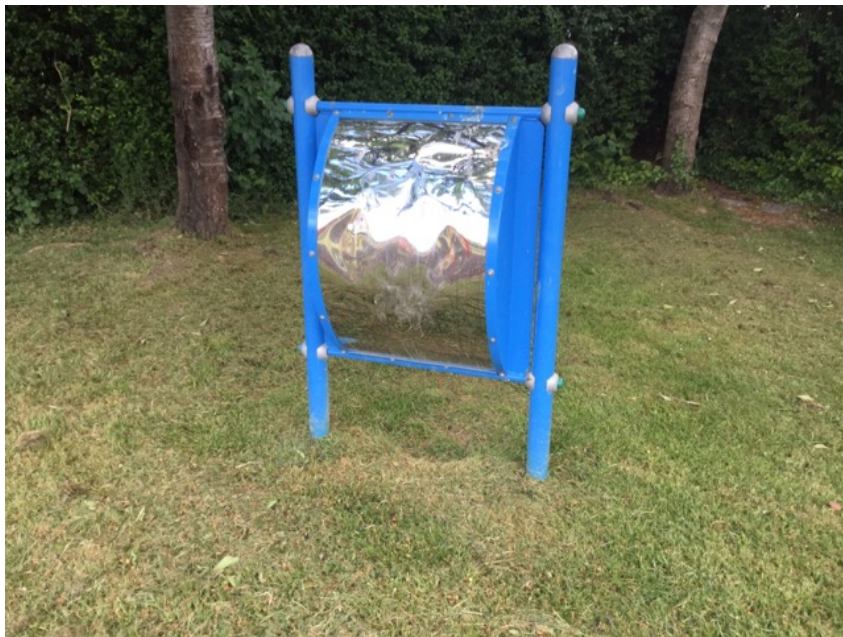
Play Panel - Mirror

Mirror bent - monitor for splits / cracks, replace if found.

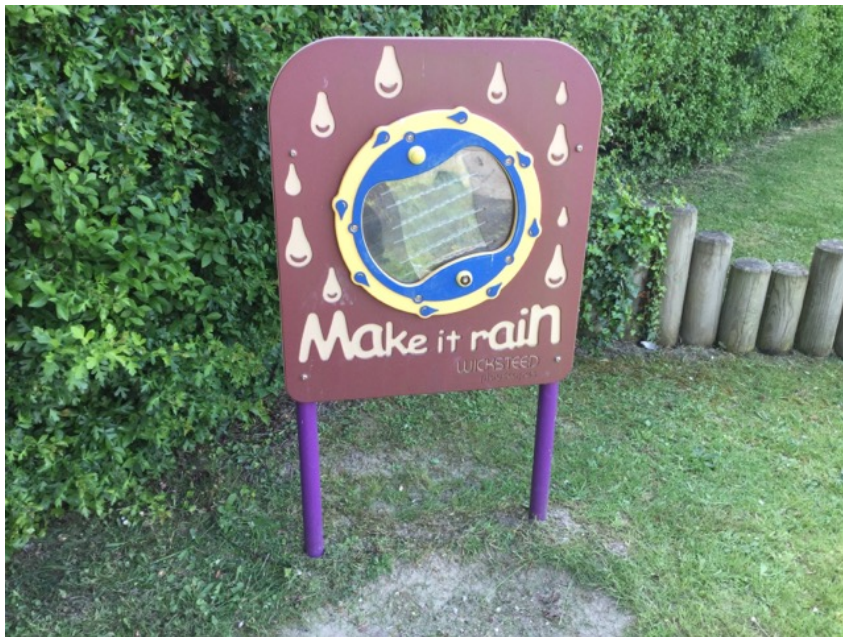
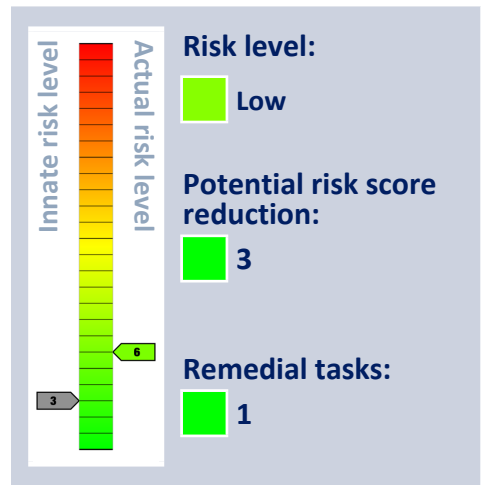
Play Panel - Make it Rain

Bolt cap damaged.

Replace.
