### **MELBOURN PARISH COUNCIL - MAINTENANCE COMMITTEE**

# A meeting of the Maintenance Committee held on Thursday, 20 May 2021 at 09:30 at All Saints Community Hall, Station Road, Melbourn SG8 6DX

# **Safety Inspection Report**

Date of inspection: 21 April 2021
Inspector: David Owen

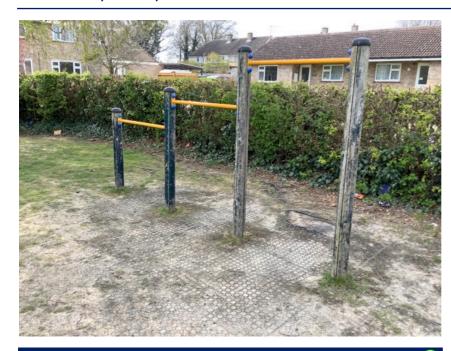
# **Agility Bars - 3 Tier**

This equipment relies on one post for its stability. Special attention should be paid to maintenance (e.g. by monitoring degradation) and if necessary decommissioning the item before the end of its operating life.

Surface needs repair.

Grass mats are damaged - replace.

Replace.

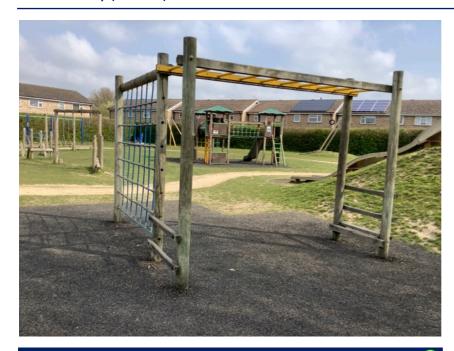
# **Climber - Net & Ladder**

Cap missing.

There is decay to timber components which may affect structural integrity. We do not recommend replacing rotten supports with timber posts which are directly set in the ground due to the increased problem of timber rot, especially in posts in contact with the ground.

One post is showing signs of softening and decay at ground level - monitor.

Fixtures loose or missing.

Net fittings are loose to the posts - remove fittings to check for corrosion and replace if found and the. Secure the net.

Item has some parts missing.

One rung and two hand holds missing - replace.

Replace.

Replace the missing parts.

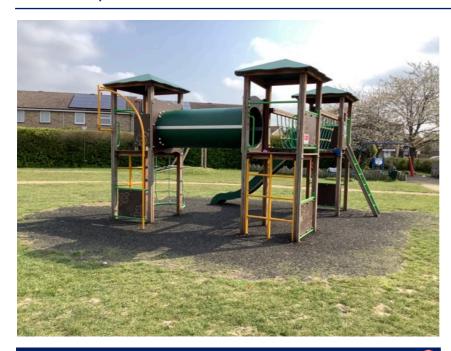
# **Multiplay - Junior**

Cap missing.

Cap plug missing exposing the thread - replace.

Two burn marks inside the tunnel - monitor.

Replace.

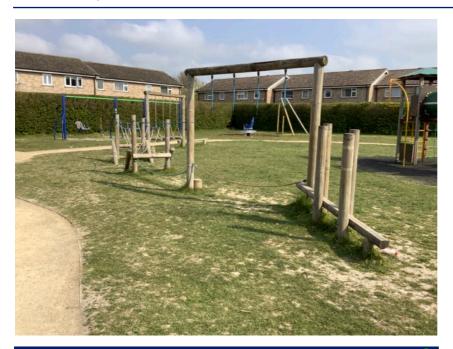
# **Agility Trail - 7 Element**

This equipment relies on one post for its stability. Special attention should be paid to maintenance (e.g. by monitoring degradation) and if necessary decommissioning the item before the end of its operating life.

Strimmer damage to supports is likely to accelerate timber rot.

Timber is decayed.

Rope walk top bar is decayed from the inside out, hollowed - replace as soon as possible.

Rope Burma Bridge post has split and damaged - repair.

The rope is rubbing on the balance beam and wearing down to the wire - monitor for broken wires and replace if found.

Prevent further damage.

Replace affected parts.

Repair.

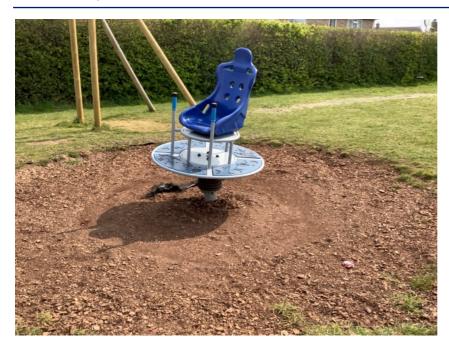
# **Rocker / Rotator - Chair - Space Rocket**

Surface needs repair.

The surfacing has worn away exposing and damaging the liner beneath. Grass & weeds have grown inside. The plastic edging strips are sharp - the whole area requires immediate repairs and alterations. Bark requires topping up.

Repair.

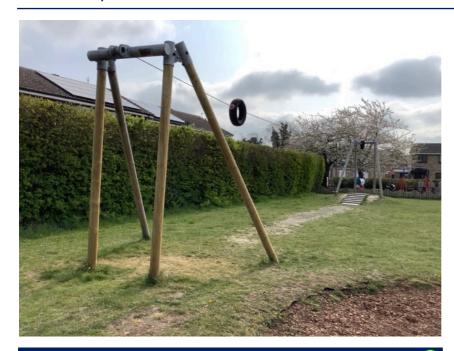
# **Cableway**

Chains links worn.

Chain link and seat connector worn.

Cables have been known to fail under load due to wear and corrosion. This is generally where the cable enters into a tube, top bar or similar, where the wire is in contact and wears and frays over time. Damaged cables require replacement. This cannot be determined during an annual inspection, and is excluded from our inspection. This finding is generically high risk and action is required. Refer to the manufacturer's instructions to ensure the correct check is carried out.

Strimmer damage to supports is likely to accelerate timber rot.

Replace the worn parts.

Repair.

Prevent further damage.

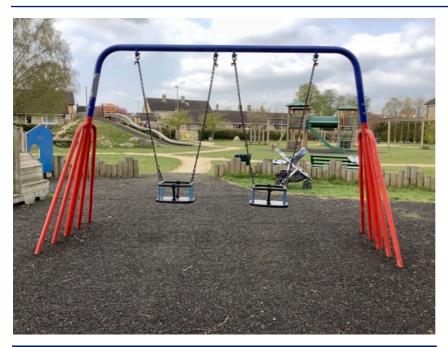
# Swing - Toddler - 1 Bay 2 Seat (2300 mm)

Wicksteed recommend that during routine inspections the area on the swing where the side frames meet the vertical support be checked for any cracks. In the event of cracks being found then remove the seats and contact Wicksteed for further advice.

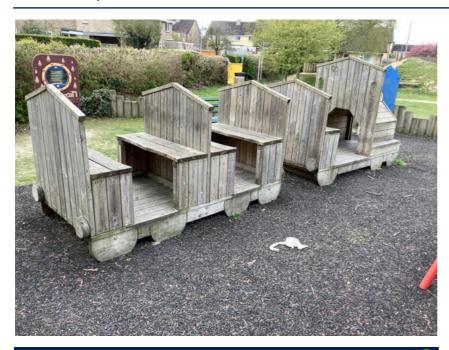
# Play Train & Carriage - With Play Panel - Station

Fixtures loose or missing.

Exhaust loose to tunnel and seat rest panels loose - secure.

Tighten/replace.

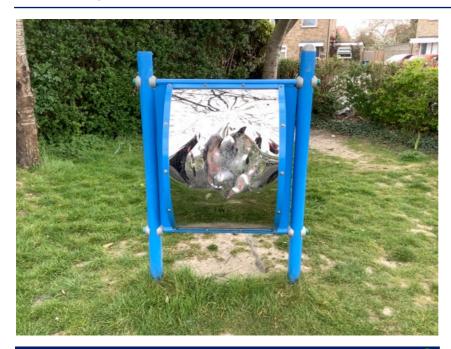
# **Play Panel - Mirror**

Cap missing.

Post caps missing where objects could be inserted and water ingress is likely to occur.

Mirror bent - monitor for splits / cracks, replace if found.

Replace.

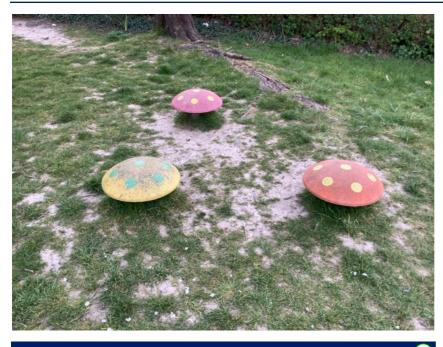
# **Stepping Posts - Mushroom x 3**

Actual risk leve Innate risk level **Very low** Risk score as low as possible No remedial tasks

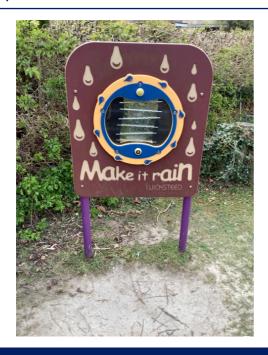
# Play Panel - Make it Rain

Bolt cap damaged.

Replace.
