Project Name: 276430.Little Hands Nursery.SG8 6ED.BWW.Melbourn

Project Description: WinCan Import in Miraculix WRc4 Standard

Project Date: 18/06/2021

Inspection Standard: MSCC4 Sewers & Drainage GB (SRM4 Scoring)

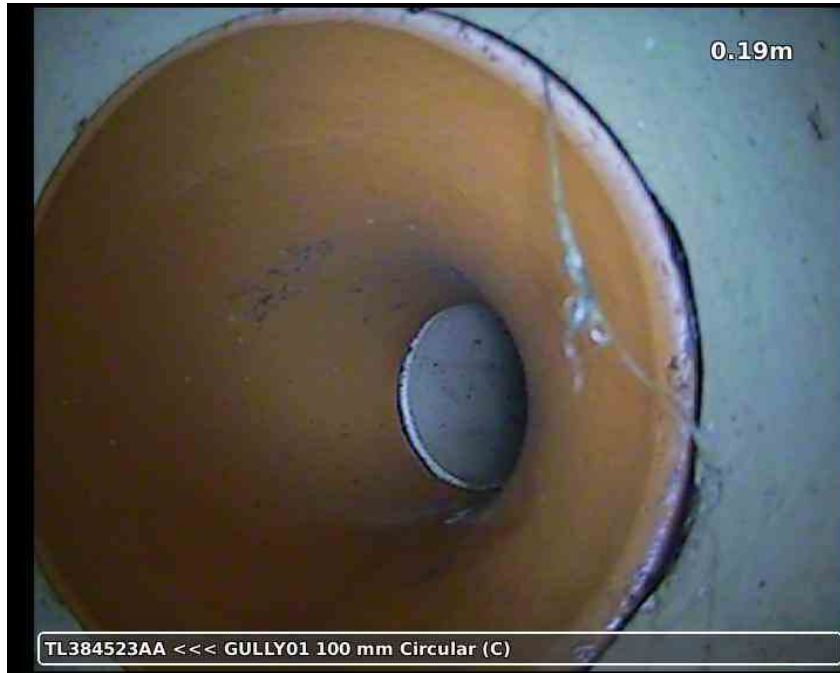
Section 1, Line appears to be disused, fine roots entering through the joint at 0.19m & a medium open joint at 1.82m

20210617-161336-snap0002.jpg, 00:00:11, 0.19 m
Roots, fine at joint

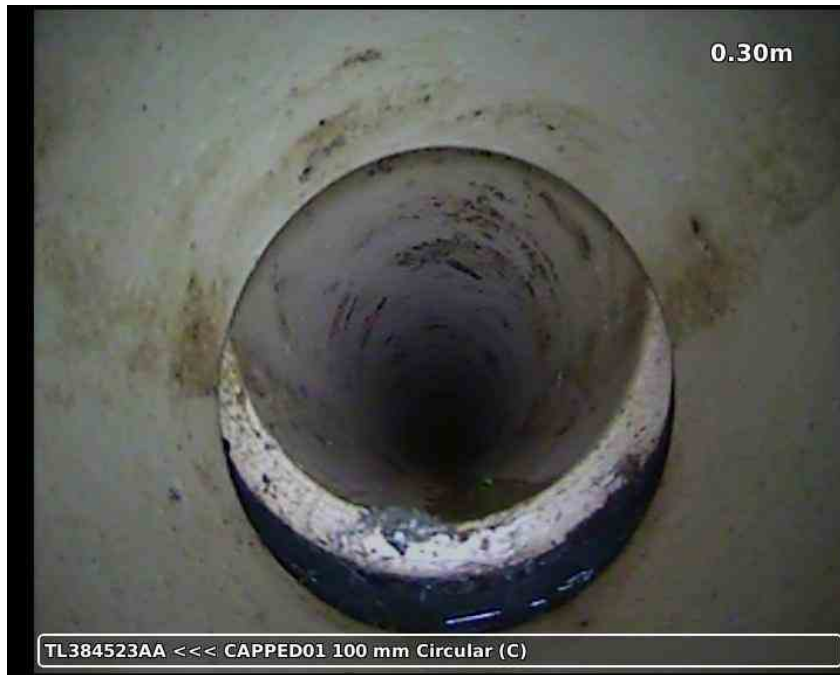
Section 2, Line is capped off at the rest bend, medium displaced joint found at 0.30m.

20210617-161651-snap0002.jpg, 00:00:18, 0.30 m
Joint displaced, 20 mm displacement

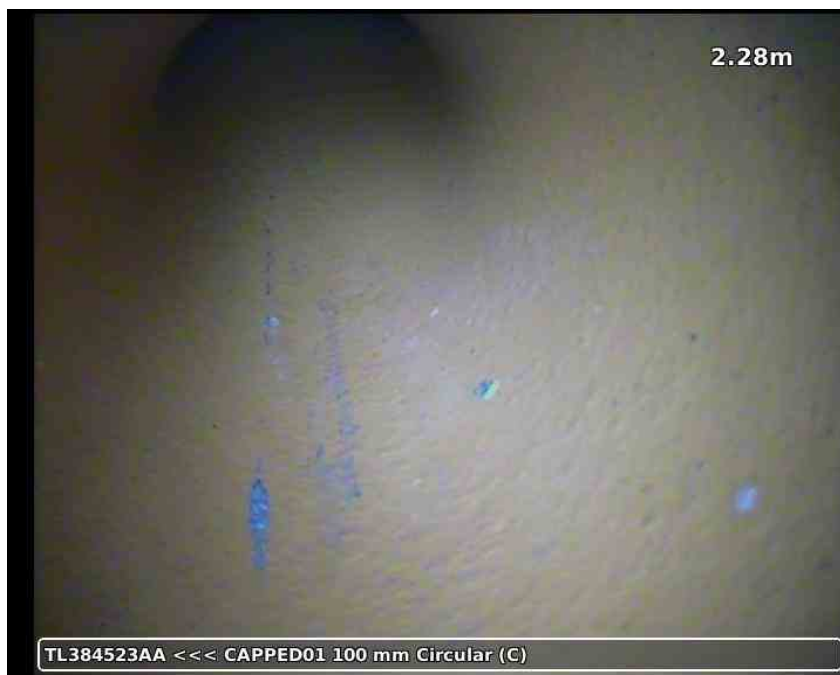
20210617-161651-snap0003.jpg, 00:00:52, 2.28 m
Finish node type, other special chamber, reference number: CAPPED01, Internal rest bend
CAPPED OFF

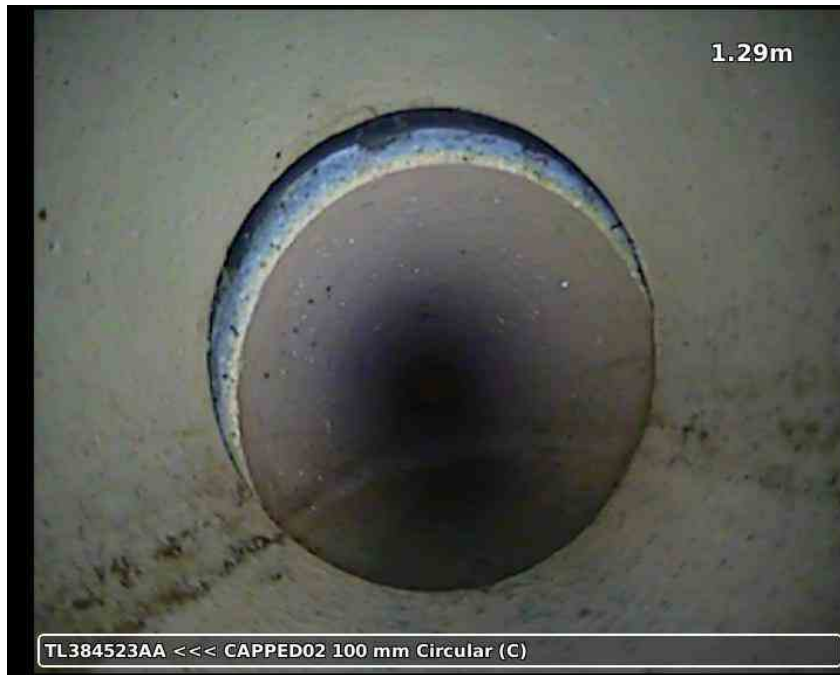
Section 3, Line is capped off at the rest bend, medium displaced joint found at 1.29m

20210617-161854-snap0002.jpg, 00:00:28, 1.29 m
Joint displaced, 10 mm displacement

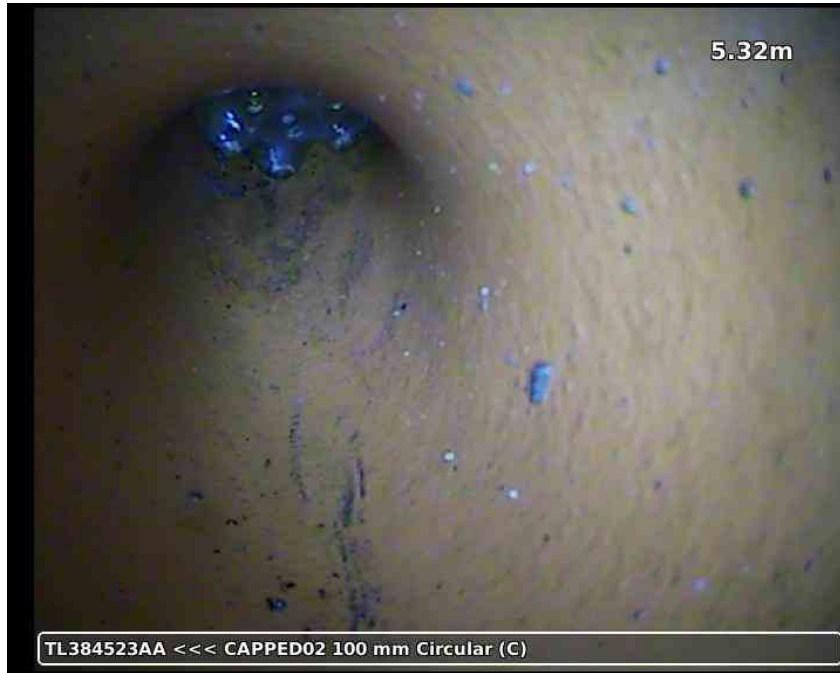
20210617-161854-snap0004.jpg, 00:01:40, 5.32 m
Finish node type, other special chamber, reference number: CAPPED02, Internal rest bend
CAPPED OFF

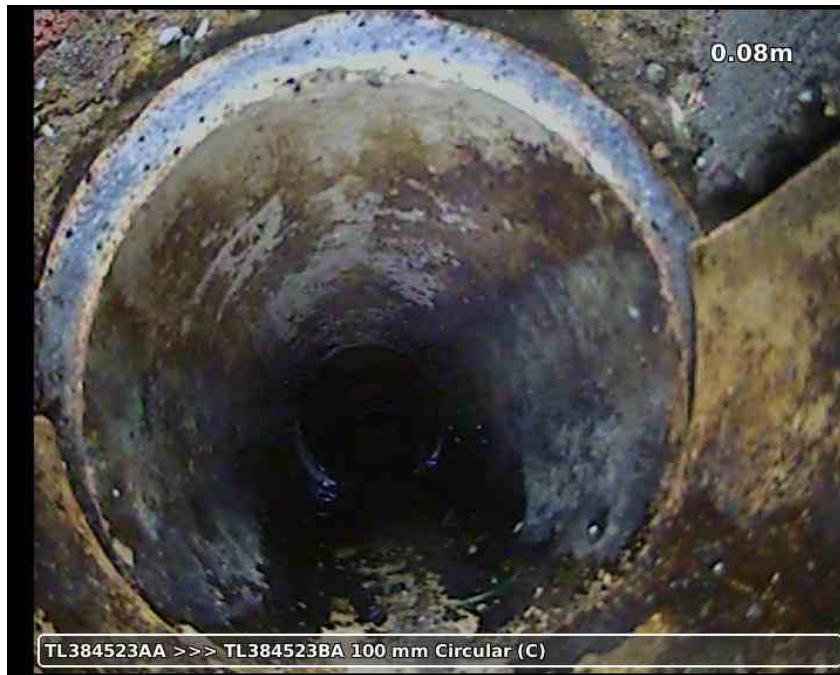
20210617-163005-snap0002.jpg, 00:00:17, 0.08 m
Joint displaced, medium

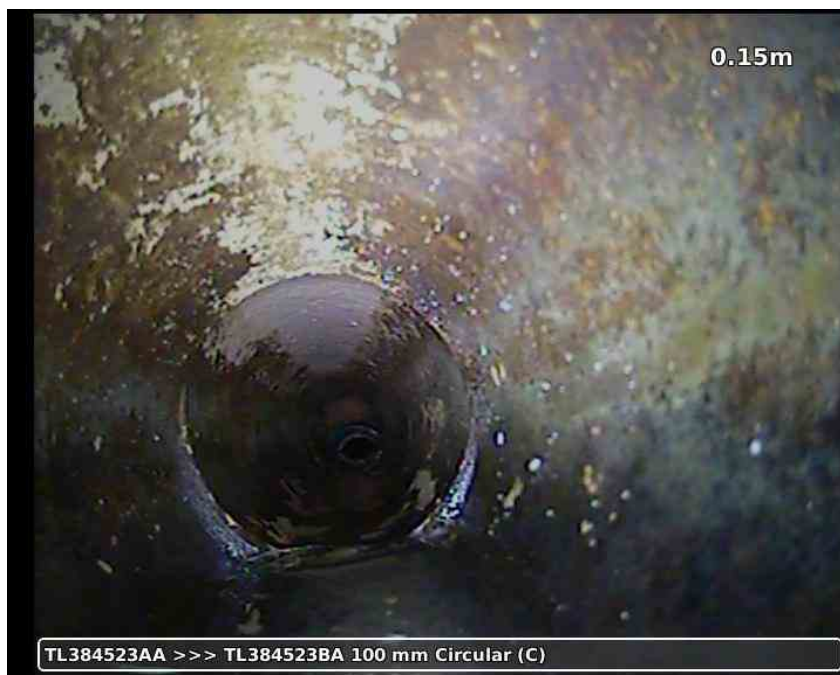
20210617-163005-snap0003.jpg, 00:00:25, 0.15 m
Attached deposits, fouling, from 01 to 11 o'clock, 5% % cross-sectional area loss, S01

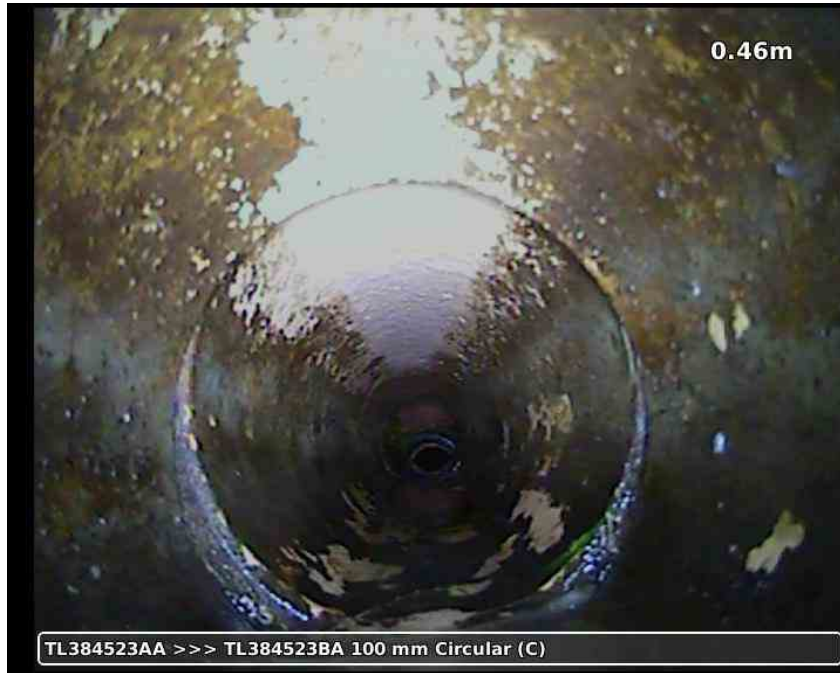
Section 4, Medium displaced joint at 0.46, Water level is upto 40% in TL384523BA

20210617-163005-snap0004.jpg, 00:00:39, 0.46 m
Joint displaced, medium

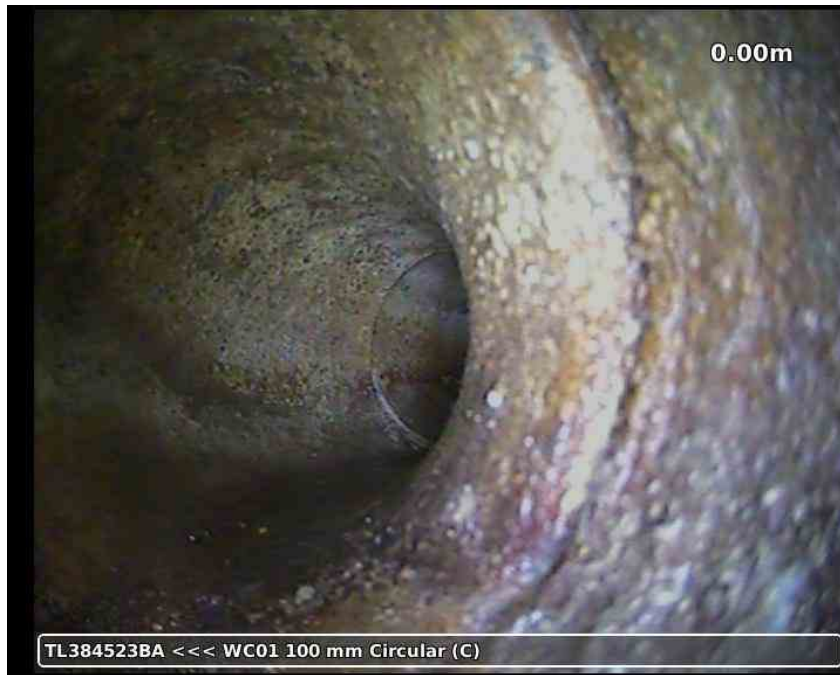
20210617-164432-snap0002.jpg, 00:00:09, 0.00 m
General remark, LINE HASN'T BEEN CLEANED PRE SURVEY

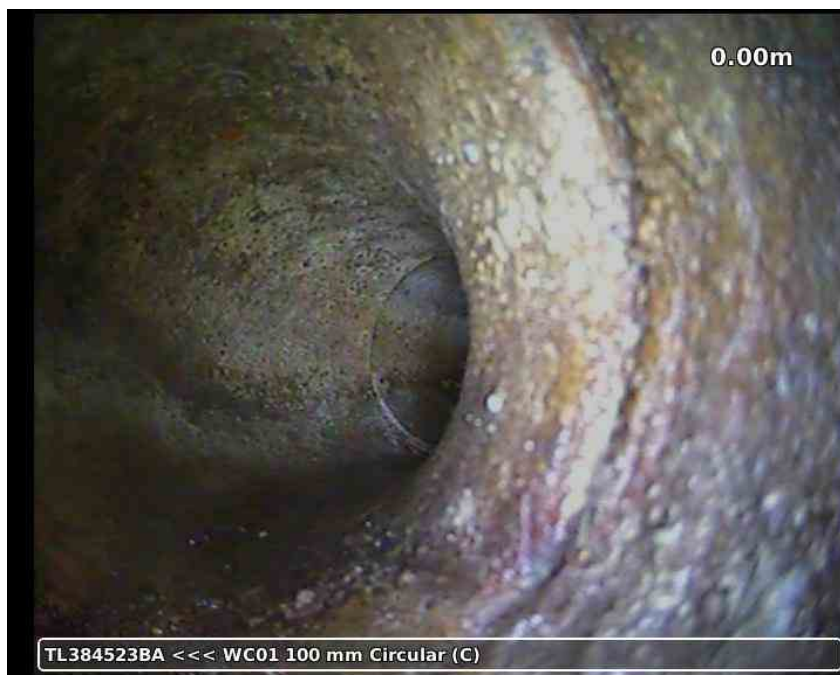
20210617-164432-snap0003.jpg, 00:00:15, 0.00 m
Attached deposits, fouling, from 01 to 12 o'clock, 5% % cross-sectional area loss, S01

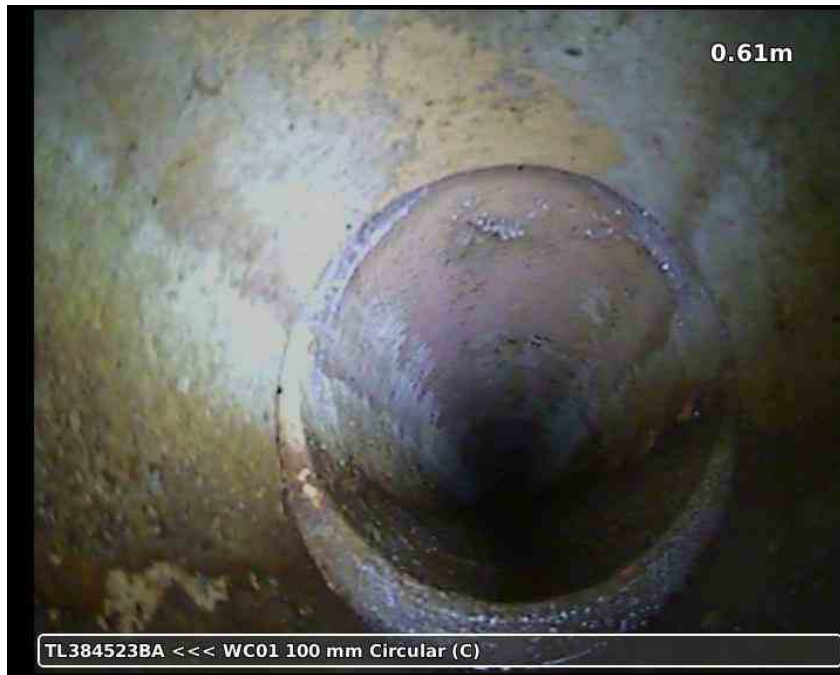
Section 5, Medium open joint at 0.46m & a medium displaced joint at 0.61.

20210617-164432-snap0006.jpg, 00:00:45, 0.61 m
Joint displaced, 10 mm displacement

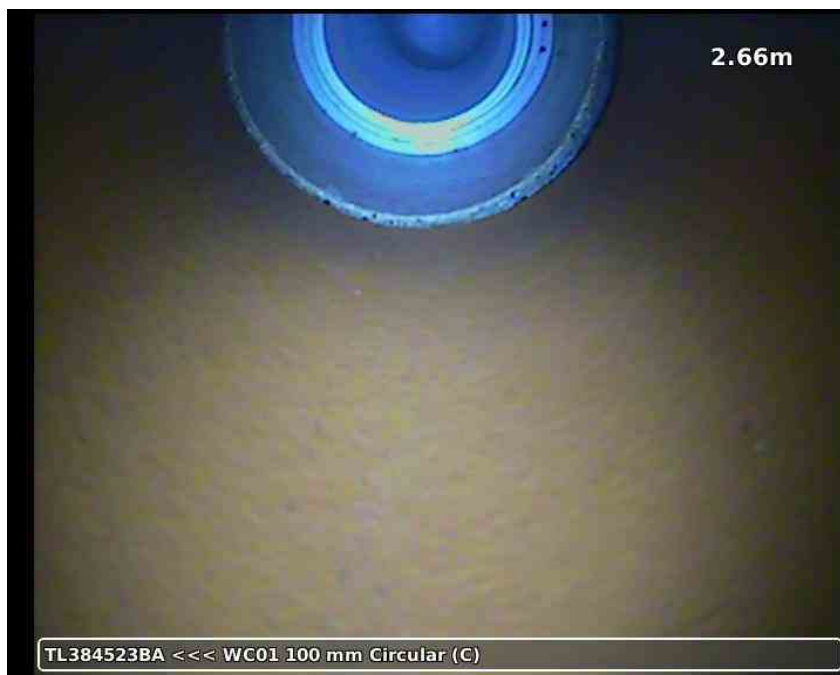
20210617-164432-snap0007.jpg, 00:01:15, 2.66 m
Finish node type, other special chamber, reference number: WC01, Internal rest bend WC01

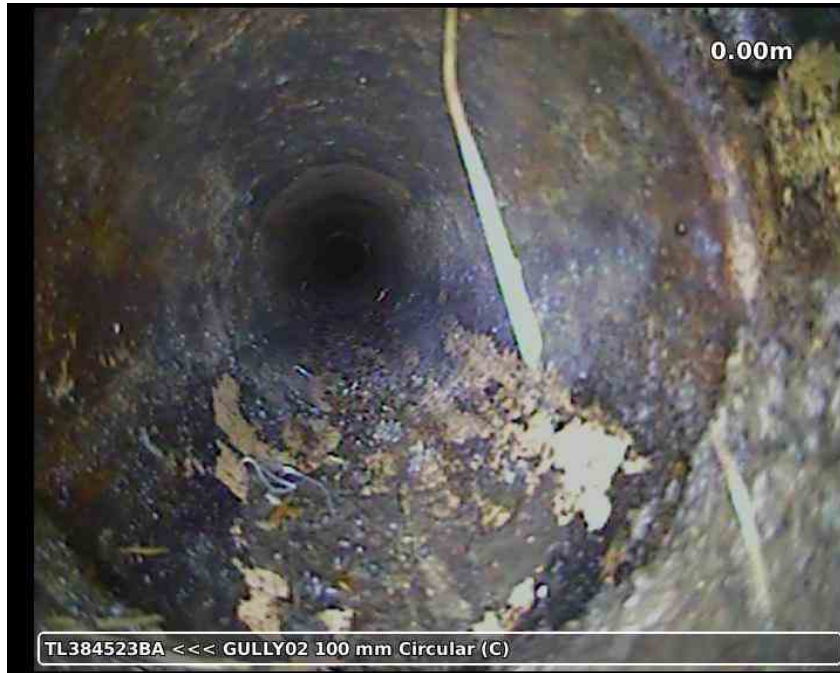
20210617-164707-snap0002.jpg, 00:00:12, 0.00 m
Attached deposits, fouling, from 01 to 12 o'clock, 5% % cross-sectional area loss, S01

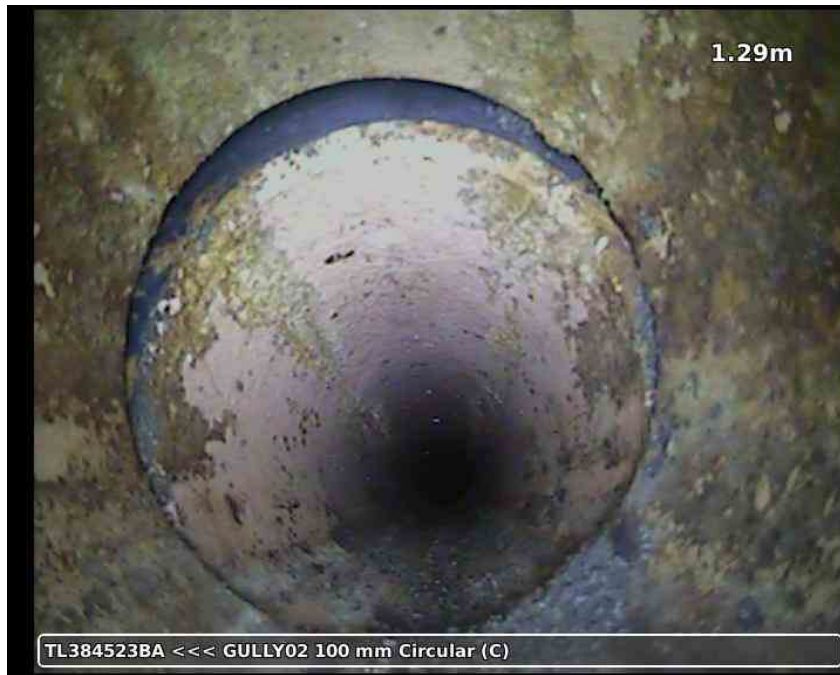
20210617-164707-snap0004.jpg, 00:00:39, 1.29 m
Joint displaced, 10 mm displacement

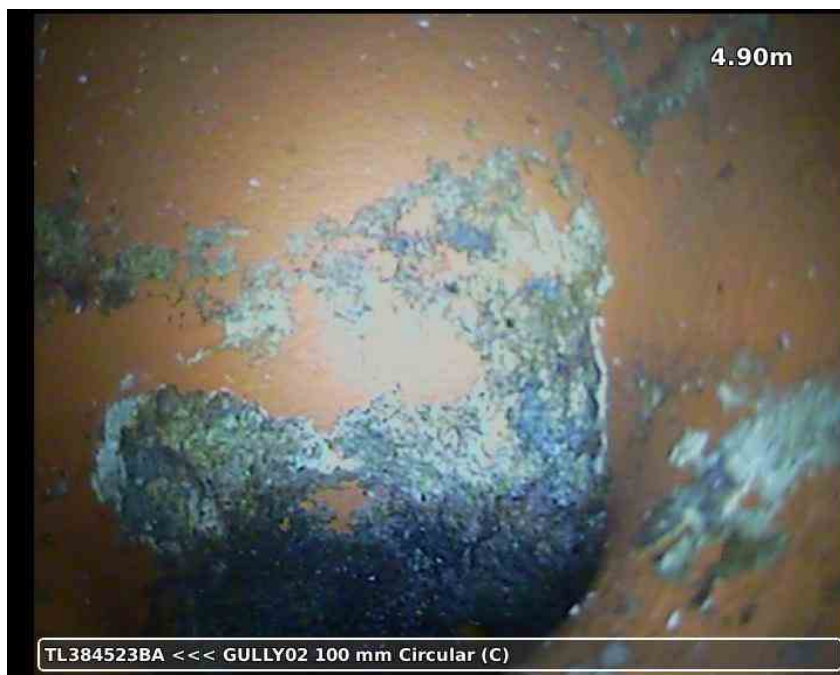
20210617-164707-snap0005.jpg, 00:01:19, 4.90 m
Finish node type, gully, reference number: GULLY02, DISUSED INTERNAL GULLY

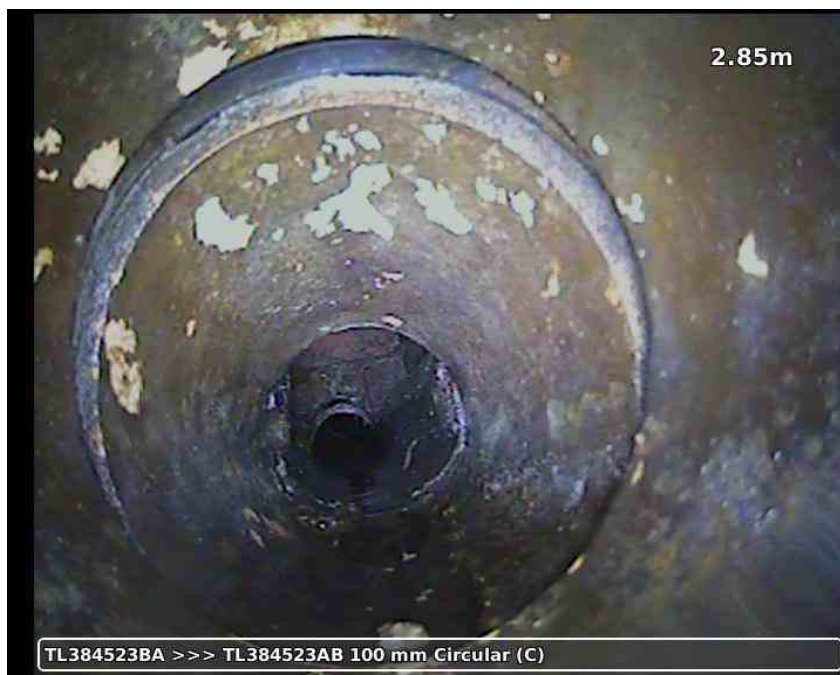
20210617-164942-snap0007.jpg, 00:01:15, 2.85 m
Joint displaced, 10 mm displacement

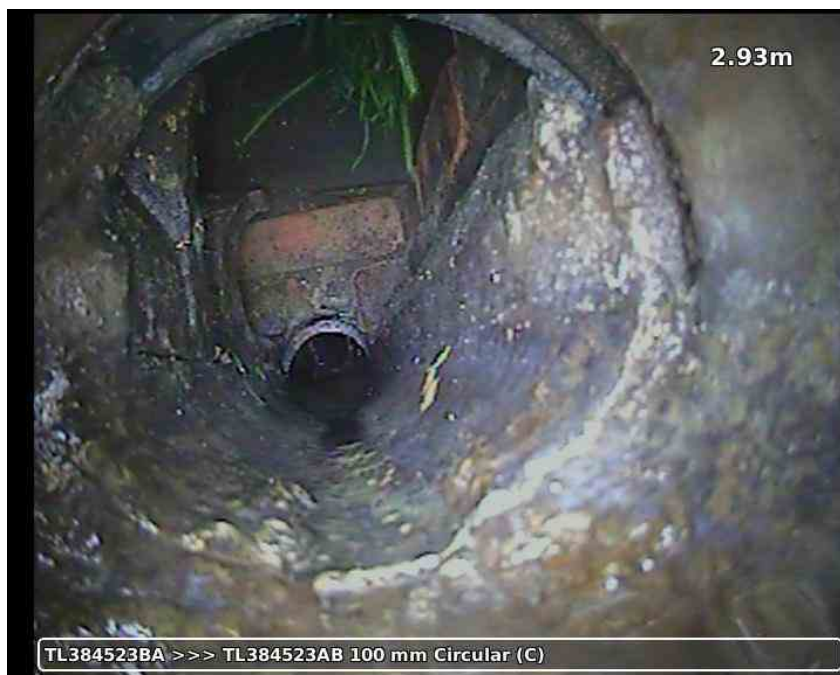
Section	PLR	Grade	Description
7	TL384523BAX	3	Settled deposits, hard or compacted, 20% % cross-sectional area loss
24	GULLY06X	3	Multiple defects
25	TL384523AHX	3	Settled deposits, fine at joint, 15% % cross-sectional area loss
27	TL384533AIX	5	Roots, mass, 30% % cross-sectional area loss

20210617-164942-snap0009.jpg, 00:01:35, 2.93 m
Settled deposits, hard or compacted, 20% % cross-sectional area loss

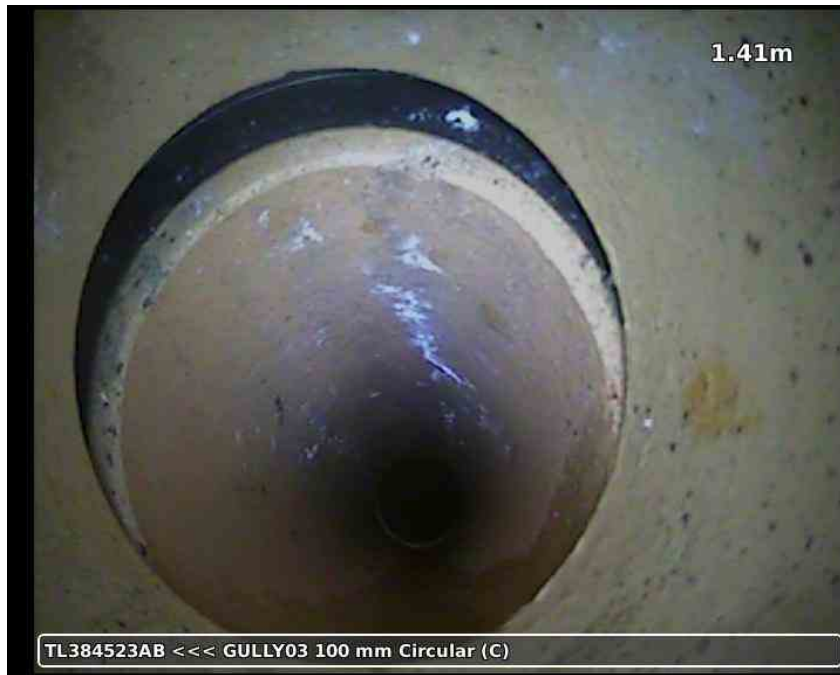
20210617-165624-snap0002.jpg, 00:00:24, 1.41 m
Joint displaced, 20 mm displacement

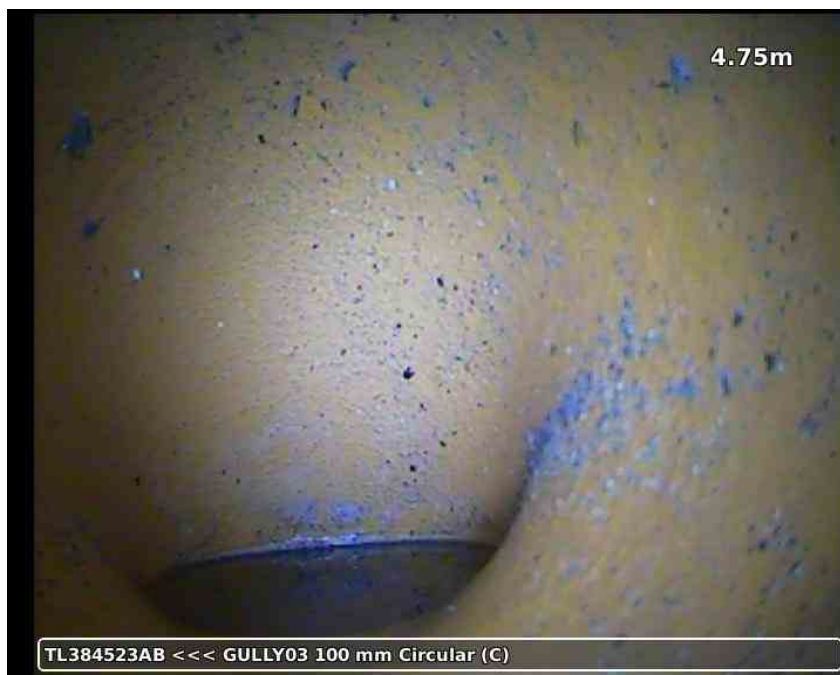
20210617-165624-snap0003.jpg, 00:00:56, 4.75 m
Finish node type, gully, reference number: GULLY03, Internal gully

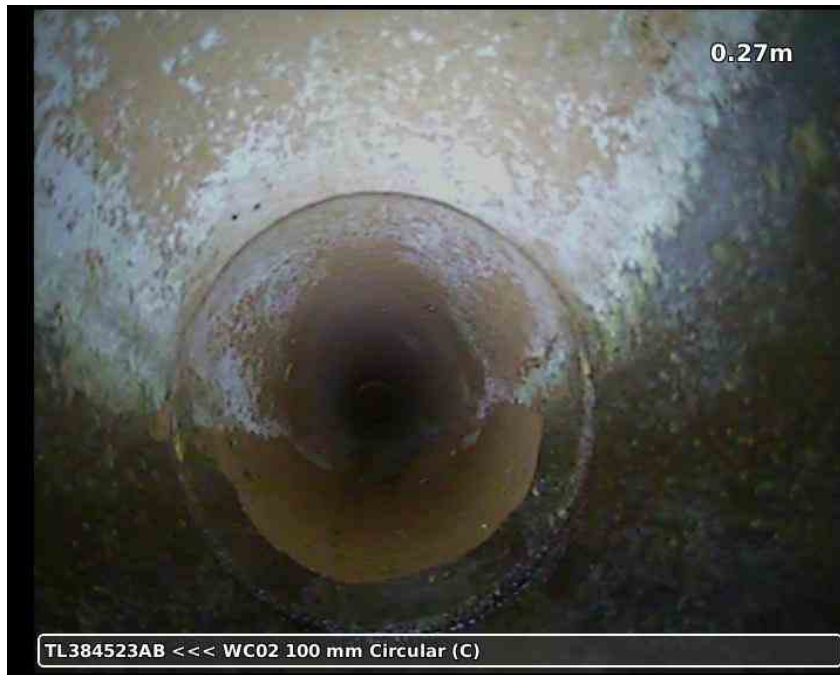
20210617-165855-snap0002.jpg, 00:00:15, 0.27 m
Attached deposits, fouling, from 02 to 10 o'clock, 5% % cross-sectional area loss

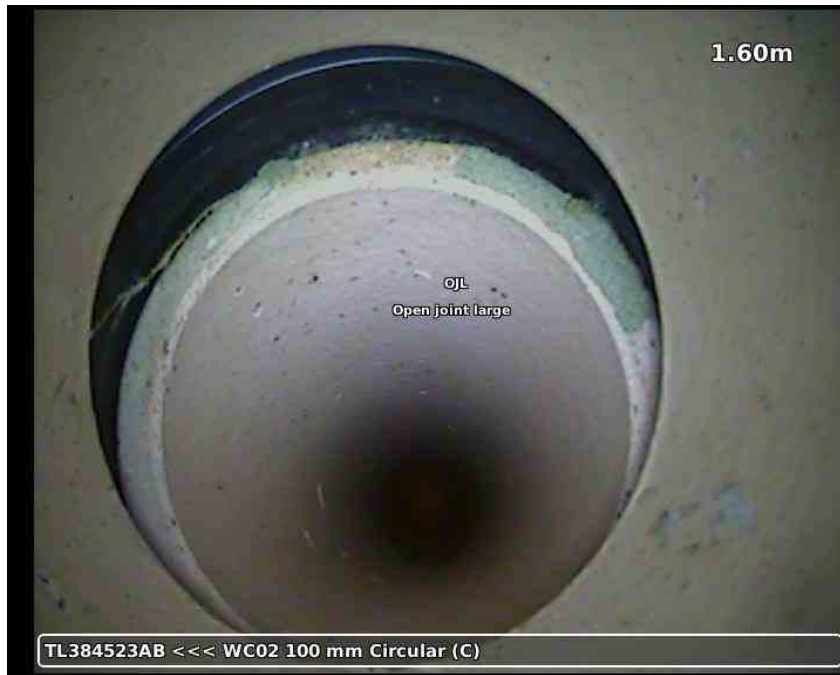
20210617-165855-snap0004.jpg, 00:00:40, 1.60 m
Joint displaced, 20 mm displacement

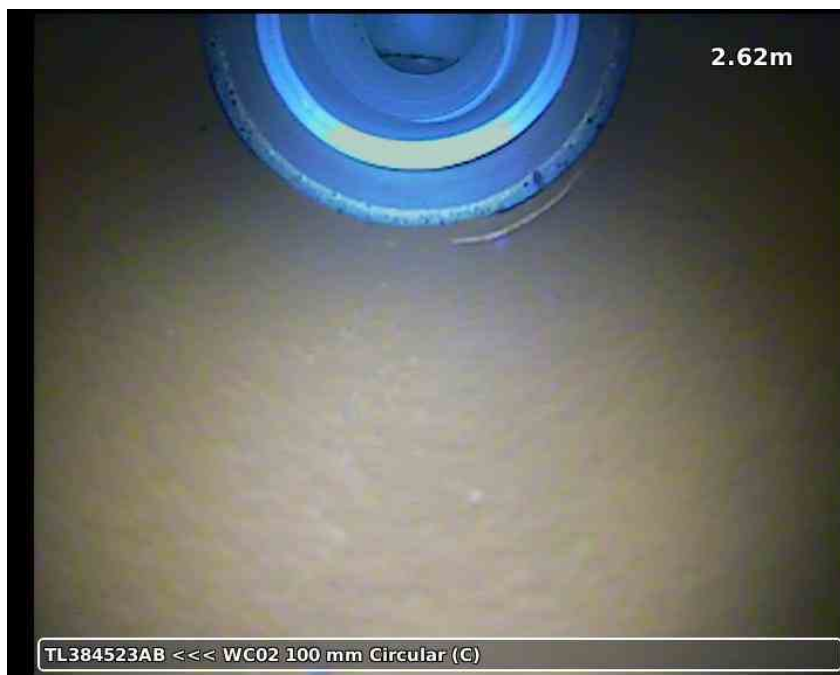
20210617-165855-snap0005.jpg, 00:01:01, 2.62 m
Finish node type, other special chamber, reference number: WC02, Internal rest bend WC02

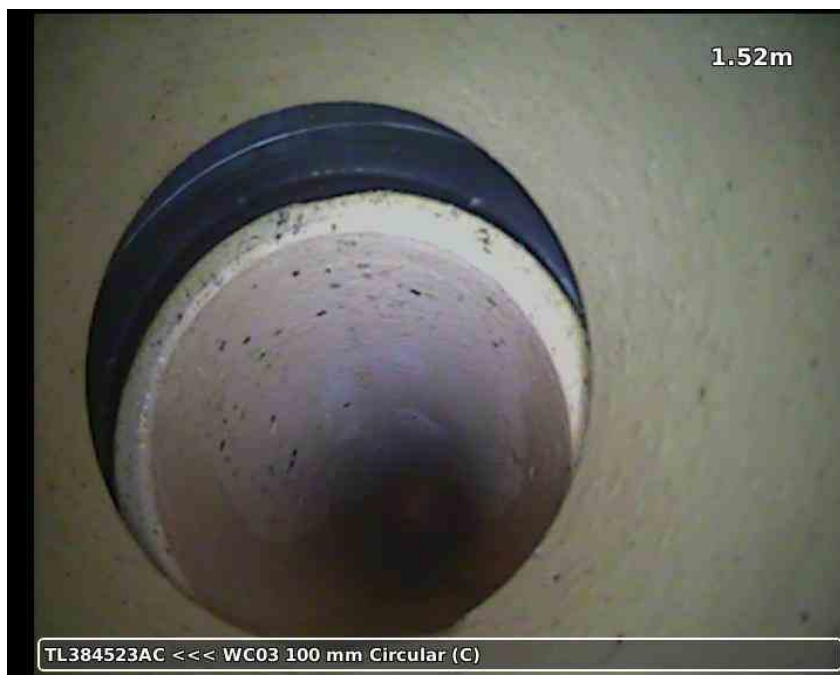
20210617-171046-snap0003.jpg, 00:00:27, 1.52 m
Joint displaced, 20 mm displacement

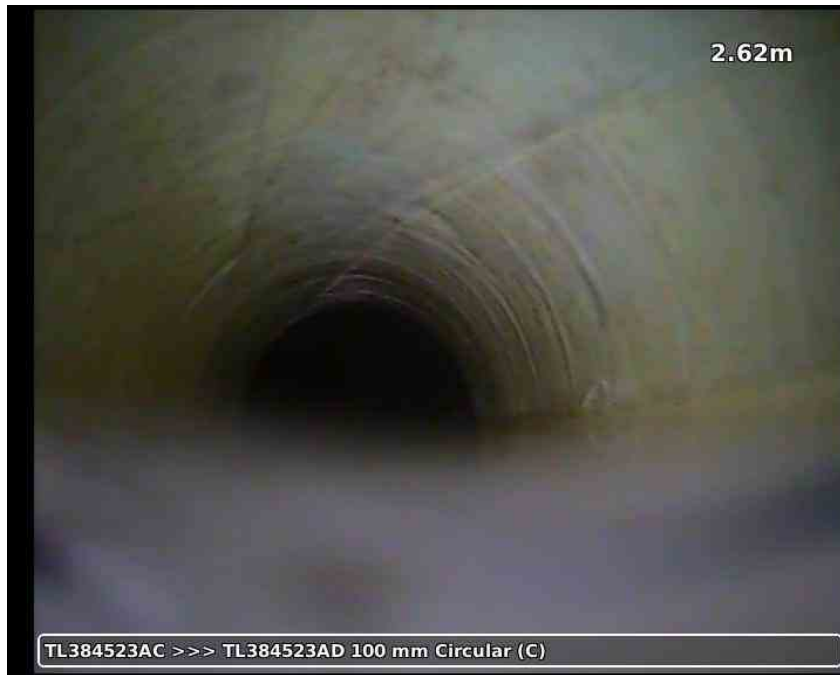
20210617-171630-snap0007.jpg, 00:02:01, 2.62 m
Cured-in-place lining ends at this point

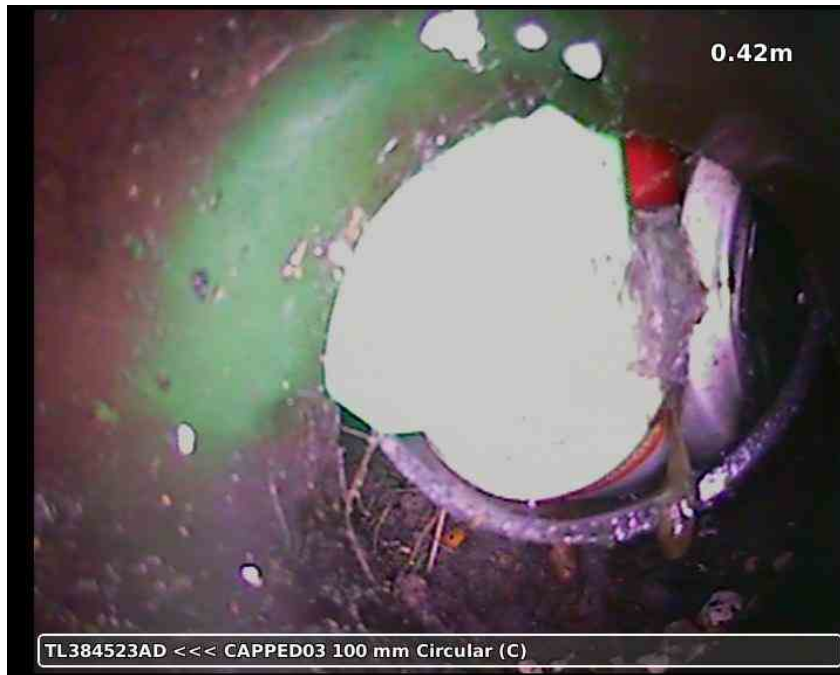
20210617-172705-snap0002.jpg, 00:00:31, 0.42 m
General remark, APPEARS TO BE A CAPPED OFF LINE

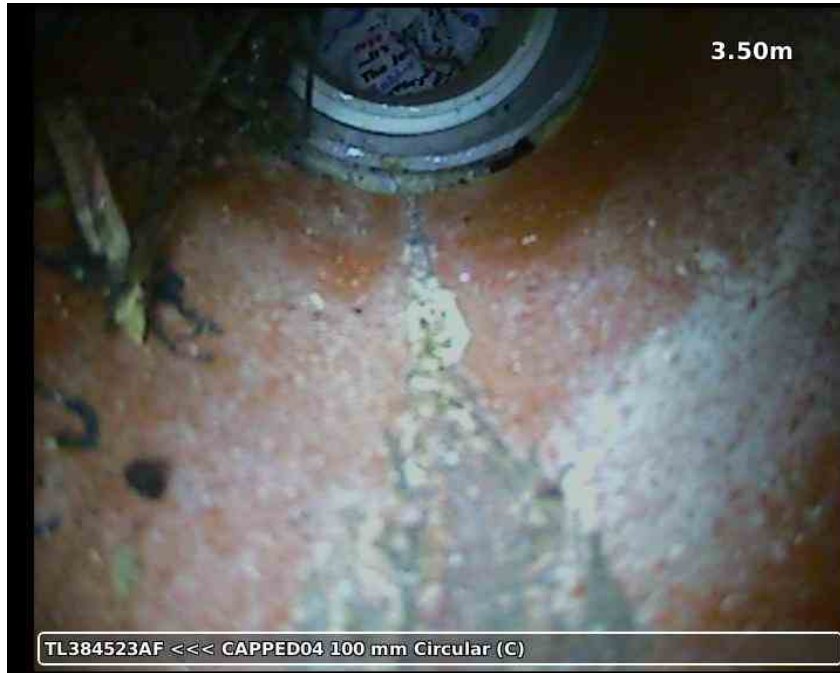
20210617-180144-snap0006.jpg, 00:01:38, 3.50 m
Finish node type, other special chamber, reference number: CAPPED04, Internal rest bend
CAPPED04

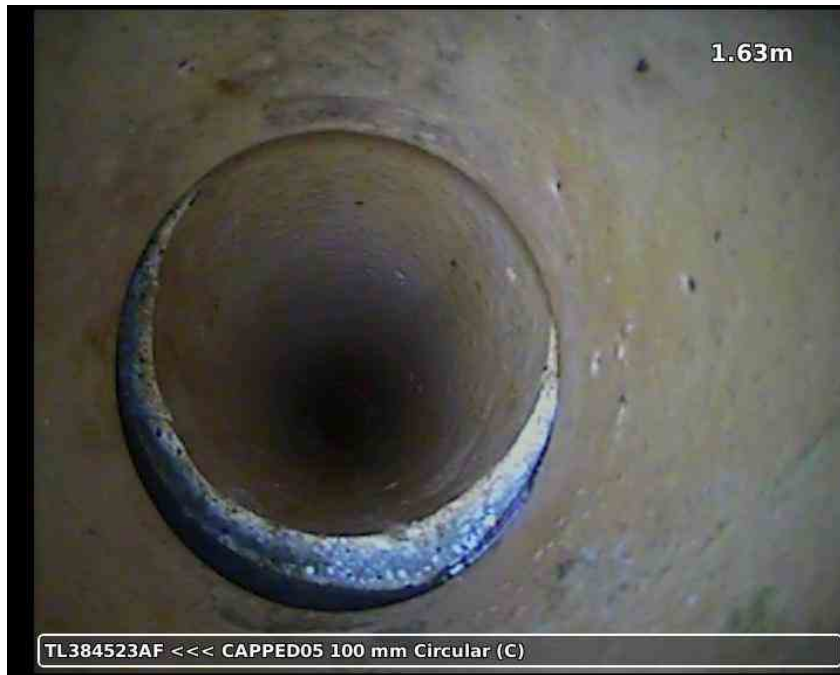
20210617-180419-snap0002.jpg, 00:00:34, 1.63 m
Joint displaced, 10 mm displacement

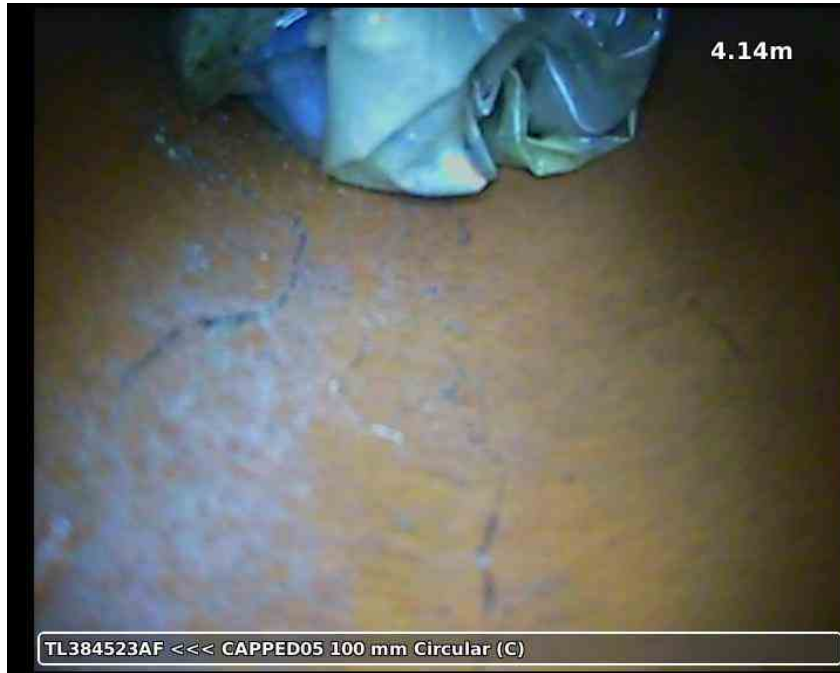
20210617-180419-snap0004.jpg, 00:01:03, 4.14 m
Finish node type, other special chamber, reference number: CAPPED05, Internal rest bend
CAPPED OFF

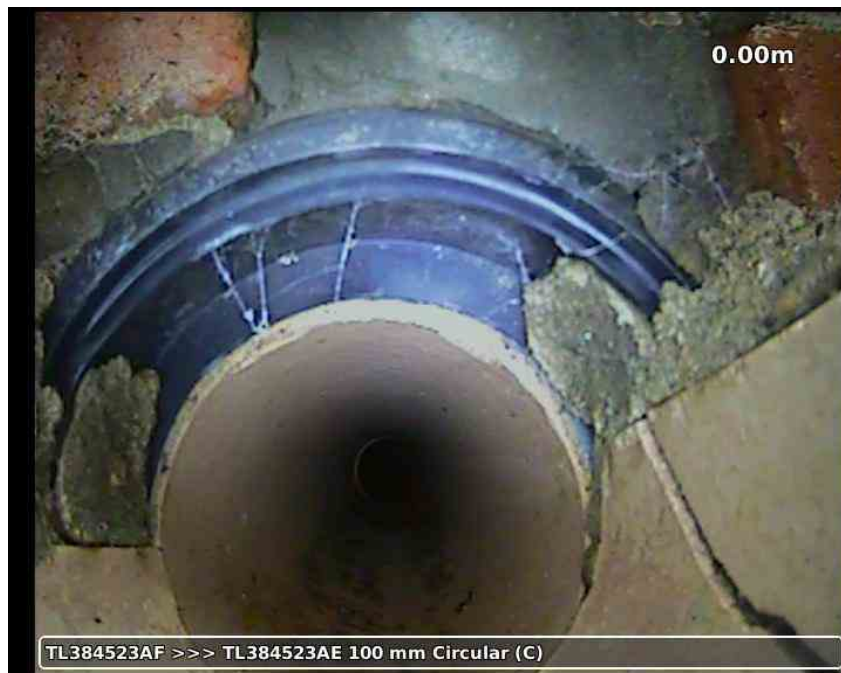
20210617-180721-snap0001.jpg, 00:00:01, 0.00 m
 Water level, 0% % of the vertical dimension, DISUSED LINE FROM PUBLIC TOILETS

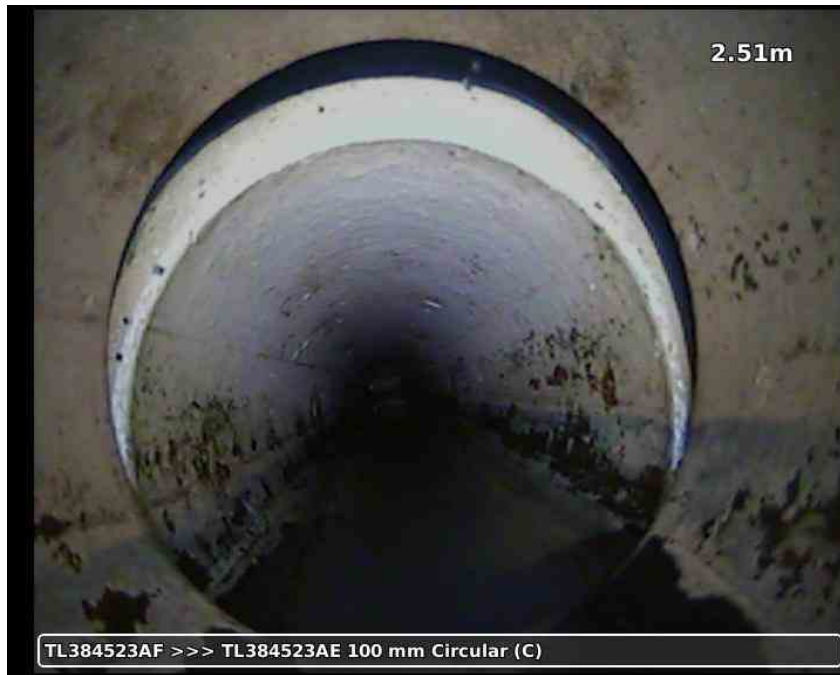
20210617-180721-snap0002.jpg, 00:00:46, 2.51 m
Joint displaced, 20 mm displacement

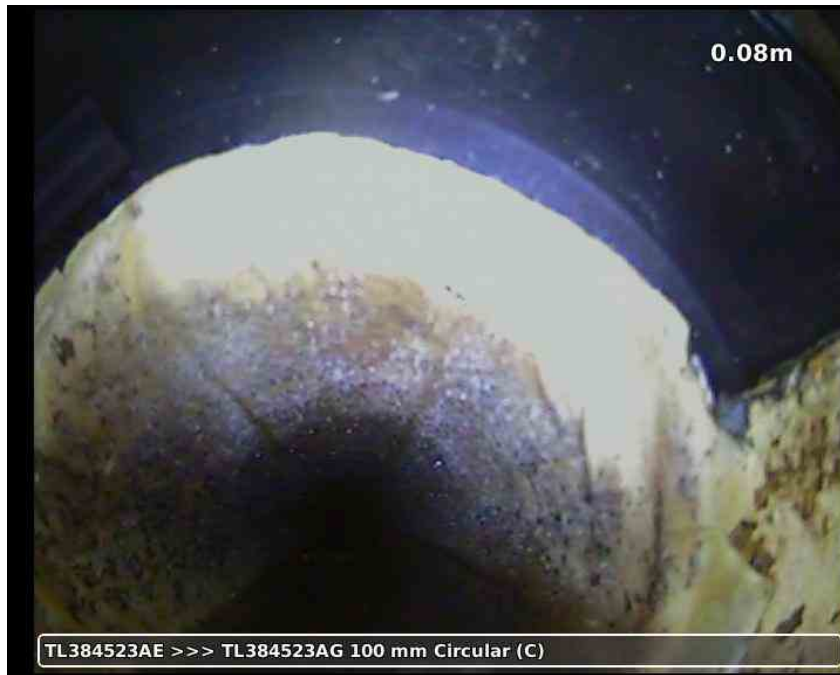
20210617-181934-snap0002.jpg, 00:00:16, 0.08 m
Lining of drain or sewer with cured-in-place lining changes to polyester at this point

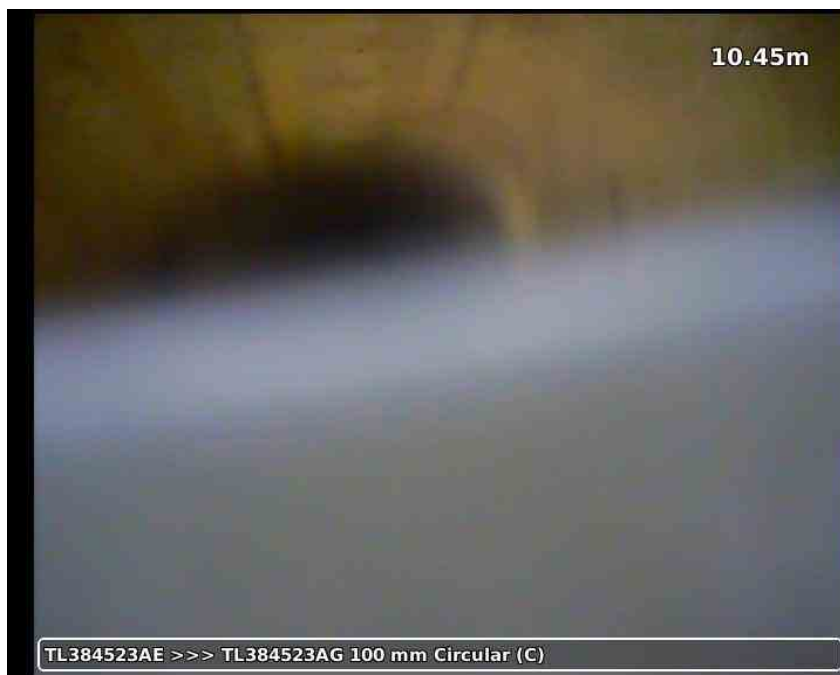
20210617-181934-snap0007.jpg, 00:02:12, 10.45 m
Loss of vision, camera under water, S01

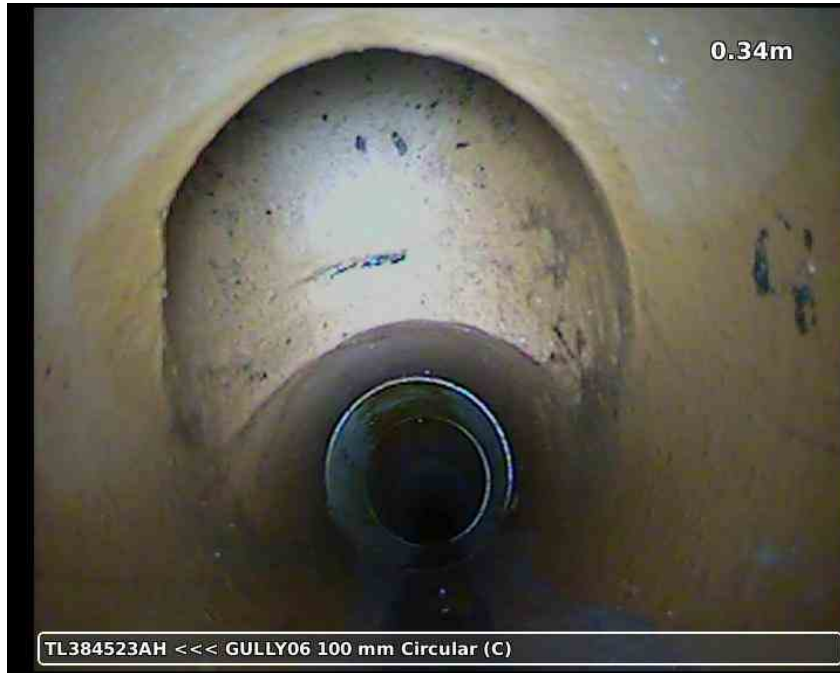
20210617-183738-snap0002.jpg, 00:00:12, 0.34 m
Junction, at 12 o'clock, diameter: 100 mm, UNKNOWN CONNECTION

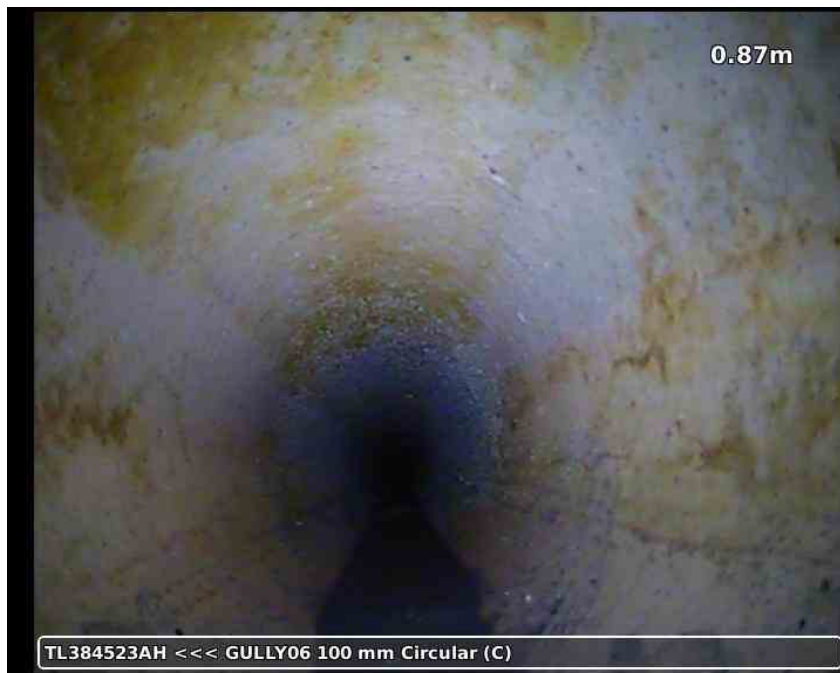
20210617-183738-snap0003.jpg, 00:00:29, 0.87 m
Settled deposits, fine, 10% % cross-sectional area loss, S01

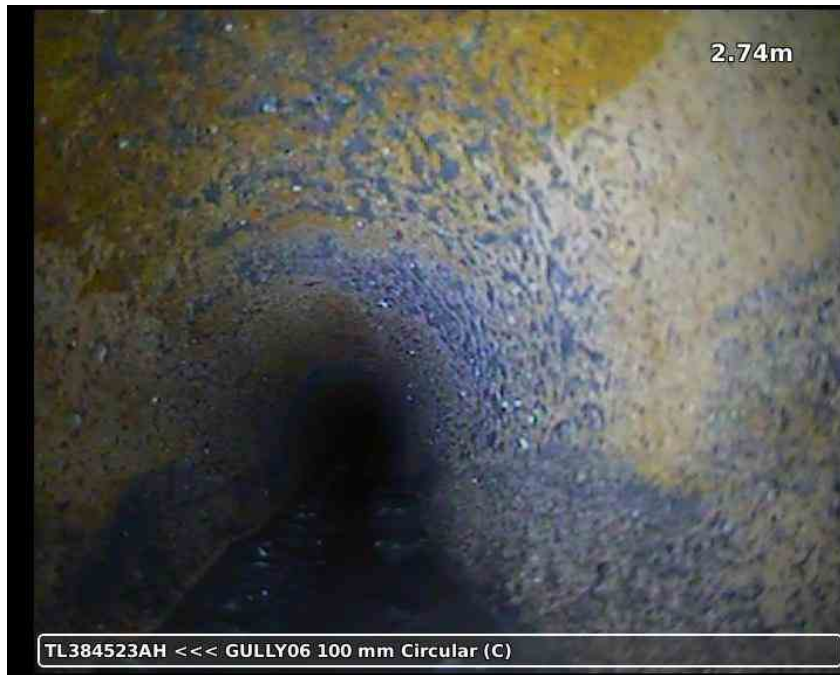
20210617-183738-snap0004.jpg, 00:00:52, 2.74 m
Settled deposits, fine, 10% % cross-sectional area loss, S02

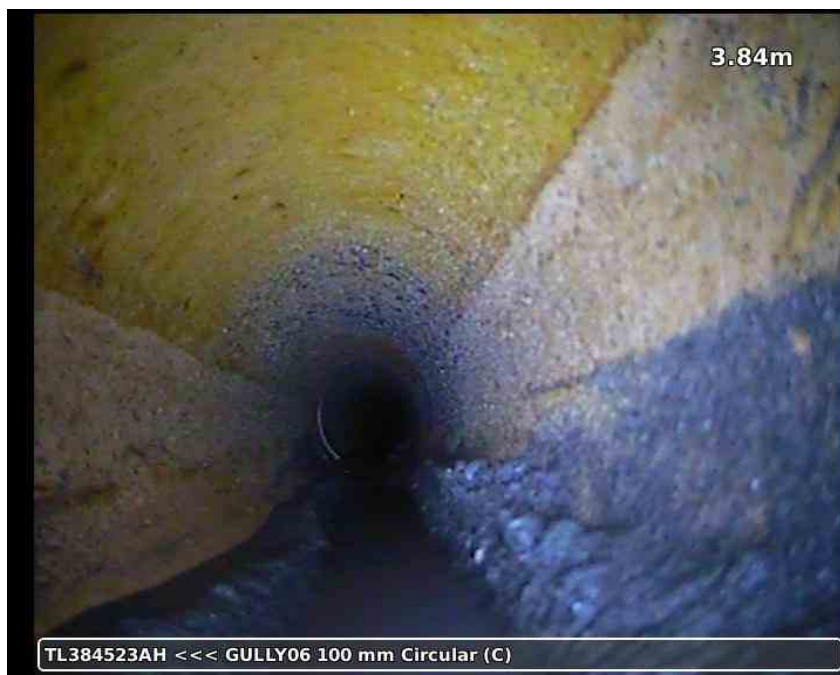
20210617-183738-snap0005.jpg, 00:01:13, 3.84 m
Settled deposits, fine, 20% % cross-sectional area loss, S03

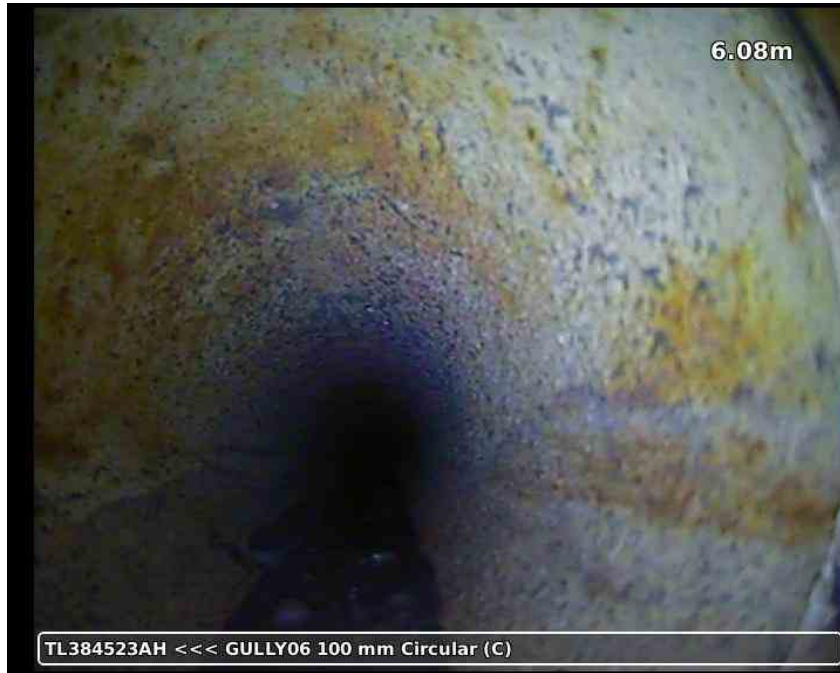
20210617-183738-snap0006.jpg, 00:01:33, 6.08 m
Settled deposits, fine, 10% % cross-sectional area loss, S04

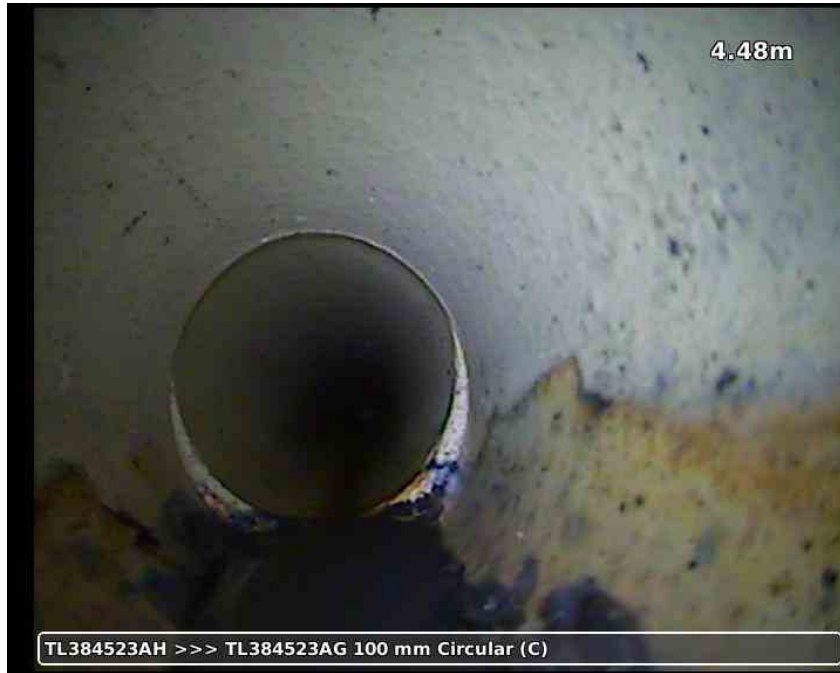
20210617-184209-snap0002.jpg, 00:00:40, 4.48 m
Settled deposits, fine at joint, 15% % cross-sectional area loss
