Project Name: 276430.Little Hands Nursery.SG8 6ED.BWW.Melbourn

Project Description: WinCan Import in Miraculix WRc4 Standard

Project Date: 18/06/2021

Inspection Standard: MSCC4 Sewers & Drainage GB (SRM4 Scoring)

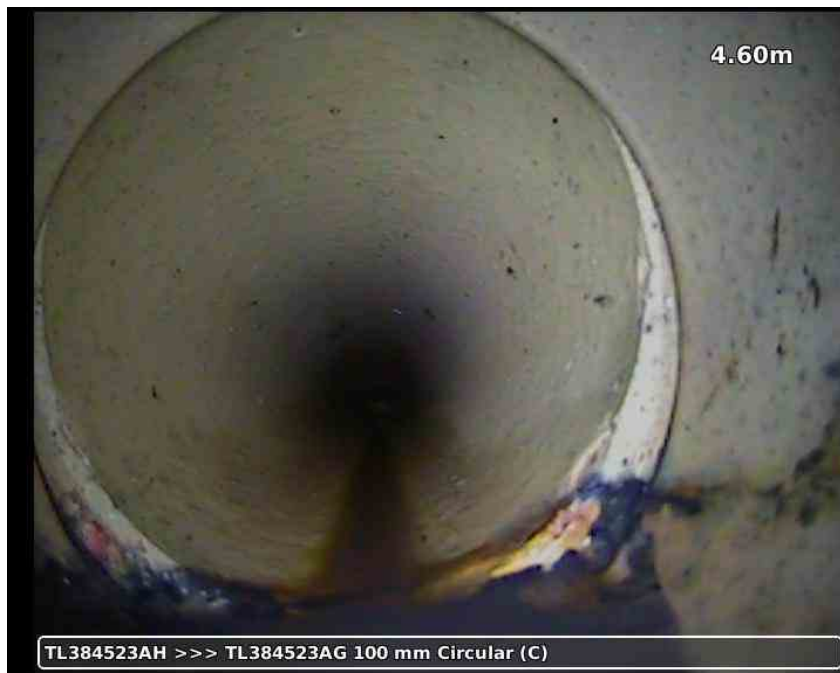
20210617-184209-snap0003.jpg, 00:00:53, 4.60 m
Joint displaced, medium

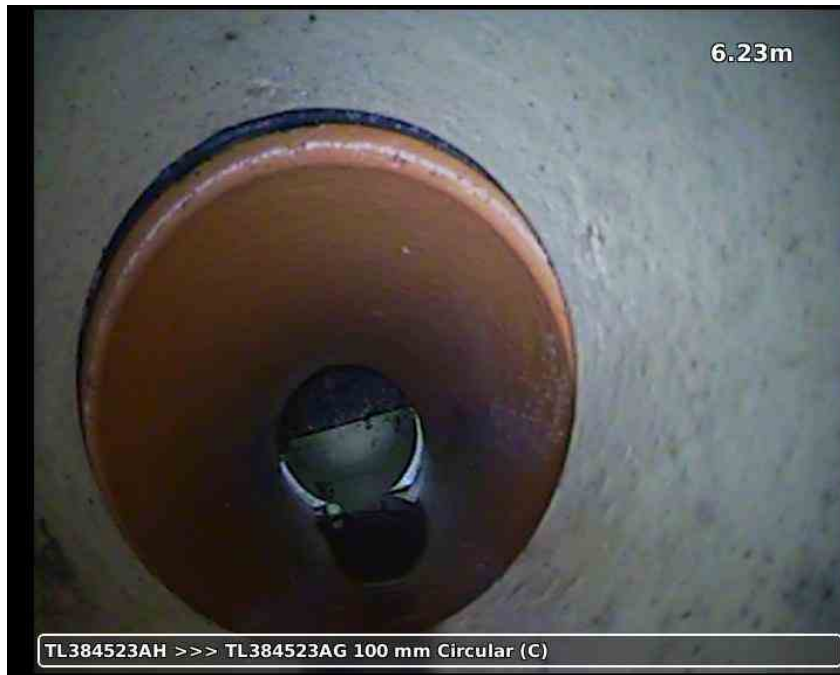
20210617-184209-snap0004.jpg, 00:01:12, 6.23 m
Joint displaced, medium

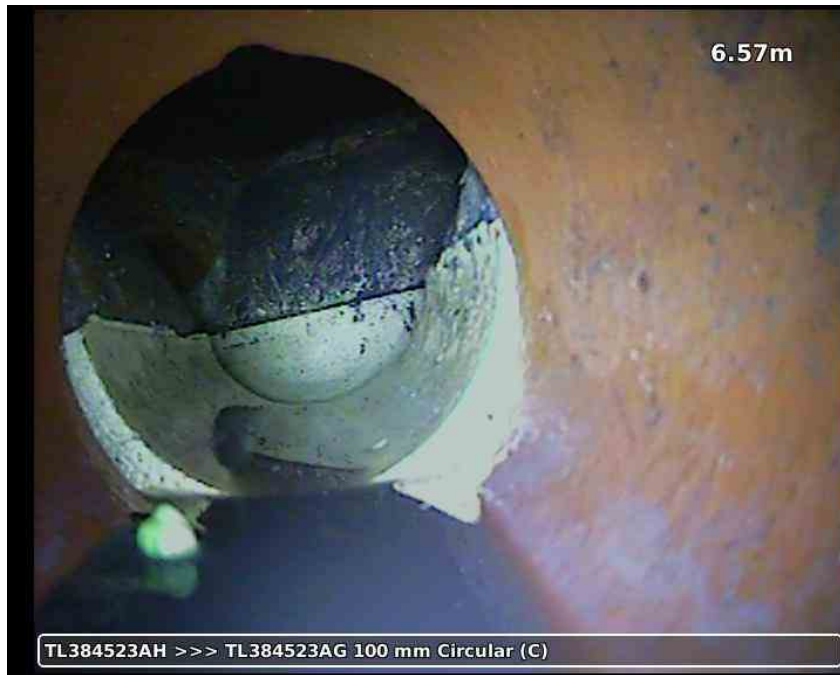
20210617-184209-snap0006.jpg, 00:01:30, 6.57 m
Joint displaced, 10 mm displacement

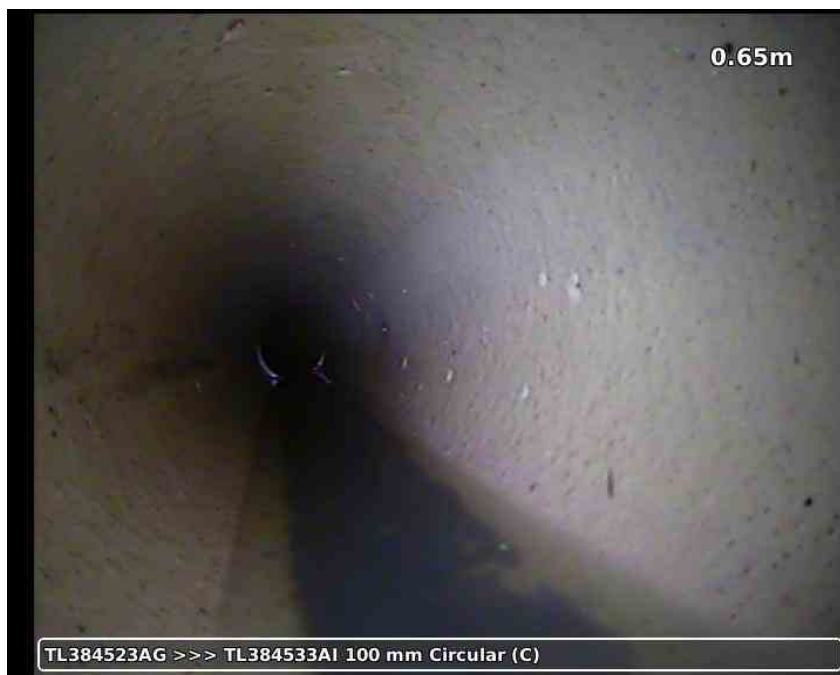
20210617-185600-snap0003.jpg, 00:00:19, 0.65 m
Settled deposits, fine, 5% % cross-sectional area loss, S01

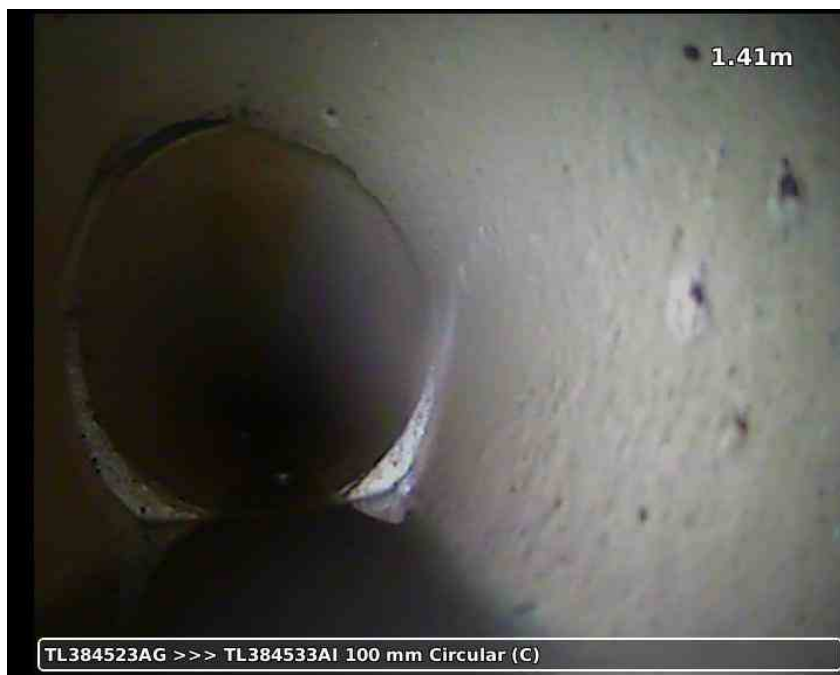
20210617-185600-snap0005.jpg, 00:00:45, 1.41 m
Joint displaced, medium

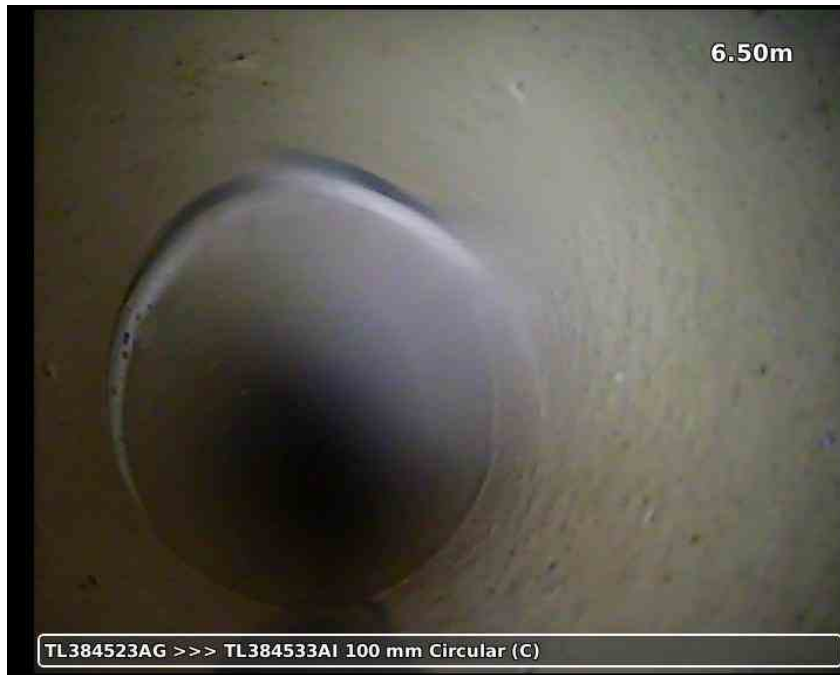
20210617-185600-snap0010.jpg, 00:02:16, 6.50 m
Joint displaced, medium

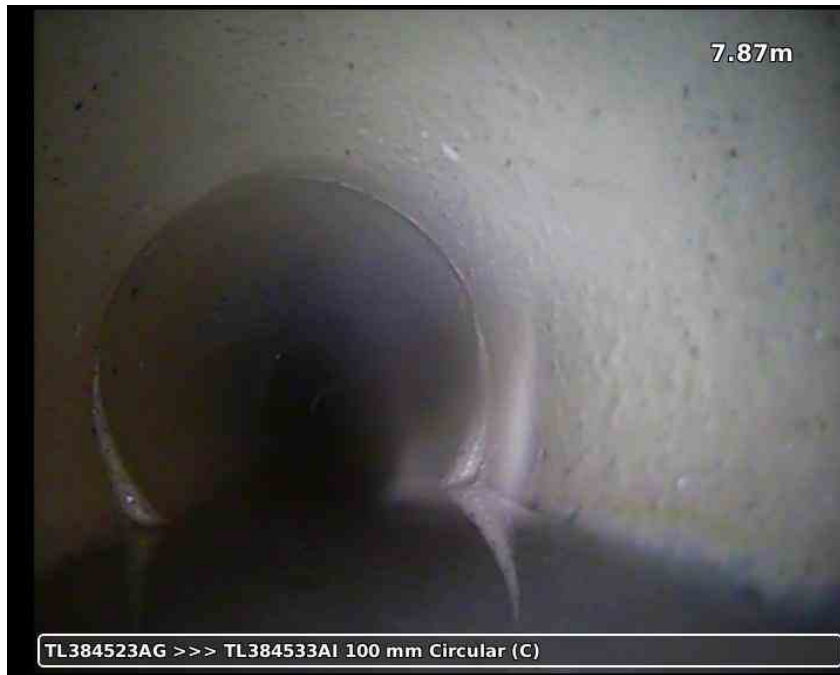
Section 26, Fine settled deposits (silt) from 0.65m to 2.13m, Longitudinal & spiral fracture at 2.28, circumferential fracture at 6.08m, medium displaced joint at 7.87, circumferential fracture at 10.91 with fine roots entering through the fracture, fine roots at 17.86m, 20% root mass at 18.05m, circumferential crack at 18.43m, Fine settled deposits (silt) from 18.43m to 20.41m, Fine settled deposits (silt) at 24.21m to 25.92m, Fine settled deposits (silt) at 26.41m to 29.15m, Fine settled deposits (silt) 20% at 29.15m to 30.51m. This run also has a liner installed from 18.66m to 30.51m.

20210617-185600-snap0012.jpg, 00:02:36, 7.87 m
Joint displaced, medium

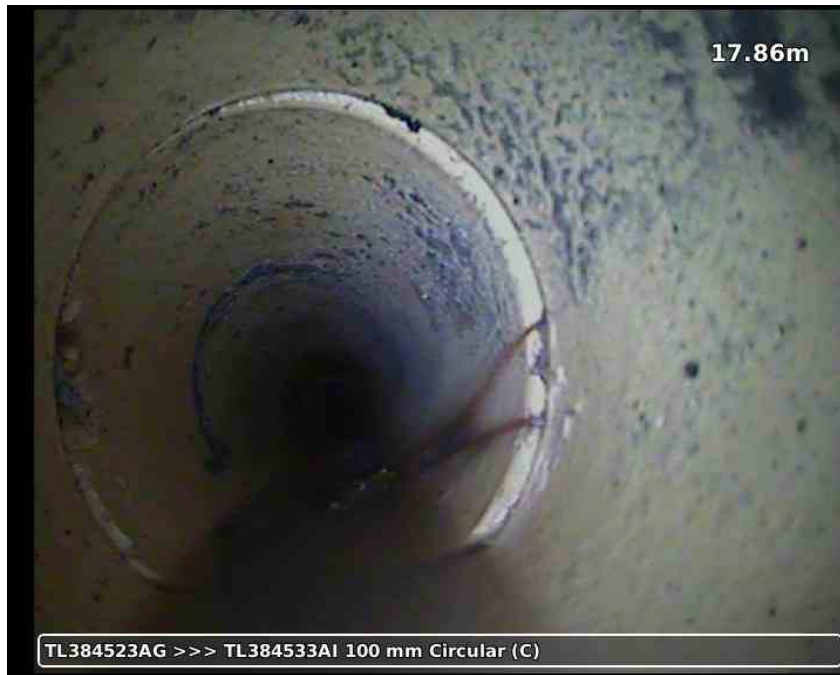
20210617-185600-snap0020.jpg, 00:04:16, 17.86 m
Roots, fine at joint

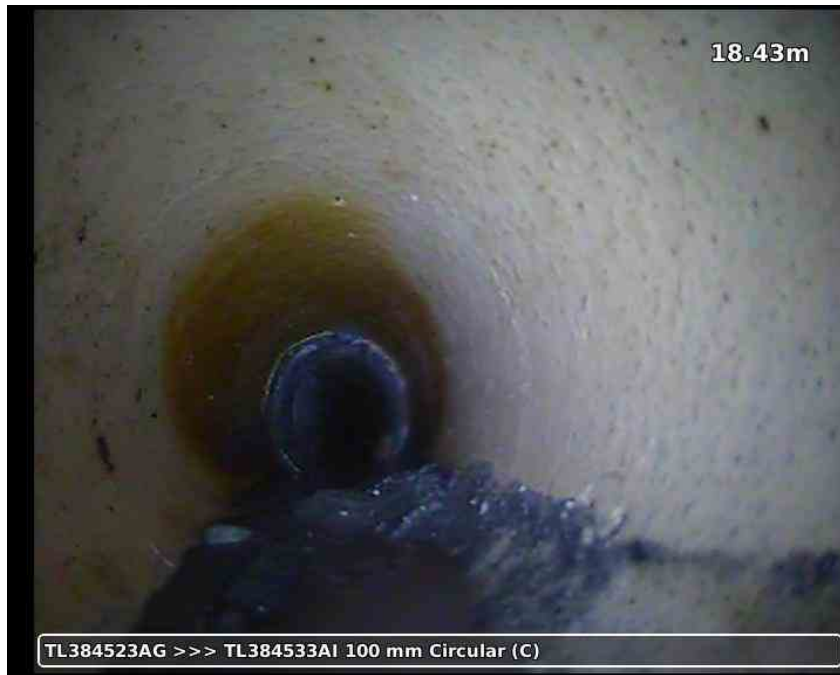
20210617-185600-snap0024.jpg, 00:04:45, 18.43 m
Settled deposits, fine, 10% % cross-sectional area loss, S02

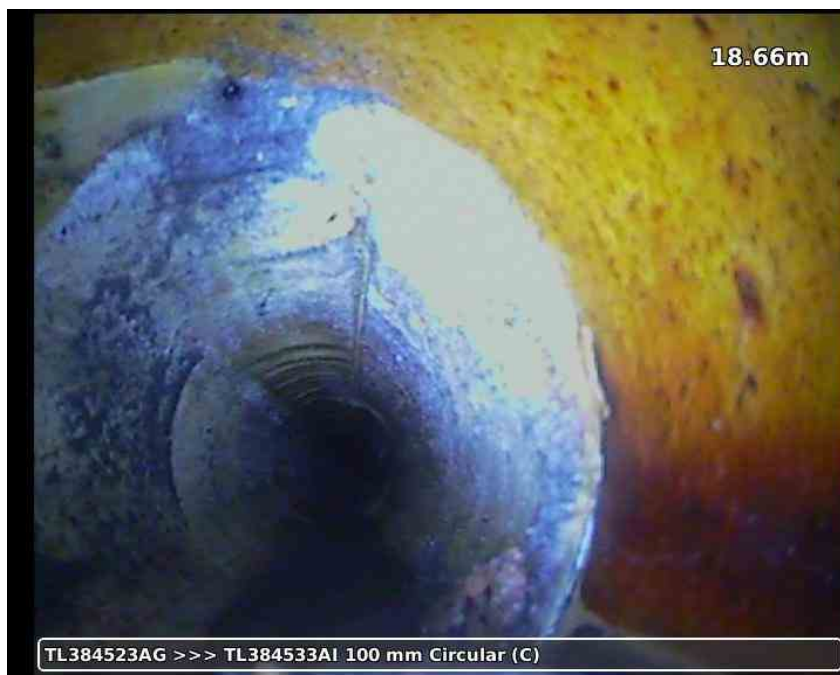
20210617-185600-snap0025.jpg, 00:04:58, 18.66 m
Lining of drain or sewer with cured-in-place lining changes to polyester at this point

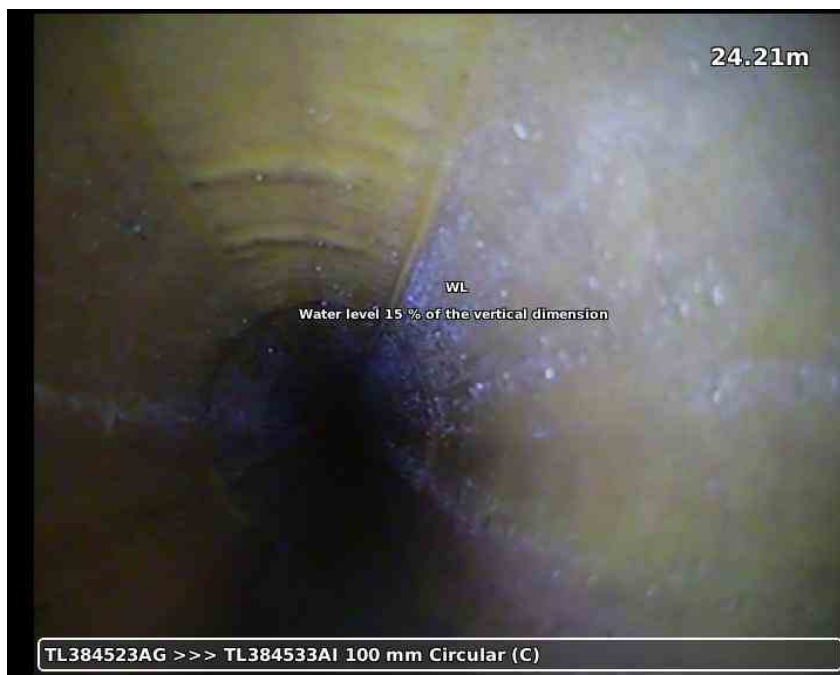
20210617-185600-snap0027.jpg, 00:05:54, 24.21 m
Settled deposits, fine, 10% % cross-sectional area loss, S03

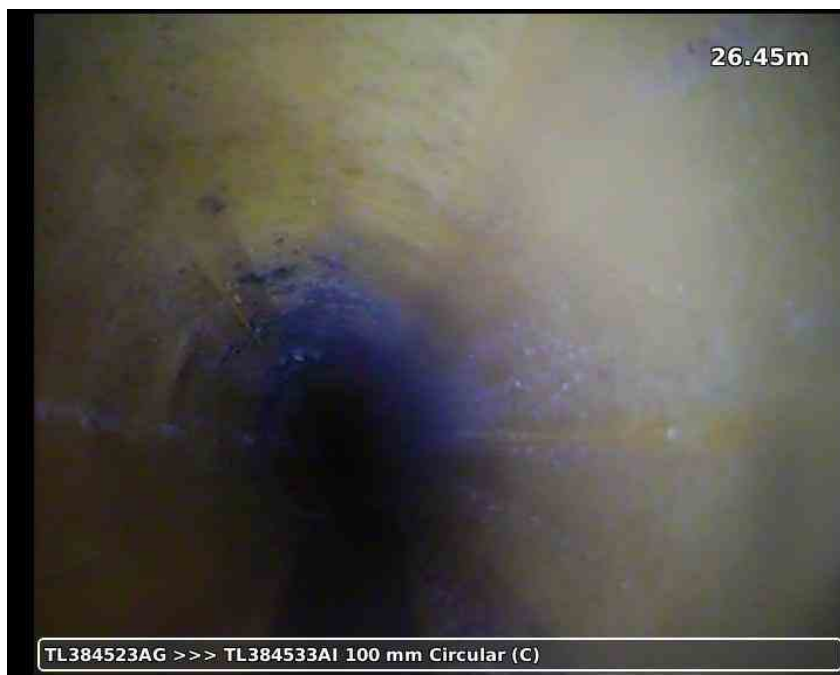
20210617-185600-snap0029.jpg, 00:06:26, 26.41 m
Settled deposits, fine, 5% % cross-sectional area loss, S04

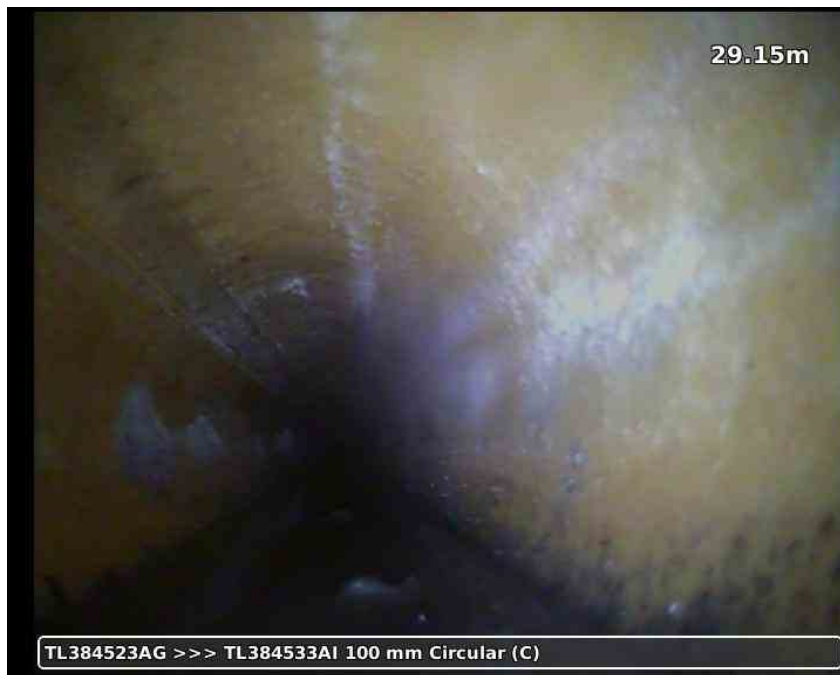
20210617-185600-snap0031.jpg, 00:06:58, 29.15 m
Settled deposits, fine, 20% % cross-sectional area loss, S05

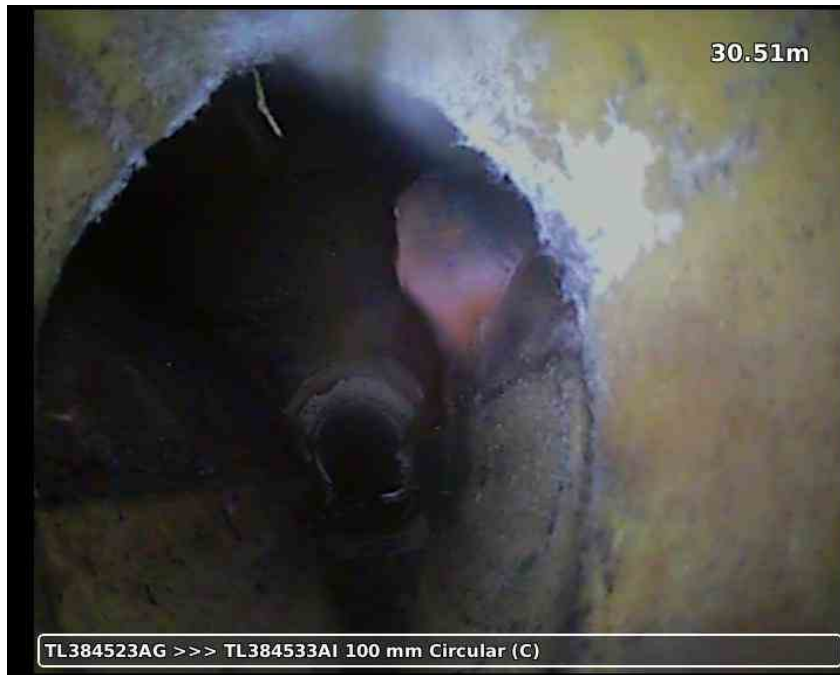
20210617-185600-snap0032.jpg, 00:07:27, 30.51 m
Cured-in-place lining ends at this point

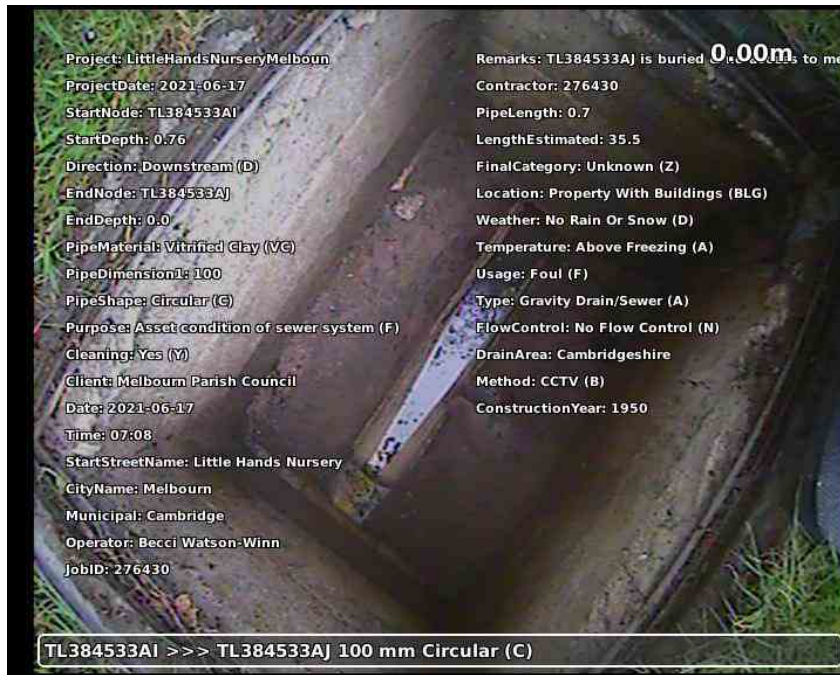
20210617-191337-snap0000.jpg, 00:00:01, 0.00 m
 Start node type, manhole, reference number: TL384533AI

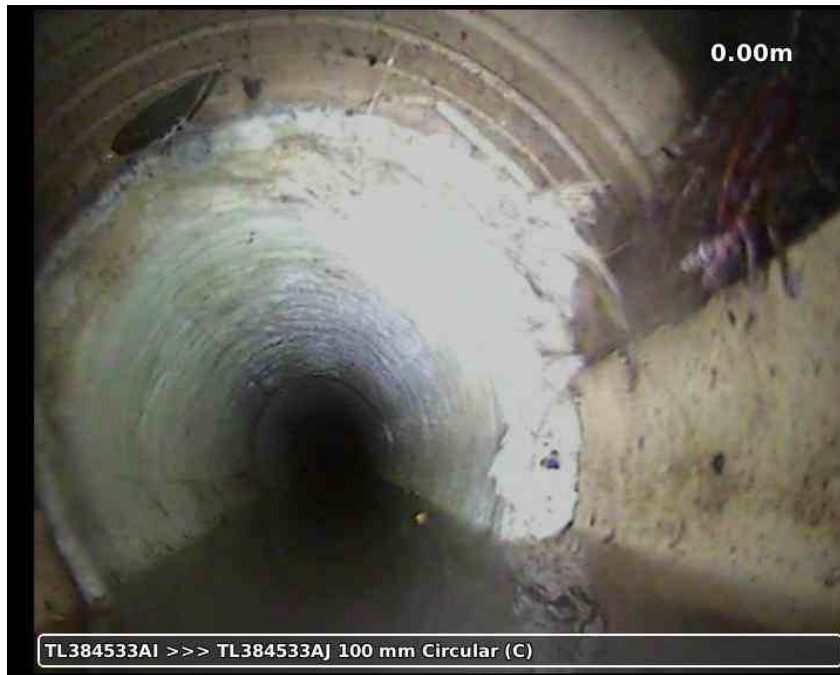
20210617-191337-snap0002.jpg, 00:00:19, 0.00 m
Lining of drain or sewer with cured-in-place lining changes to epoxy at this point

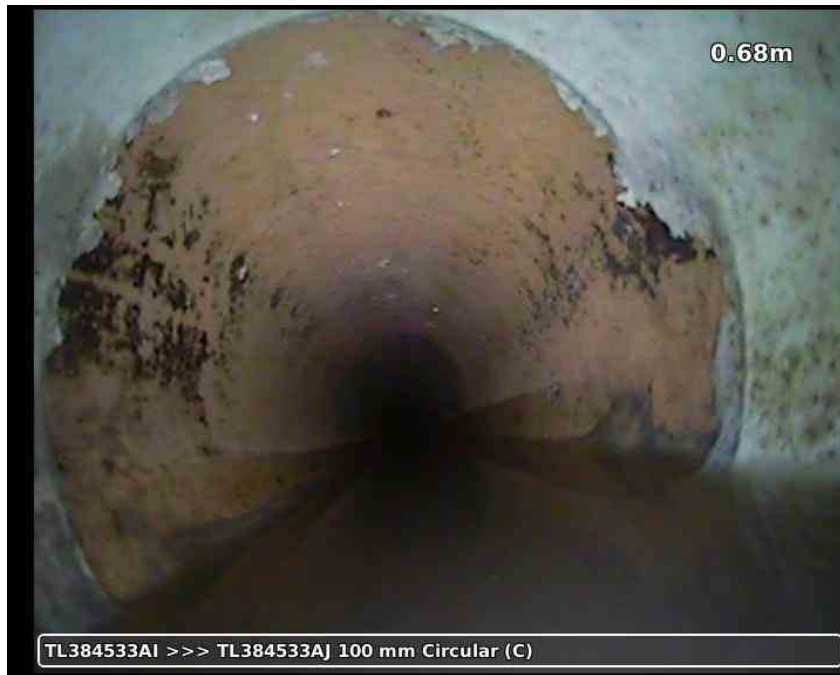
20210617-191337-snap0004.jpg, 00:00:56, 0.68 m
Cured-in-place lining ends at this point

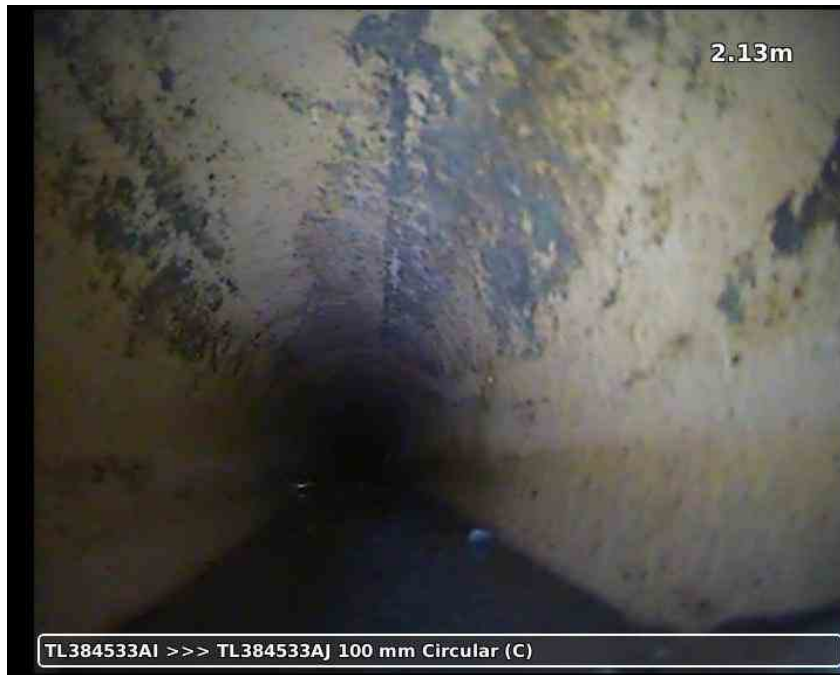
20210617-191337-snap0006.jpg, 00:01:20, 2.13 m
Settled deposits, fine, 10% % cross-sectional area loss, S01

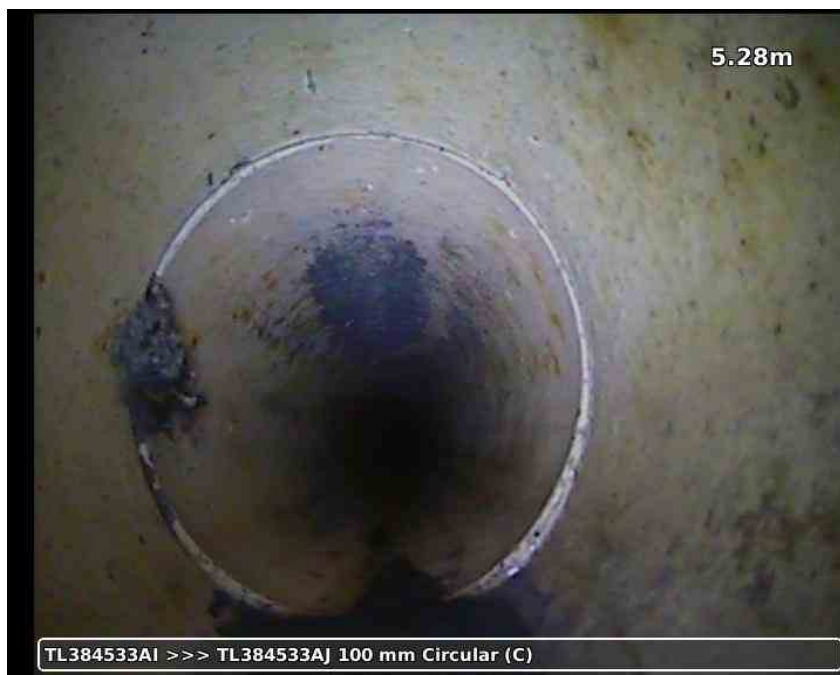
20210617-191337-snap0007.jpg, 00:01:58, 5.28 m
Roots, mass at joint, 5% % cross-sectional area loss

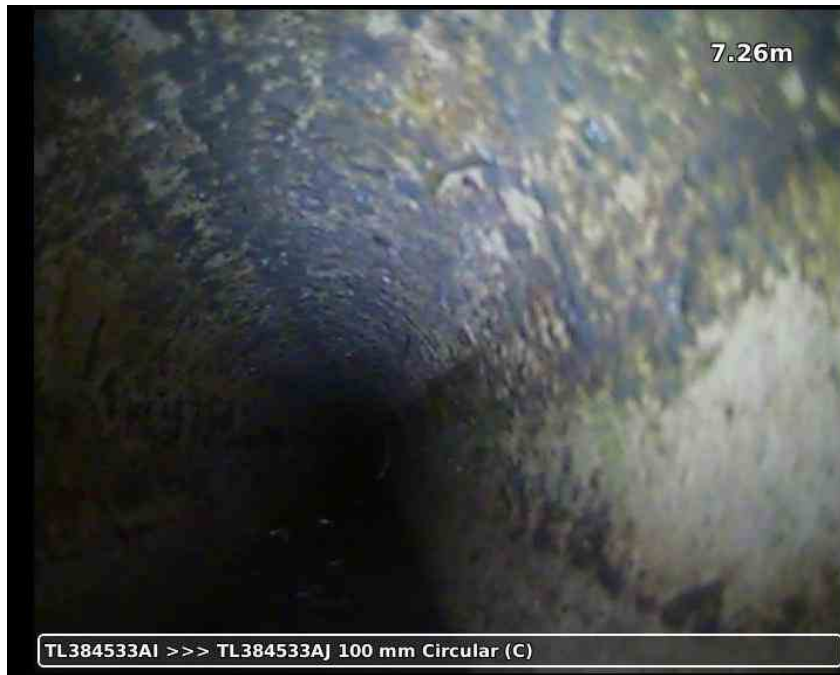
20210617-191337-snap0010.jpg, 00:02:38, 7.26 m
Attached deposits, fouling, from 07 to 05 o'clock, 5% % cross-sectional area loss, S02

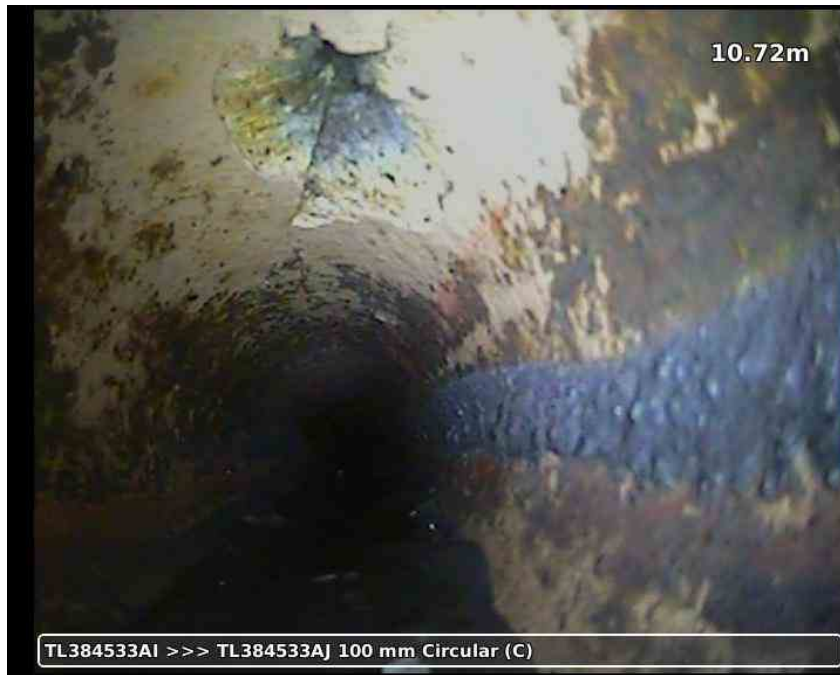
Section	PLR	Grade	Description
16	UNKNOWN01X	3	Fracture, circumferential, from 03 to 11 o'clock
17	CAPPED04X	4	Fracture spiral, from 12 to 11 o'clock
26	TL384523AGX	4	Fracture spiral, from 12 to 11 o'clock
27	TL384533AIX	4	Hole in drain or sewer, from 11 to 01 o'clock

20210617-191337-snap0012.jpg, 00:03:34, 10.72 m
Hole in drain or sewer, from 11 to 01 o'clock

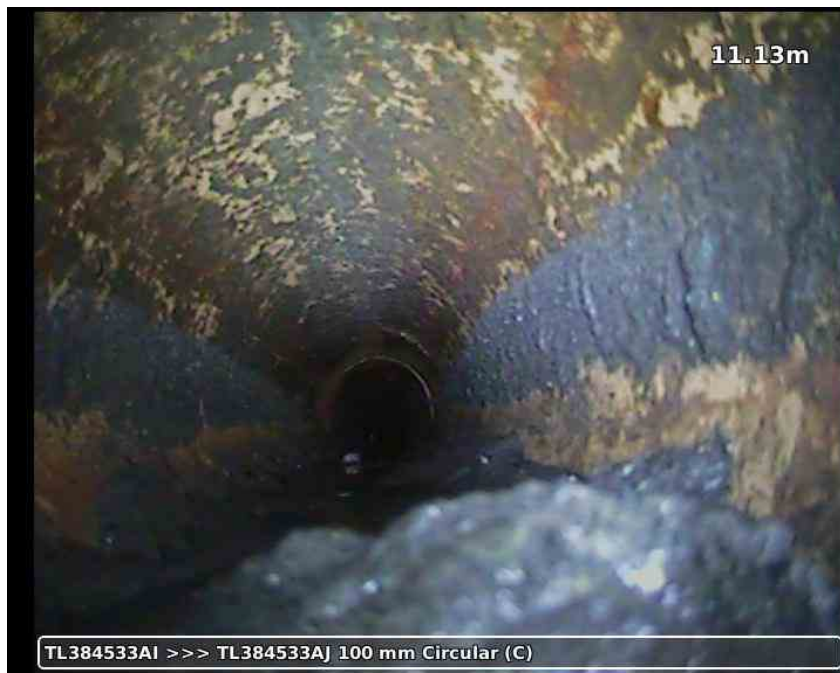
20210617-191337-snap0013.jpg, 00:03:52, 11.13 m
Settled deposits, fine, 20% % cross-sectional area loss, S03

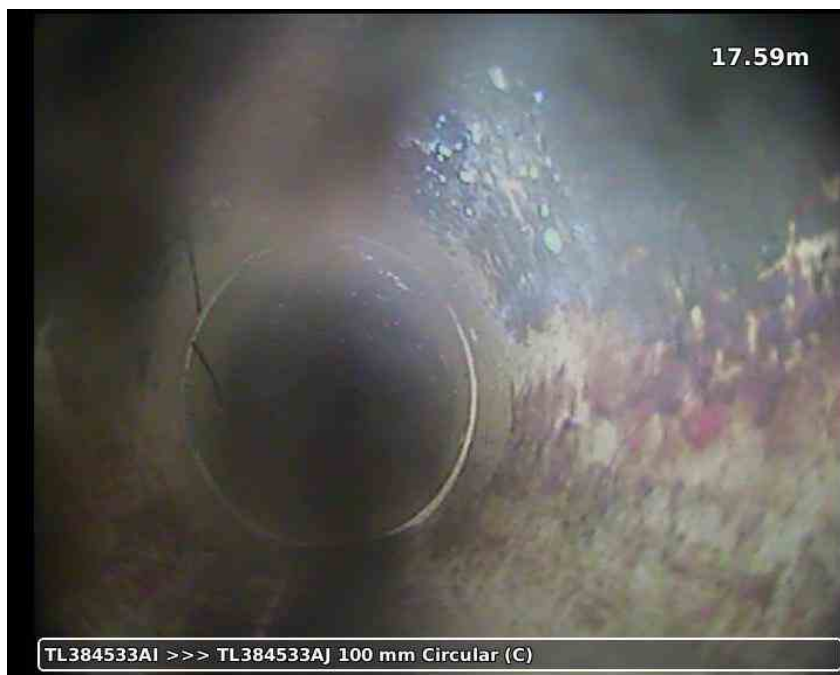
20210617-191337-snap0015.jpg, 00:05:00, 17.59 m
Roots, fine at joint

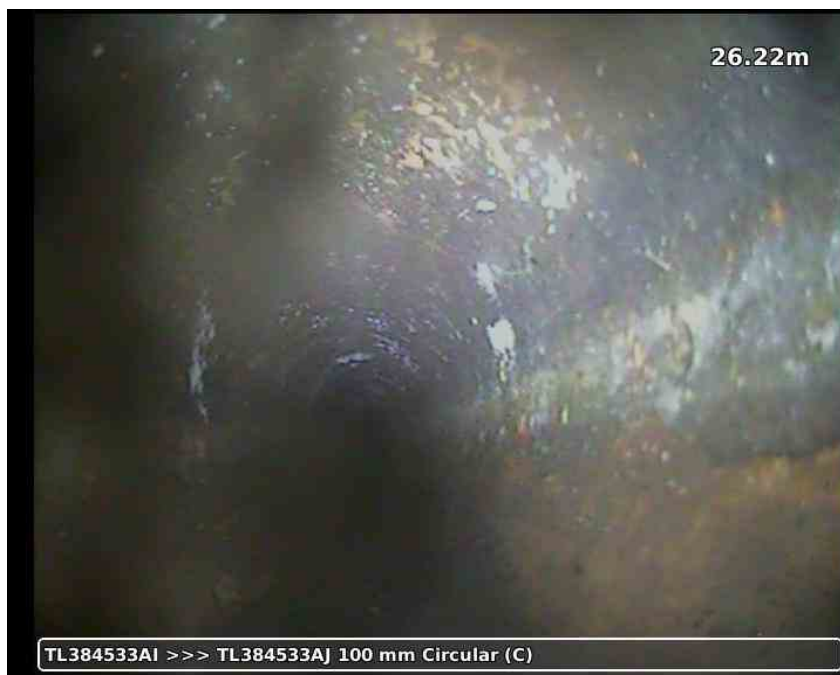
20210617-191337-snap0019.jpg, 00:06:24, 26.22 m
Settled deposits, fine, 10% % cross-sectional area loss, S05

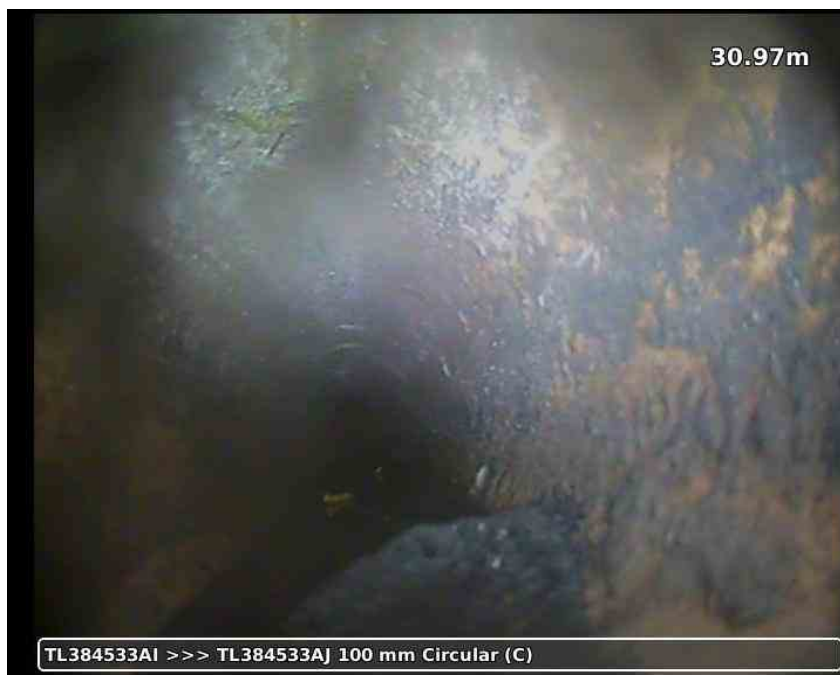
20210617-191337-snap0021.jpg, 00:07:19, 30.97 m
Settled deposits, fine, 10% % cross-sectional area loss, S06

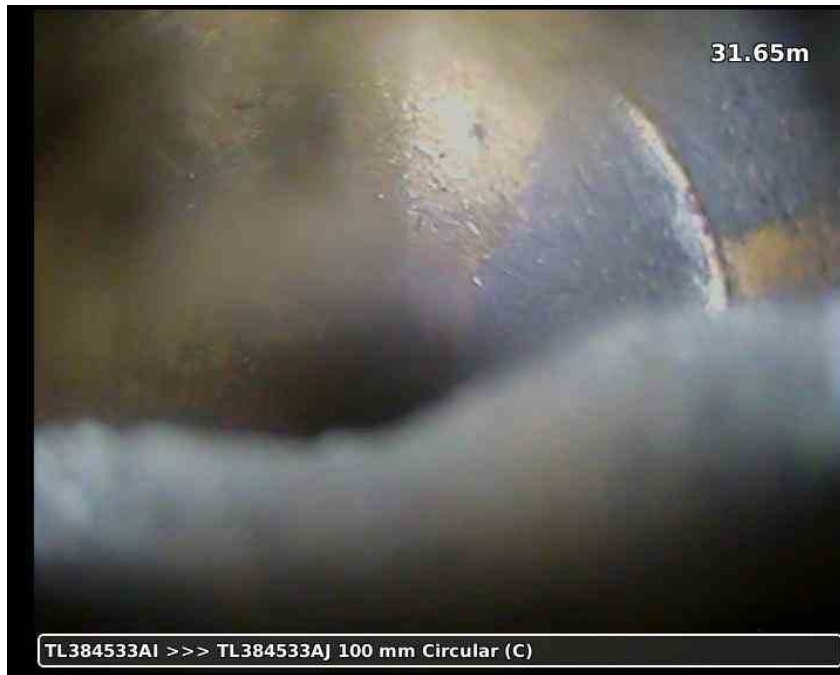
20210617-191337-snap0022.jpg, 00:07:42, 31.65 m
Settled deposits, fine, 30% % cross-sectional area loss

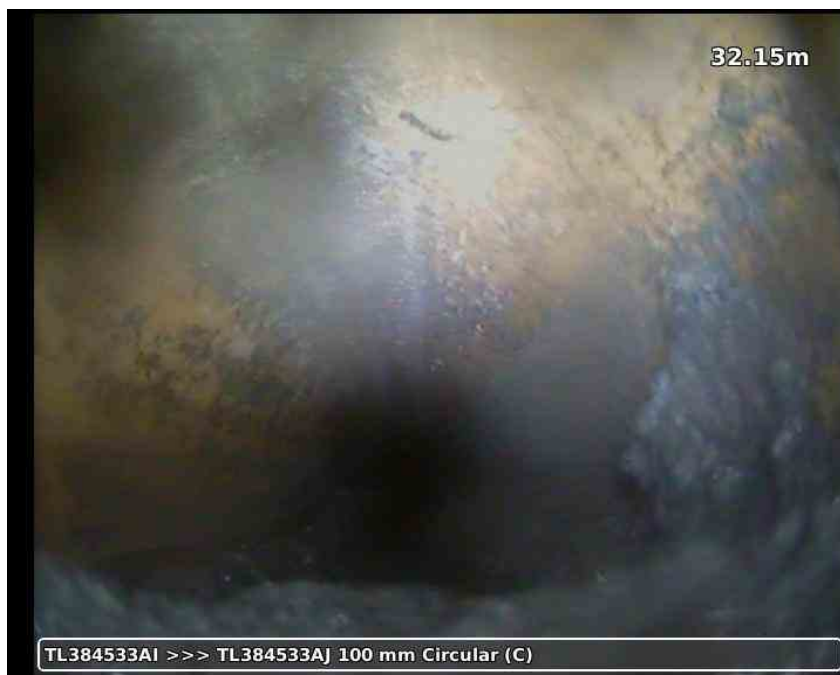
20210617-191337-snap0023.jpg, 00:07:53, 32.15 m
Settled deposits, fine, 20% % cross-sectional area loss, S07

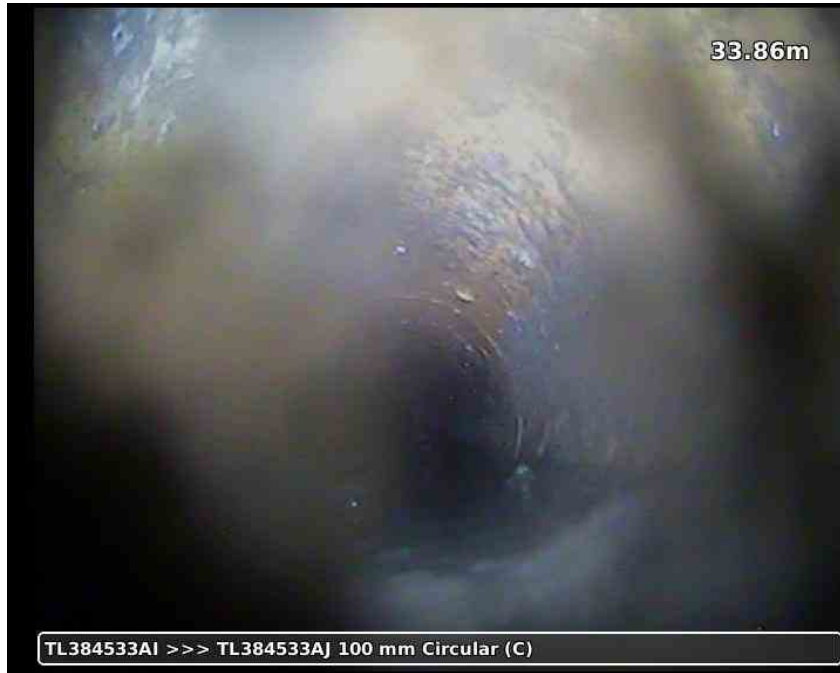
20210617-191337-snap0024.jpg, 00:08:16, 33.86 m
Settled deposits, fine, 30% % cross-sectional area loss, S08

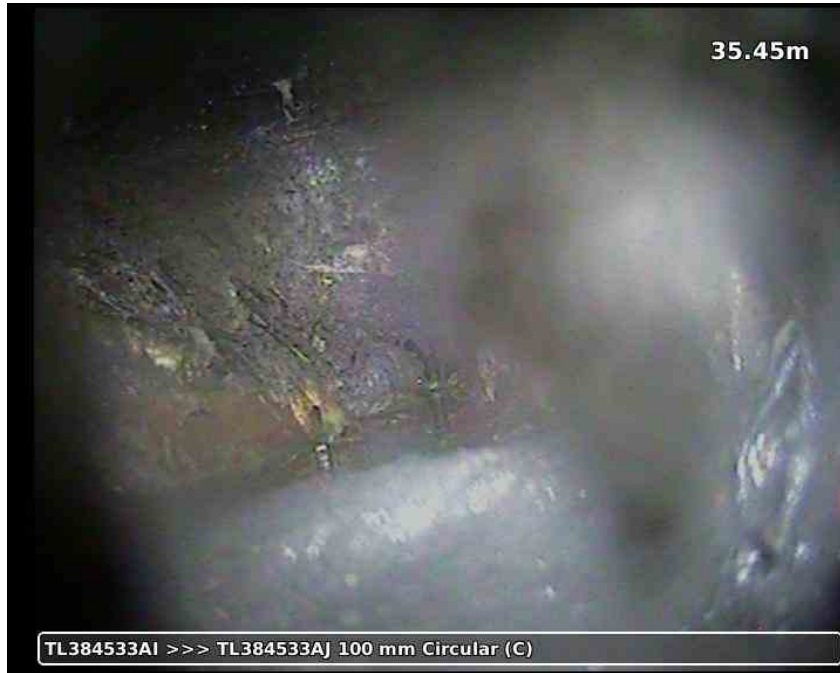
20210617-191337-snap0026.jpg, 00:08:48, 35.45 m
Finish node type, manhole, reference number: TL384533AJ, HIDDEN CHAMBER
