MELBOURN PARISH COUNCIL - MAINTENANCE COMMITTEE
(District of South Cambridgeshire)

A meeting of the Maintenance Committee held on Thursday 17 August at 09:30
in the Austen Room, Community Hub, 30 High Street, Melbourn SG8 6DZ

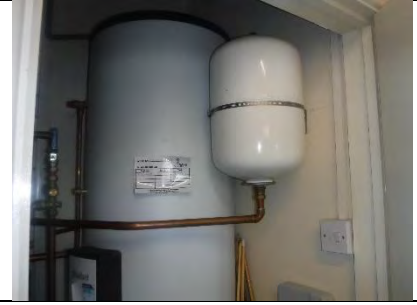
**CYLINDER 1 EXPANSION VESSEL FIT
FLUSHING VALVE**

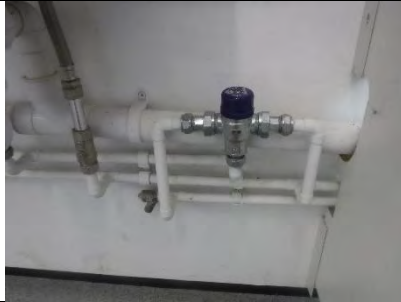
**INSULATE MAINS PIPE WORK
TMVS SERVICED 12/22**

<p>RS.13a - Install suitably approved insulation to the domestic mains cold water pipework throughout the building.</p>	<p>P1</p>	
<p>RISK EVALUATION WITH ADDITIONAL CONTROL COMPLETE</p>	<p>A</p>

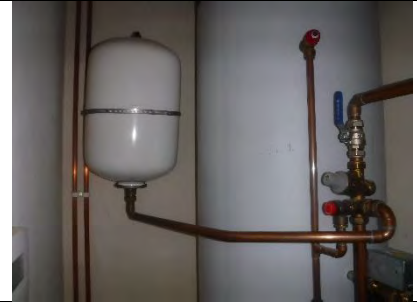
**CYLINDER 2 EXPANSION VESSEL FIT
FLUSHING VALVE
FAULTY EXPANSION VESSEL**

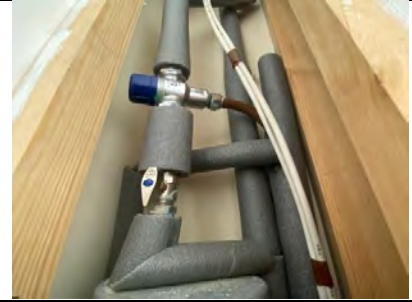
CENTRALISED TMV BEHIND THE PANEL IN DISABLED W/C

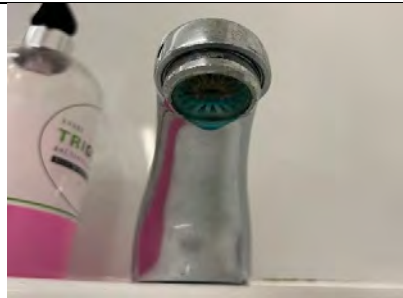
SLIGHT SCALE PRESENT ON OUTLETS

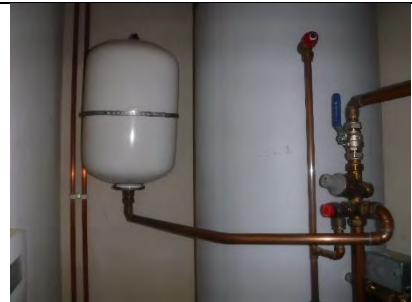
**HWSV 02
FAULTY EXPANSION VESSEL**
