the **play inspection** company

Annual Inspection

Melbourn Parish Council

The Moor Play Area

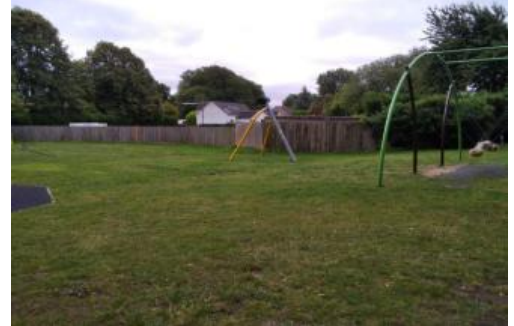
Item: Site General
Manufacturer: Owner/Operator
Surface Type: N/A
Item Quantity: 1
Equipment Compliance: N/A
Surface Area Compliance: N/A

This item is satisfactory - no work required -

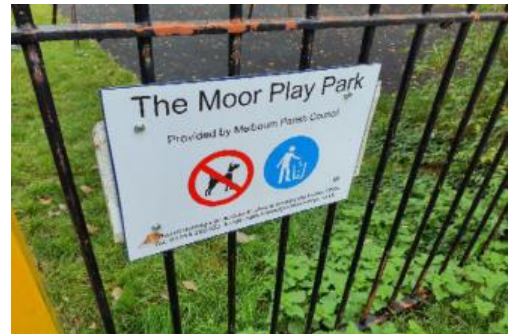
Item: Playground Sign
Manufacturer: Owner/Operator
Surface Type: N/A
Item Quantity: 9
Equipment Compliance: N/A
Surface Area Compliance: N/A

This item is satisfactory - no work required -

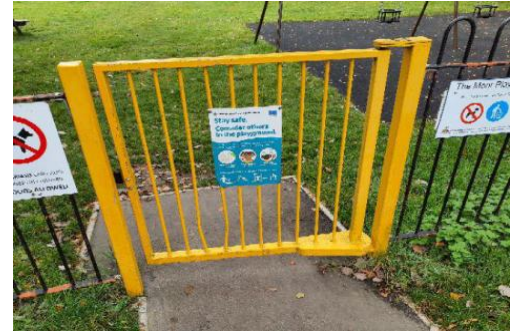
Item: Gate - Self Closing
Manufacturer: I.A.E. Fencing
Surface Type: Tarmac
Item Quantity: 1
Equipment Compliance: N/A
Surface Area Compliance: N/A

There is some damage to the item - Monitor for any further deterioration and repair as required

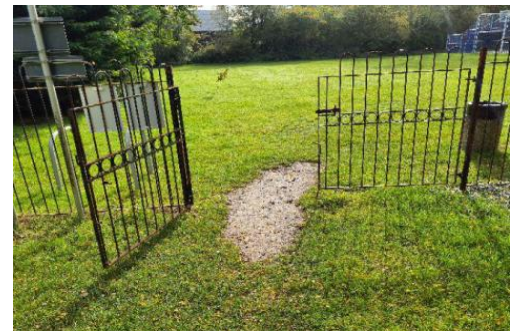
Item: Gate - Maintenance
Manufacturer: Not Identified
Surface Type: Grass
Item Quantity: 1
Equipment Compliance: N/A
Surface Area Compliance: N/A

The surface has eroded in some areas and may be slippery in wet conditions - Reinstate the surface

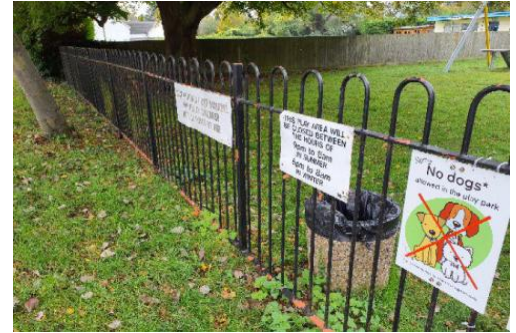
Item: Fence - Bow Top
Manufacturer: Not Identified
Surface Type: Grass
Item Quantity: 1
Equipment Compliance: N/A
Surface Area Compliance: N/A

The paint is flaking off the metalwork - Rub down and re-paint

The fence is damaged in places - Repair or replace all affected sections

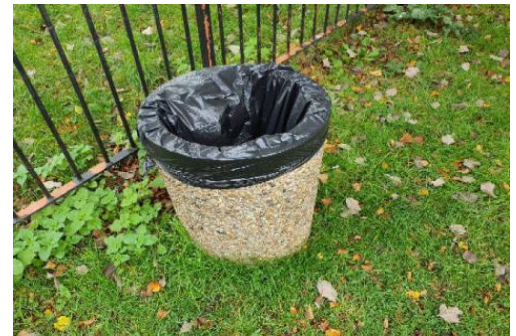
Item: Litter Bin
Manufacturer: Not Identified
Surface Type: Grass
Item Quantity: 3
Equipment Compliance: N/A
Surface Area Compliance: N/A

The liner of the litter bin is not secured - Ensure the lid/door is kept locked and the liner secured

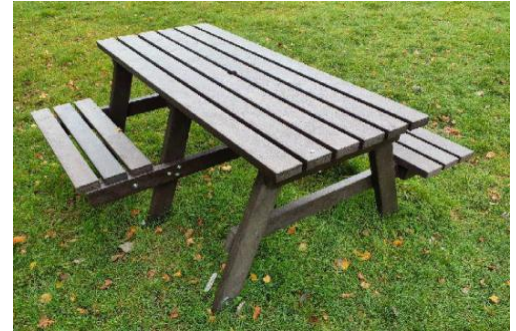
Item: Picnic Table
Manufacturer: Not Identified
Surface Type: Grass
Item Quantity: 2
Equipment Compliance: N/A
Surface Area Compliance: N/A

There is some evidence of fire damage to the item - Monitor for any further deterioration and repair as required

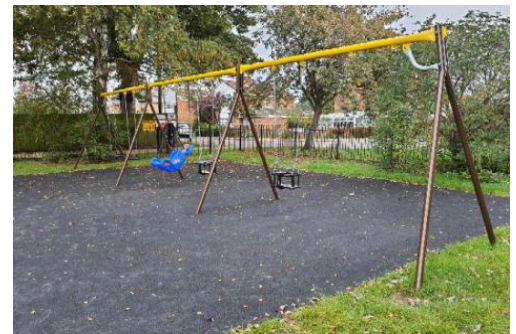
Item: 3 Bay Swing
Manufacturer: Hags
Surface Type: Wet Pour
Item Quantity: 1
Equipment Compliance: Yes
Surface Area Compliance: Yes

The seat(s) and suspension were missing at the time of inspection and the inspector was unable to make a full compliance assessment - Replace missing seat(s) and suspension

There is some notable evidence of chain wear - Monitor for any further deterioration and replace when 40% worn

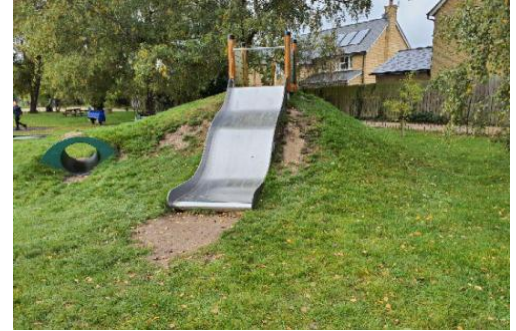
Item: Embankment Slide
Manufacturer: Hags
Surface Type: Grass
Item Quantity: 1
Equipment Compliance: Yes
Surface Area Compliance: Yes

The surface has eroded in some areas and may be slippery in wet conditions - Reinstate the surface

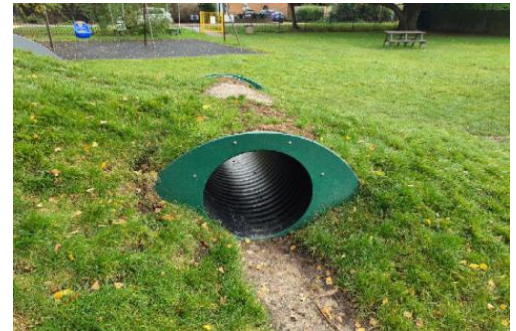
Item: Tunnel Mound
Manufacturer: Hags
Surface Type: Grass
Item Quantity: 1
Equipment Compliance: No
Surface Area Compliance: Yes

The surface has eroded in some areas and may be slippery in wet conditions - Reinstate the surface

This design / configuration of tunnel mound is well established and has been successfully included in large quantities of playgrounds throughout the UK. Whilst the design does not fully meet the requirements of BS EN 1176 with regards to falls in excess of 600mm over the edge of the tunnel to the surface below, it has been risk assessed as fit for purpose in this regard and no changes are recommended to the design unless otherwise stated in additional findings - Monitor - No remedial work recommended

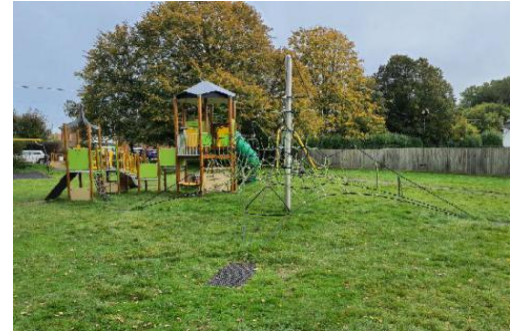
Item: Multi Play (Junior)
Manufacturer: Hags
Surface Type: Grass Matrix Tiles
Item Quantity: 1
Equipment Compliance: No
Surface Area Compliance: Yes

There are falls in excess of 600mm between adjacent components on the structure, in contravention of the recommendations set out in BS EN 1176 Part 1; 4.2.8.4 - Monitor - No remedial work recommended

The item fails to meet the requirements of BS EN 1176 Part 1 4.2.7.2 head and neck entrapment in the barriers and/or steps - Monitor - No remedial work recommended

The grass mats are silted up and the soil is compacted; this may have an effect on the impact absorbing properties of the surface - Consider HIC testing impact absorbing properties to ensure the correct surface qualities are maintained for the equipment and replace as required

The item has been taped and we are unable to fully assess the condition of the item - Repair or replace as required

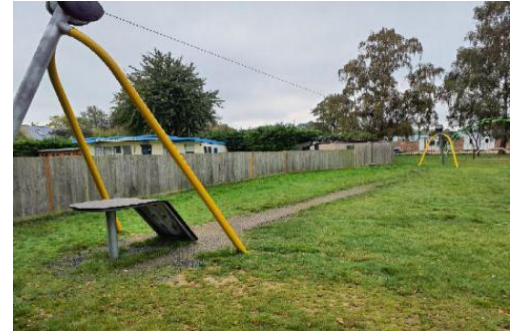
Item: Cable Runway
Manufacturer: Hags
Surface Type: Grass Matrix Tiles
Item Quantity: 1
Equipment Compliance: Yes
Surface Area Compliance: Yes

We have completed a visual inspection of the suspension links, cable and fixing points from ground level, however it is not possible to fully inspect these areas without either hiring equipment to gain access or removing the cable and suspension and inspecting at ground level. We recommend that the main cable and fixing security is thoroughly inspected at least in accordance with the manufacturers recommendations to check for wear, damage, security or internal rusting; this will help to ensure the continued safe use of the equipment - Inspect in accordance with the manufacturers recommendations

The seat connection cannot be inspected without dismantling the seat - Dismantle the seat to inspect the seat connection for wear

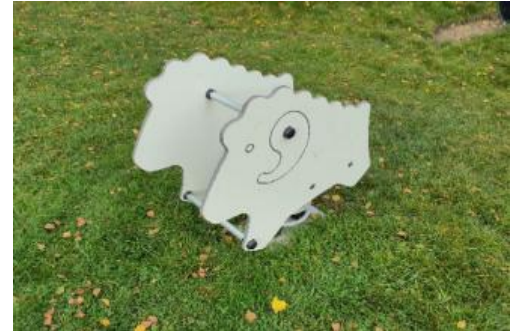
Item: Spring Sheep
Manufacturer: Hags
Surface Type: Grass Matrix Tiles
Item Quantity: 1
Equipment Compliance: Yes
Surface Area Compliance: Yes

This item is satisfactory - no work required -
