Operational Inspection

Melbourn Parish Council

The Moor Play Area
The Moor, Royston, Cambridgeshire, SG8 6ED

Inspection Ref: 2256362

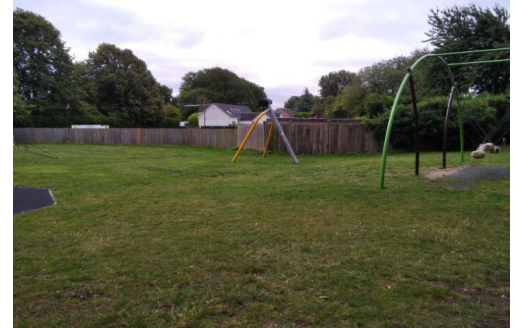
Item: Site General
Manufacturer: Owner/Operator
Surface Type: N/A
Item Quantity: 1
Equipment Compliance: N/A
Surface Area Compliance: N/A

The tree canopy overhangs the equipment and is less than 2.0m away - Lift tree canopy to ensure a minimum clearance of 2.0m from the equipment

There is some tree debris on the surfacing - Remove and maintain

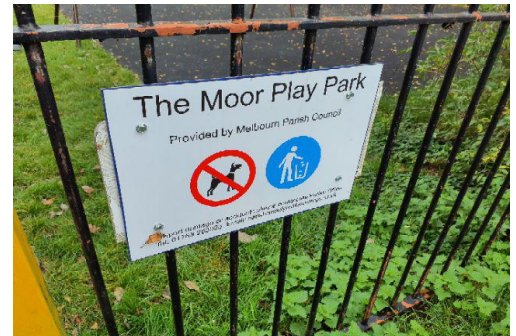
Item: Playground Sign
Manufacturer: Owner/Operator
Surface Type: N/A
Item Quantity: 9
Equipment Compliance: N/A
Surface Area Compliance: N/A

The item has been damaged - Monitor for any further deterioration and replace as required

The item has been severely damaged leaving sharp edges to remaining fixings - Replace item

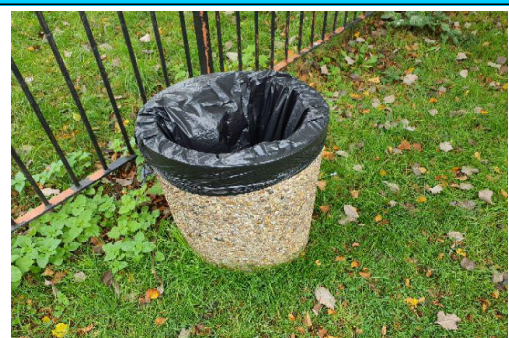
Item: Litter Bin
Manufacturer: Not Identified
Surface Type: Grass
Item Quantity: 3
Equipment Compliance: N/A
Surface Area Compliance: N/A

This item is satisfactory - no work required -

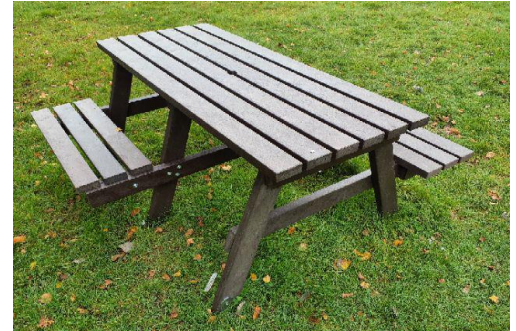
Item: Picnic Table
Manufacturer: Not Identified
Surface Type: Grass
Item Quantity: 2
Equipment Compliance: N/A
Surface Area Compliance: N/A

There is some evidence of fire damage to the item - Monitor for any further deterioration and repair as required

There is some graffiti present - Remove the graffiti

There is excrement on site - Clean and maintain area

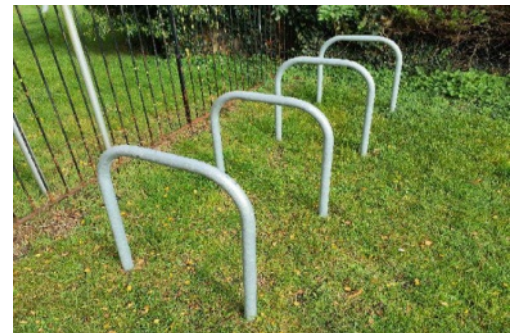
Item: Cycle Rack
Manufacturer: Not Identified
Surface Type: Grass
Item Quantity: 1
Equipment Compliance: N/A
Surface Area Compliance: N/A

This item is satisfactory - no work required -

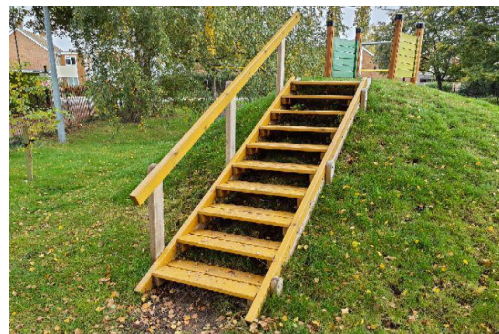
Item: Steps
Manufacturer: Hags
Surface Type: Grass
Item Quantity: 1
Equipment Compliance: N/A
Surface Area Compliance: N/A

The tree canopy overhangs the equipment and is less than 2.0m away - Lift tree canopy to ensure a minimum clearance of 2.0m from the equipment

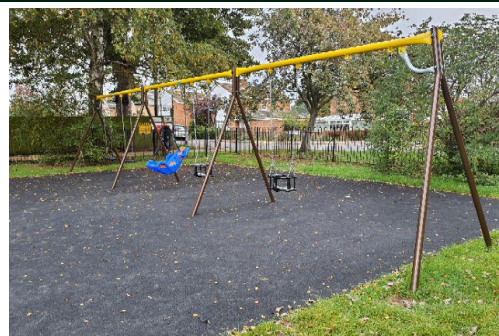
Item: 3 Bay Swing
Manufacturer: Hags
Surface Type: Wet Pour
Item Quantity: 1
Equipment Compliance: Yes
Surface Area Compliance: Yes

A number of fixing(s) have worked loose - Secure all loose fixings

There is some notable evidence of chain wear - Monitor for any further deterioration and replace when 40% worn

There is some tree debris on the surfacing - Remove and maintain

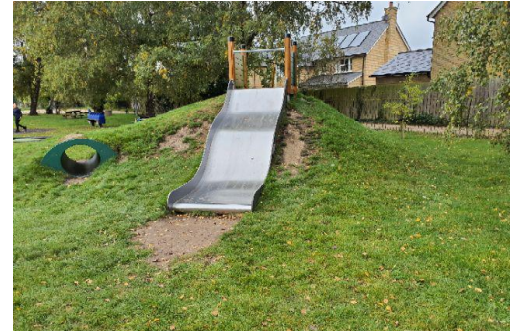
Item: Embankment Slide
Manufacturer: Hags
Surface Type: Grass
Item Quantity: 1
Equipment Compliance: Yes
Surface Area Compliance: Yes

The grass mats are silted up, the soil is compacted and the area will become very slippery when the soil is wet. -
Reinstate as required

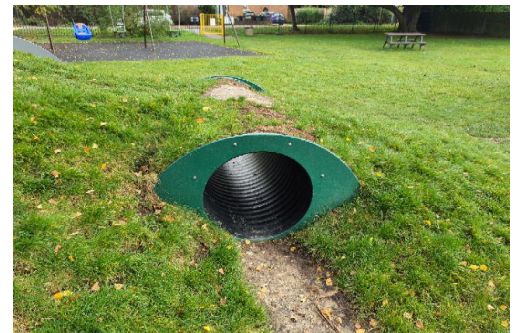
Item: Tunnel Mound
Manufacturer: Hags
Surface Type: Grass
Item Quantity: 1
Equipment Compliance: No
Surface Area Compliance: Yes

This item is satisfactory - no work required -

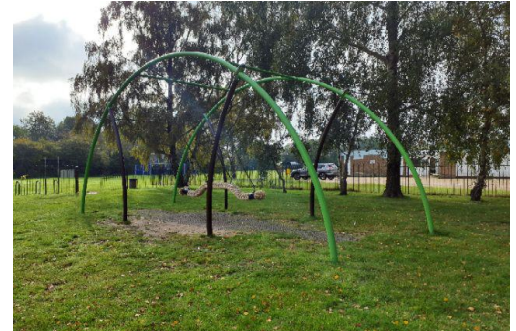
Item: Giant Rope Swing
Manufacturer: Hags
Surface Type: Grass Matrix Tiles
Item Quantity: 1
Equipment Compliance: Yes
Surface Area Compliance: Yes

There is some wear to the shackles x 4 quick links - Monitor for any further deterioration and replace when 40% worn

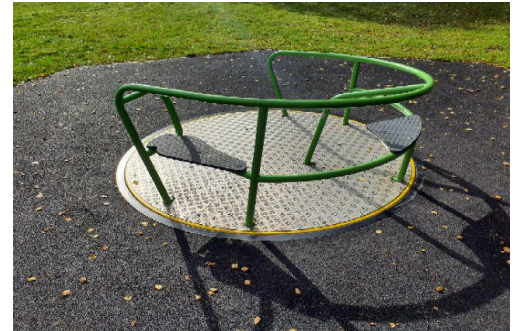
Item: Inclusive Roundabout
Manufacturer: Hags
Surface Type: Wet Pour
Item Quantity: 1
Equipment Compliance: Yes
Surface Area Compliance: Yes

Wet pour sinking at edge causing trip hazard 2 lm - Monitor repair

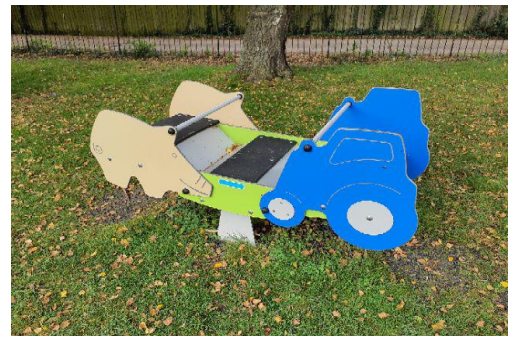
Item: See Saw
Manufacturer: Hags
Surface Type: Grass
Item Quantity: 1
Equipment Compliance: Yes
Surface Area Compliance: Yes

The grass mats are silted up, the soil is compacted and the area will become very slippery when the soil is wet. - Reinstate as required

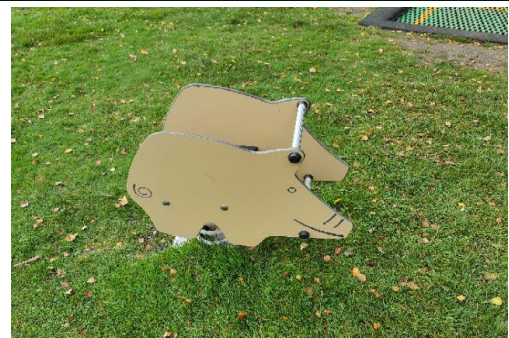
Item: Spring Pig
Manufacturer: Hags
Surface Type: Grass Matrix Tiles
Item Quantity: 1
Equipment Compliance: Yes
Surface Area Compliance: Yes

Finding 1
 The grass mats are silted up, the soil is compacted and the area will become very slippery when the soil is wet. - Reinstate as required

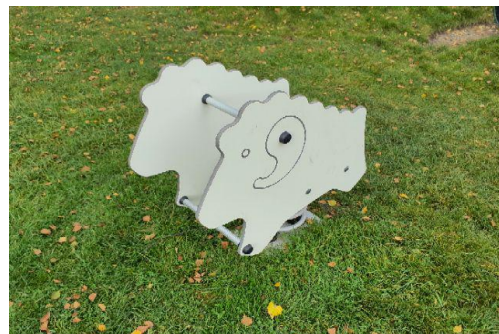
Item: Spring Sheep
Manufacturer: Hags
Surface Type: Grass Matrix Tiles
Item Quantity: 1
Equipment Compliance: Yes
Surface Area Compliance: Yes

The grass mats are silted up and the soil is compacted; this may have an effect on the impact absorbing properties of the surface - Consider HIC testing impact absorbing properties to ensure the correct surface qualities are maintained for the equipment and replace as required

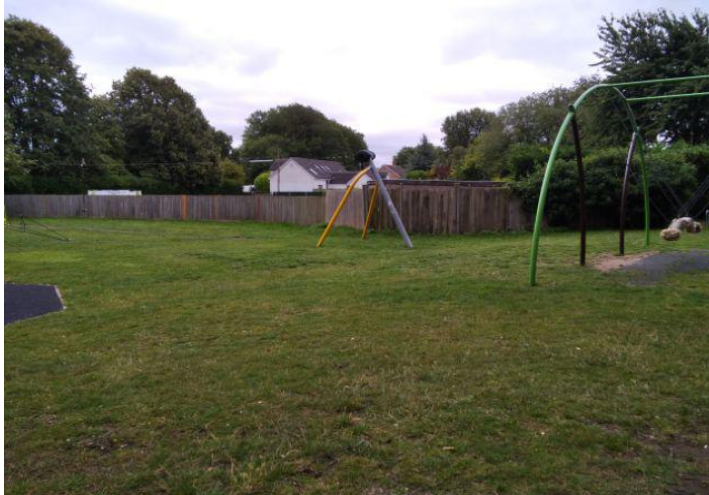
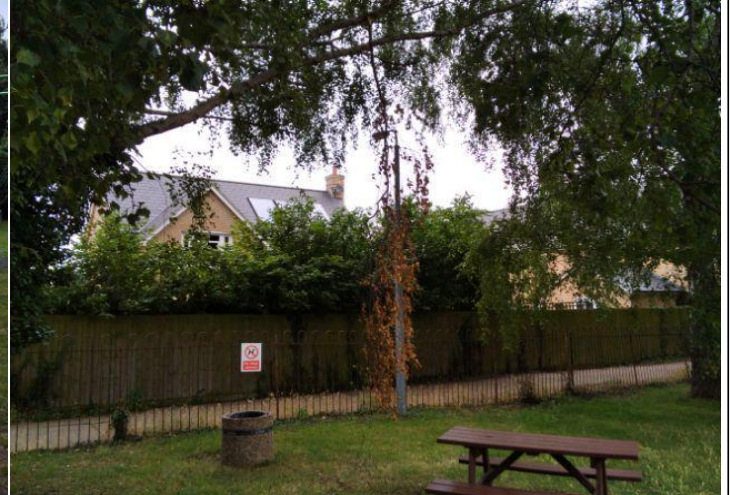
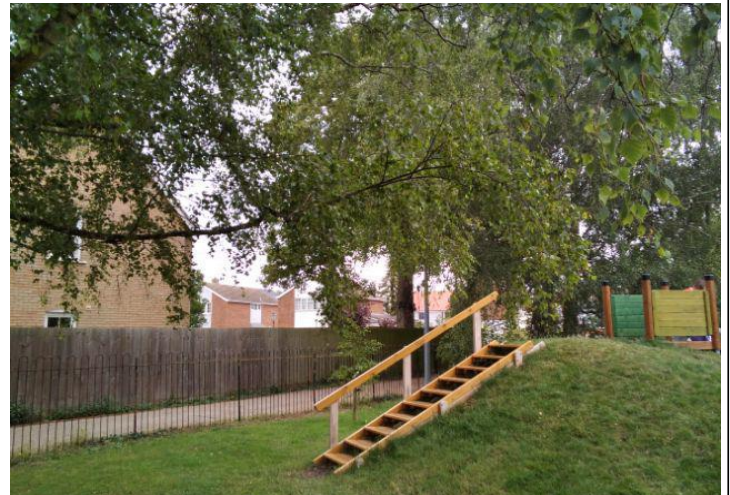
Item: Ancillary Items - Site General
Manufacturer: Owner/Operator

Finding: The tree canopy overhangs the equipment and is less than 2.0m away

Action: Lift tree canopy to ensure a minimum clearance of 2.0m from the equipment

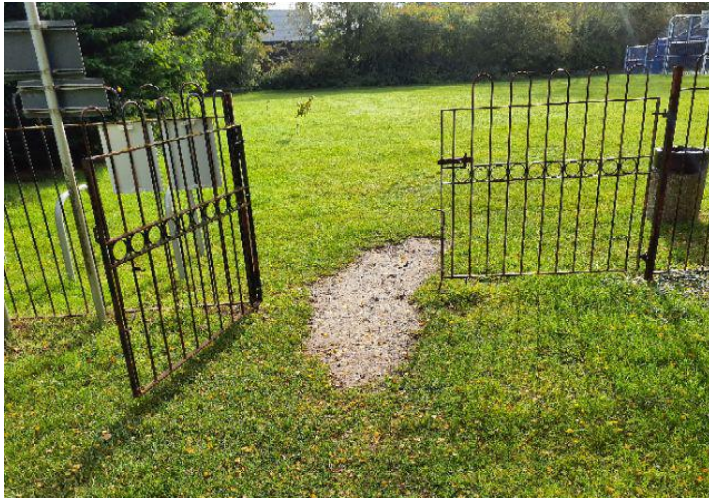
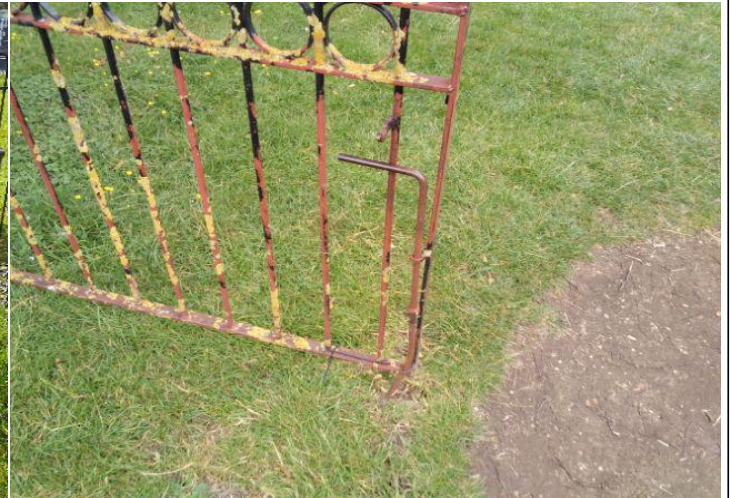
Item: Gates - Gate - Maintenance
Manufacturer: Not Identified

Finding: There is no padlock on the maintenance gate

Action: Provide a padlock to secure the gate

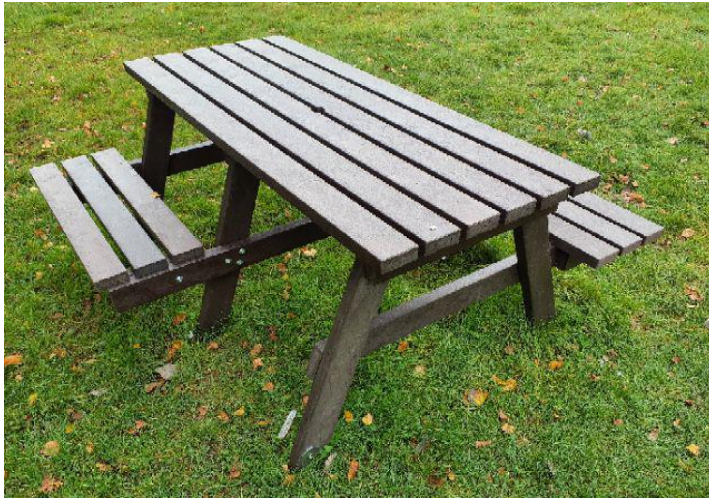
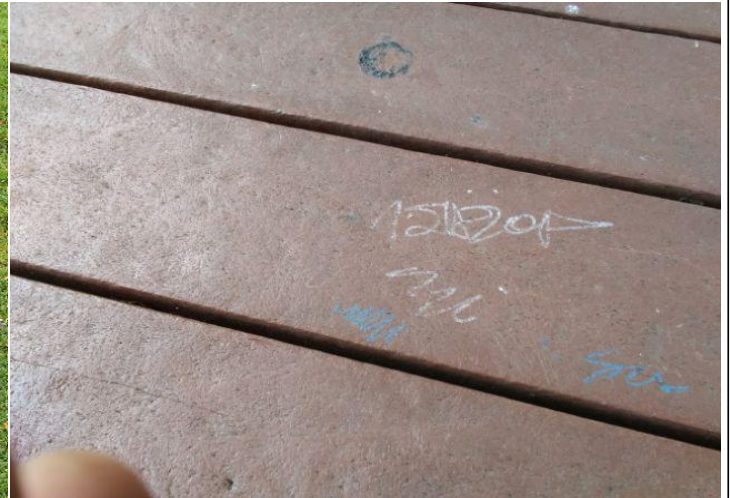
Item: Ancillary Items - Picnic Table
Manufacturer: Not Identified

Finding: There is some graffiti present

Action: Remove the graffiti

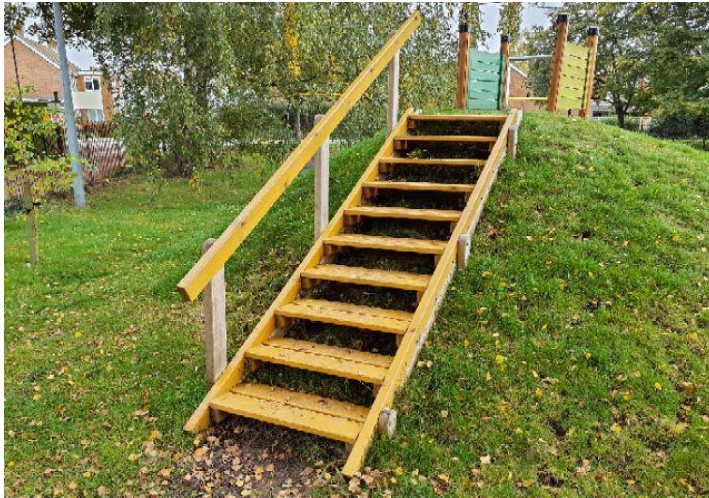
Item: Ancillary Items - Steps
Manufacturer: Hags

Finding: The tree canopy overhangs the equipment and is less than 2.0m away

Action: Lift tree canopy to ensure a minimum clearance of 2.0m from the equipment

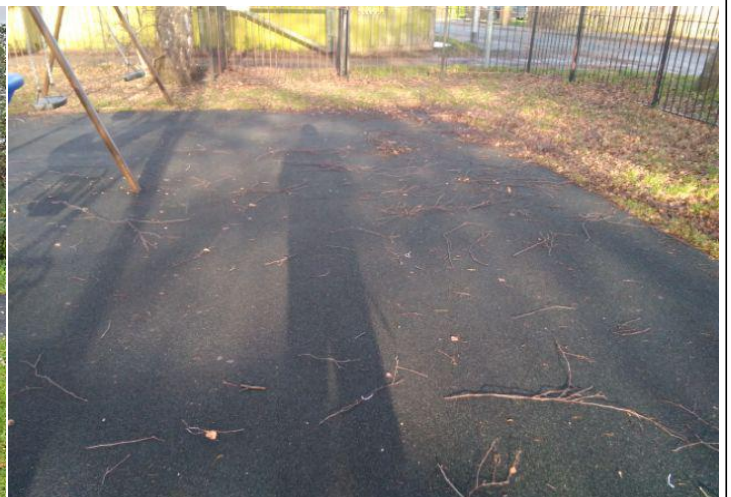
Item: Swings - 3 Bay Swing
Manufacturer: Hags

Finding: There is some tree debris on the surfacing

Action: Remove and maintain

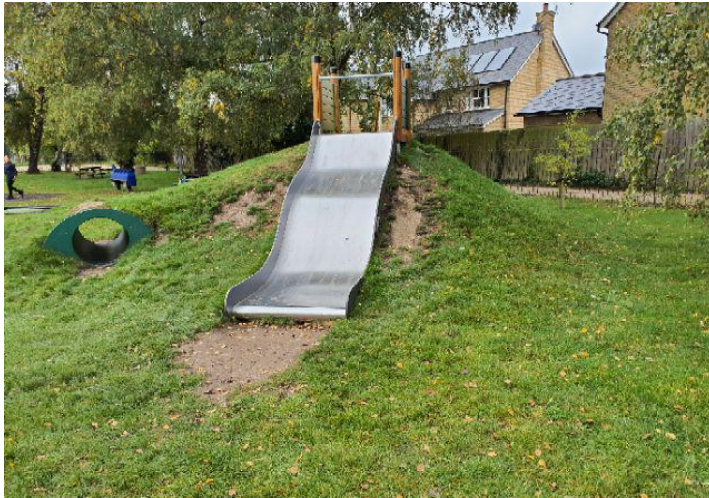
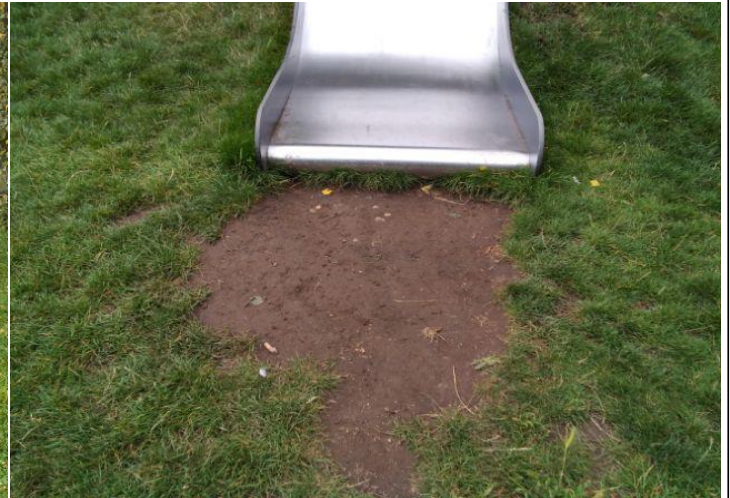
Item: Other - Embankment Slide
Manufacturer: Hags

Finding: The grass mats are silted up, the soil is compacted and the area will become very slippery when the soil is wet. **Action:** Reinstate as required

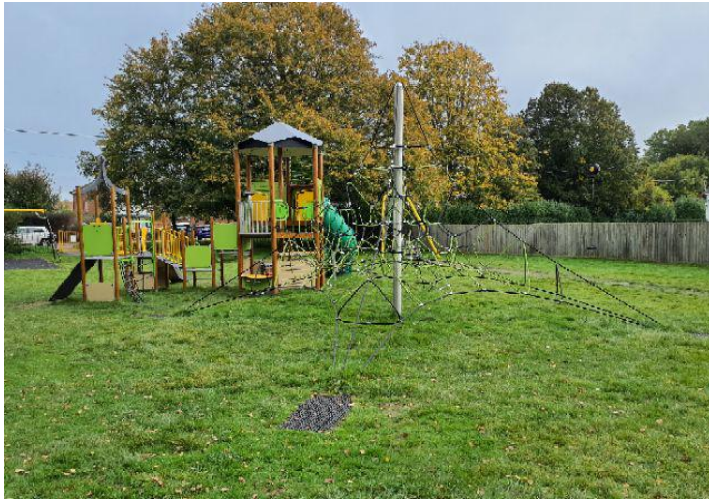
Item: Activity Equipment - Multi Play (Junior)
Manufacturer: Hags

Finding: Gaps have been taped!

Action: Na

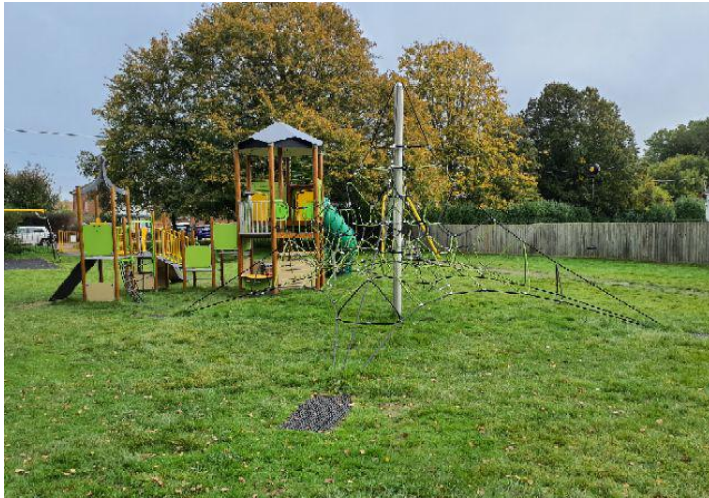
Item: Activity Equipment - Multi Play (Junior)
Manufacturer: Hags

Finding: The grass mats are silted up, the soil is compacted and the area will become very slippery when the soil is wet. **Action:** Reinstate as required

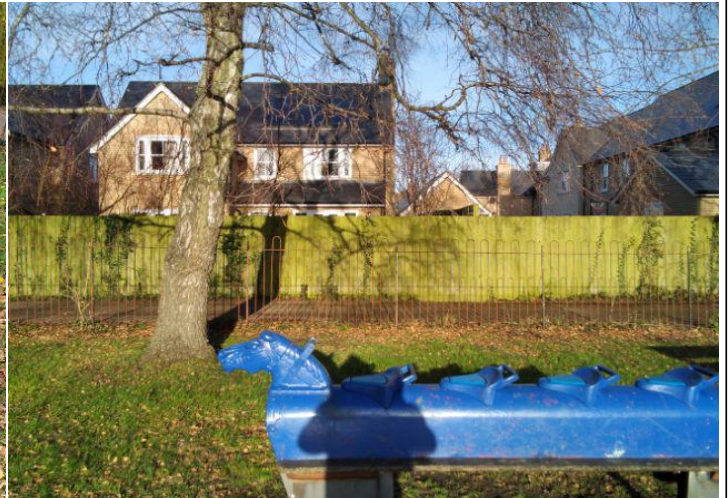
Item: Rocking Equipment - Rocking Horse
Manufacturer: Not Identified

Finding: The tree canopy overhangs the equipment and is less than 2.0m away

Action: Lift tree canopy to ensure a minimum clearance of 2.0m from the equipment

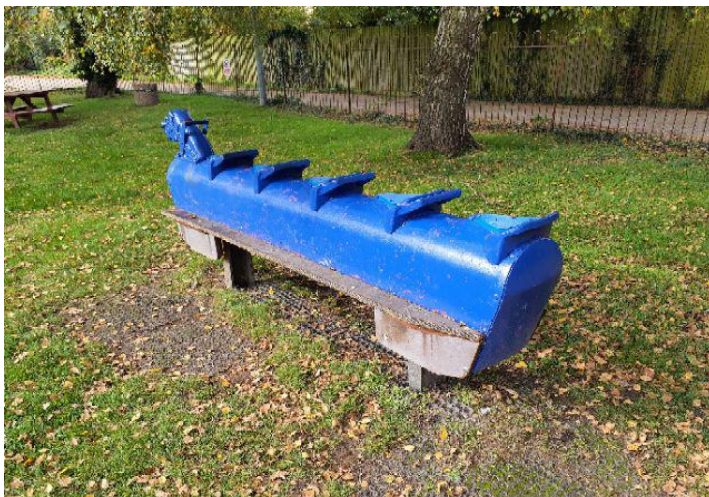
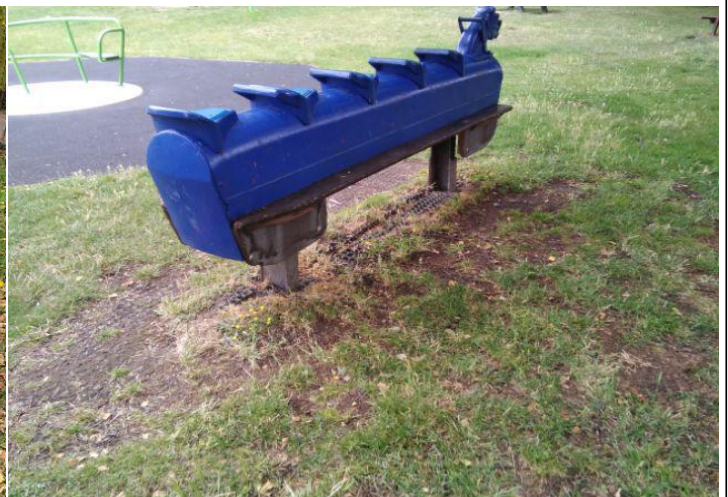
Item: Rocking Equipment - Rocking Horse
Manufacturer: Not Identified

Finding: The grass mats are silted up, the soil is compacted and the area will become very slippery when the soil is wet.

Action: Reinstate as required

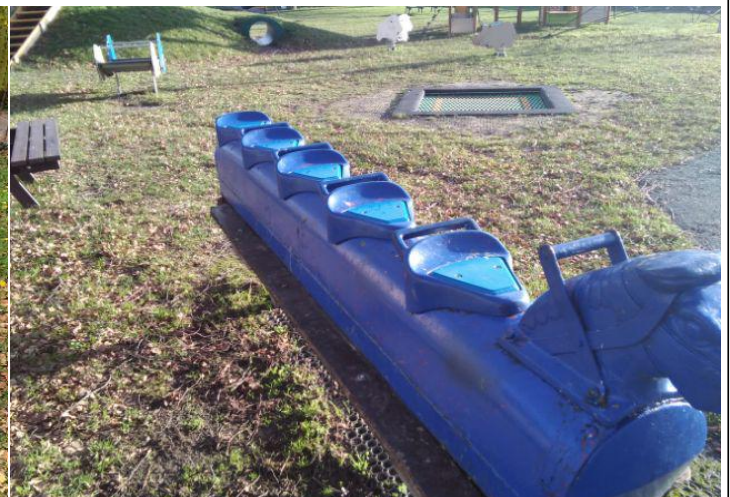
Item: Rocking Equipment - Rocking Horse
Manufacturer: Not Identified

Finding: There is excrement on site

Action: Clean and maintain area

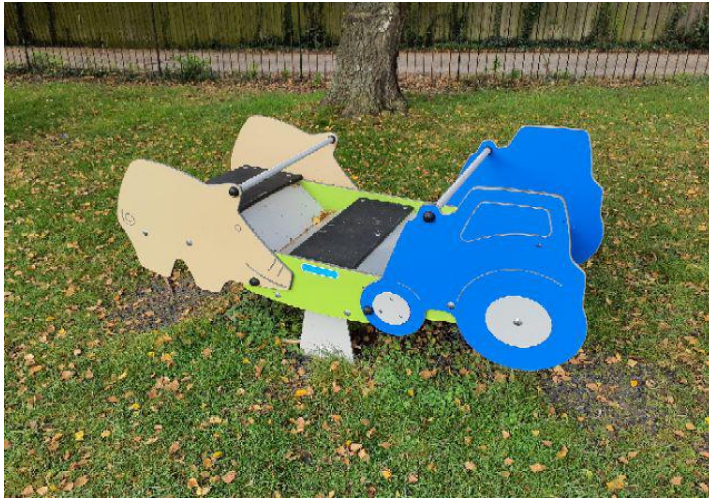
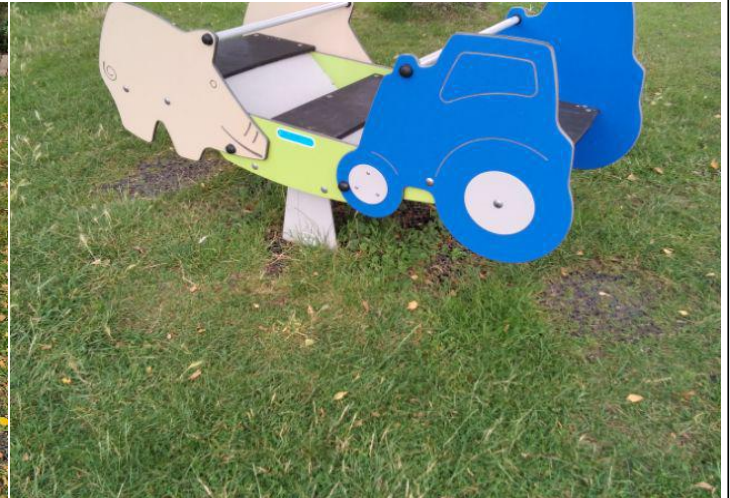
Item: Rocking Equipment - See Saw
Manufacturer: Hags

Finding: The grass mats are silted up, the soil is compacted and the area will become very slippery when the soil is wet. **Action:** Reinstate as required

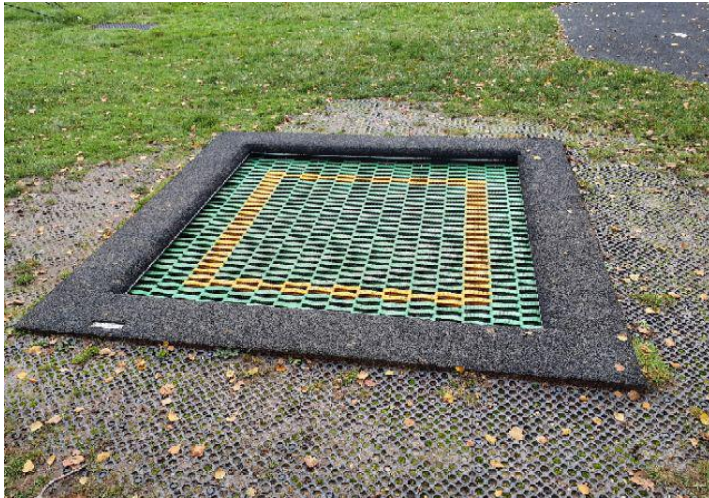
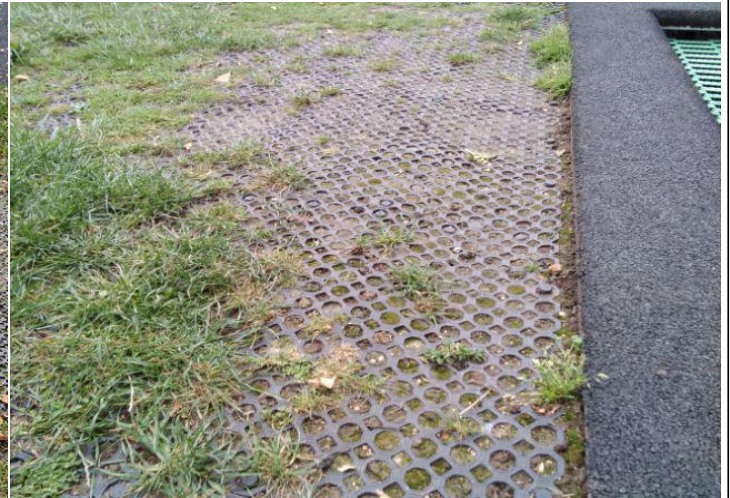
Item: Other - Bouncing Facility
Manufacturer: 1 Move

Finding: The grass mats are silted up, the soil is compacted and the area will become very slippery when the soil is wet. **Action:** Reinstate as required

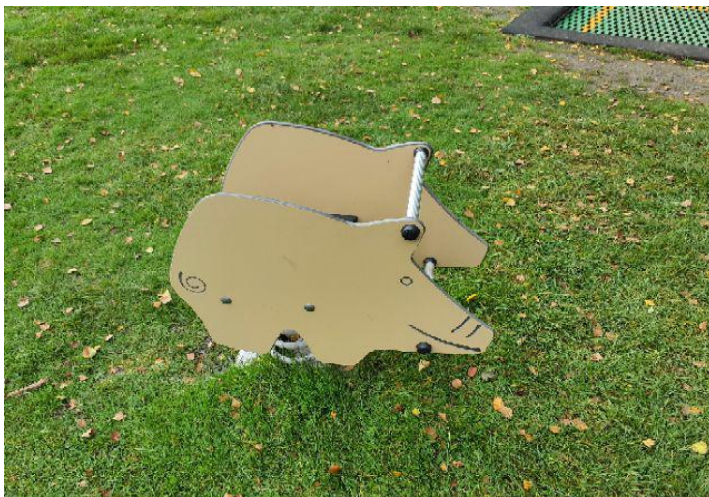
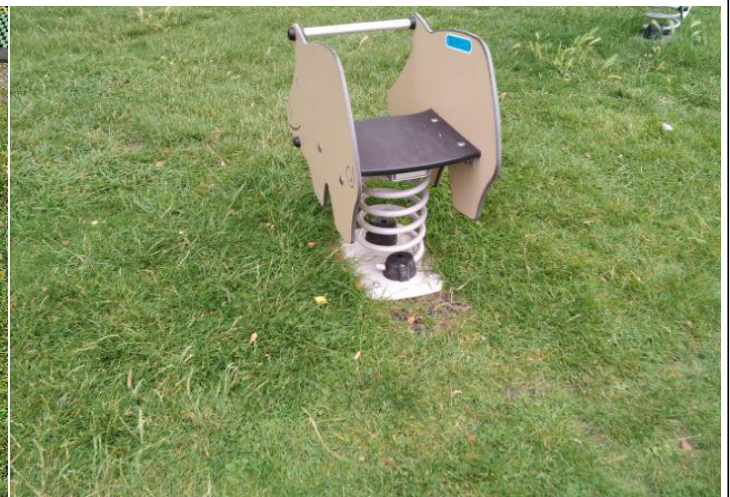
Item: Rocking Equipment - Spring Pig
Manufacturer: Hags

Finding: The grass mats are silted up, the soil is compacted and the area will become very slippery when the soil is wet. **Action:** Reinstate as required

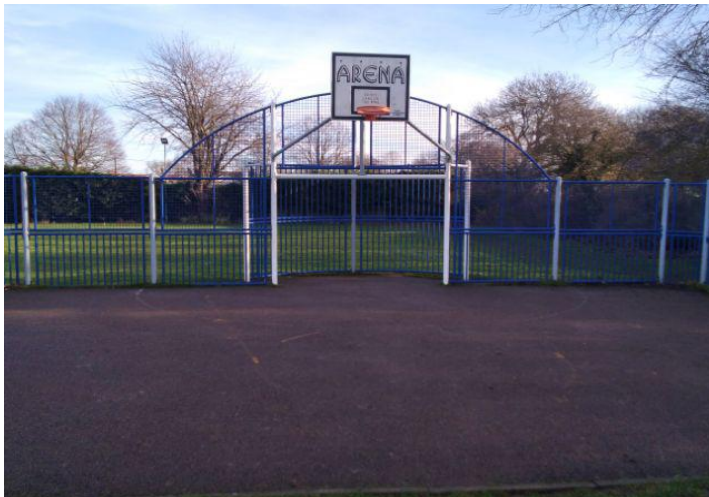
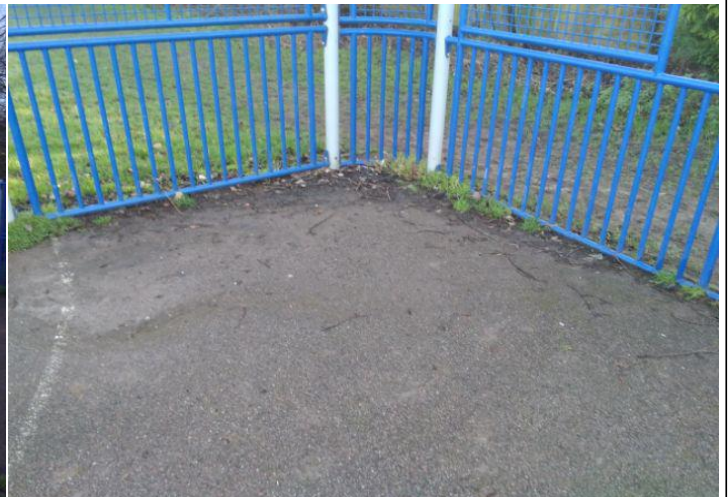
Item: Multi Use Games Area - Basket Ball Goal
Manufacturer: Hags

Risk Level: L - Low Risk
Surface: Tarmac

Finding: There are weeds/vegetation growth between or around the edges of the surfacing

Action: Remove weeds/vegetation growth

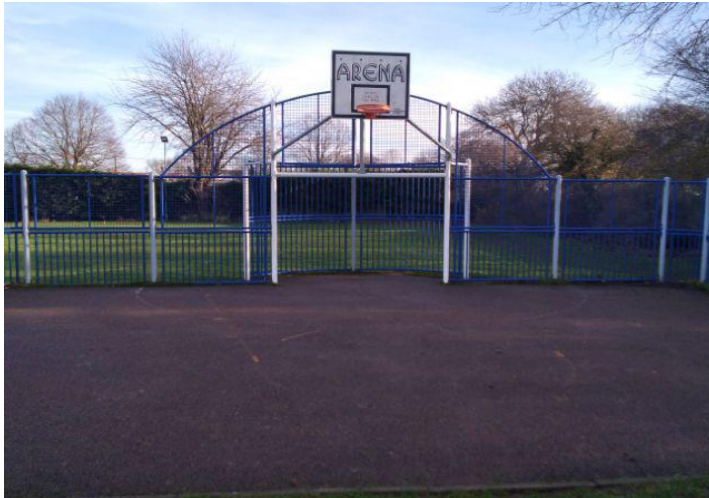
Item: Multi Use Games Area - Basket Ball Goal
Manufacturer: Hags

Risk Level: L - Low Risk
Surface: Tarmac

Finding: There is algae or moss on the surface of the equipment

Action: Clean and treat appropriately

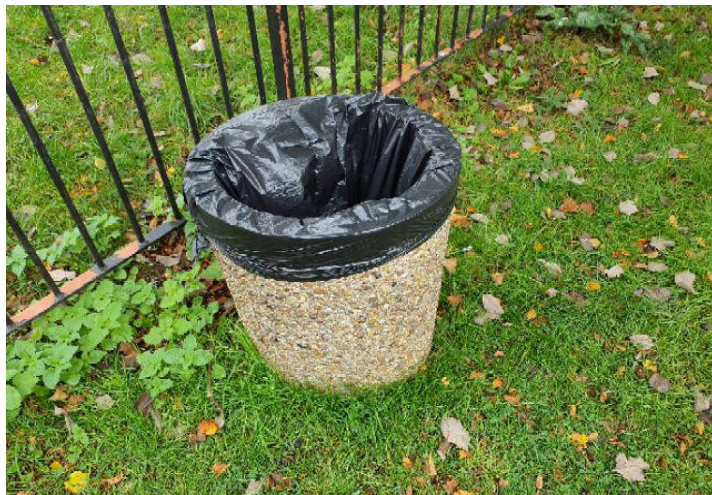
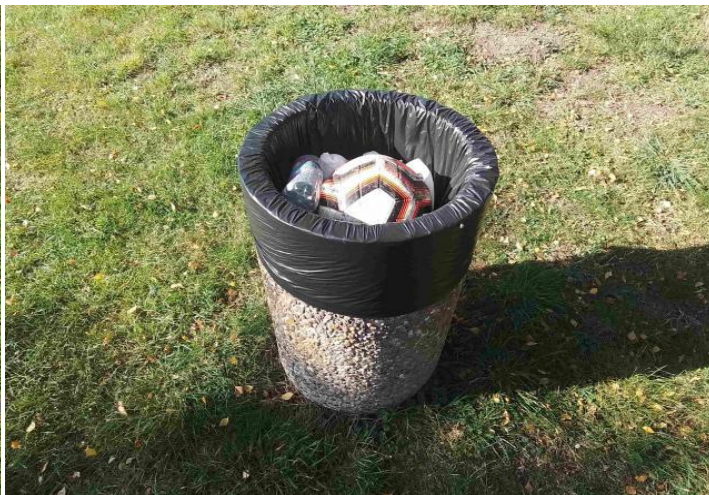
Item: Ancillary Items - Litter Bin
Manufacturer: Not Identified

Risk Level: L - Low Risk
Surface: Grass

Finding: The litter bin is full

Action: Empty and review the collection routine

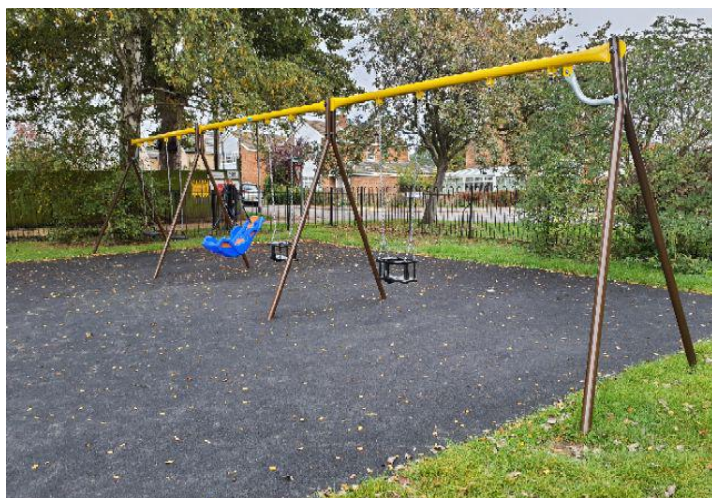
Item: Swings - 3 Bay Swing
Manufacturer: Hags

Risk Level: M - Moderate Risk
Surface: Wet Pour

Finding: The end seat has gone and requires replacing

Action: Replace damaged seat
