QUOTATION

EXPERT
ACCESS
SOLUTIONS

Site Reference Melbourn Community Hub SG8 6DZ
30 High Street
Melbourn
SG8 6DZ

Door Location: 3no. Auto Swing Doors – Main Entrance Outer (Asset 440328277), Main Entrance Inner (Asset 440328278), Rear Exit (Asset 440328279)

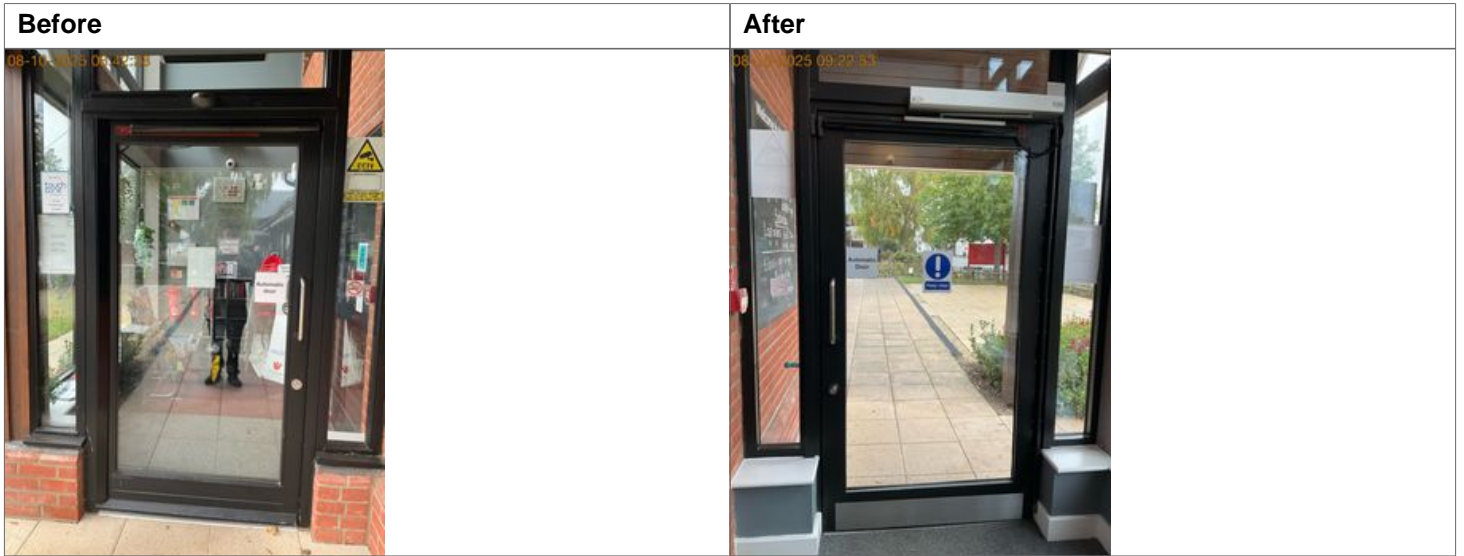
440328277

*Main Entrance Outer 440328277: Safety device insufficient on opening edge. Additional safety sensor module to be fitted into existing on-door sensor housing to prove full door width coverage. Finger guard fitted too high from floor level. Finger guard requires removing, bottom lip of door to be cut with multi tool and then finger guard refitted back on door, lower to floor.

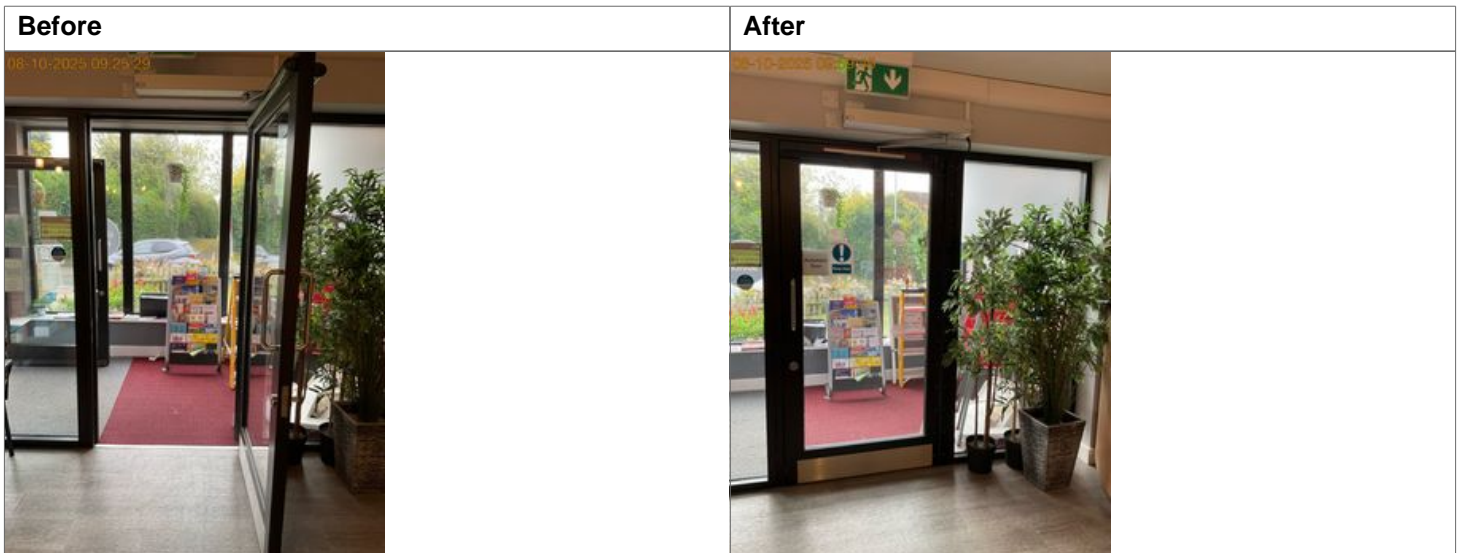
440328278

*Main Entrance Inner 440328278: Safety device insufficient on opening edge. Requires new housing therefore a replacement sensor fitting to opening edge to provide full door width coverage. Finger guard fitted too high from floor level. Finger guard requires refitting lower to floor.
