MELBOURN PARISH COUNCIL

Meeting: 23 July 2020 (Maintenance Committee)

Agenda Item: MA008/20d) Update on works to River Mel

Mending the Mel – a selection of pictures

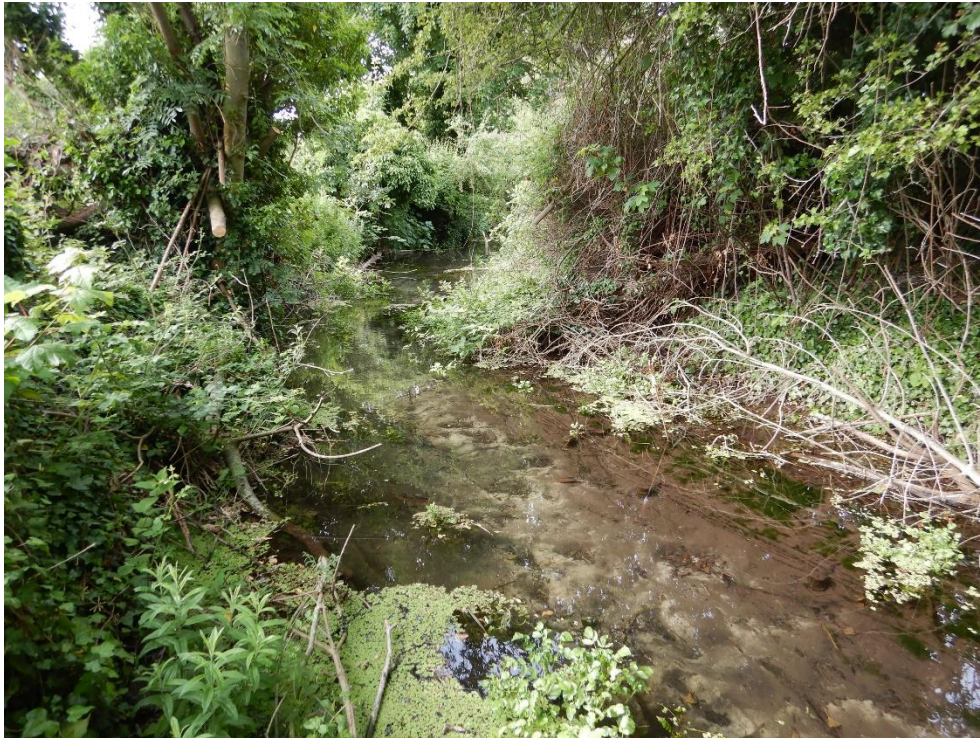
Before - a silty channel with existing ledges not performing properly due to past shade suppressing vegetation growth.

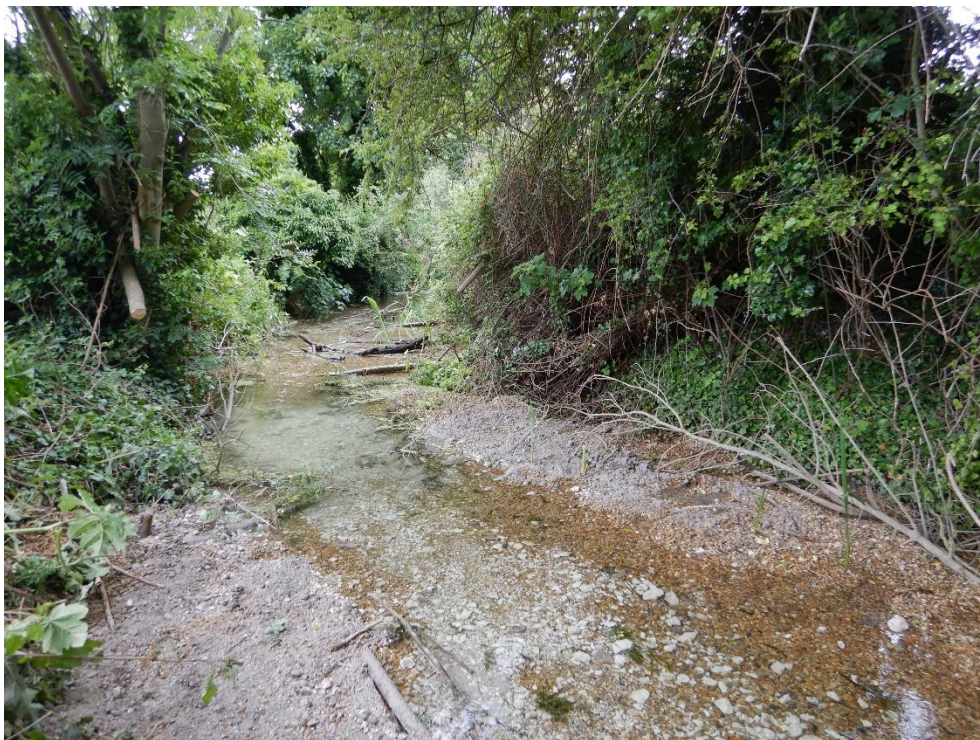
After - the riverbed has been lined with mixed-grade gravel to provide new trout spawning habitat. The margins have been stabilised to aid plant rooting and growth. Yellow flag irises have been planted and margins seeded.

In total 76T of 2mm to 20mm gravel and 10T of rough graded chalk was added over ~100m of river. A small surplus of material has been left in 1 location (amongst nettles) with some smaller piles. This material will be used once some settlement occurs. I can undertake stone picking off the playing field if required.

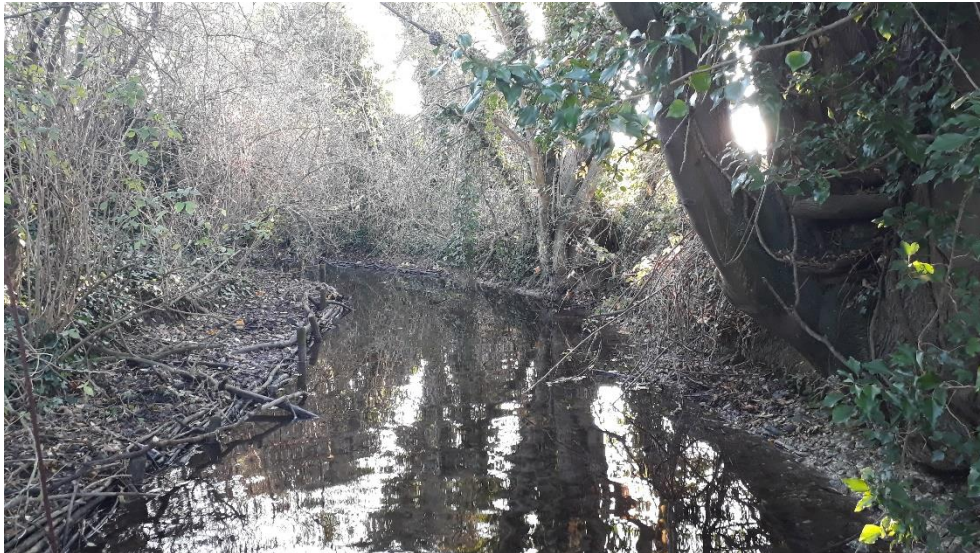
Before - the over-shaded river offered little to sustain water voles and the lack of flow diversity limited the river's ability to cleanse silt from its bed.

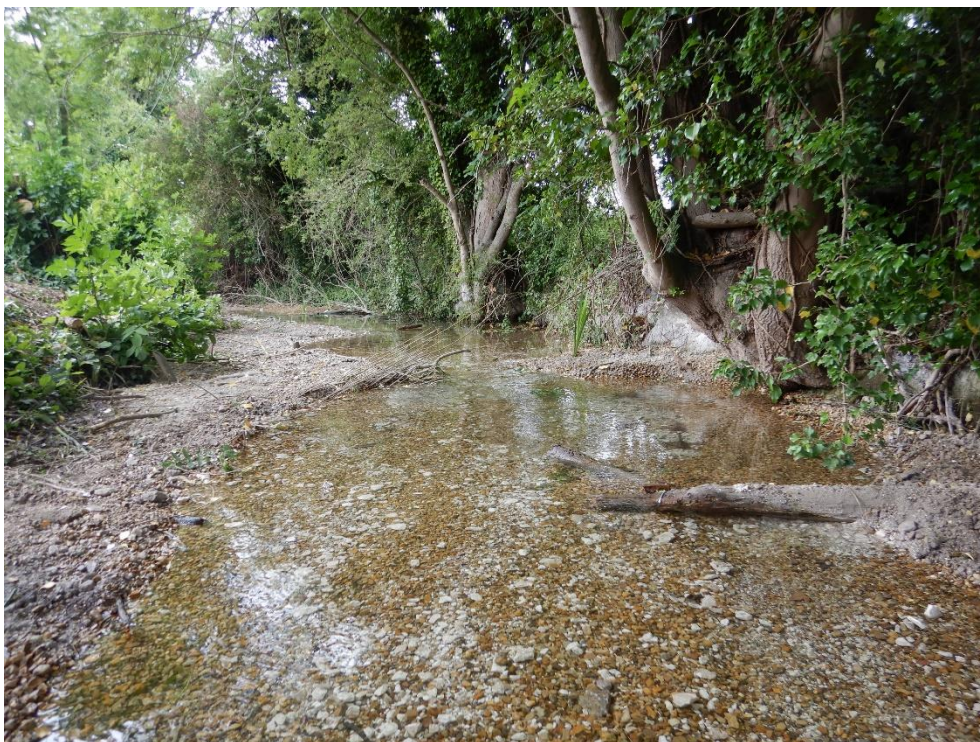
After - by raising the riverbed and through careful narrowing, the flow velocity has been increased which enhances the river's ability to transport fine sediment thus preventing it from smothering the riverbed. The presence of clean gravel will increase the river's invertebrate population (food for fish and birds).

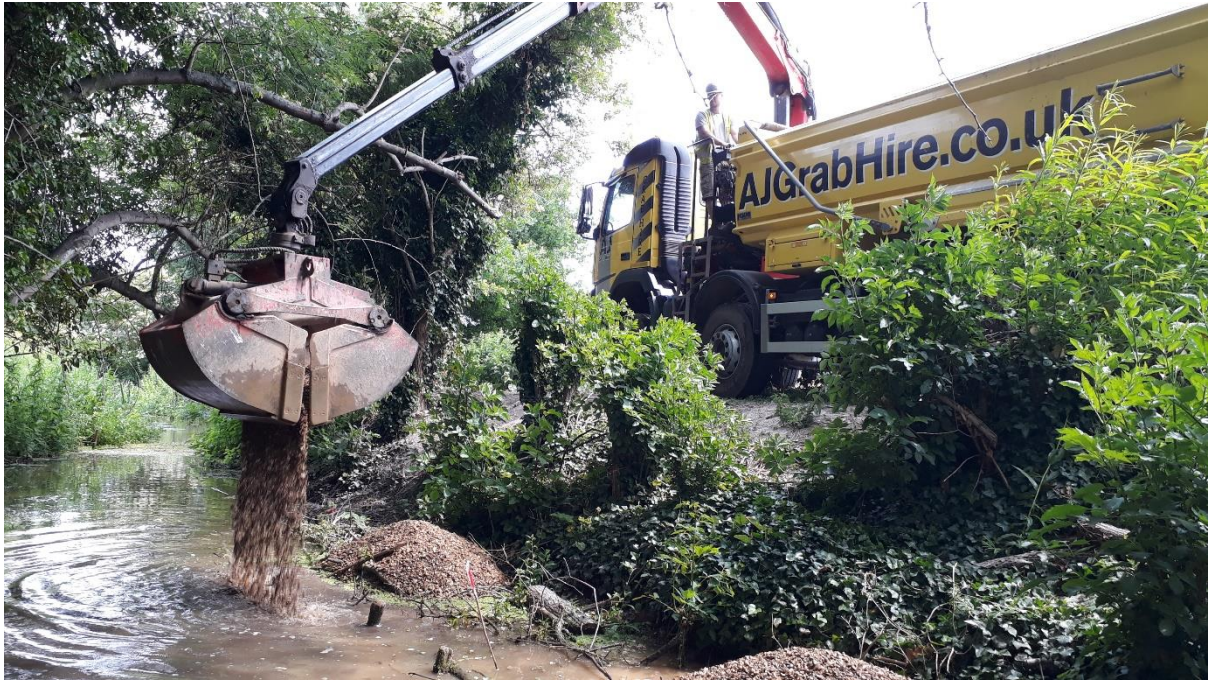
Due to COVID19 restrictions community volunteers could not be used for delivery. Instead a team was formed from a local landscape company (Meldreth Landscapes) and gravel was crudely delivered by grab lorry.

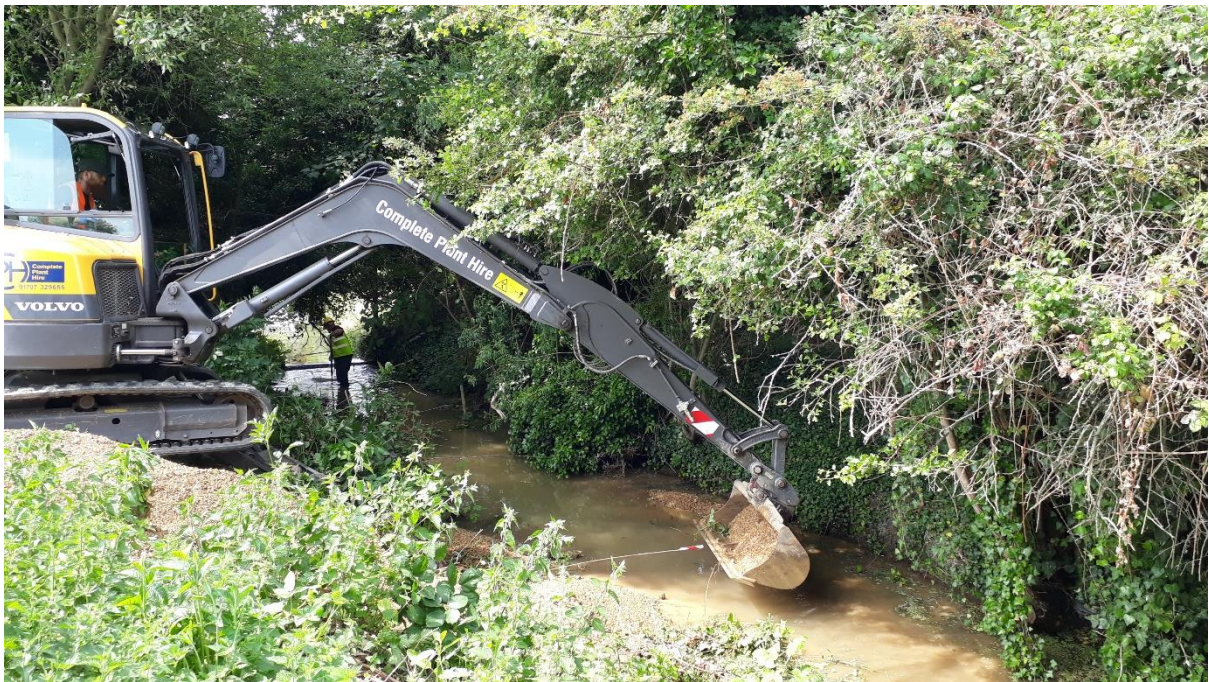
A 5T excavator was used to place gravel into tight locations. The labourer (upstream in shot) had the role of raking out gravel under careful instruction.

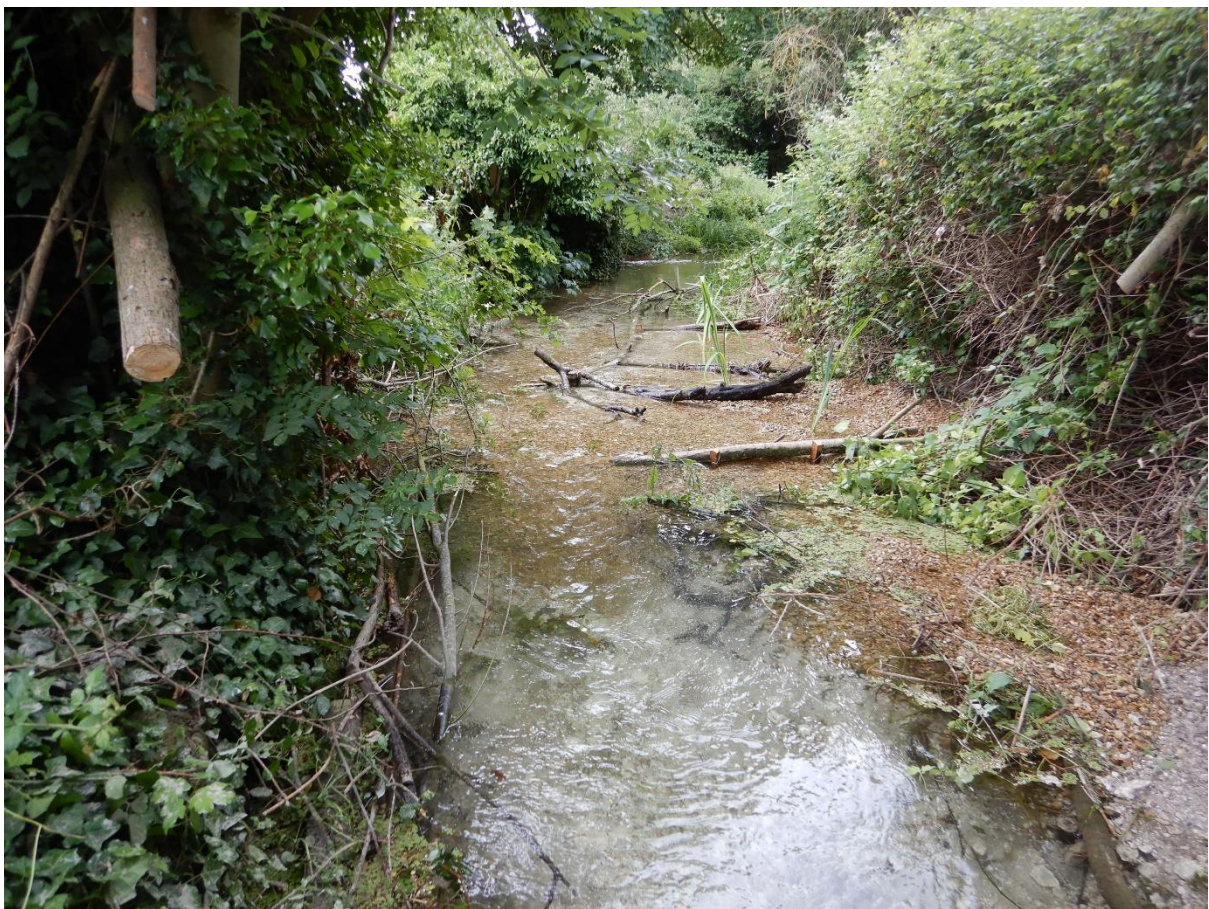
The river now has depth variation and flow diversity. Small pieces of wood have been fixed in the margins to aid vegetation retention as fragments drift downstream.

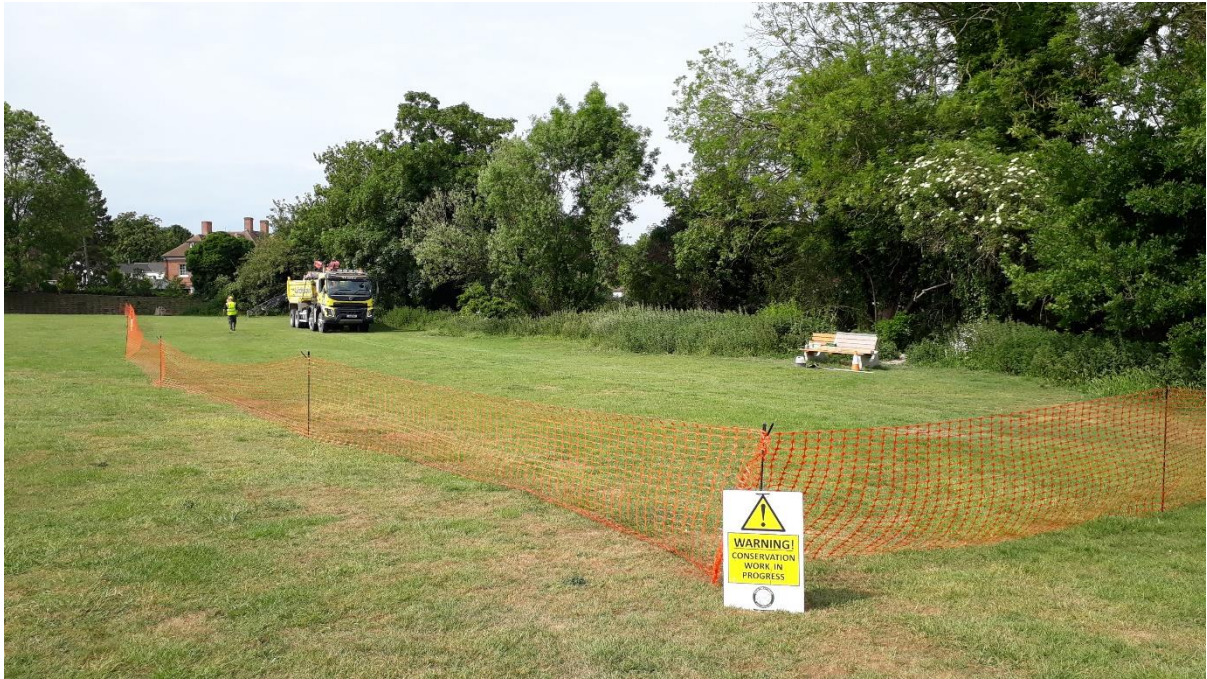
The work area was safely separated from the public.

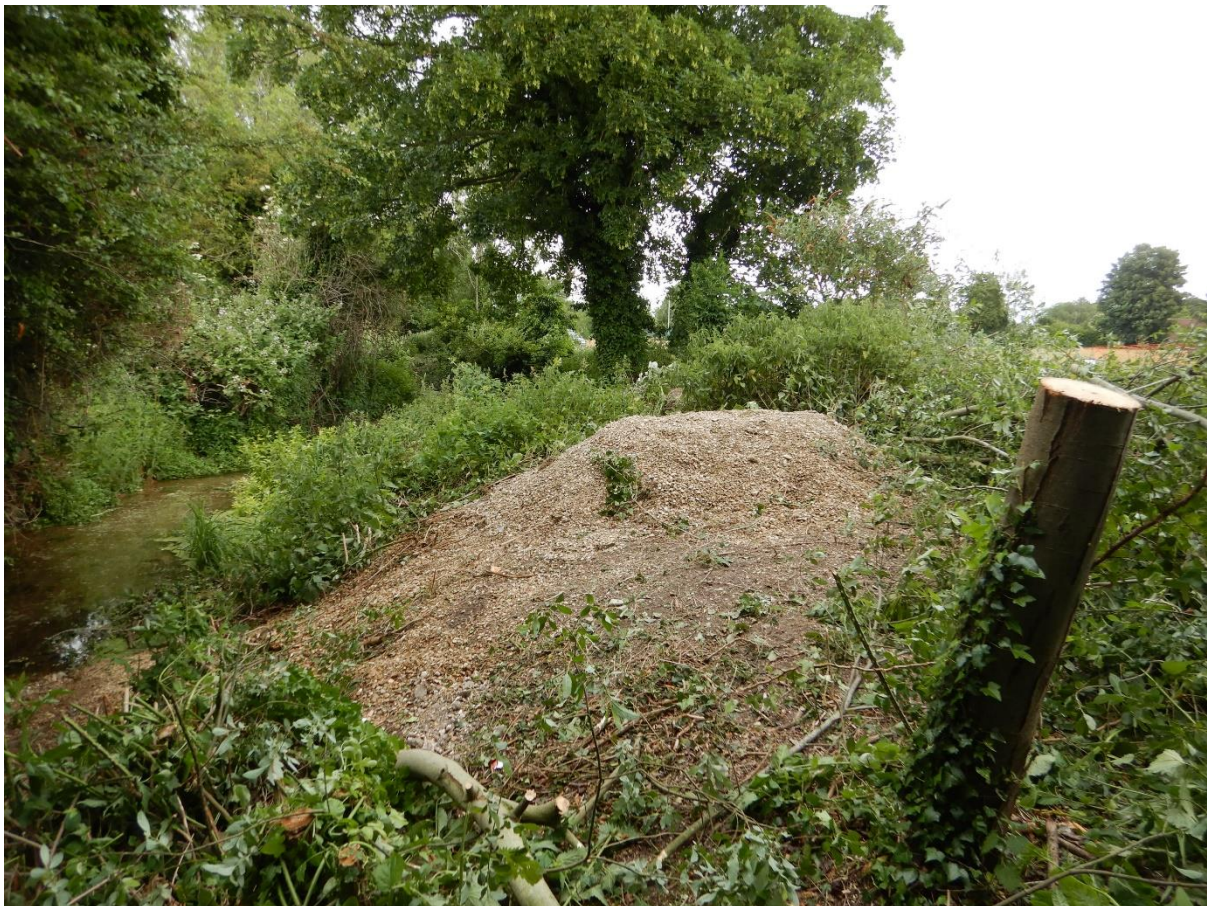
A small surplus of gravel and chalk has been left on site to allow for adjustments once the material settles. If the material requires moving, please do not hesitate to contact Rob Mungovan.

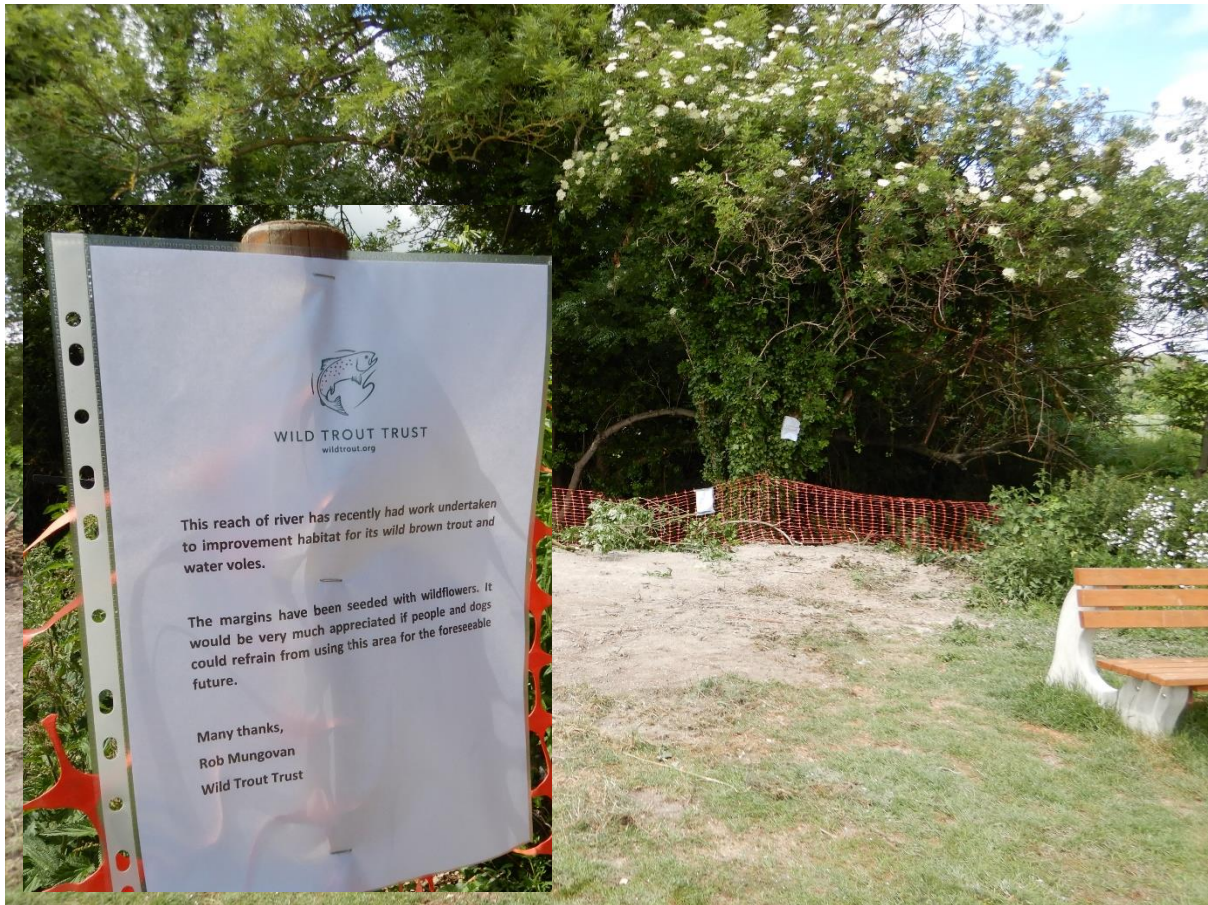
A discrete area has had the barrier fencing relocated try to and offer protection whilst the bankside vegetation recovers. It can be removed at any time upon request.

The previous scrub clearance, followed by an excavator tracking through some parts has opened up an area of river (behind the seat). I am keen that this area does not get disturbed whilst the vegetation establishes again. As such I have fixed some barrier fencing with signage to try and deter people. In future, I think the best approach would be to retain piles of brash material to act as dead hedging to control which parts of the river people can access. I'd have to admit that the "hands off" approach has simply allowed brambles to cover the shrubs which has resulted in dense shading of the river, hidden log jams and a lack of amenity, but protection of the rabbits which are now beneath it. A further review of the bankside shrubs should be undertaken in the autumn to see if it's wise to open up further area once more.
