Safety Inspection Report

Annual Inspection

Clear Crescent Play Area

21 April 2021

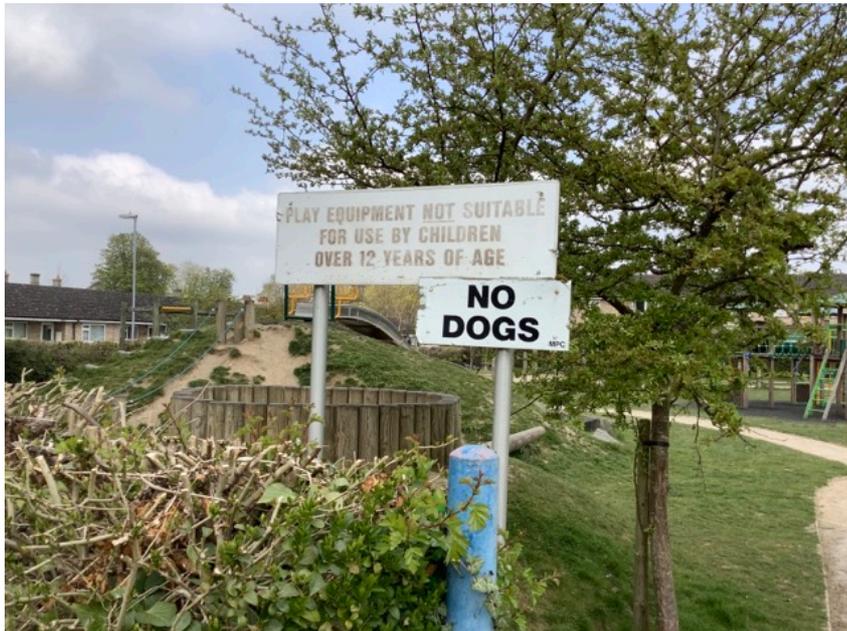
Signage

Dog ban & ownership signs recommended.

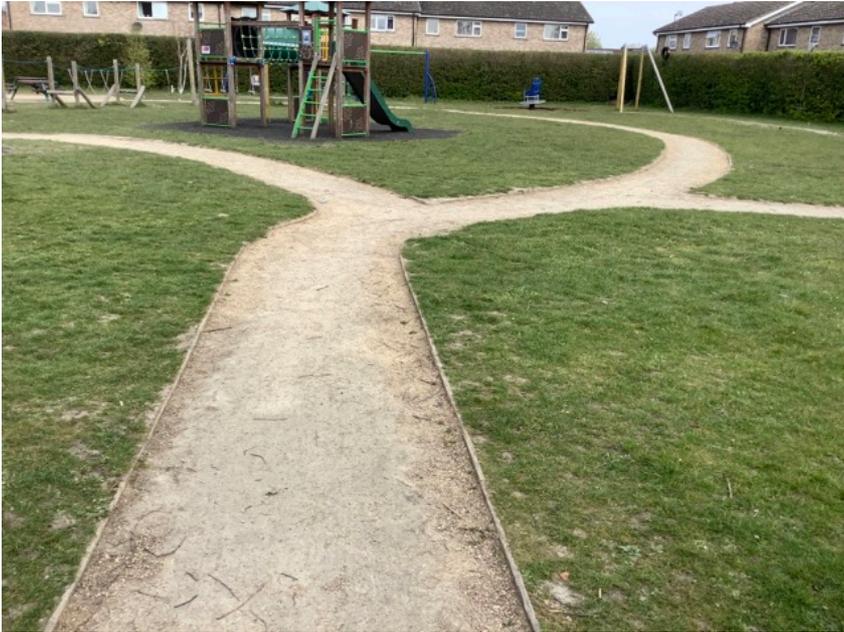
Pathways

Surface is wearing.

Surface wearing and creating a trip point around the edgings.

Repair.

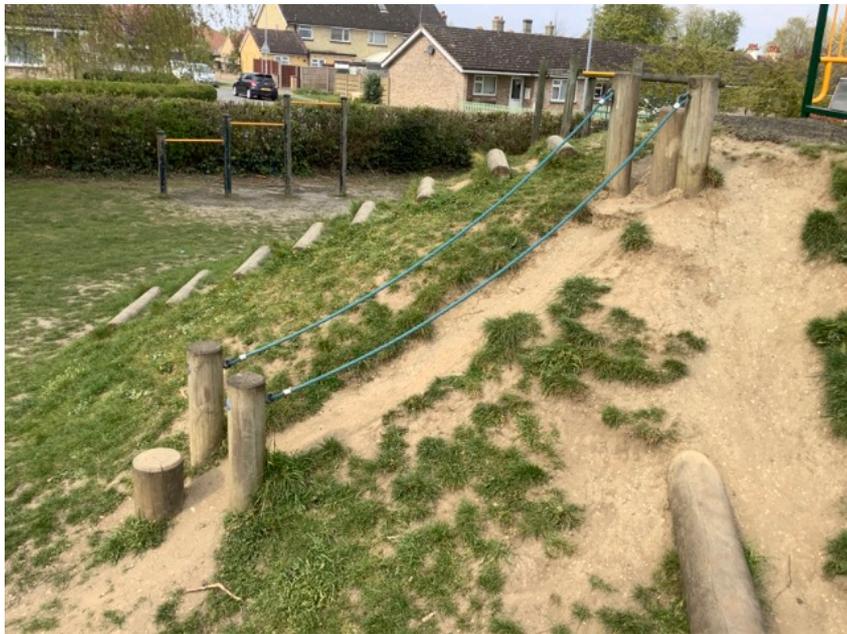
Rope Balance - Embankment

Bolt cap damaged.

Replace.

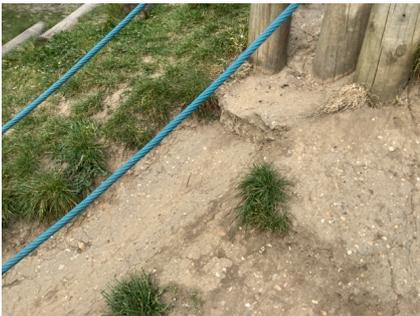
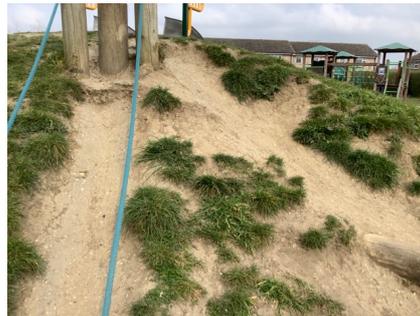
Foundations exposed mound has eroded in places - reinstate mound.

Repair the worn areas.

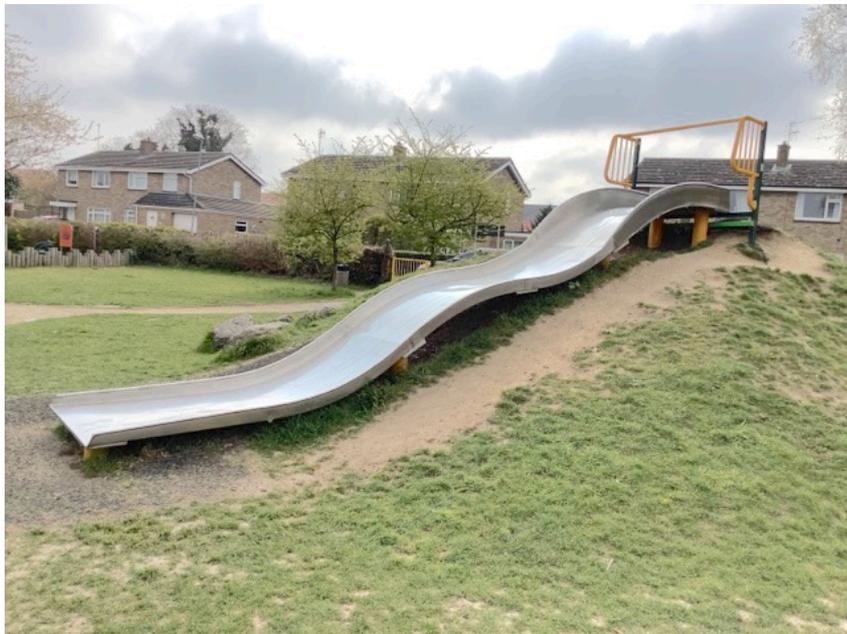
Slide - Embankment - With Log Steps

Surface needs repair.

Repair.

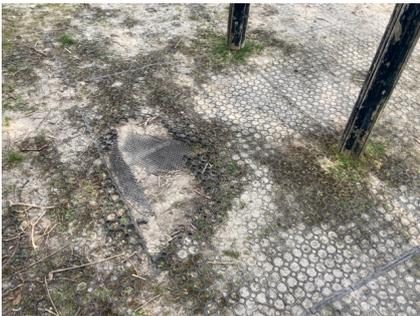
Surface needs repair.

Grass mats are damaged - replace.

Replace.

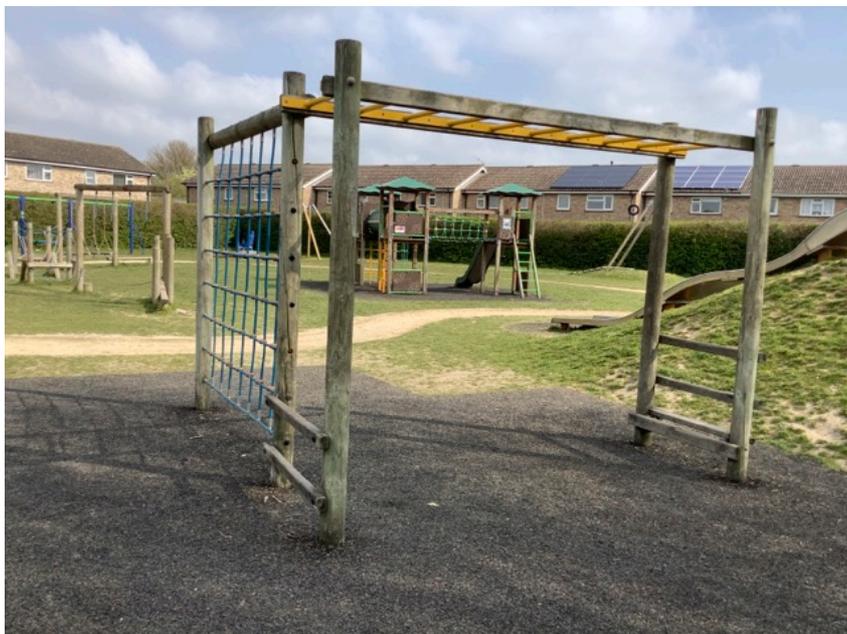
Climber - Net & Ladder

Cap missing.

Replace.

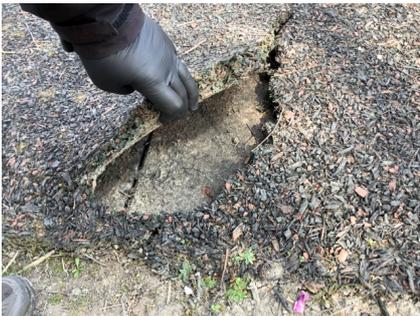
The surface is cracking.

The surfacing has cracked.

Repair.

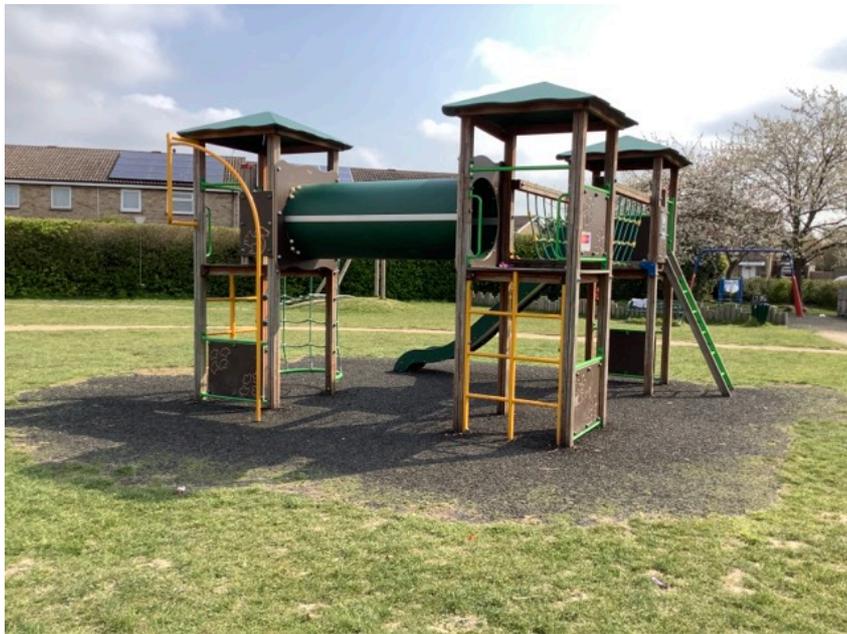
Multiplay - Junior

Cap missing.

Cap plug missing exposing the thread - replace.

Replace.

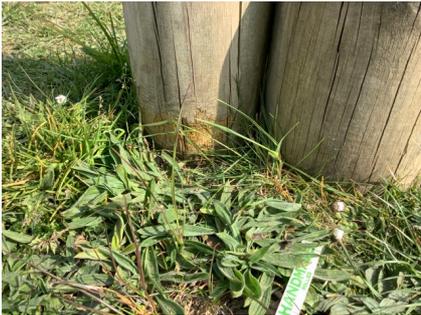
Strimmer damage to supports is likely to accelerate timber rot.

Prevent further damage.

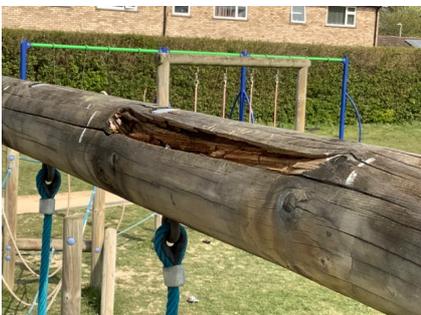
Timber is decayed.

Rope walk top bar is decayed from the inside out, hollowed - replace as soon as possible.

Replace affected parts.

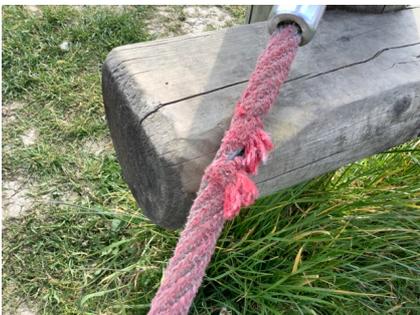
The rope is rubbing on the balance beam and wearing down to the wire - monitor for broken wires and replace if found.

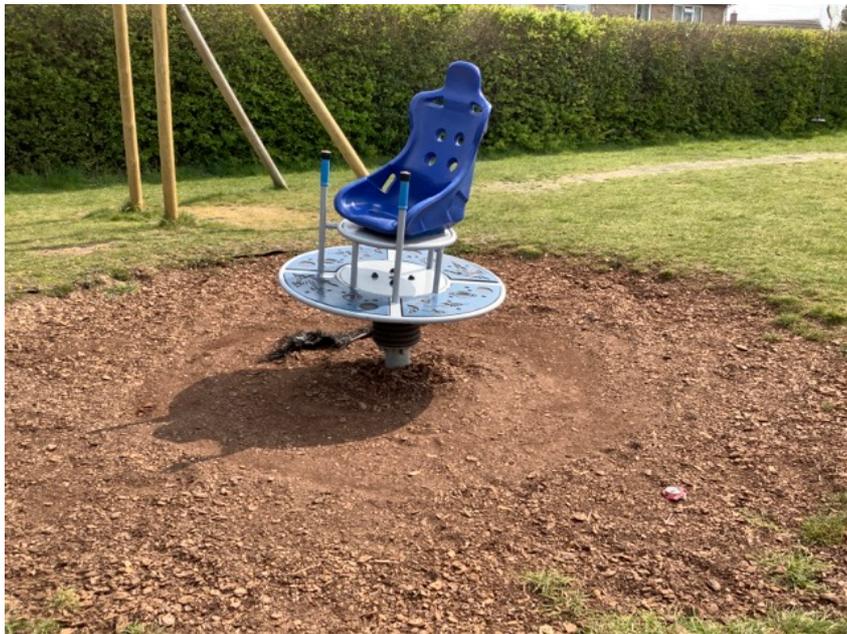
Rocker / Rotator - Chair - Space Rocket

Surface needs repair.

The surfacing has worn away exposing and damaging the liner beneath. Grass & weeds have grown inside. The plastic edging strips are sharp - the whole area requires immediate repairs and alterations. Bark requires topping up.

Repair.

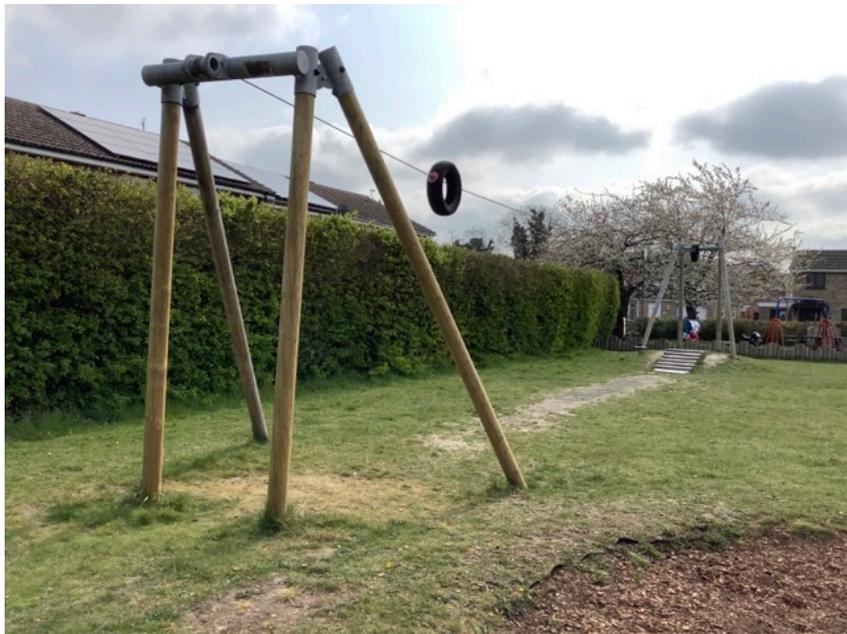
Cableway

Chains links worn.

Chain link and seat connector worn.

Replace the worn parts.

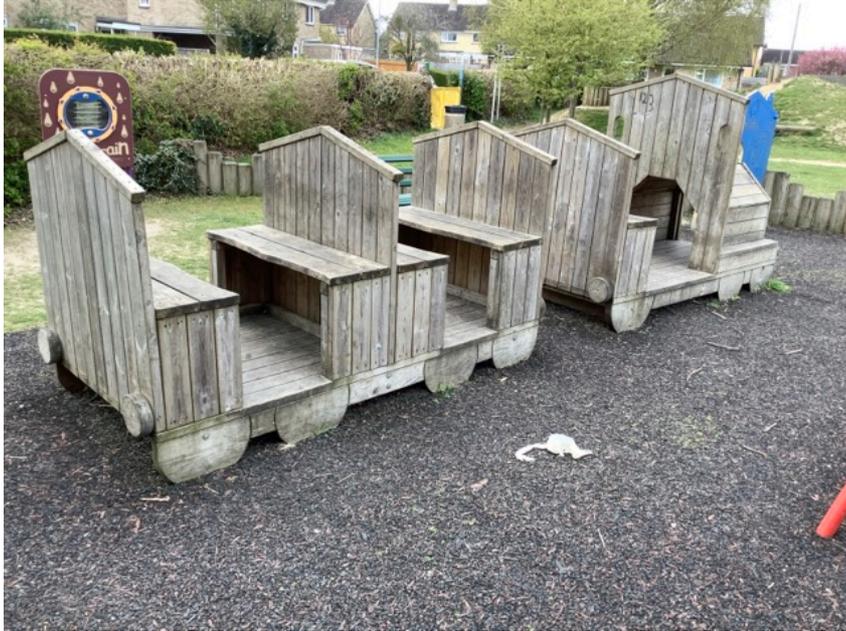
Play Train & Carriage - With Play Panel - Station

Fixtures loose or missing.

Exhaust loose to tunnel and seat rest panels loose - secure.

Tighten/replace.

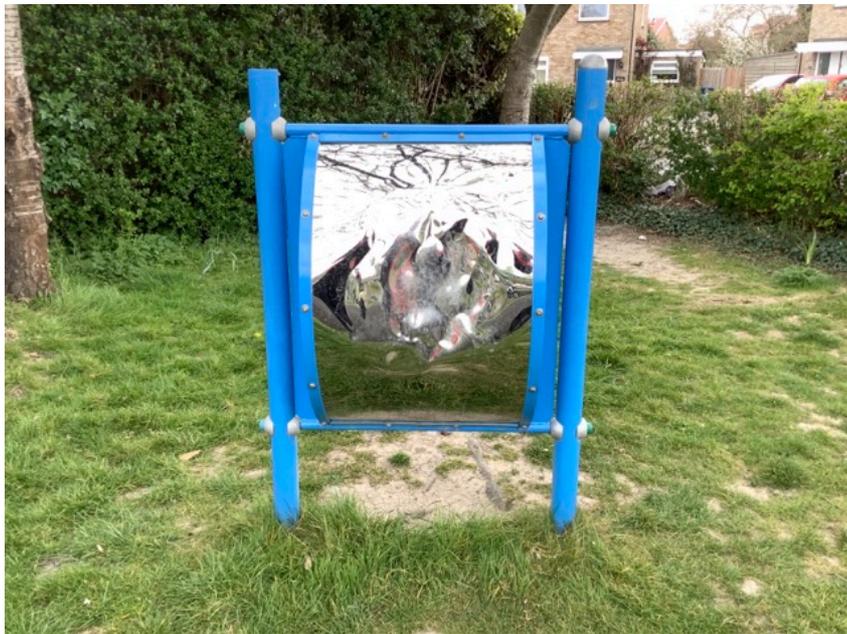
Play Panel - Mirror

Cap missing.

Post caps missing where objects could be inserted and water ingress is likely to occur.

Mirror bent - monitor for splits / cracks, replace if found.

Replace.

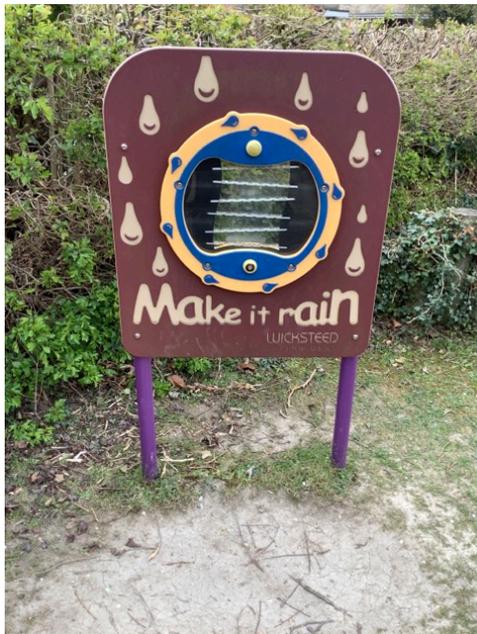
Play Panel - Make it Rain

Bolt cap damaged.

Replace.
