Project Name: 276430.Little Hands Nursery.SG8 6ED.BWW.Melbourn

Project Description: WinCan Import in Miraculix WRc4 Standard

Project Date: 18/06/2021

Inspection Standard: MSCC4 Sewers & Drainage GB (SRM4 Scoring)

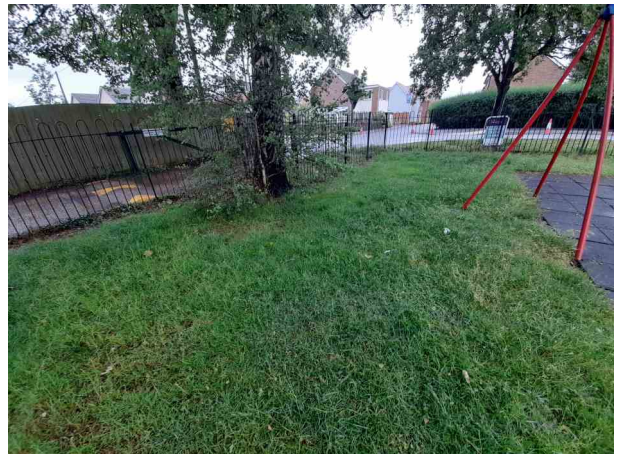
Section 27.3, TL384533AJ is hidden somewhere in this area

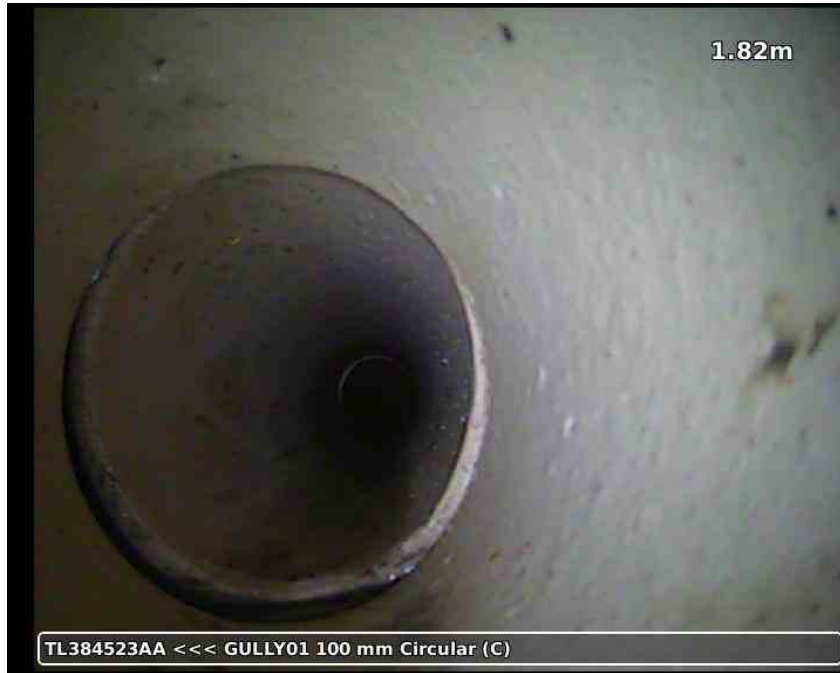
Section 1, Line appears to be disused, fine roots entering through the joint at 0.19m & a medium open joint at 1.82m

20210617-161336-snap0004.jpg, 00:00:31, 1.82 m
Open joint, medium

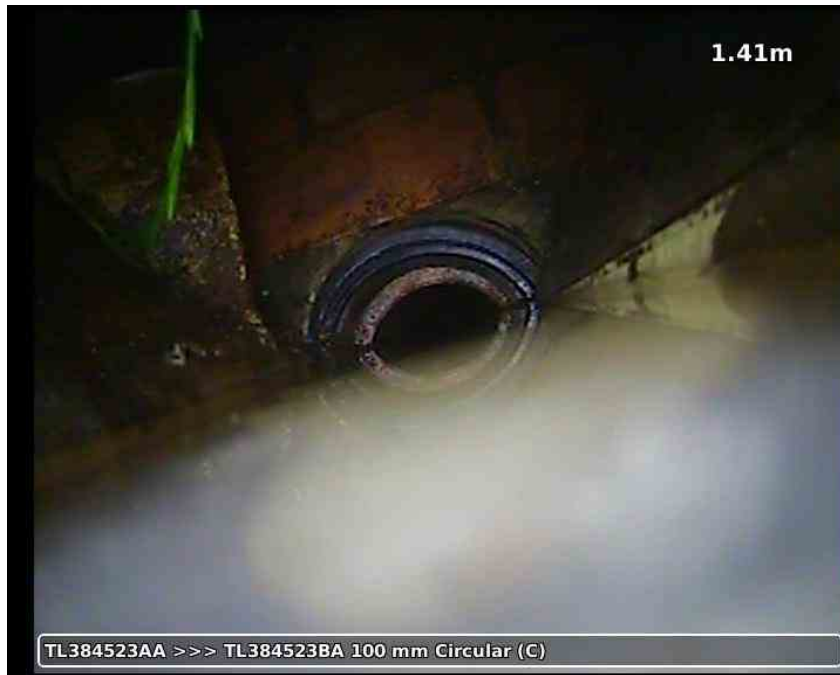
Section 4, Medium displaced joint at 0.46, Water level is upto 40% in TL384523BA

20210617-163005-snap0006.jpg, 00:01:02, 1.41 m
Water level, 40% % of the vertical dimension

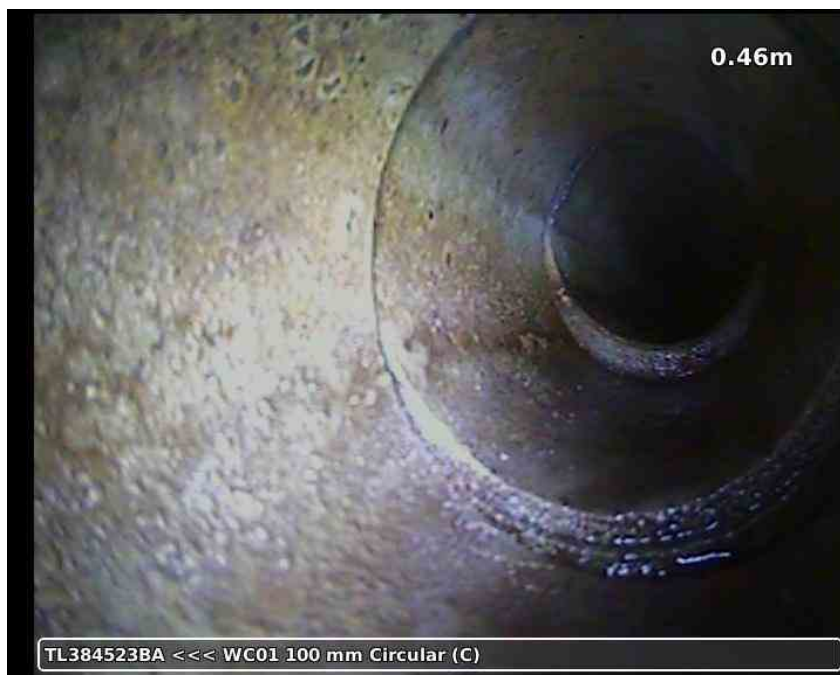
Section 5, Medium open joint at 0.46m & a medium displaced joint at 0.61.

20210617-164432-snap0005.jpg, 00:00:35, 0.46 m
Open joint, medium

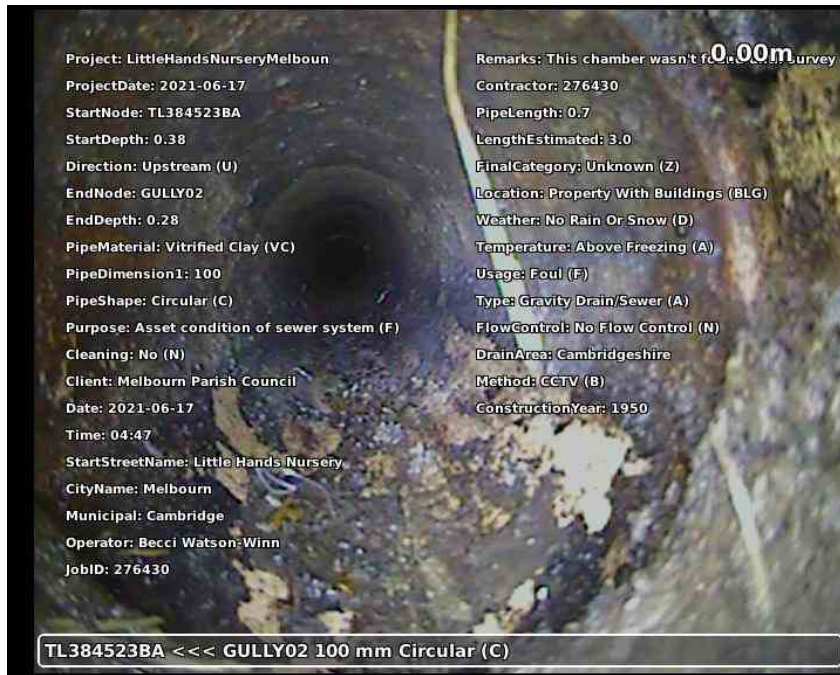
20210617-164707-snap0000.jpg, 00:00:00, 0.00 m
 Start node type, manhole, reference number: TL384523BA

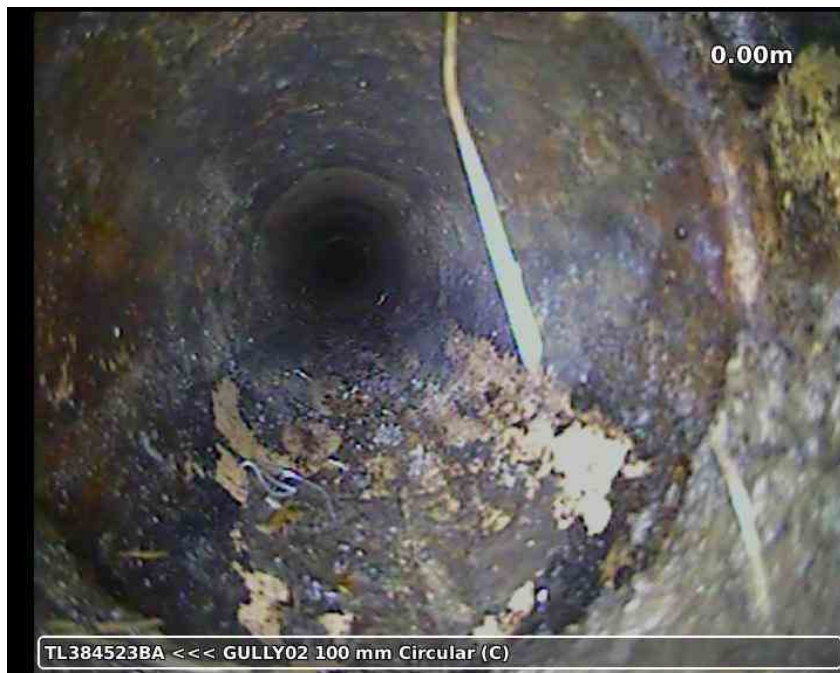
20210617-164707-snap0001.jpg, 00:00:01, 0.00 m
 Water level, 0% % of the vertical dimension, DISUSED GULLY

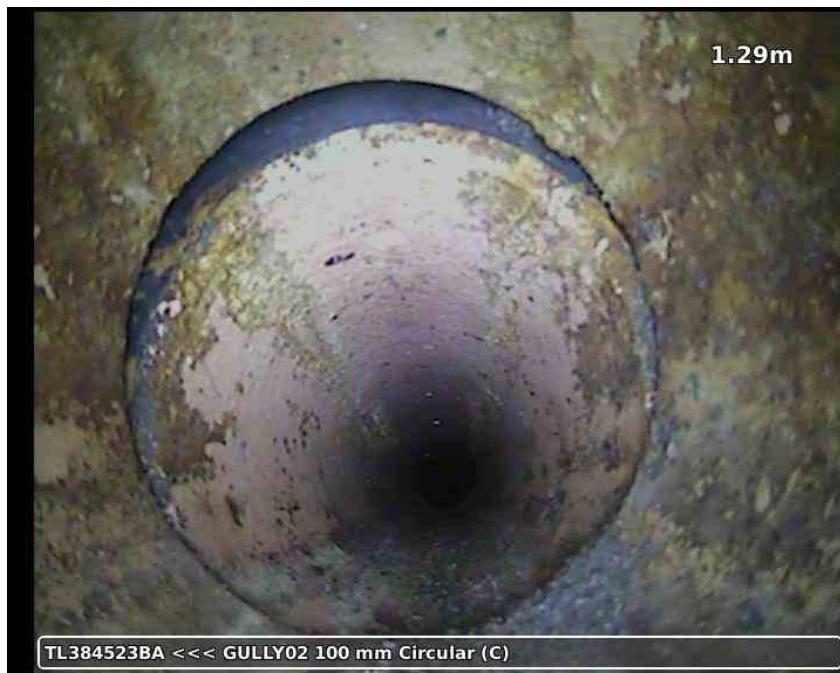
20210617-164707-snap0003.jpg, 00:00:35, 1.29 m
Open joint, medium

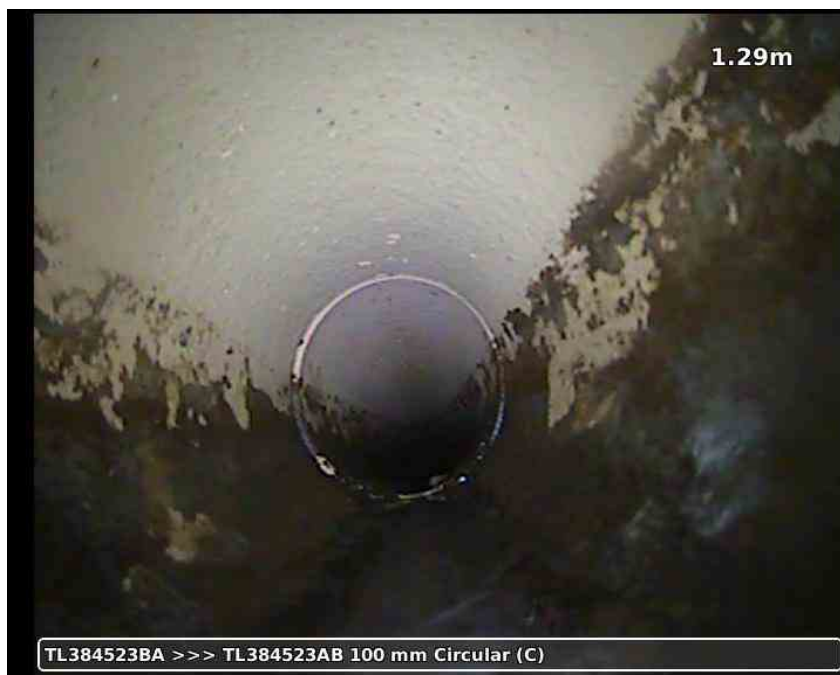
20210617-164942-snap0003.jpg, 00:00:36, 1.29 m
Water level, 10% % of the vertical dimension

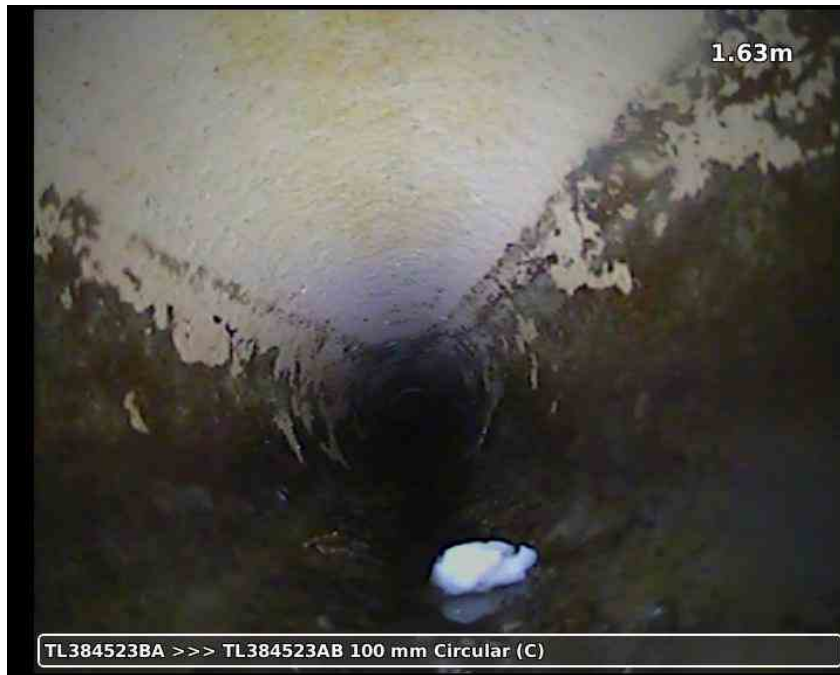
20210617-164942-snap0006.jpg, 00:00:58, 1.63 m
Water level, 5% % of the vertical dimension

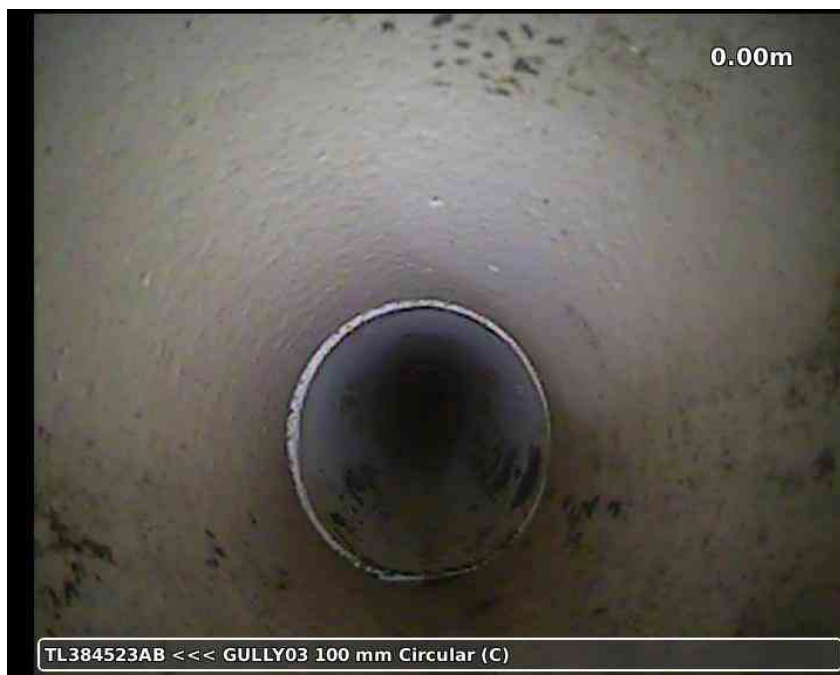
20210617-165624-snap0001.jpg, 00:00:01, 0.00 m
 Water level, 5% % of the vertical dimension

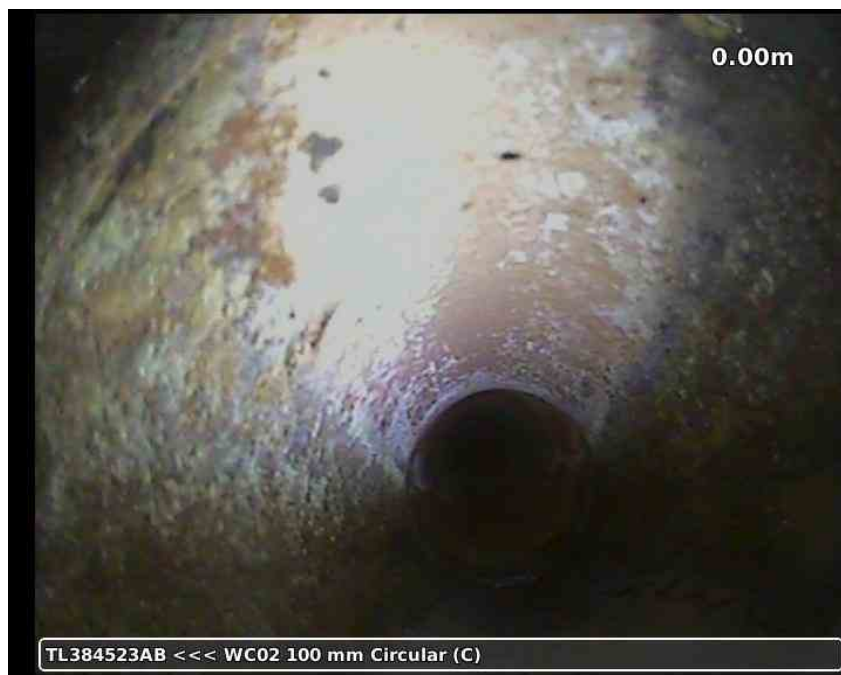
20210617-165855-snap0001.jpg, 00:00:01, 0.00 m
 Water level, 5% % of the vertical dimension

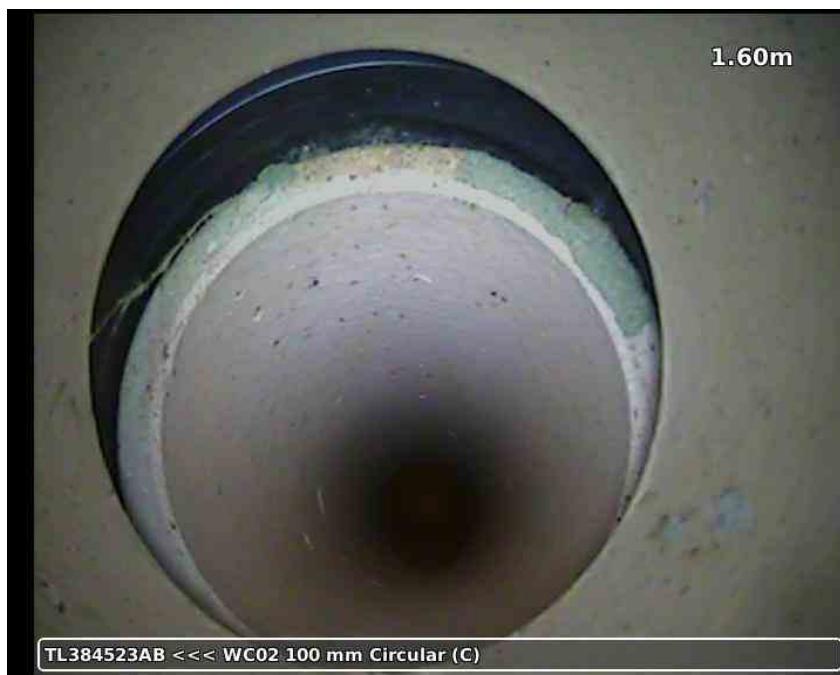
20210617-165855-snap0003.jpg, 00:00:36, 1.60 m
Open joint, large

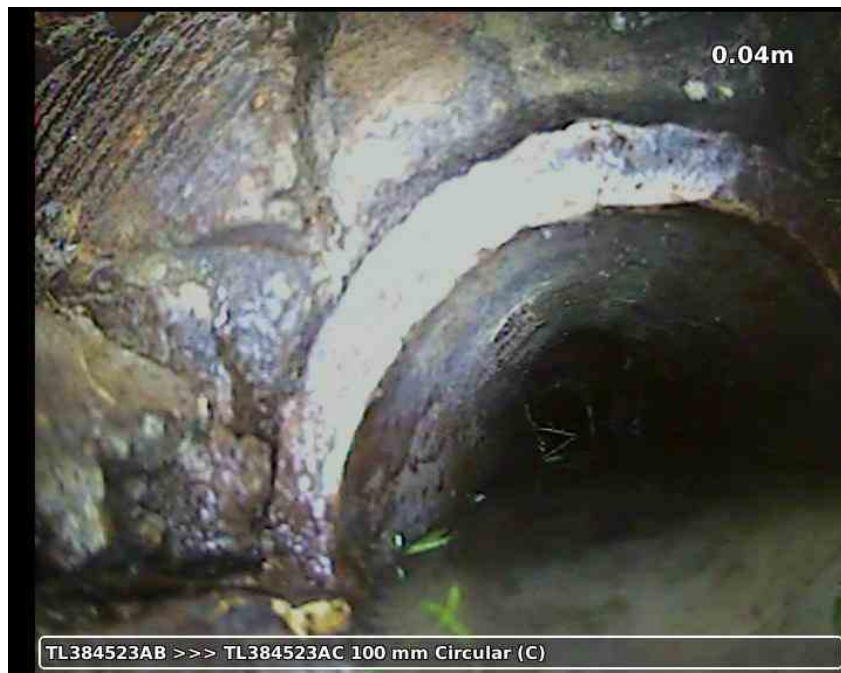
Section 10, Starting water level is 40% which increases upto 60% & back flowing was observed.

20210617-170147-snap0001.jpg, 00:00:02, 0.00 m
 Water level, 40% % of the vertical dimension

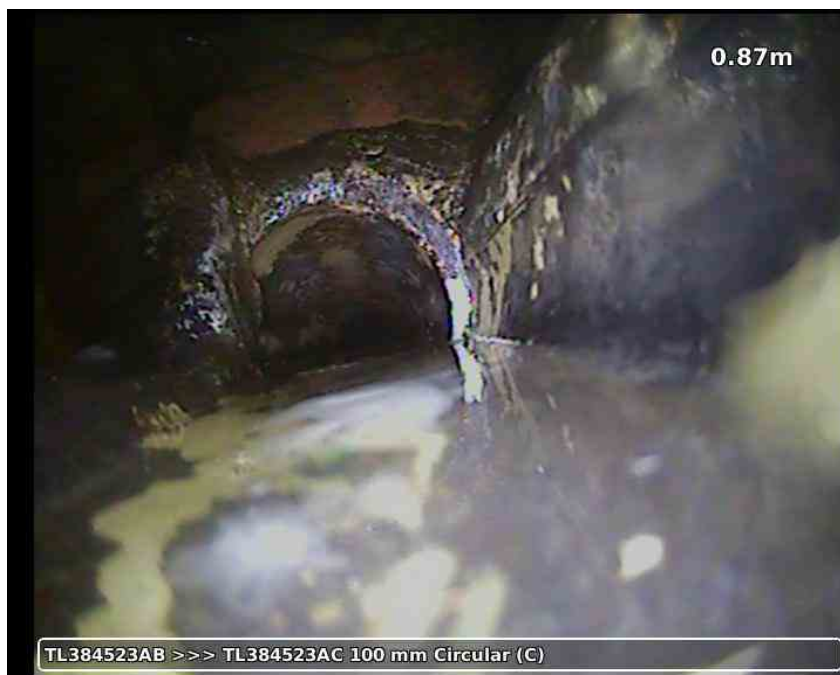
20210617-170147-snap0003.jpg, 00:00:29, 0.87 m
Water level, 20% % of the vertical dimension, BACK FLOWING

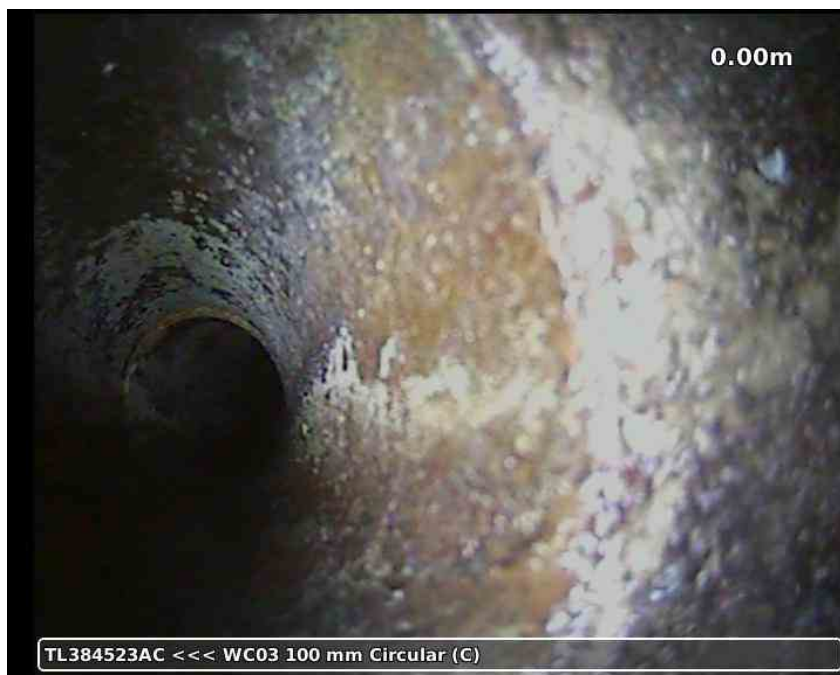
20210617-171046-snap0001.jpg, 00:00:02, 0.00 m
 Water level, 5% % of the vertical dimension

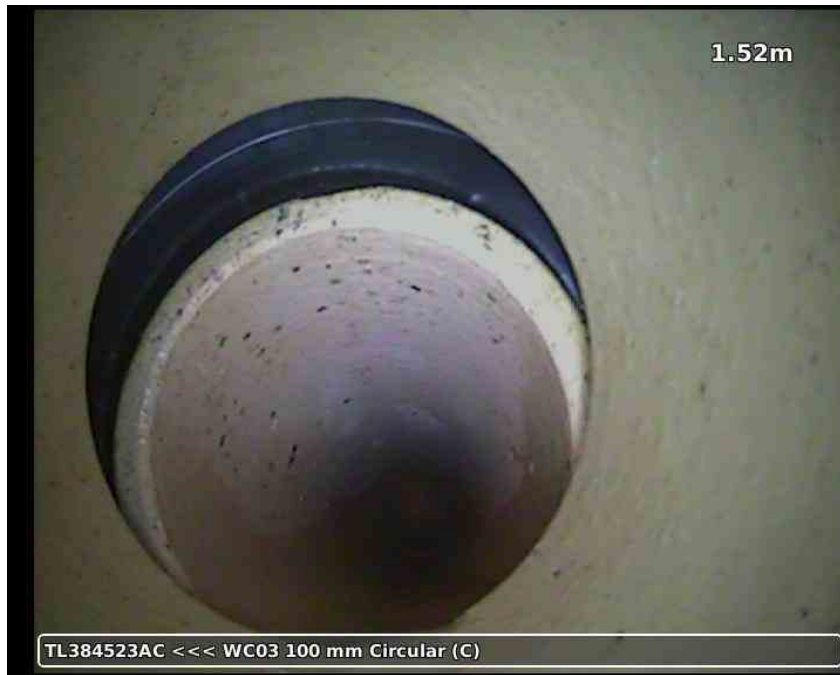
20210617-171046-snap0002.jpg, 00:00:23, 1.52 m
Open joint, large

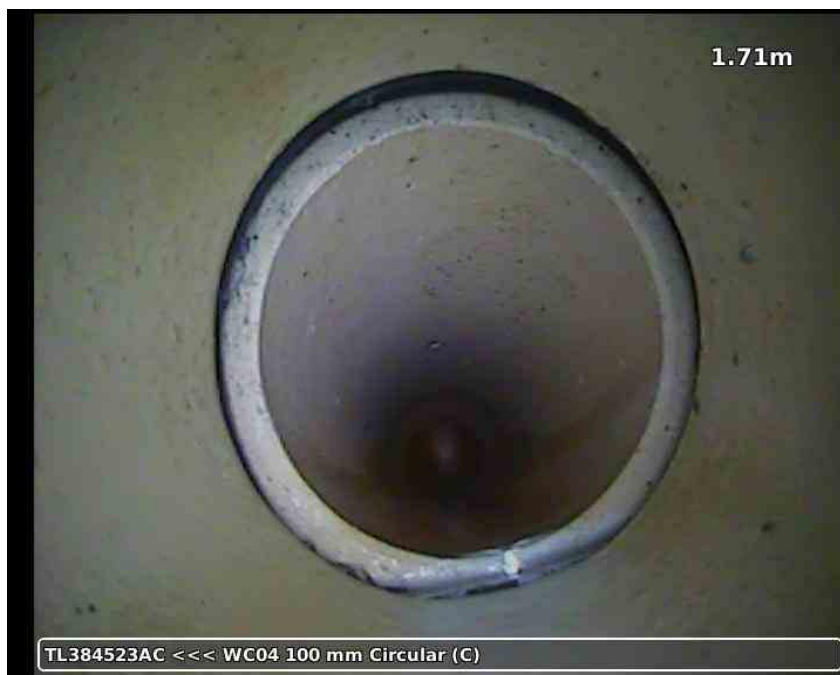
20210617-171300-snap0003.jpg, 00:00:29, 1.71 m
Open joint, medium

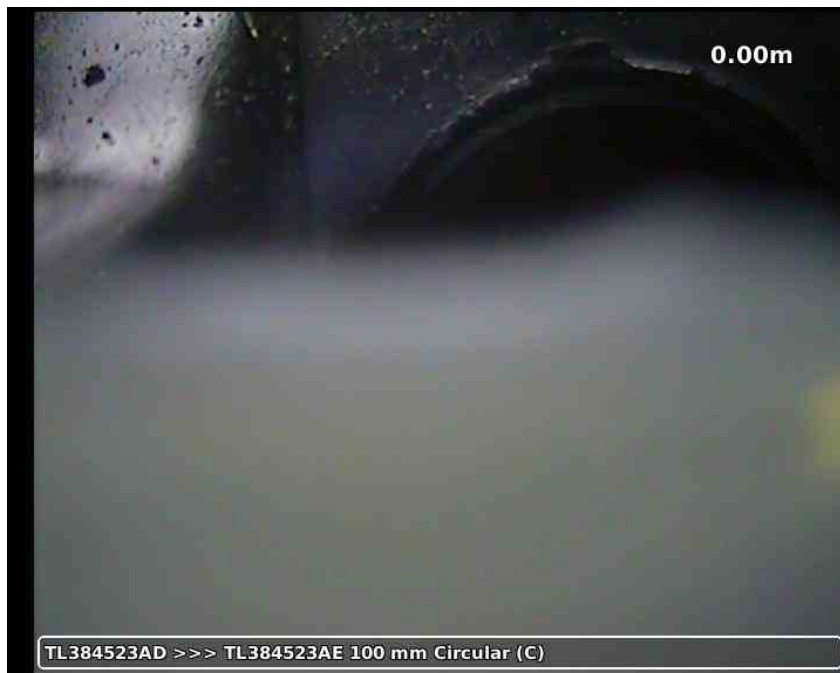
20210617-173215-snap0001.jpg, 00:00:07, 0.00 m
Water level, 70% % of the vertical dimension

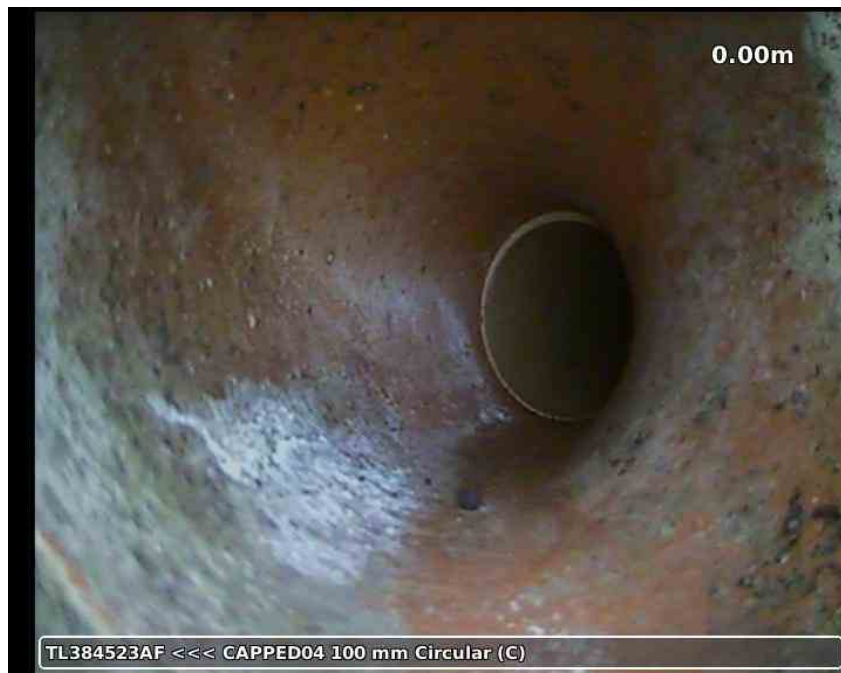
20210617-180144-snap0001.jpg, 00:00:01, 0.00 m
 Water level, 0% % of the vertical dimension, CAPPED OFF

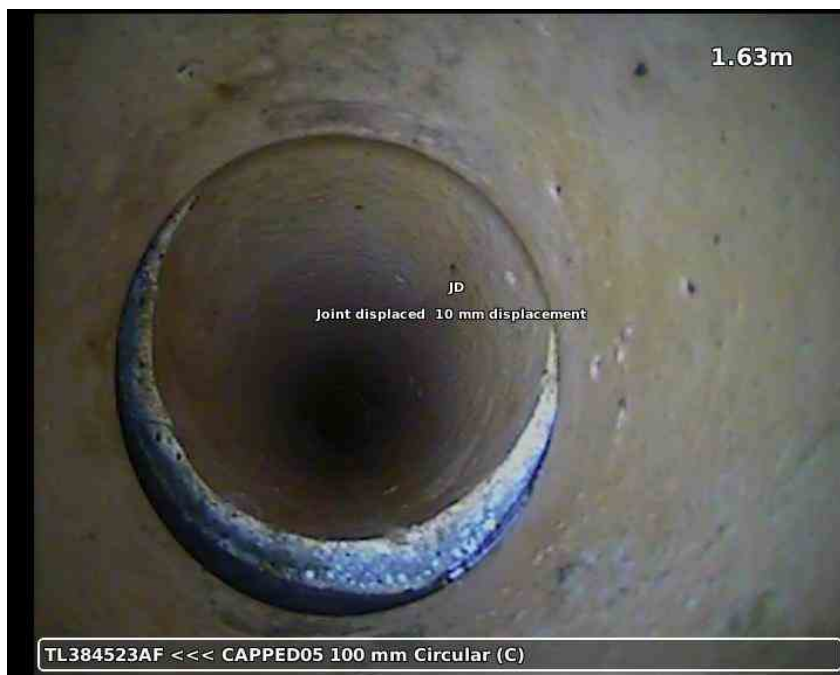
20210617-180419-snap0003.jpg, 00:00:40, 1.63 m
Open joint, medium

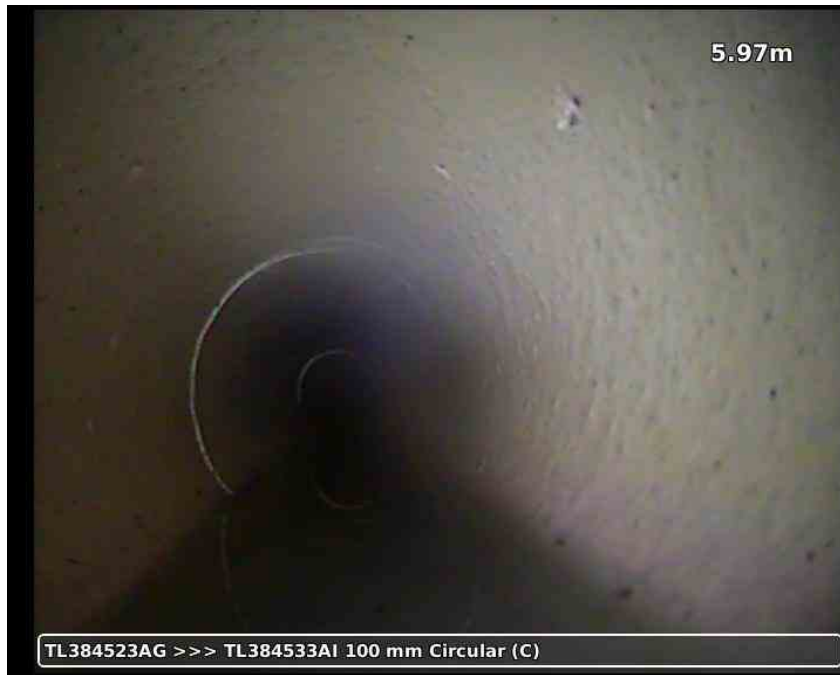
20210617-185600-snap0008.jpg, 00:01:41, 5.97 m
Water level, 20% % of the vertical dimension

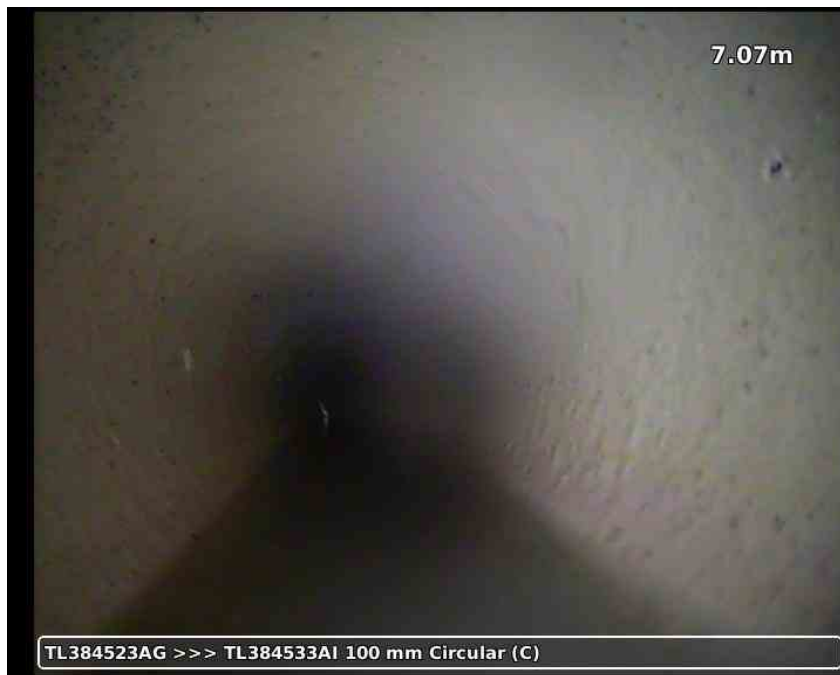
20210617-185600-snap0011.jpg, 00:02:22, 7.07 m
Water level, 20% % of the vertical dimension

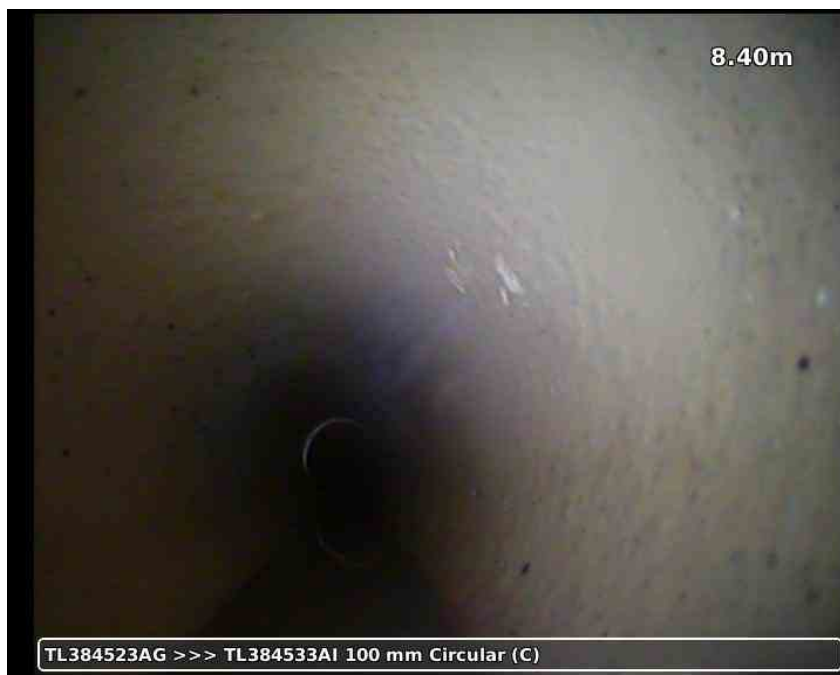
20210617-185600-snap0013.jpg, 00:02:45, 8.40 m
Water level, 10% % of the vertical dimension

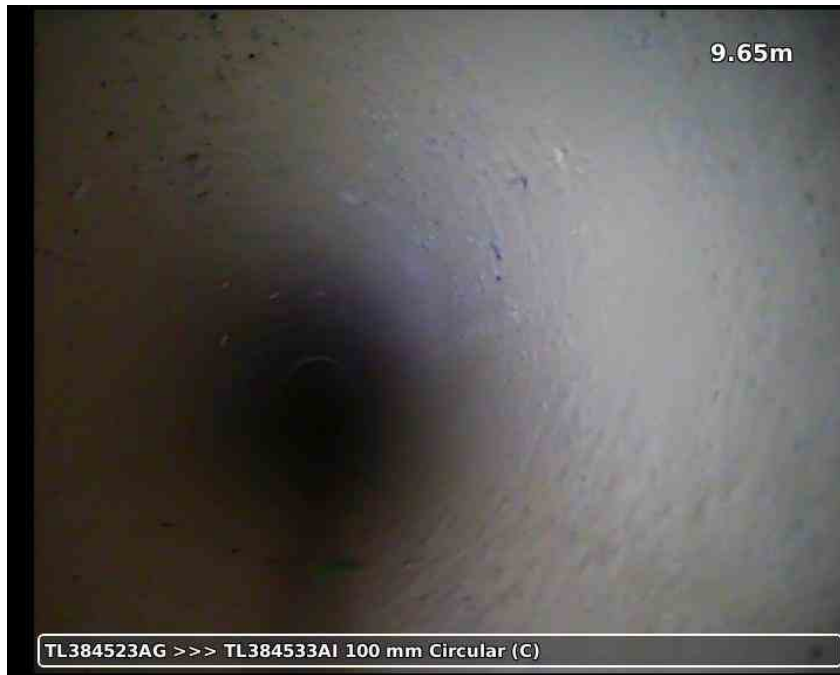
20210617-185600-snap0014.jpg, 00:02:57, 9.65 m
Water level, 5% % of the vertical dimension

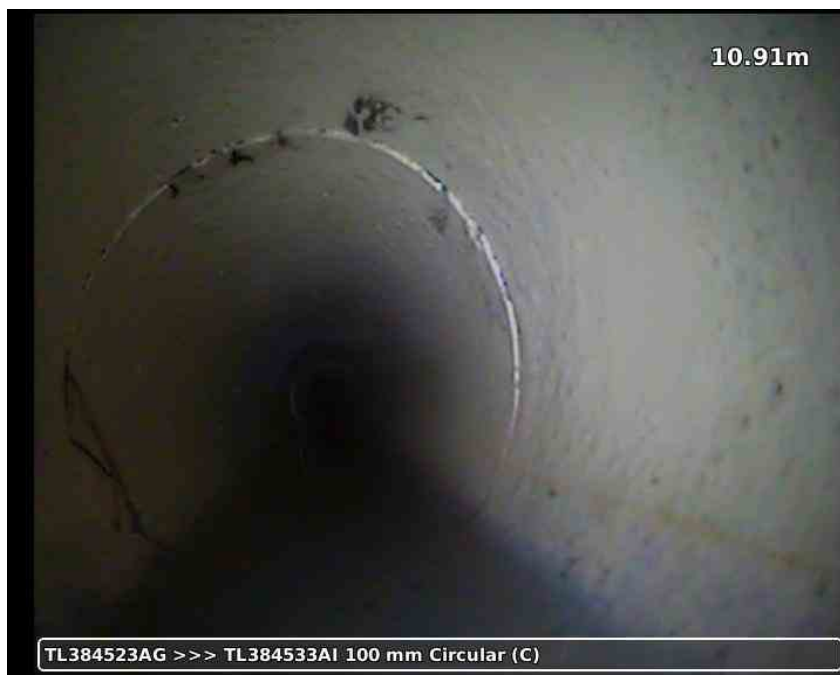
20210617-185600-snap0015.jpg, 00:03:08, 10.91 m
Water level, 20% % of the vertical dimension

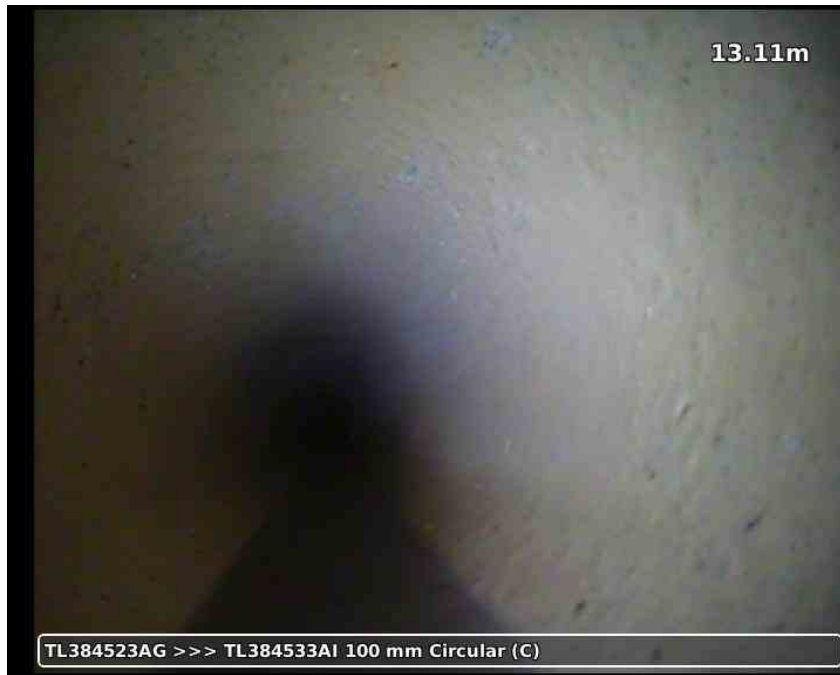
20210617-185600-snap0018.jpg, 00:03:43, 13.11 m
Water level, 10% % of the vertical dimension

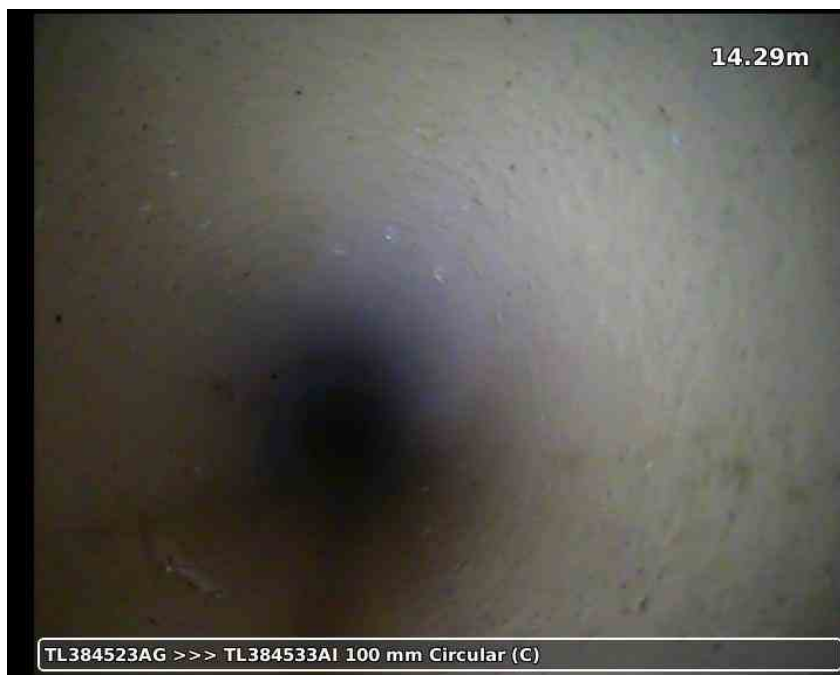
20210617-185600-snap0019.jpg, 00:03:52, 14.29 m
Water level, 5% % of the vertical dimension

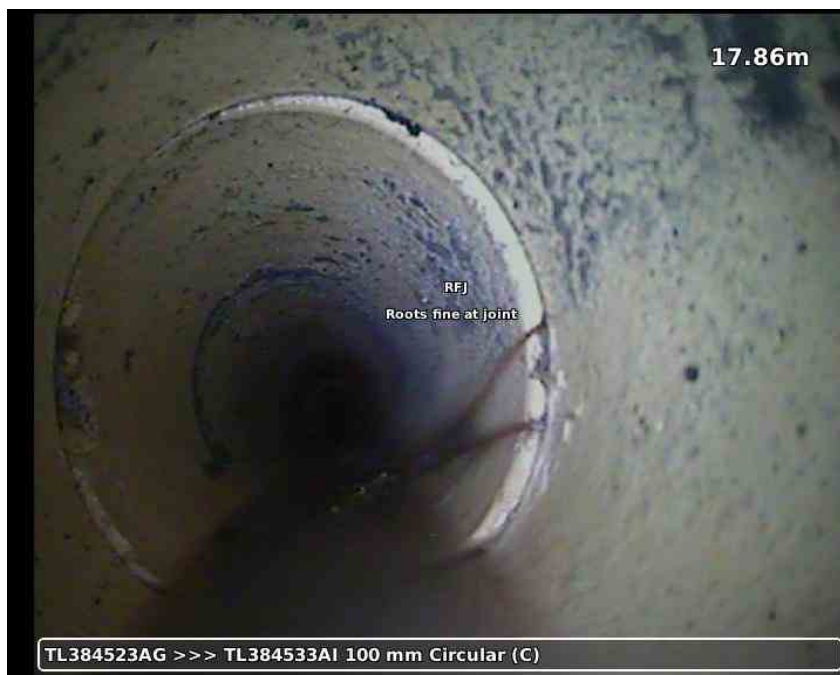
20210617-185600-snap0021.jpg, 00:04:19, 17.86 m
Water level, 15% % of the vertical dimension

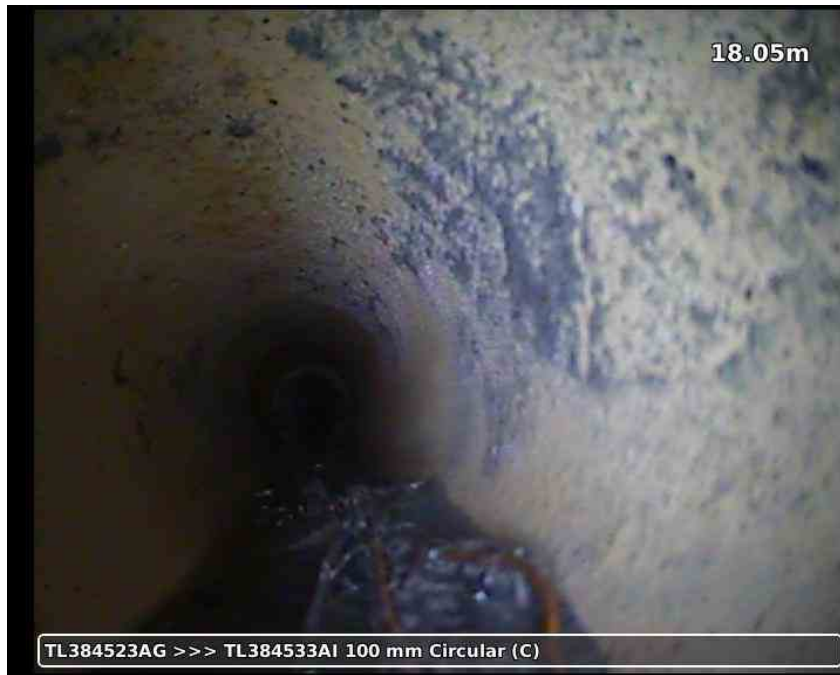
20210617-185600-snap0022.jpg, 00:04:28, 18.05 m
Roots, mass, 20% % cross-sectional area loss

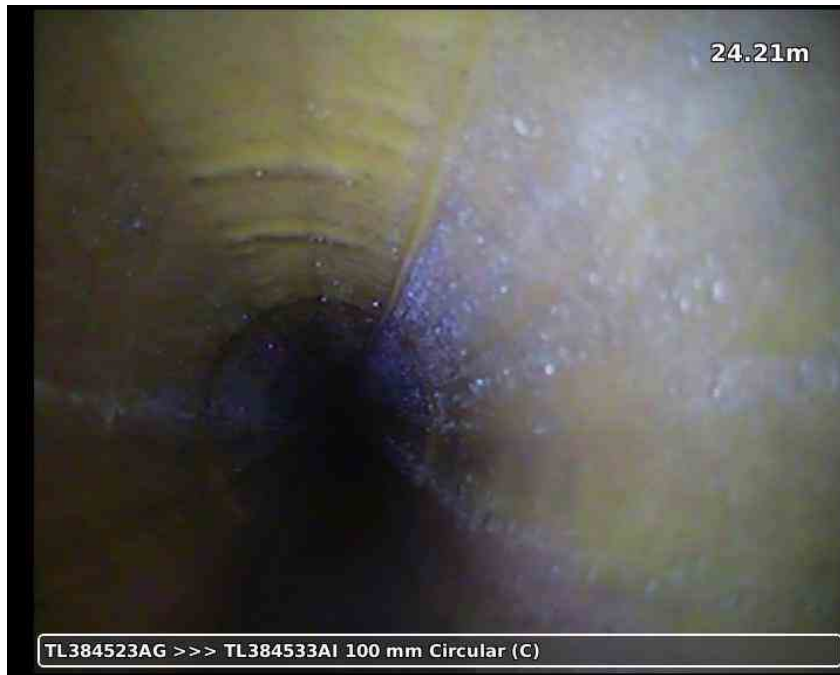
20210617-185600-snap0026.jpg, 00:05:49, 24.21 m
Water level, 15% % of the vertical dimension

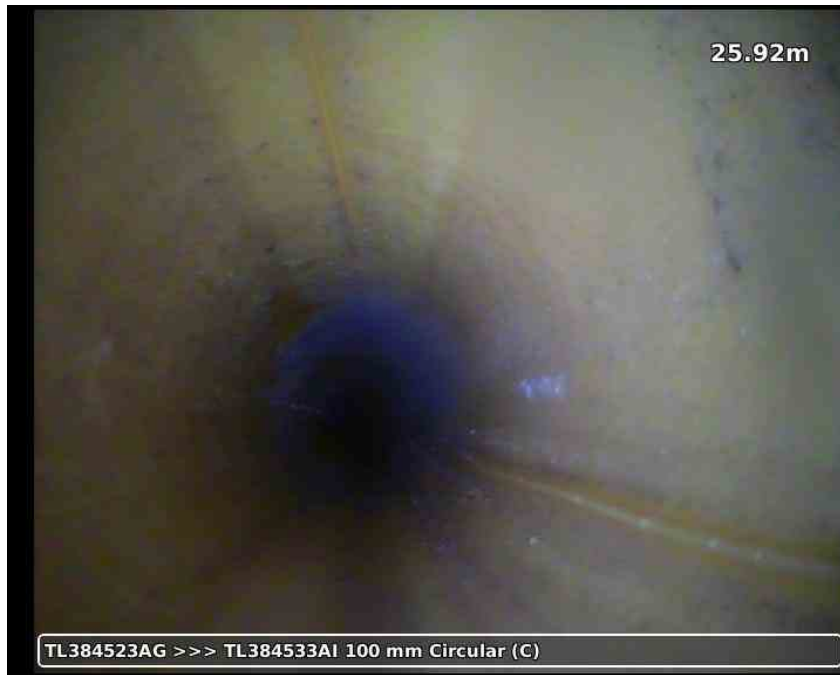
20210617-185600-snap0028.jpg, 00:06:18, 25.92 m
Water level, 5% % of the vertical dimension

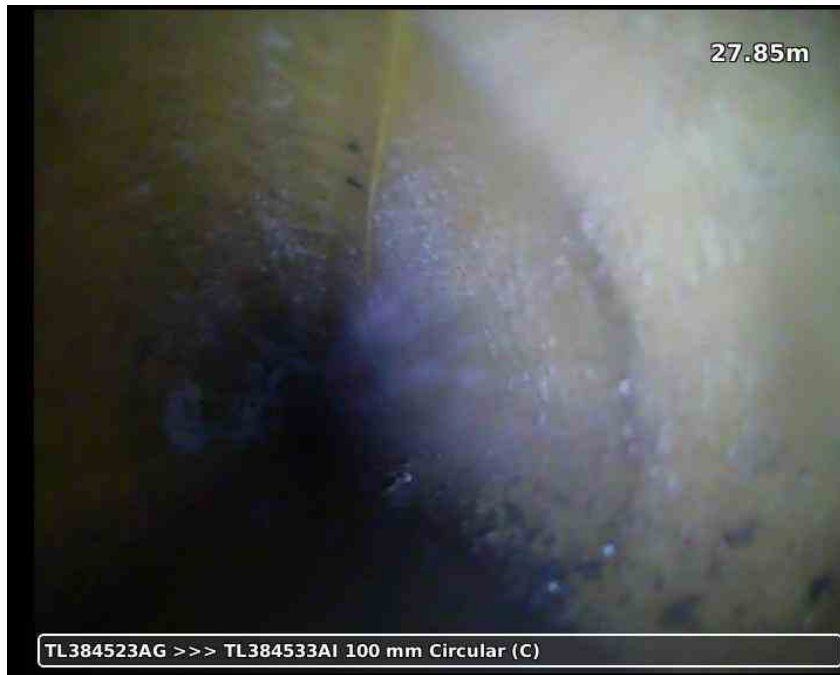
20210617-185600-snap0030.jpg, 00:06:38, 27.85 m
Water level, 10% % of the vertical dimension

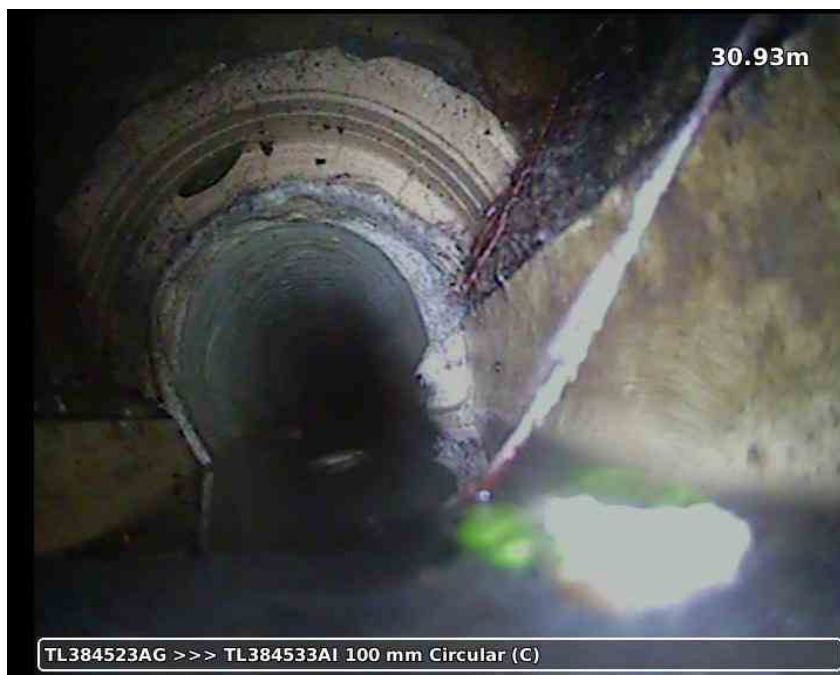
20210617-185600-snap0033.jpg, 00:07:35, 30.93 m
Finish node type, manhole, reference number: TL384533AI

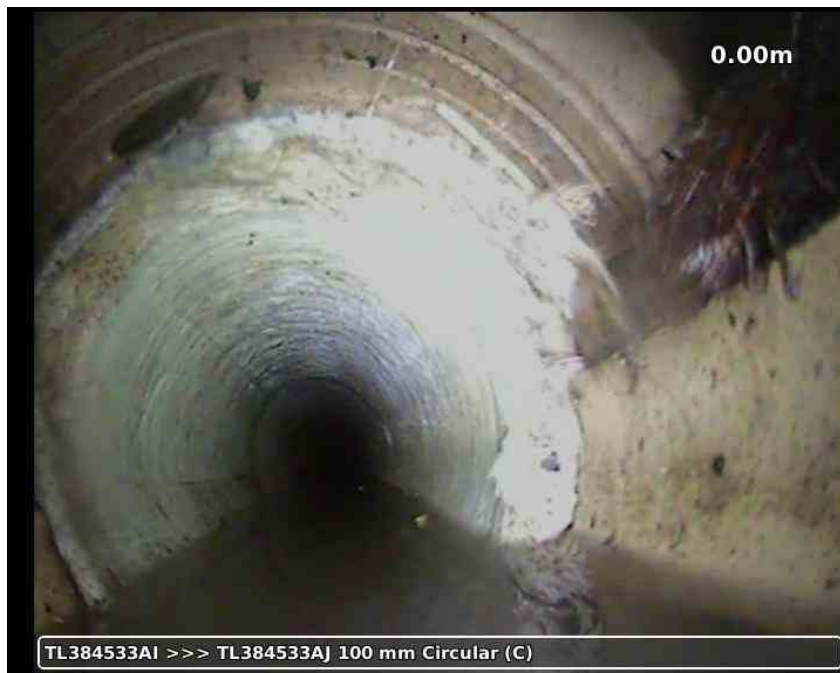
20210617-191337-snap0001.jpg, 00:00:02, 0.00 m
 Water level, 10% % of the vertical dimension

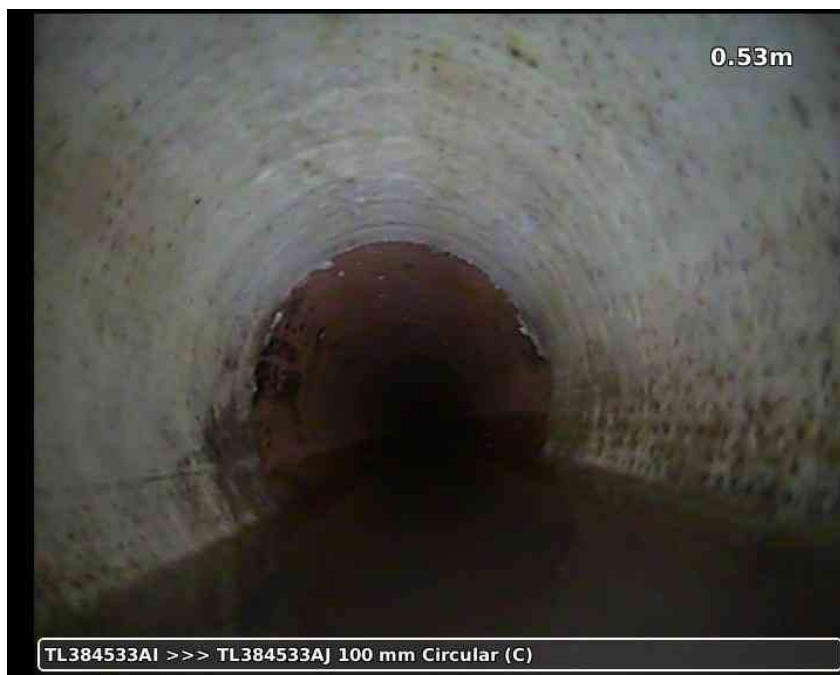
20210617-191337-snap0003.jpg, 00:00:29, 0.53 m
Water level, 20% % of the vertical dimension

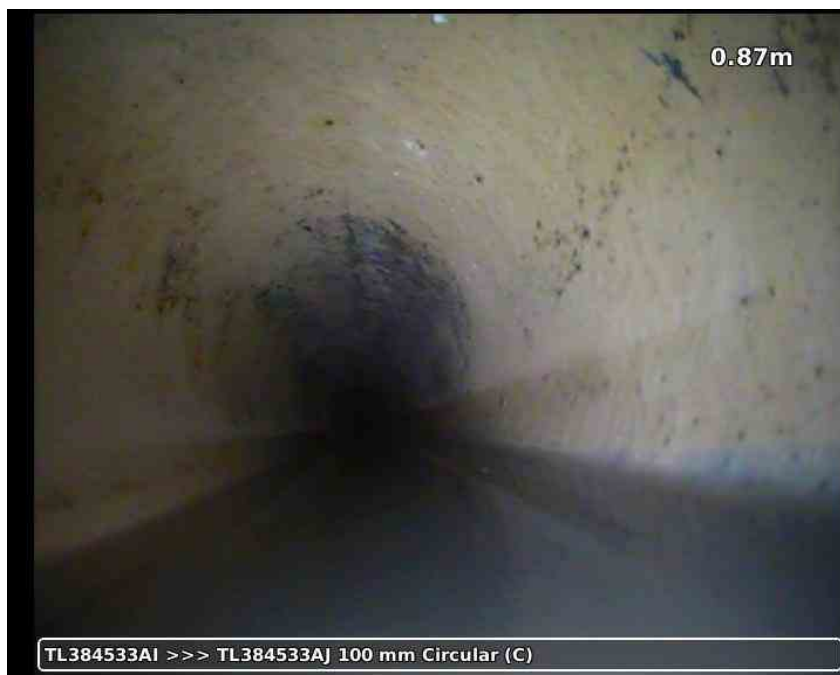
20210617-191337-snap0005.jpg, 00:01:05, 0.87 m
Water level, 20% % of the vertical dimension

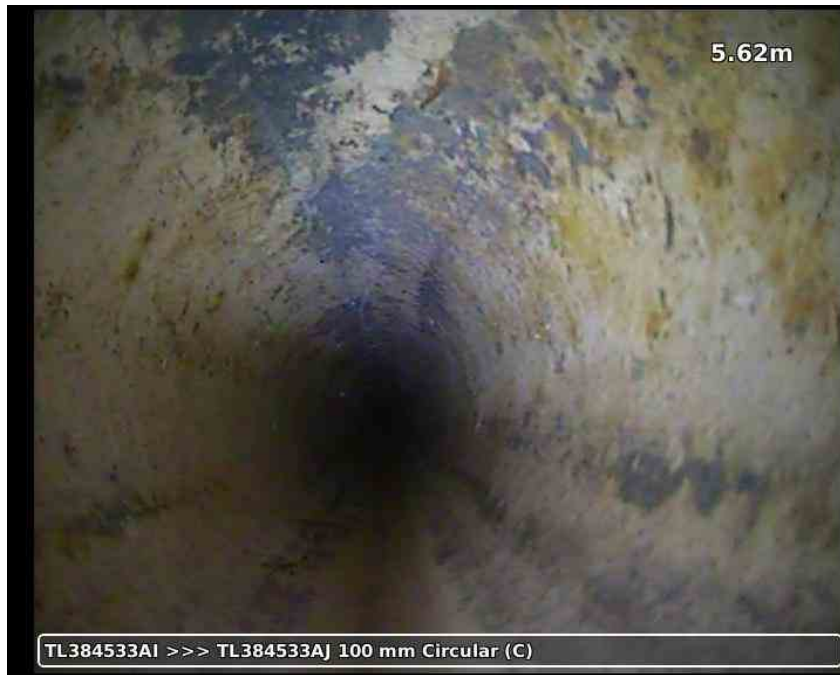
20210617-191337-snap0008.jpg, 00:02:06, 5.62 m
Water level, 5% % of the vertical dimension

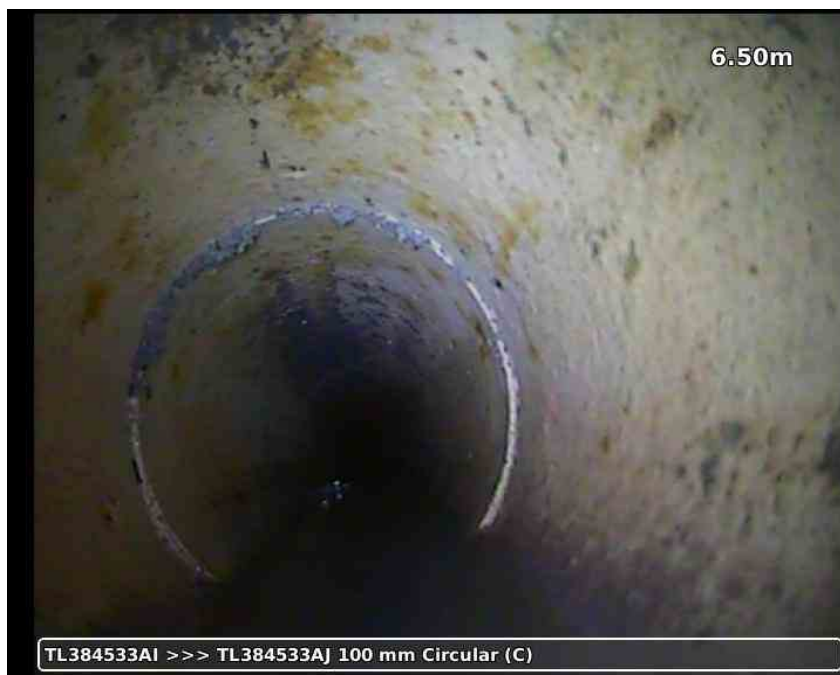
20210617-191337-snap0009.jpg, 00:02:26, 6.50 m
Water level, 10% % of the vertical dimension

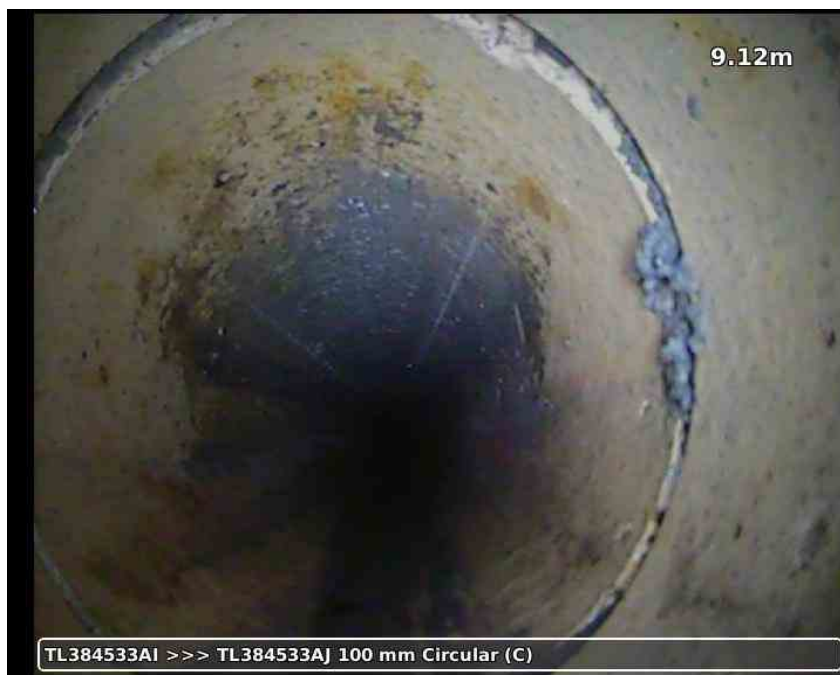
20210617-191337-snap0011.jpg, 00:03:14, 9.12 m
Water level, 5% % of the vertical dimension
