Project Name: 276430.Little Hands Nursery.SG8 6ED.BWW.Melbourn

Project Description: WinCan Import in Miraculix WRc4 Standard

Project Date: 18/06/2021

Inspection Standard: MSCC4 Sewers & Drainage GB (SRM4 Scoring)

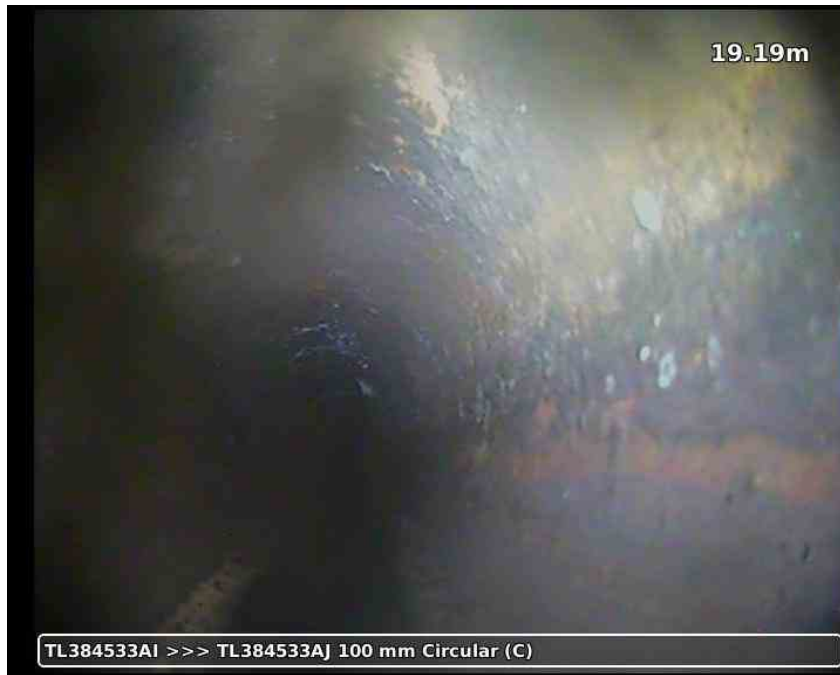
20210617-191337-snap0016.jpg, 00:05:16, 19.19 m
Water level, 10% % of the vertical dimension

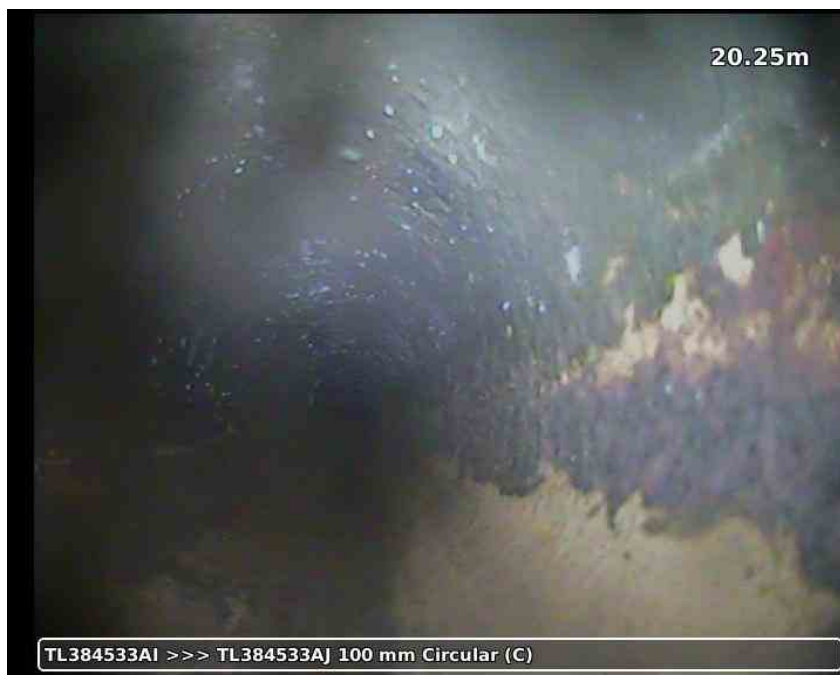
20210617-191337-snap0017.jpg, 00:05:29, 20.25 m
Water level, 5% % of the vertical dimension

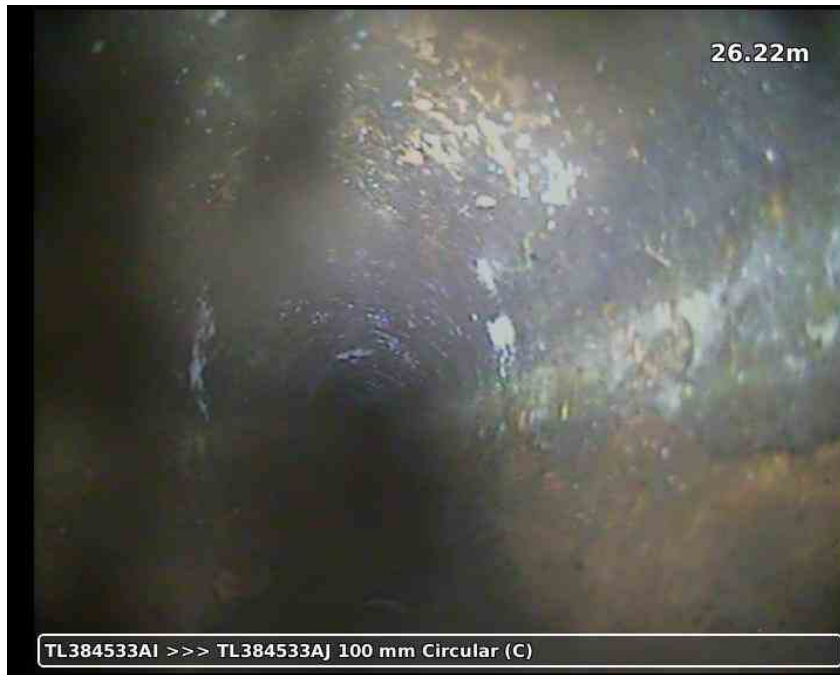
20210617-191337-snap0018.jpg, 00:06:19, 26.22 m
Water level, 10% % of the vertical dimension

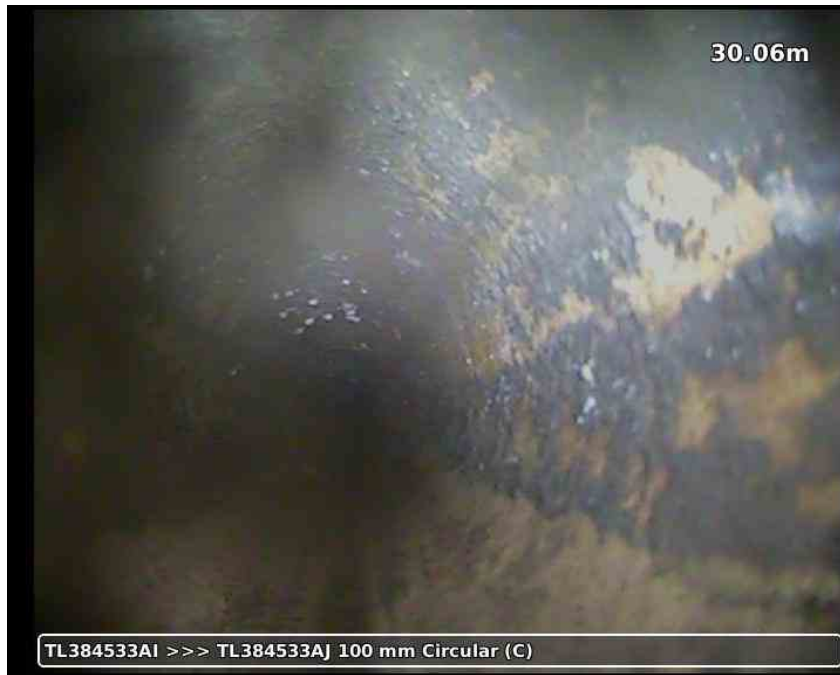
20210617-191337-snap0020.jpg, 00:07:07, 30.06 m
Water level, 5% % of the vertical dimension

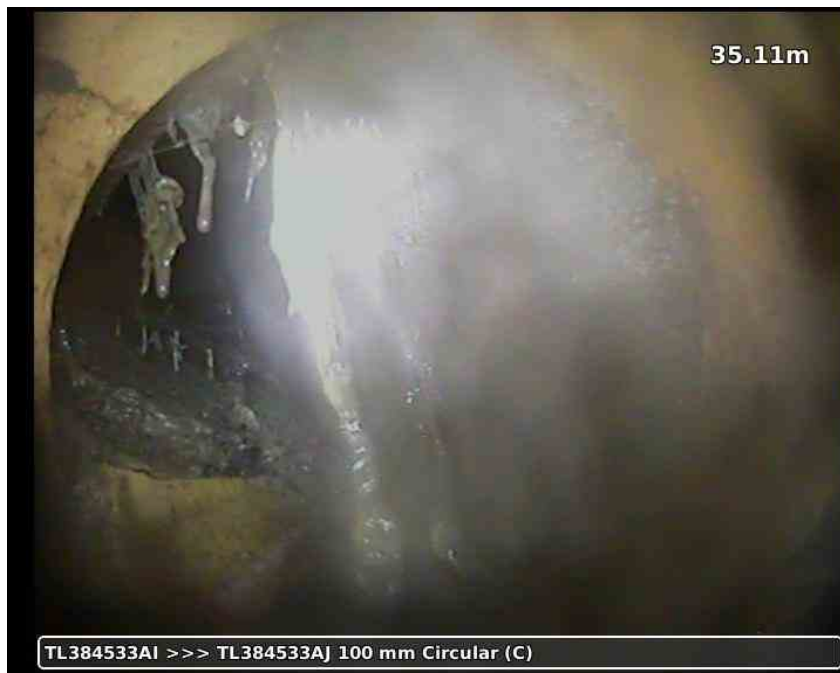
20210617-191337-snap0025.jpg, 00:08:34, 35.11 m
Roots, mass, 30% % cross-sectional area loss
