MELBOURN PARISH COUNCIL - MAINTENANCE COMMITTEE

A meeting of the Maintenance Committee held on Thursday, 22 July 2021 at 09:30 at The Pavilion on the New Rec, The Moor, Melbourn, SG8 6ED

Inspection Standard: MSCC4 Sewers & Drainage GB (SRM4 Scoring)

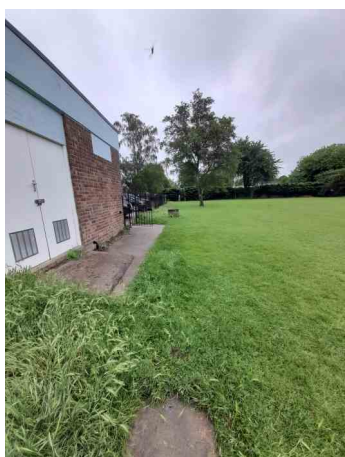
Section 10

Section 10, Starting water level is 40% which increases upto 60% & back flowing was observed.

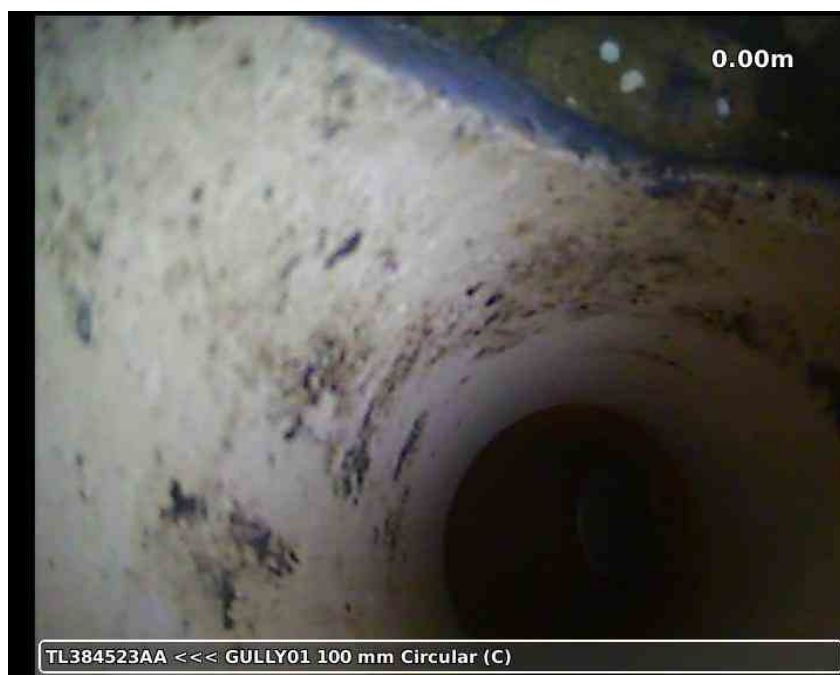
20210617-161336-snap0001.jpg, 00:00:02, 0.00 m
 Water level, 5% % of the vertical dimension

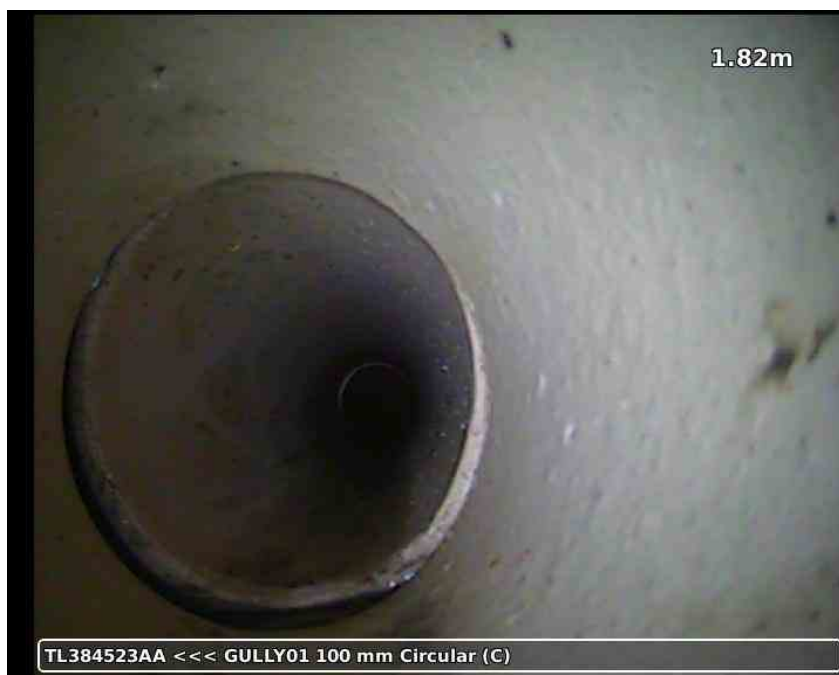
20210617-161336-snap0004.jpg, 00:00:31, 1.82 m
Open joint, medium

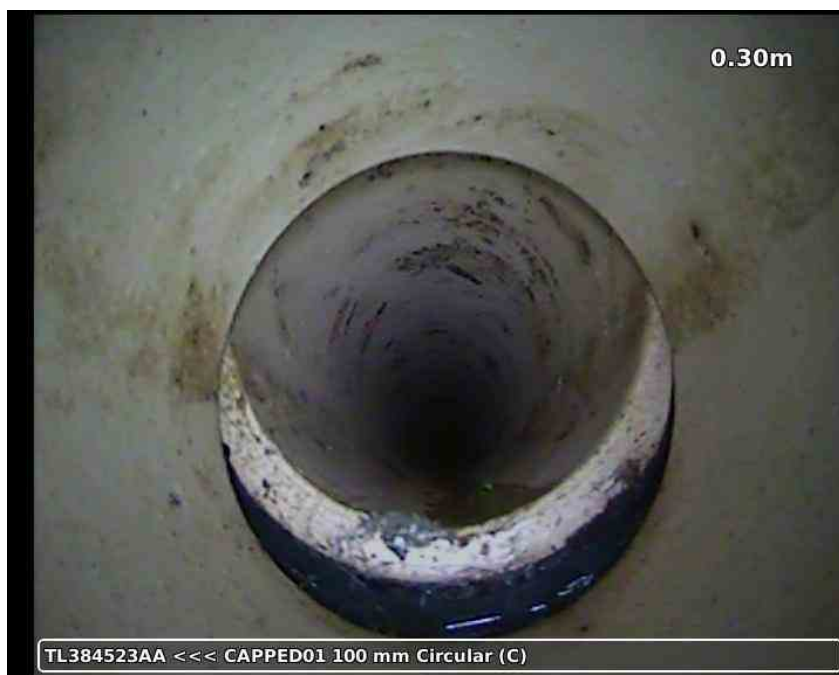
Section 2, Line is capped off at the rest bend, medium displaced joint found at 0.30m.

20210617-161651-snap0002.jpg, 00:00:18, 0.30 m
 Joint displaced, 20 mm displacement

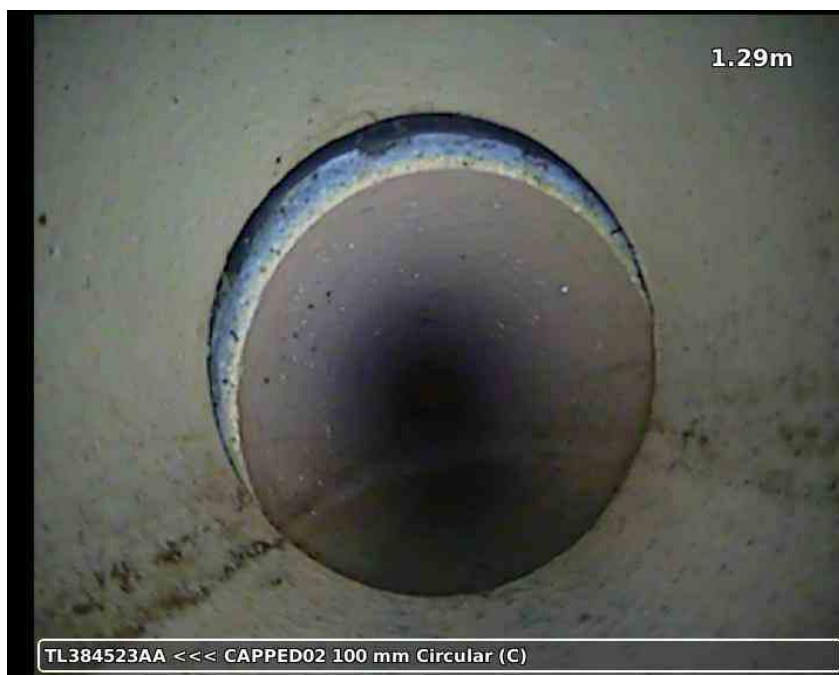
Section 3, Line is capped off at the rest bend, medium displaced joint found at 1.29m

20210617-161854-snap0002.jpg, 00:00:28, 1.29 m
Joint displaced, 10 mm displacement

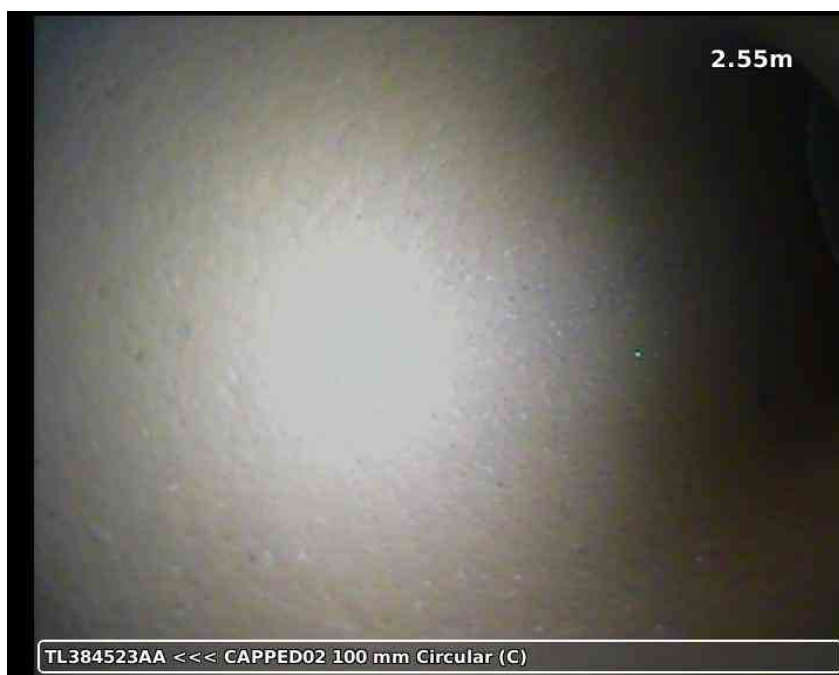
20210617-161854-snap0003.jpg, 00:01:01, 2.55 m
Line deviates right

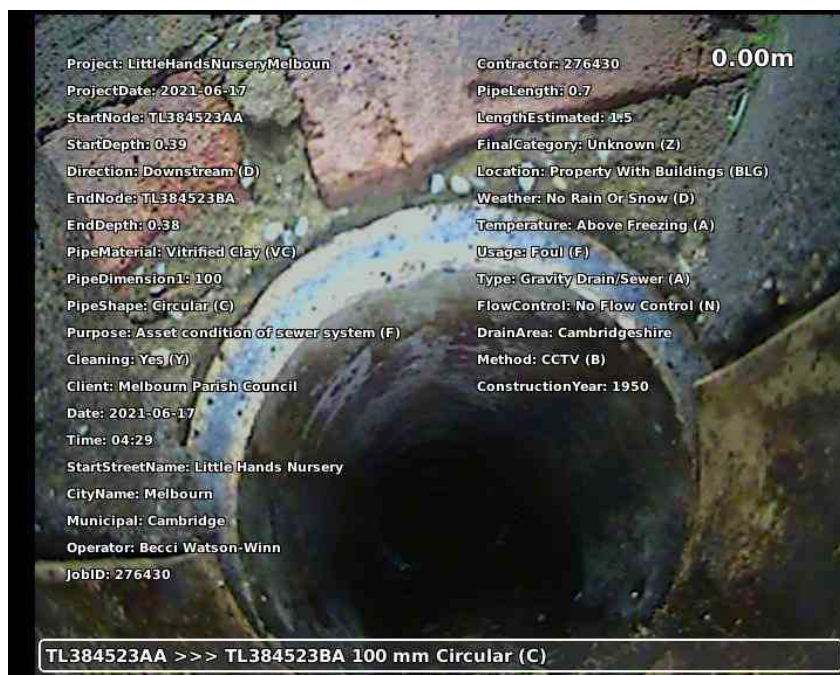
Town or Village:	Melbourn	Inspection Direction:	Downstream	Upstream Node:	TL384523AA
Road:	Little Hands Nursery	Inspected Length:	1.41 m	Upstream Pipe Depth:	0.390 m
Location:	Other pedestrian area	Total Length:	1.41 m	Downstream Node:	TL384523BA
Surface Type:	Grass	Joint Length:	0.70 m	Downstream Pipe Depth:	0.380 m
Use:	Foul	Pipe Shape:	Circular		
Type of Pipe:	Gravity drain/sewer	Dia/Height:	100 mm		
Year Constructed:	1950	Pipe Material:	Vitrified clay pipe (i.e. all clayware)		
Flow Control:	No flow control	Lining Type:	No Lining		
Inspection Purpose:	Sample survey to determine asset condition			Lining Material:	No Lining
Comments:	Chamber lid is damaged				
Recommendations:	Replace chamber frame & cover

20210617-163005-snap0000.jpg, 00:00:00, 0.00 m
 Start node type, manhole, reference number: TL384523AA

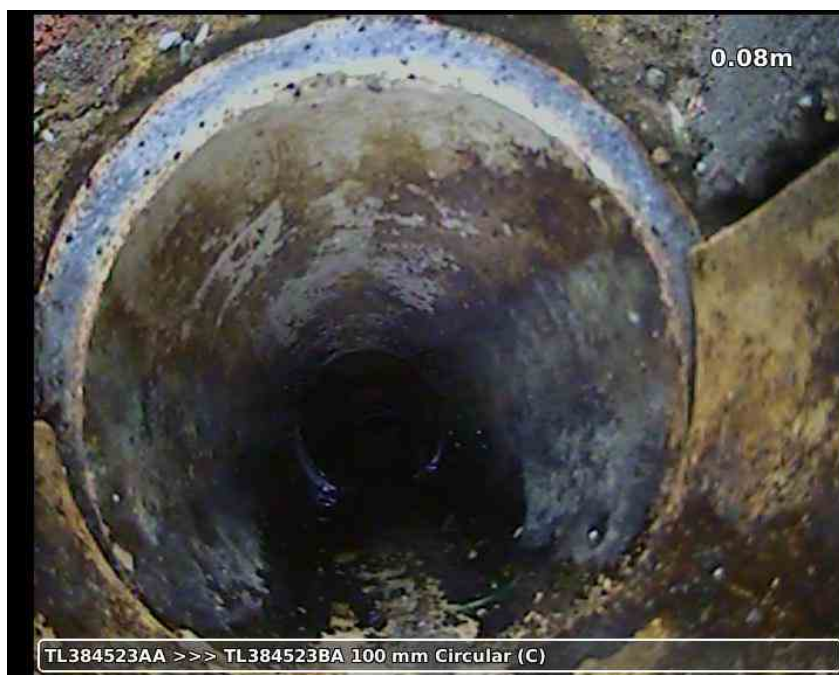
20210617-163005-snap0002.jpg, 00:00:17, 0.08 m
Joint displaced, medium

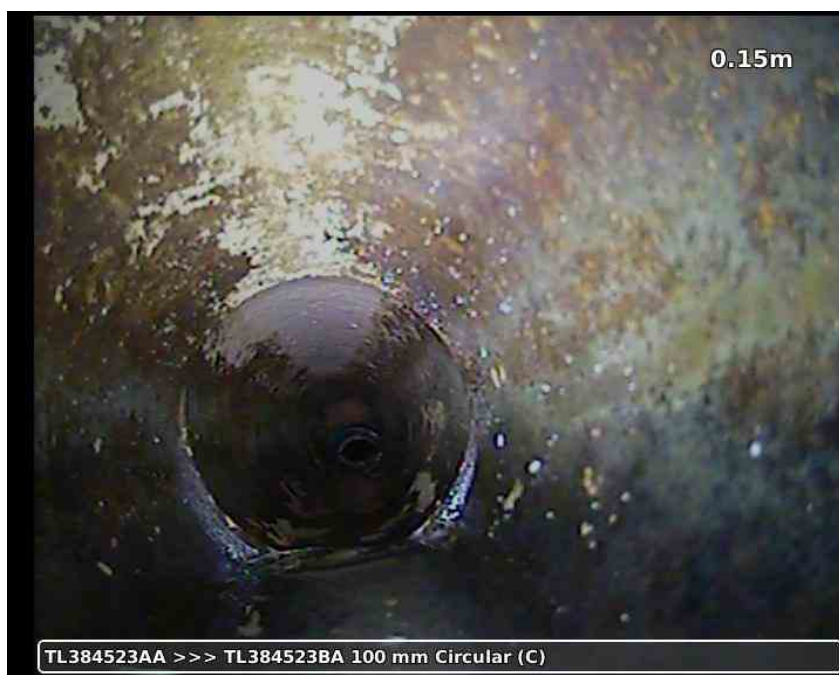
20210617-163005-snap0003.jpg, 00:00:25, 0.15 m
Attached deposits, fouling, from 01 to 11 o'clock, 5% % cross-sectional area loss, S01

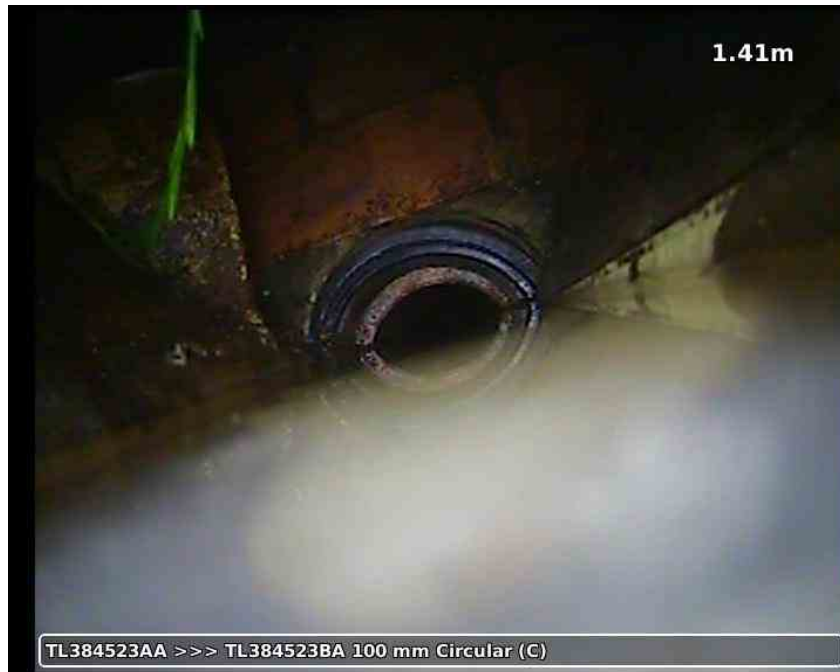
20210617-163005-snap0006.jpg, 00:01:02, 1.41 m
Water level, 40% % of the vertical dimension

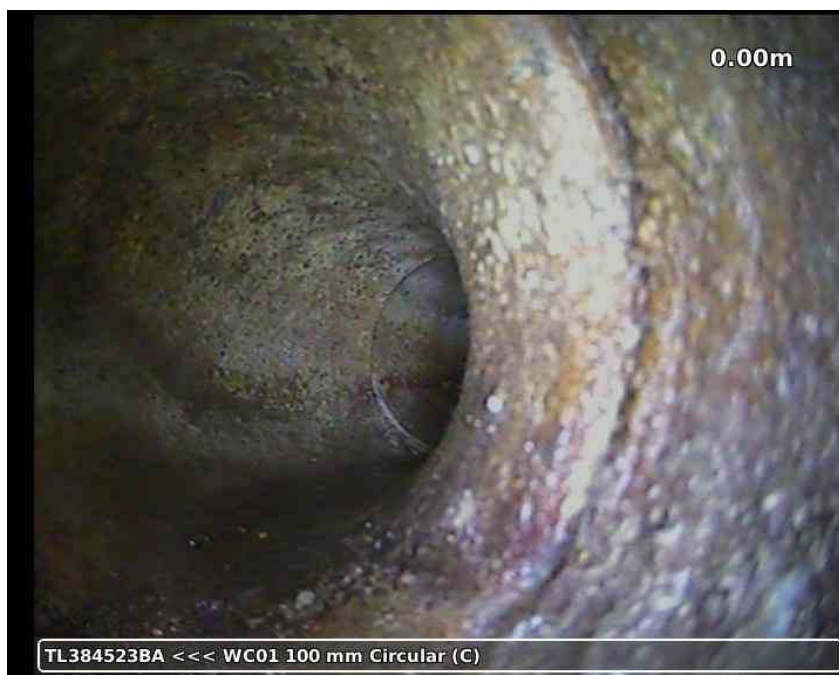
20210617-164432-snap0002.jpg, 00:00:09, 0.00 m
General remark, LINE HASN'T BEEN CLEANED PRE SURVEY

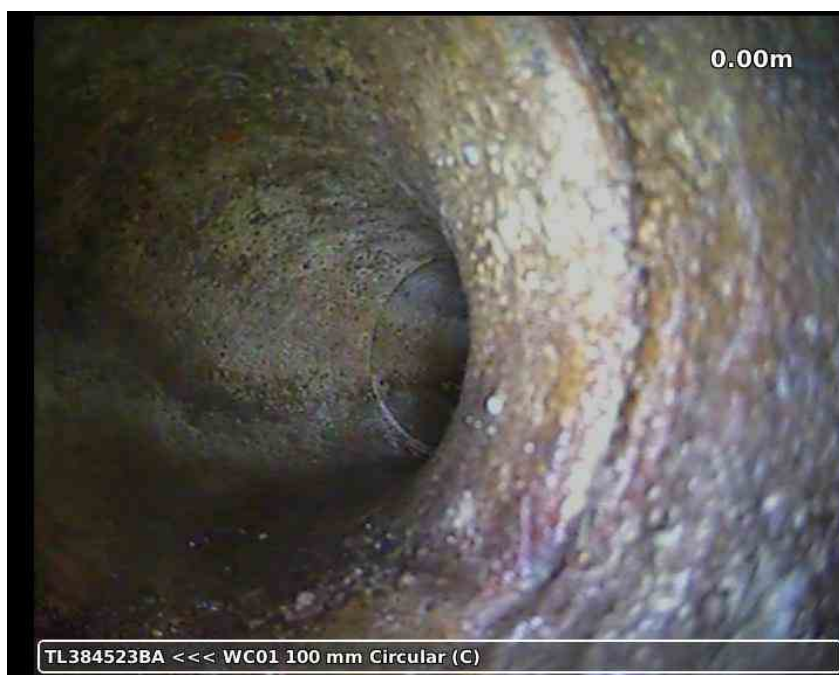
20210617-164432-snap0003.jpg, 00:00:15, 0.00 m
Attached deposits, fouling, from 01 to 12 o'clock, 5% % cross-sectional area loss, S01

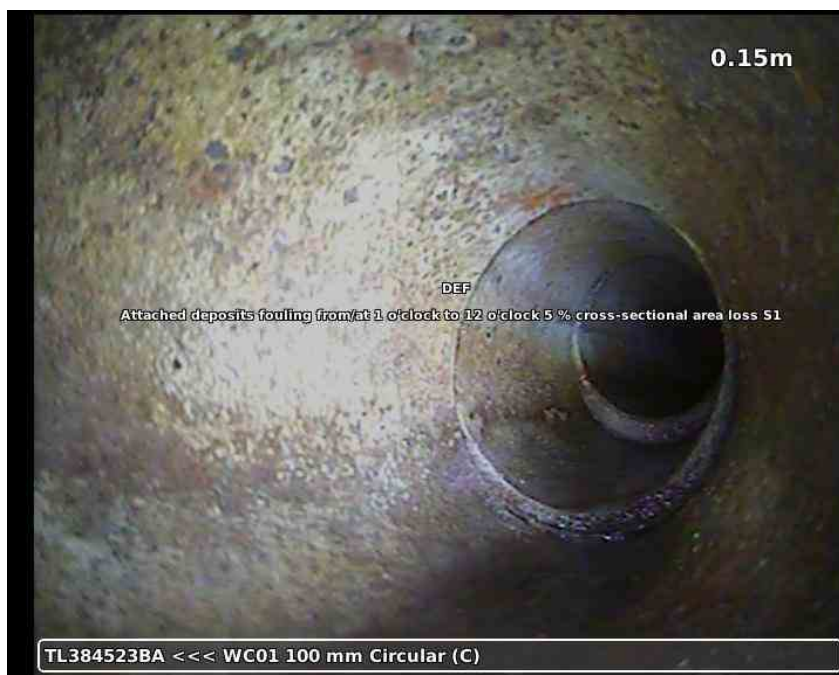
20210617-164432-snap0004.jpg, 00:00:24, 0.15 m
Line deviates right

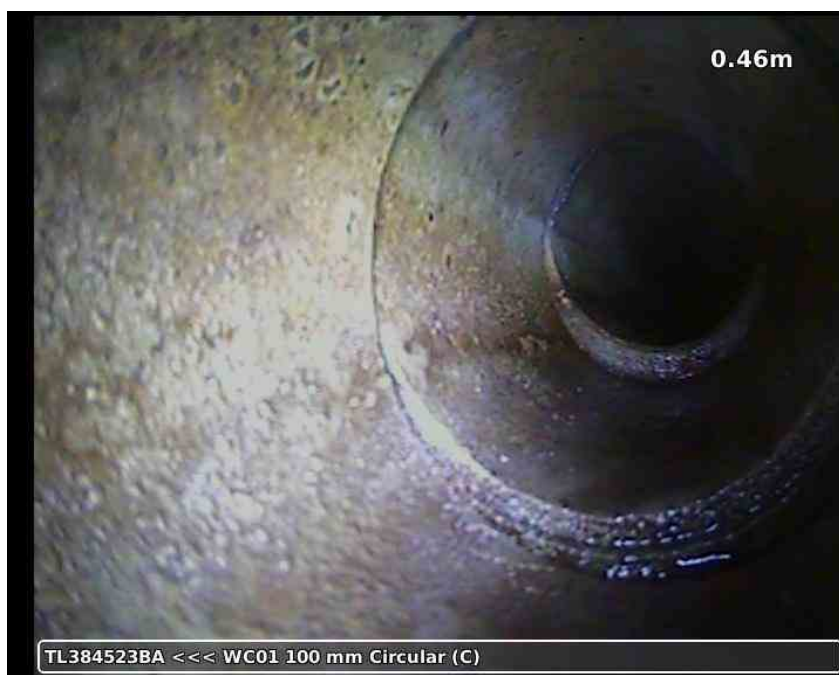
20210617-164432-snap0005.jpg, 00:00:35, 0.46 m
Open joint, medium

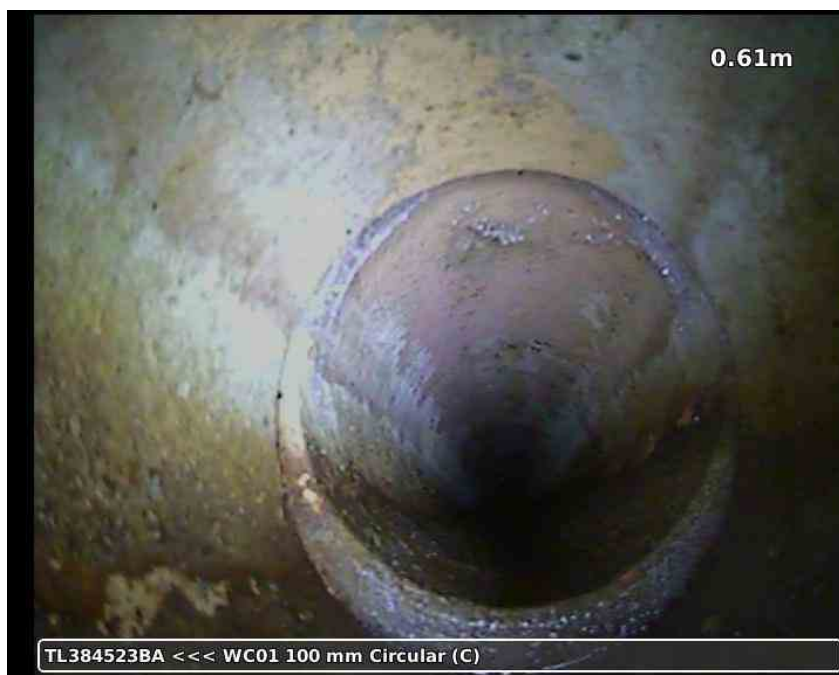
20210617-164432-snap0006.jpg, 00:00:45, 0.61 m
 Joint displaced, 10 mm displacement

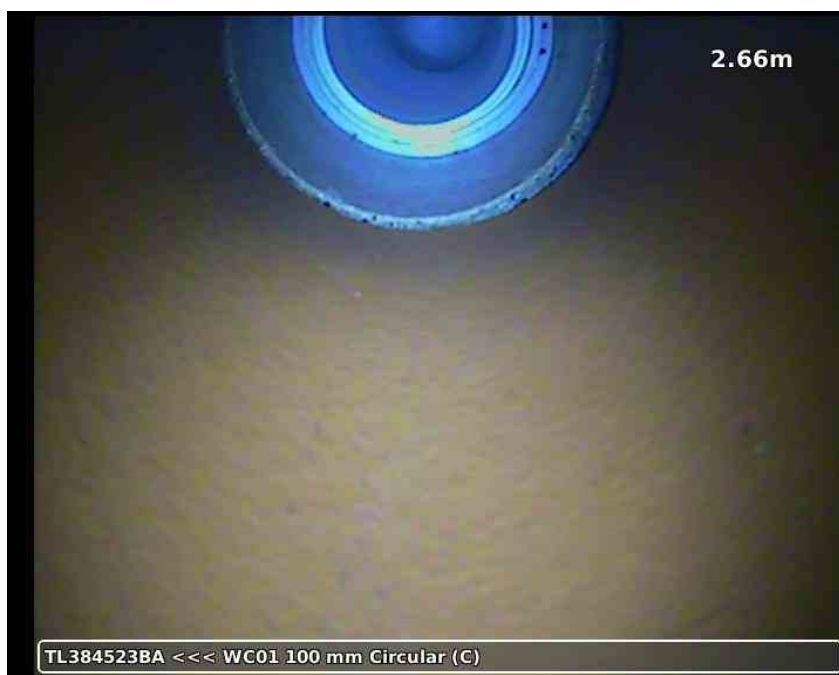
20210617-164432-snap0007.jpg, 00:01:15, 2.66 m
 Finish node type, other special chamber, reference number: WC01, Internal rest bend WC01

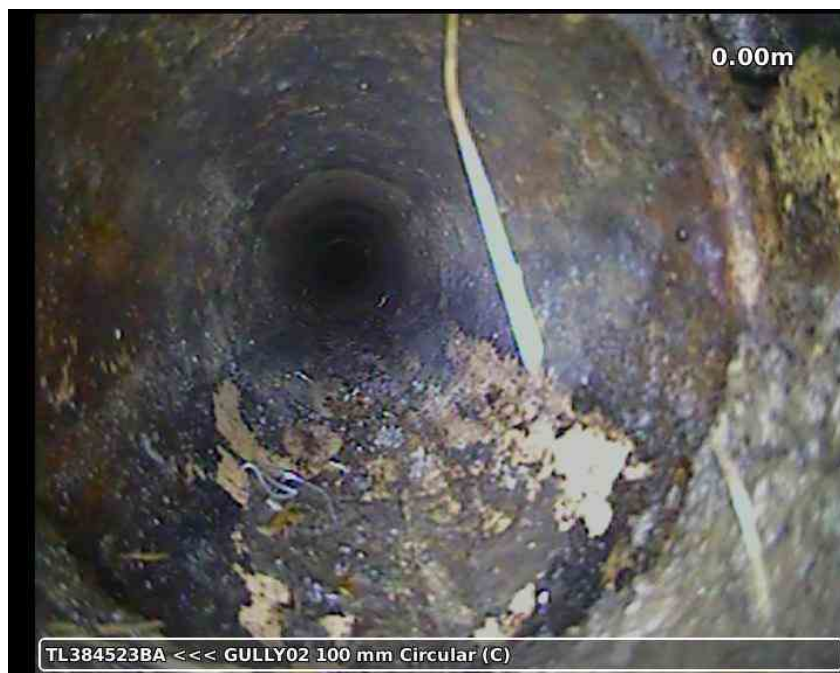
20210617-164707-snap0001.jpg, 00:00:01, 0.00 m
 Water level, 0% % of the vertical dimension, DISUSED GULLY

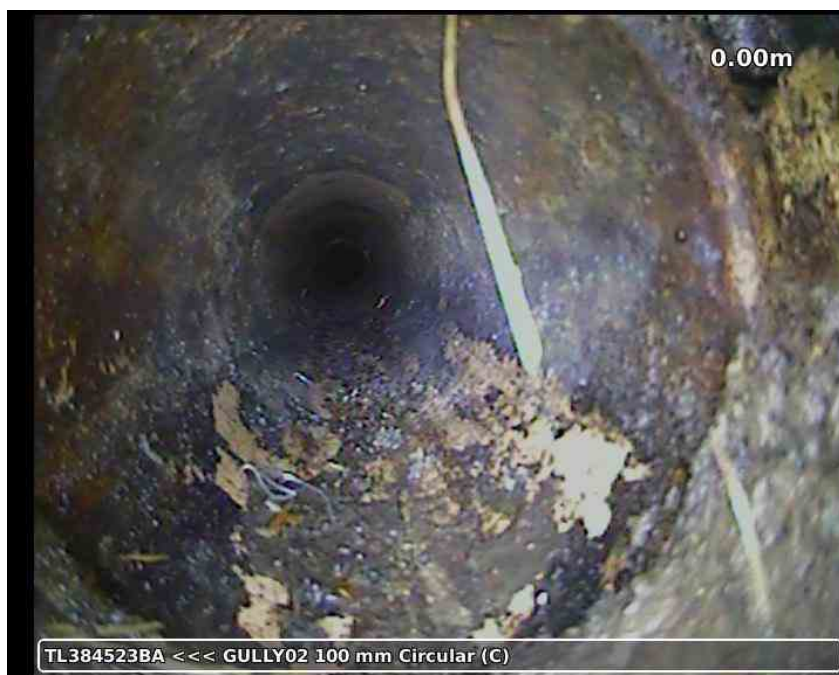
20210617-164707-snap0002.jpg, 00:00:12, 0.00 m
Attached deposits, fouling, from 01 to 12 o'clock, 5% % cross-sectional area loss, S01

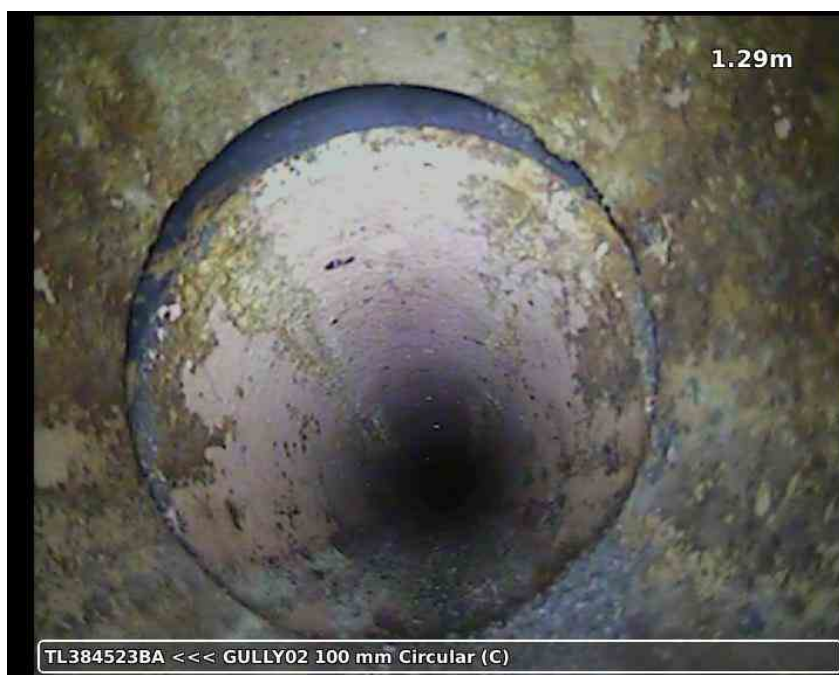
20210617-164707-snap0003.jpg, 00:00:35, 1.29 m
Open joint, medium

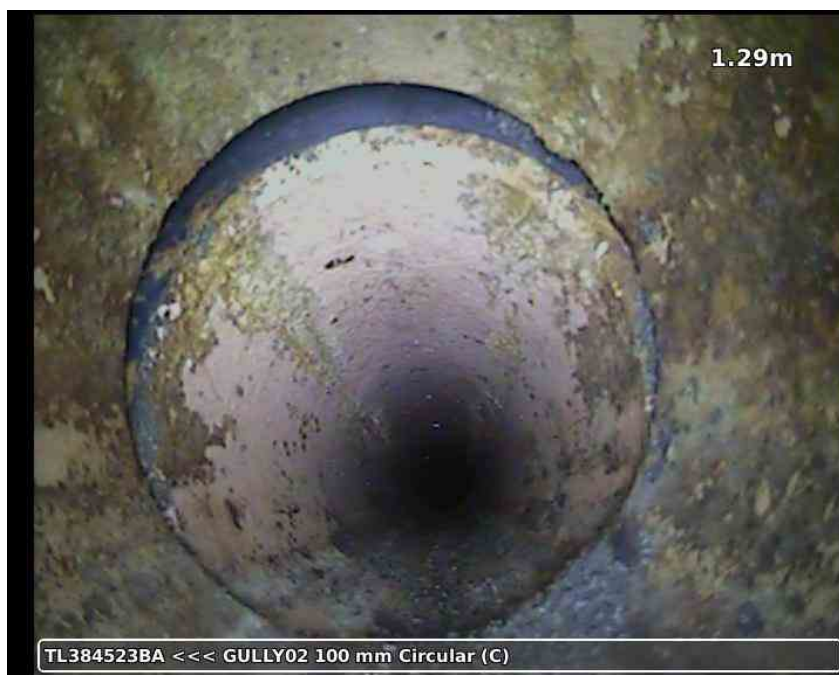
20210617-164707-snap0004.jpg, 00:00:39, 1.29 m
Joint displaced, 10 mm displacement

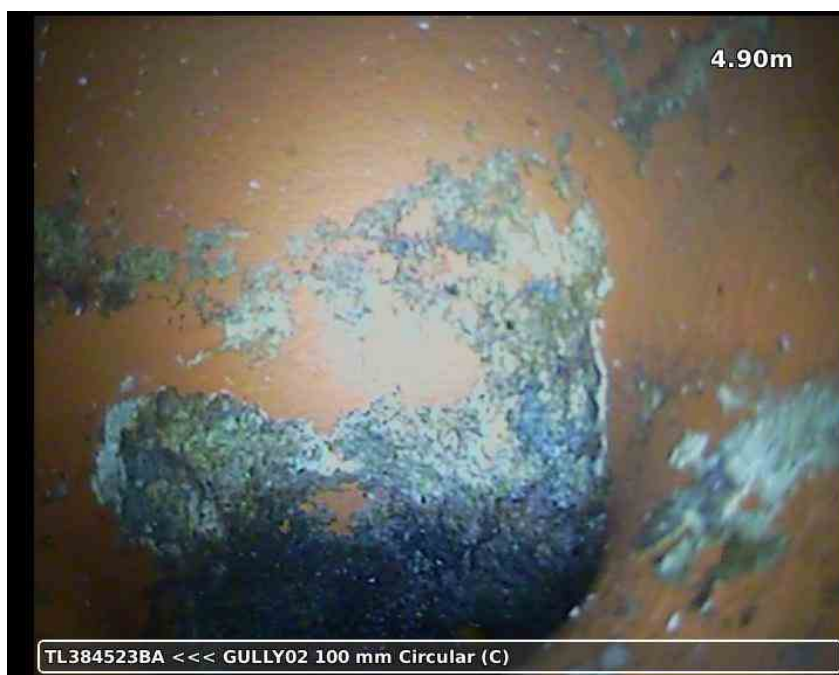
20210617-164707-snap0005.jpg, 00:01:19, 4.90 m
Finish node type, gully, reference number: GULLY02, DISUSED INTERNAL GULLY

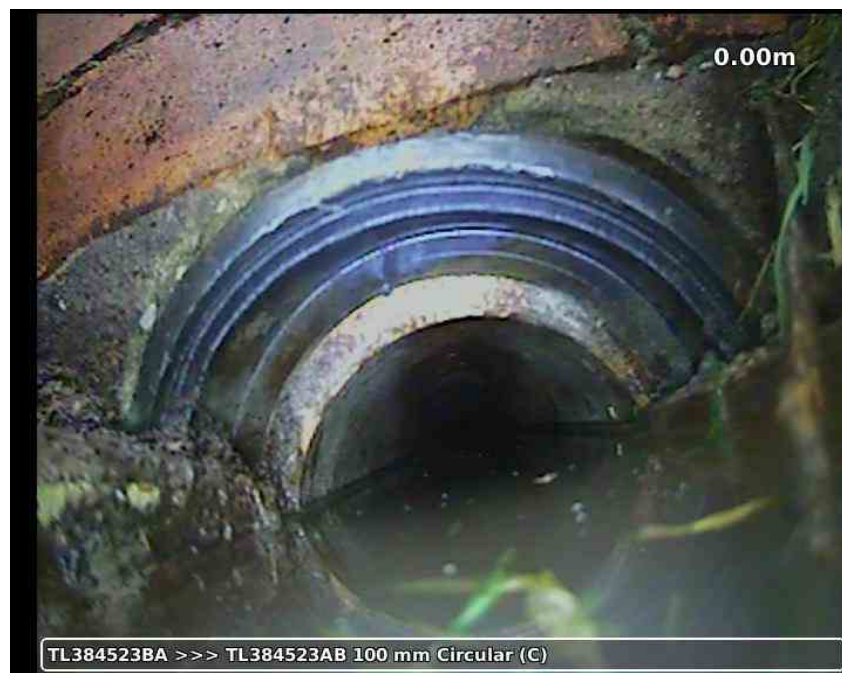
20210617-164942-snap0001.jpg, 00:00:01, 0.00 m
 Water level, 50% % of the vertical dimension

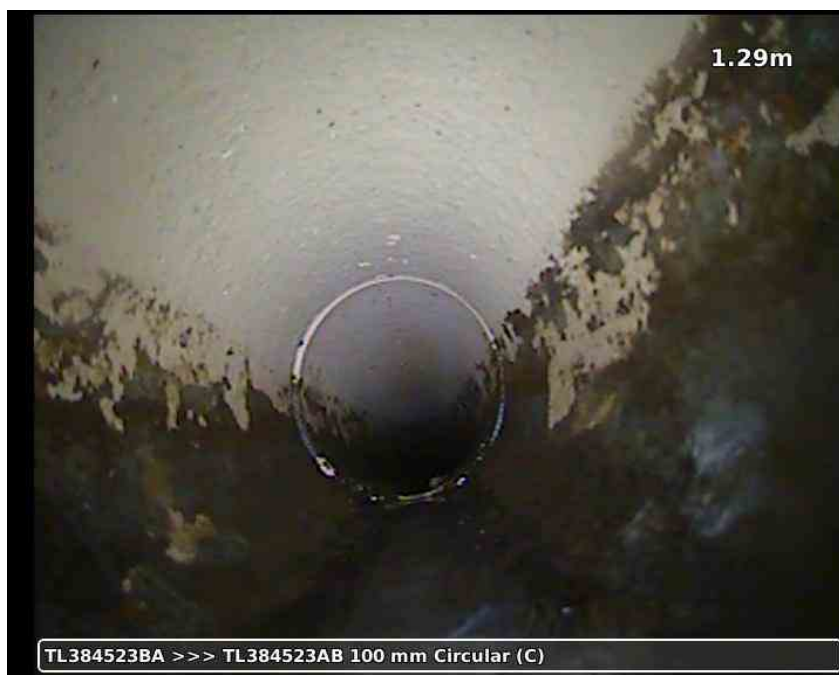
20210617-164942-snap0004.jpg, 00:00:40, 1.29 m
Attached deposits, fouling, from 02 to 10 o'clock, 5% % cross-sectional area loss, S02

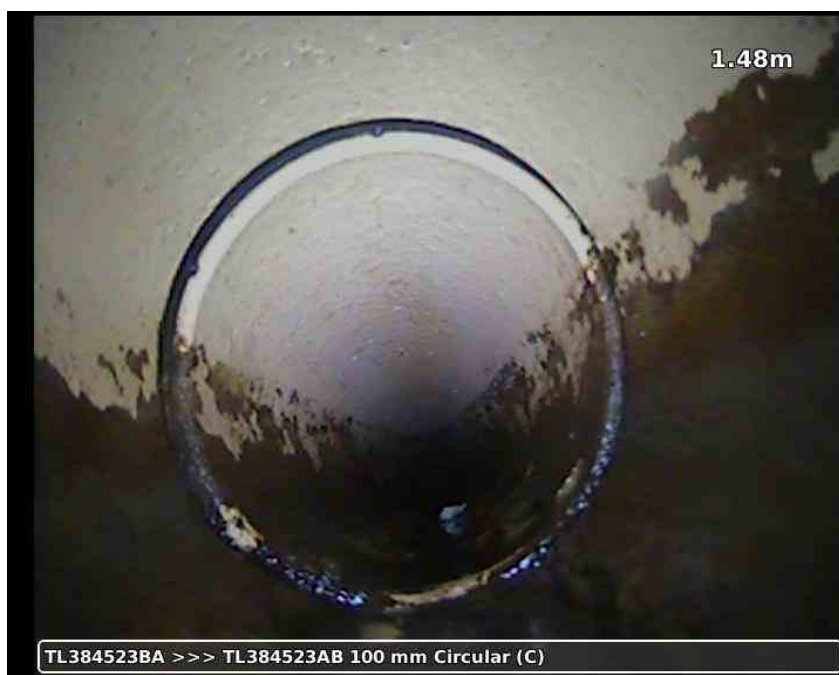
20210617-164942-snap0005.jpg, 00:00:52, 1.48 m
Open joint, medium

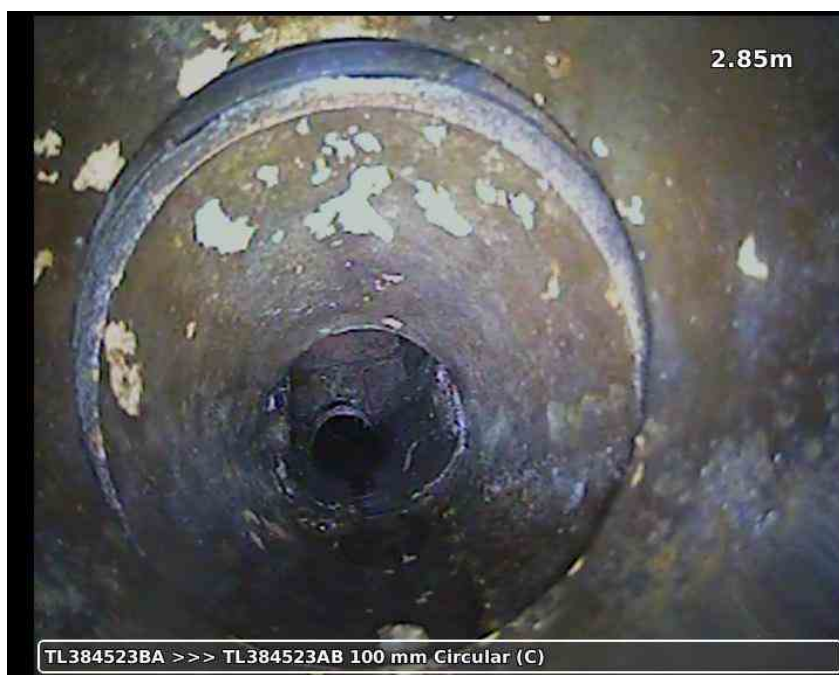
20210617-164942-snap0007.jpg, 00:01:15, 2.85 m
Joint displaced, 10 mm displacement

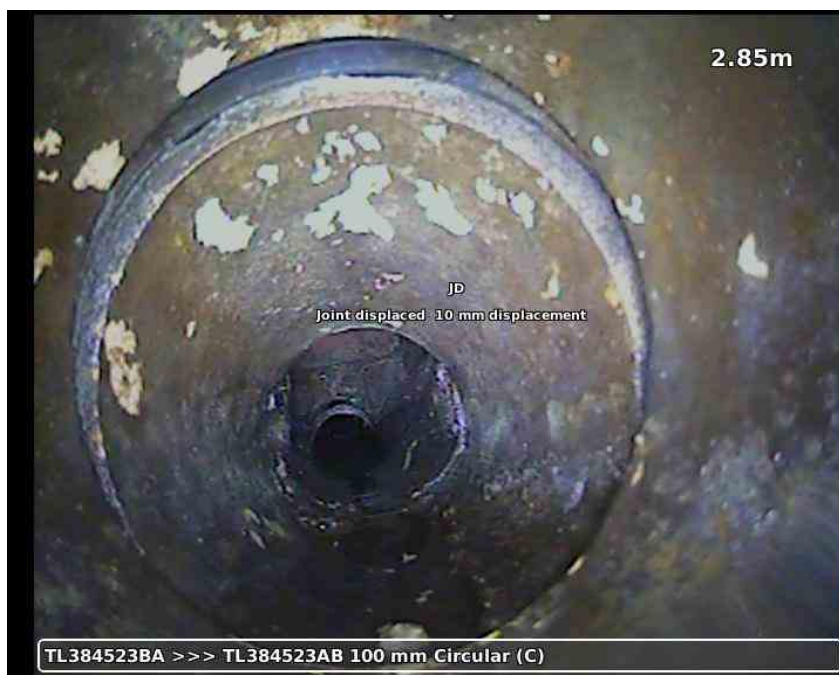
20210617-164942-snap0008.jpg, 00:01:21, 2.85 m
Open joint, medium

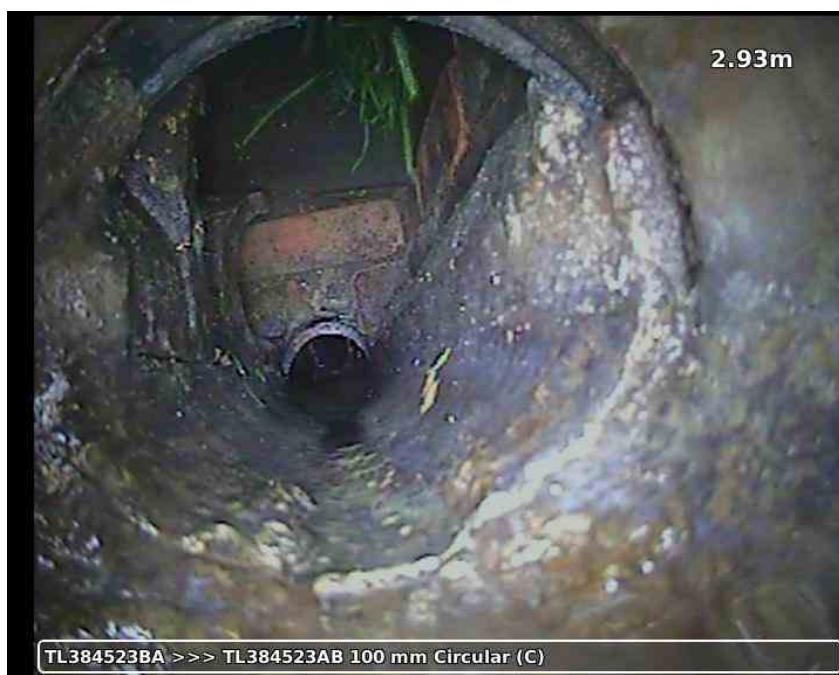
Section	PLR	Grade	Description
7	TL384523BAX	3	Settled deposits, hard or compacted, 20% % cross-sectional area loss
24	GULLY06X	3	Multiple defects
25	TL384523AHX	3	Settled deposits, fine at joint, 15% % cross-sectional area loss
27	TL384533AIX	5	Roots, mass, 30% % cross-sectional area loss

20210617-164942-snap0009.jpg, 00:01:35, 2.93 m
Settled deposits, hard or compacted, 20% % cross-sectional area loss

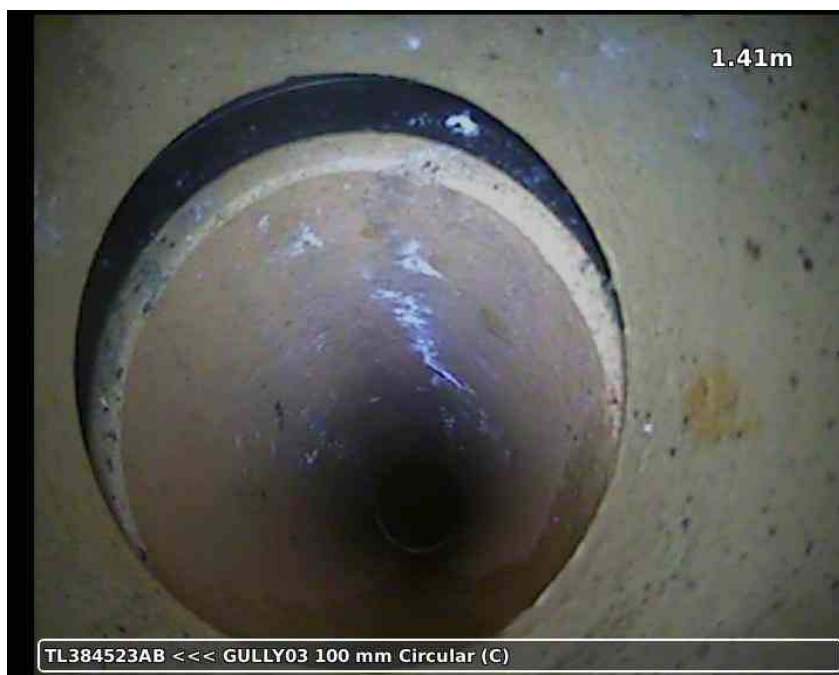
20210617-165624-snap0002.jpg, 00:00:24, 1.41 m
Joint displaced, 20 mm displacement

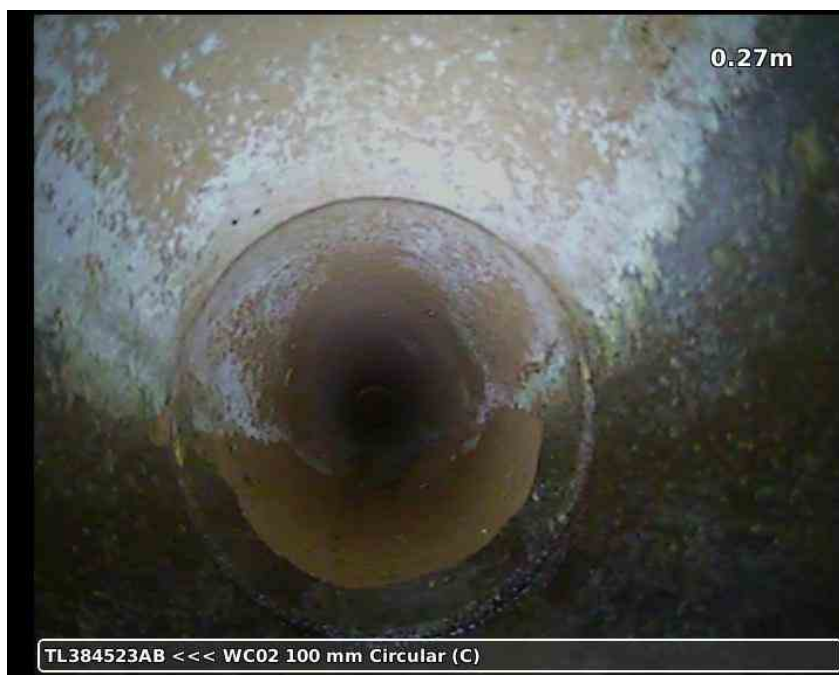
20210617-165855-snap0002.jpg, 00:00:15, 0.27 m
Attached deposits, fouling, from 02 to 10 o'clock, 5% % cross-sectional area loss

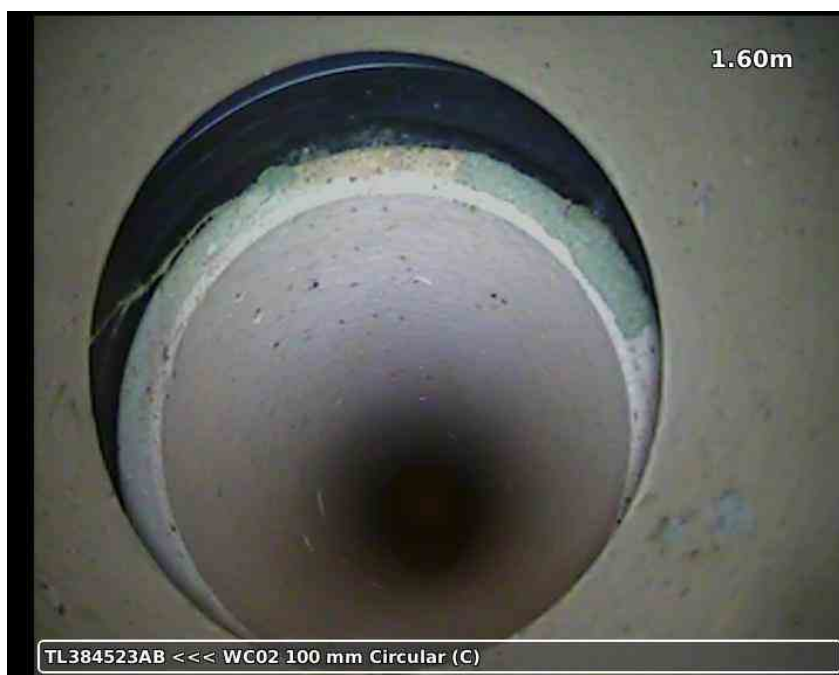
20210617-165855-snap0003.jpg, 00:00:36, 1.60 m
Open joint, large

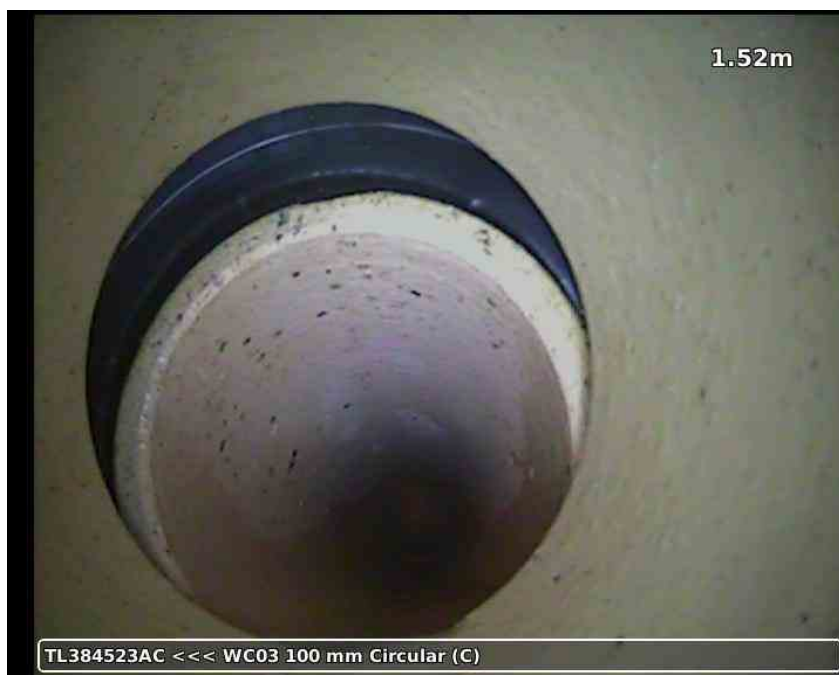
20210617-171046-snap0002.jpg, 00:00:23, 1.52 m
Open joint, large

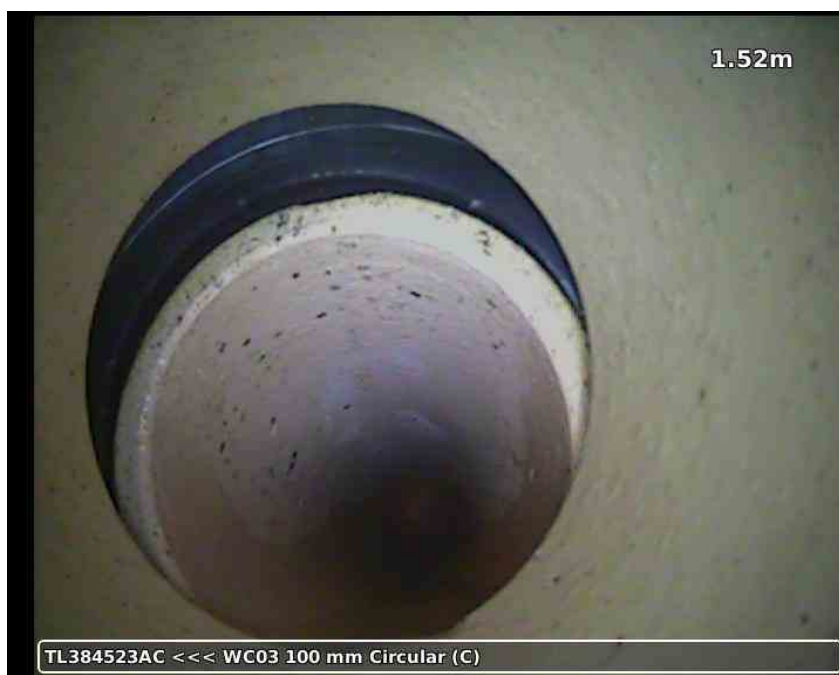
20210617-171046-snap0003.jpg, 00:00:27, 1.52 m
Joint displaced, 20 mm displacement

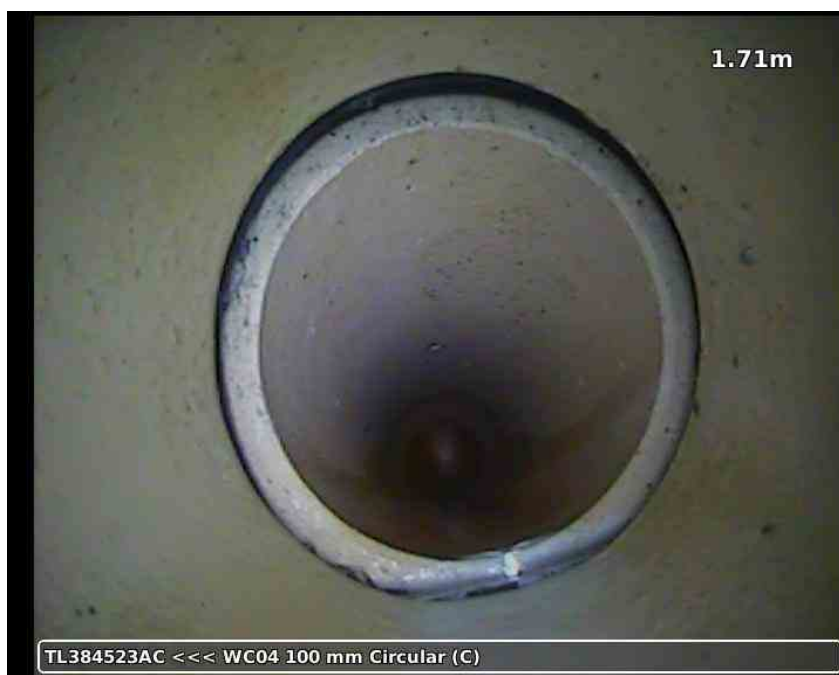
20210617-171300-snap0003.jpg, 00:00:29, 1.71 m
Open joint, medium

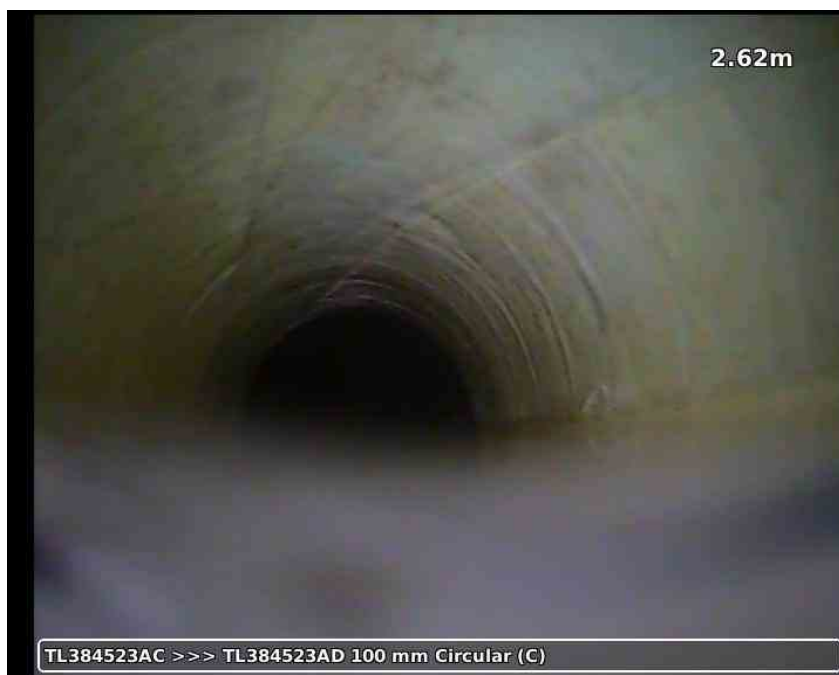
20210617-171630-snap0007.jpg, 00:02:01, 2.62 m
 Cured-in-place lining ends at this point

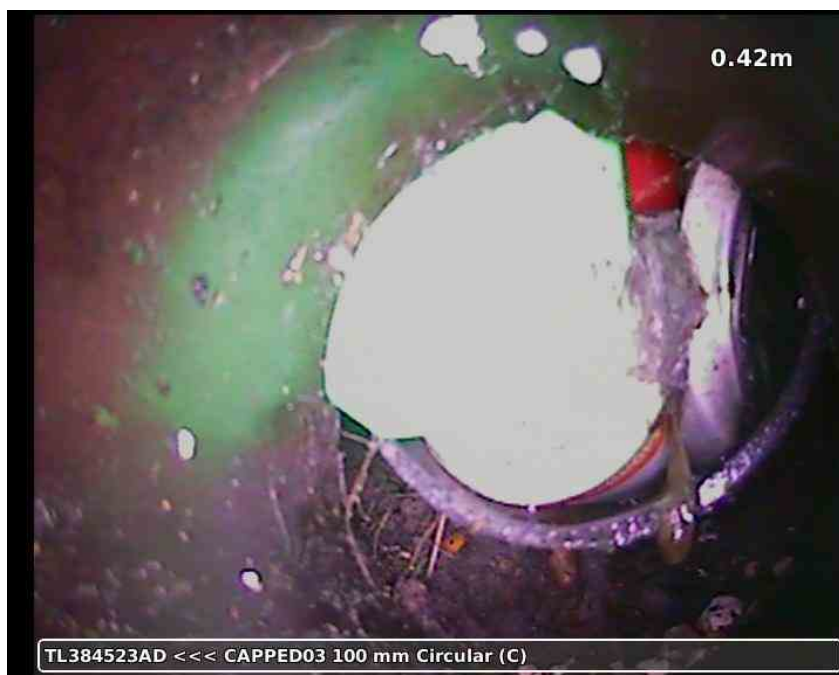
20210617-172705-snap0002.jpg, 00:00:31, 0.42 m
General remark, APPEARS TO BE A CAPPED OFF LINE

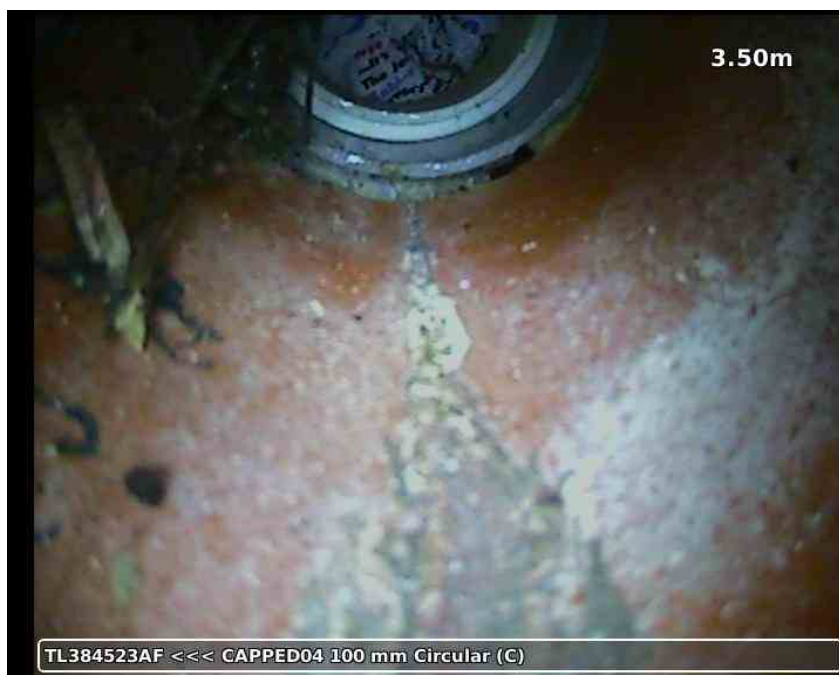
20210617-180144-snap0006.jpg, 00:01:38, 3.50 m
Finish node type, other special chamber, reference number: CAPPED04, Internal rest bend
CAPPED04

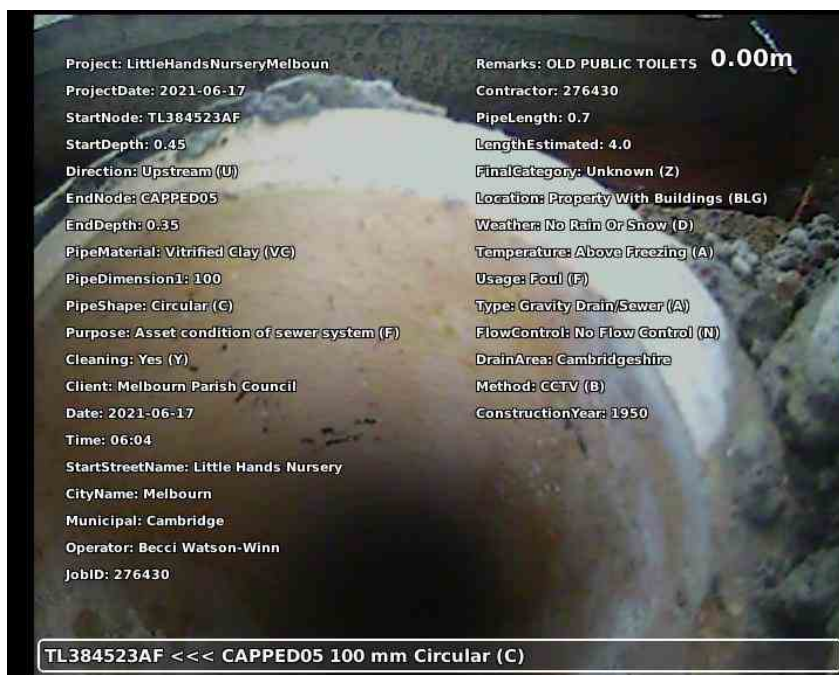
20210617-180419-snap0000.jpg, 00:00:00, 0.00 m
 Start node type, manhole, reference number: TL384523AF

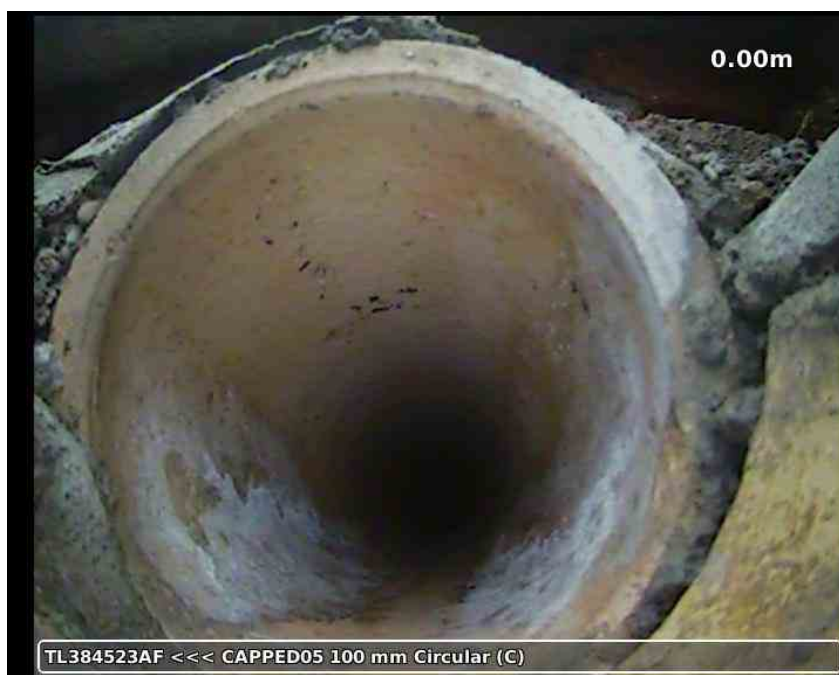
20210617-180419-snap0001.jpg, 00:00:02, 0.00 m
 Water level, 0% % of the vertical dimension, CAPPED OFF

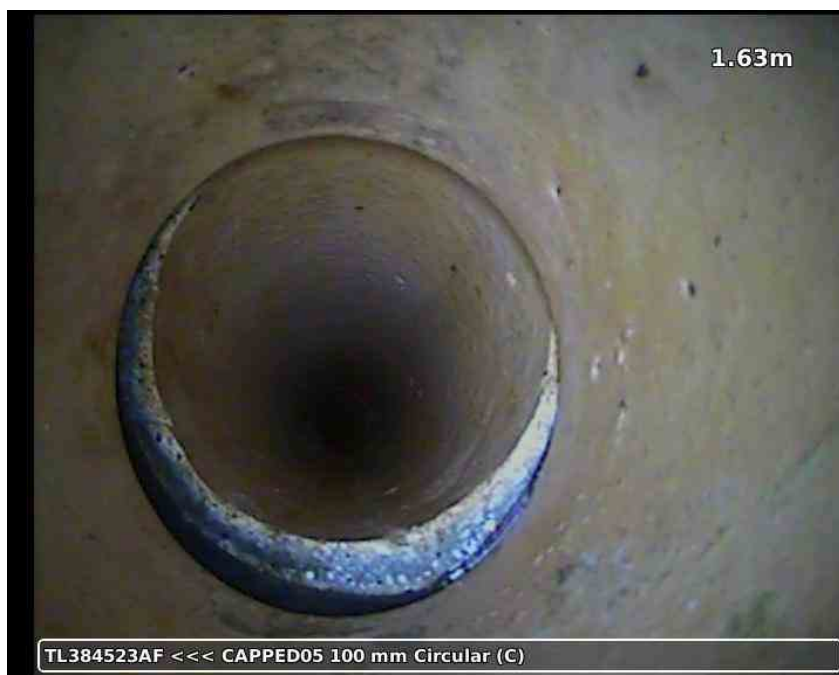
20210617-180419-snap0002.jpg, 00:00:34, 1.63 m
Joint displaced, 10 mm displacement
