MELBOURN PARISH COUNCIL - MAINTENANCE COMMITTEE

A meeting of the Maintenance Committee held on Thursday, 22 July 2021 at 09:30 at The Pavilion on the New Rec, The Moor, Melbourn, SG8 6ED

Inspection Standard: MSCC4 Sewers & Drainage GB (SRM4 Scoring)

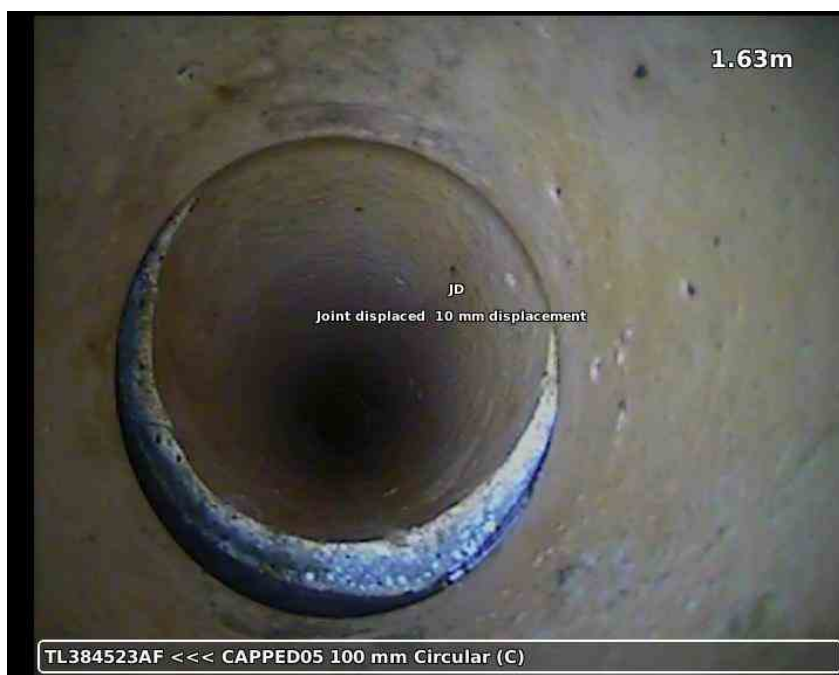
20210617-180419-snap0003.jpg, 00:00:40, 1.63 m
Open joint, medium

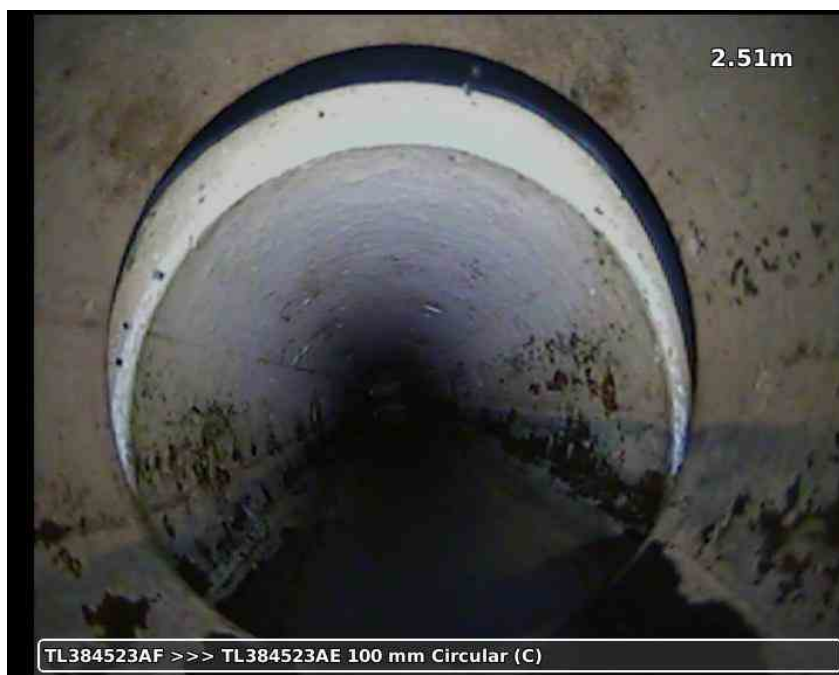
20210617-180721-snap0002.jpg, 00:00:46, 2.51 m
Joint displaced, 20 mm displacement

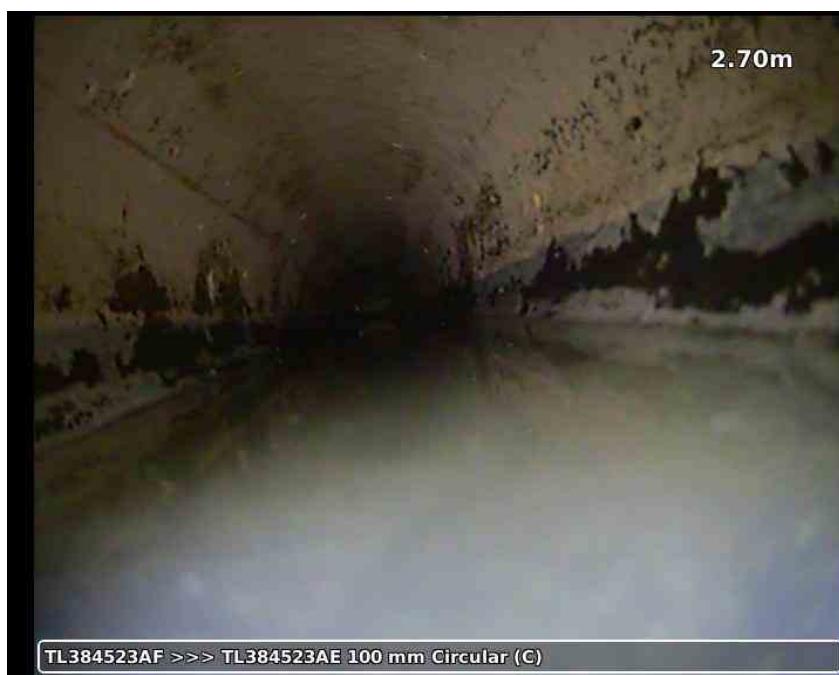
20210617-180721-snap0003.jpg, 00:00:52, 2.70 m
Water level, 25% % of the vertical dimension

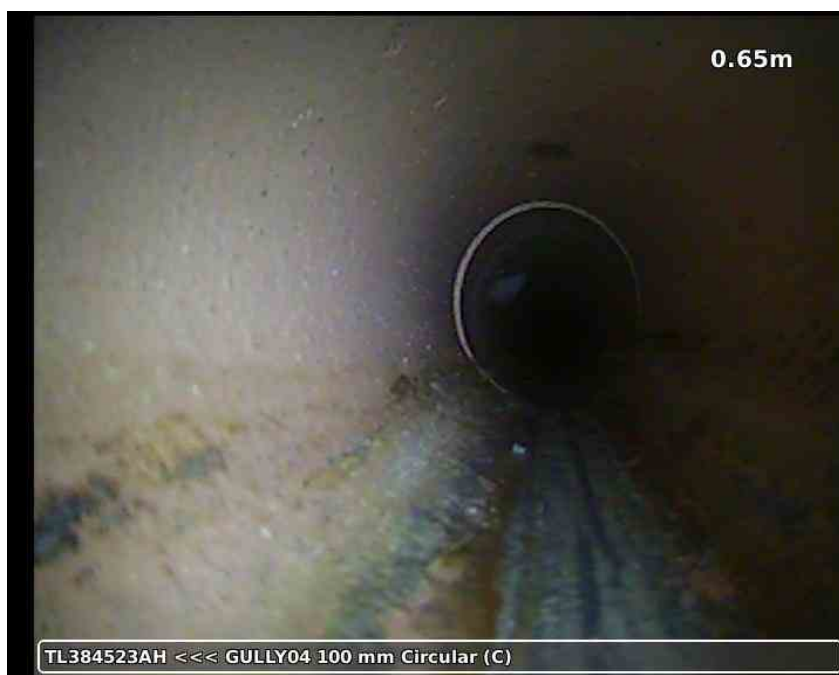
20210617-183231-snap0003.jpg, 00:00:12, 0.65 m
 Attached deposits, encrustation, from 05 to 07 o'clock, 5% % cross-sectional area loss, S01,
 Scale

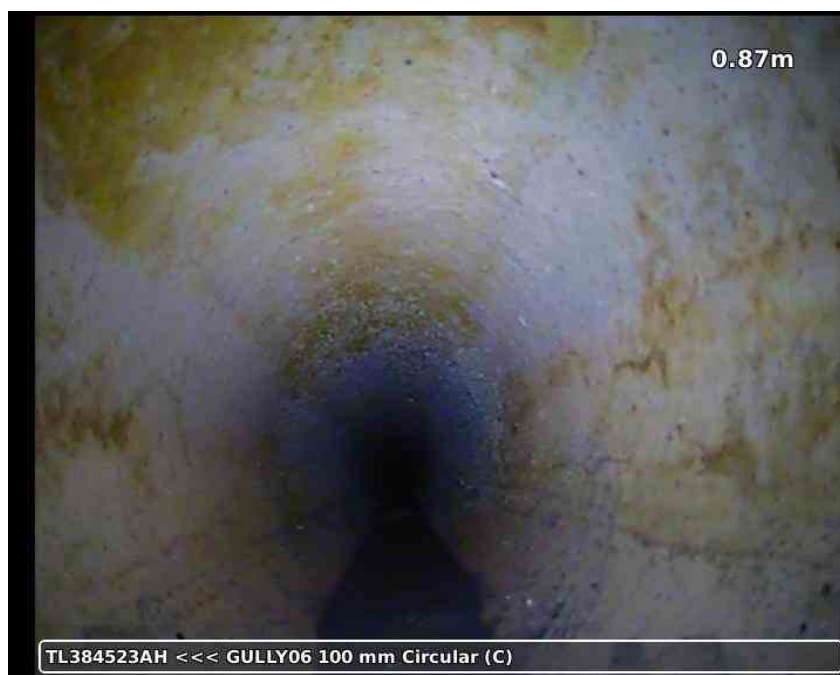
20210617-183738-snap0003.jpg, 00:00:29, 0.87 m
Settled deposits, fine, 10% % cross-sectional area loss, S01

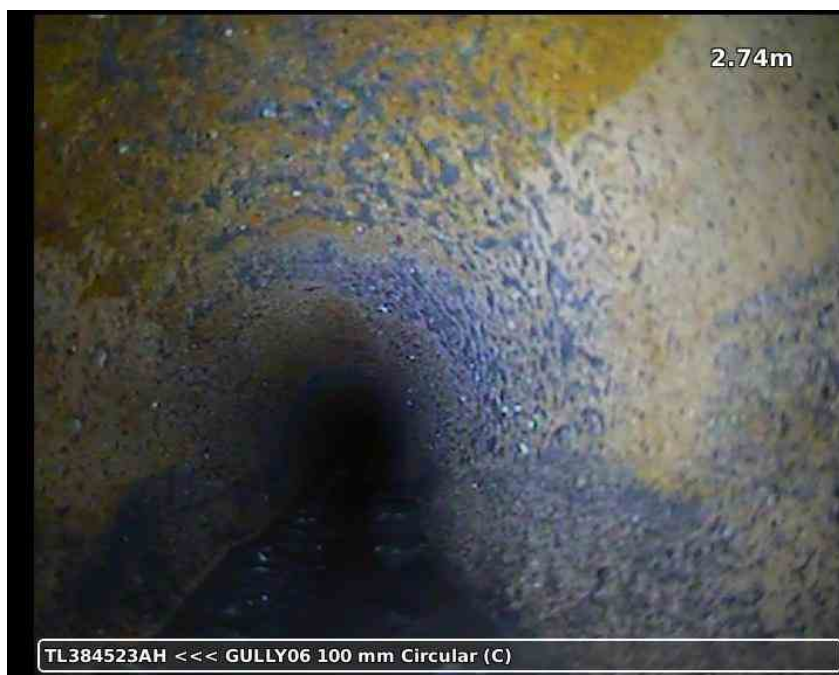
20210617-183738-snap0004.jpg, 00:00:52, 2.74 m
 Settled deposits, fine, 10% % cross-sectional area loss, S02

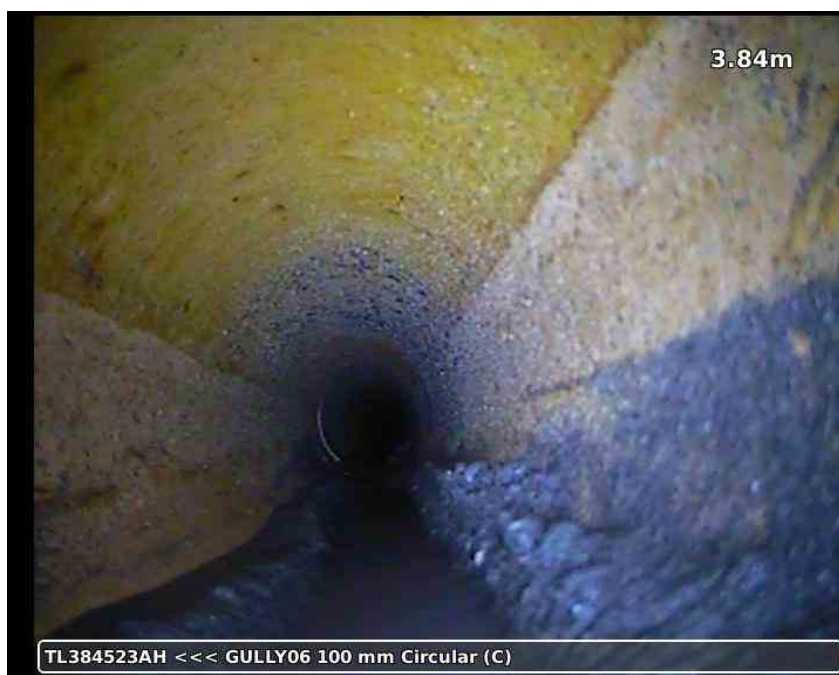
20210617-183738-snap0005.jpg, 00:01:13, 3.84 m
 Settled deposits, fine, 20% % cross-sectional area loss, S03

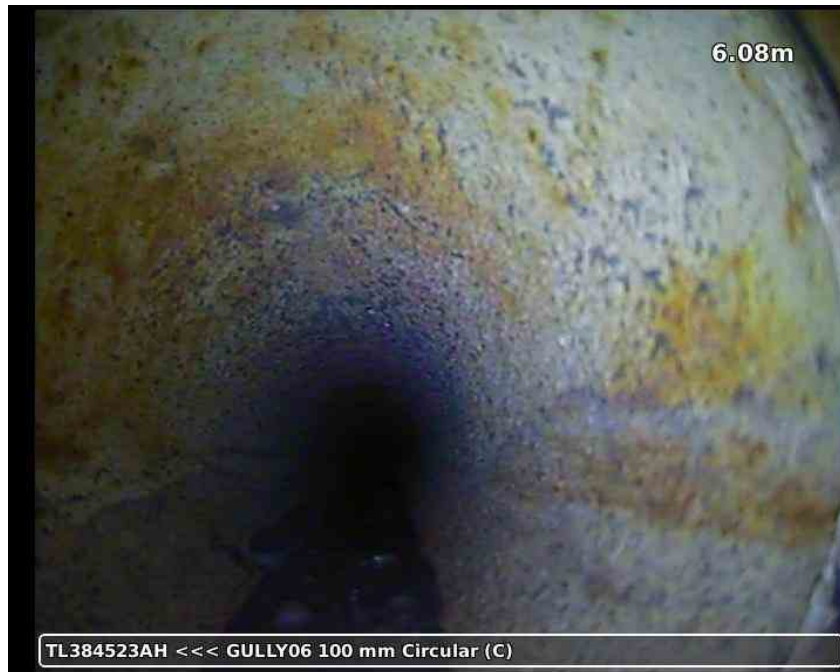
20210617-183738-snap0006.jpg, 00:01:33, 6.08 m
Settled deposits, fine, 10% % cross-sectional area loss, S04

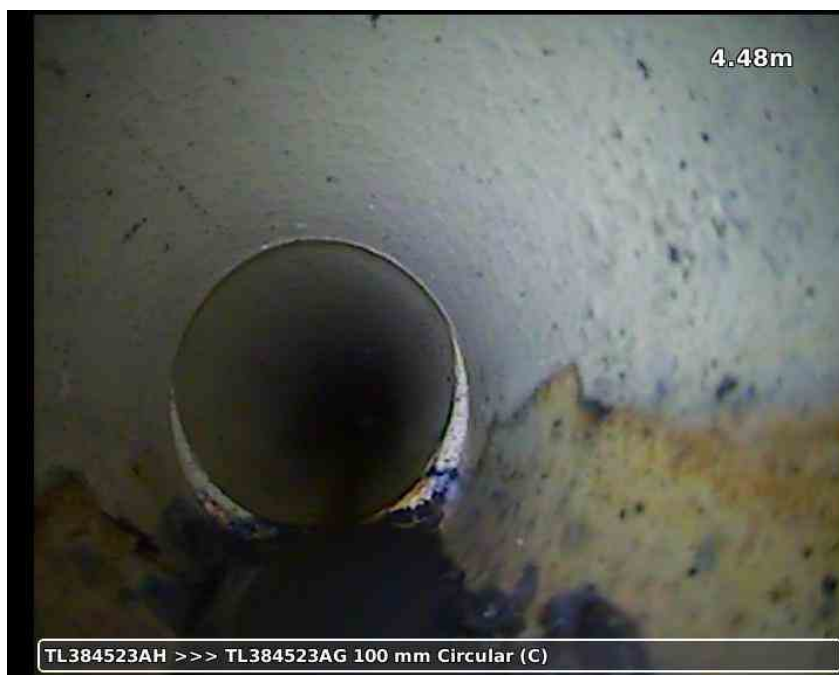
20210617-184209-snap0002.jpg, 00:00:40, 4.48 m
Settled deposits, fine at joint, 15% % cross-sectional area loss

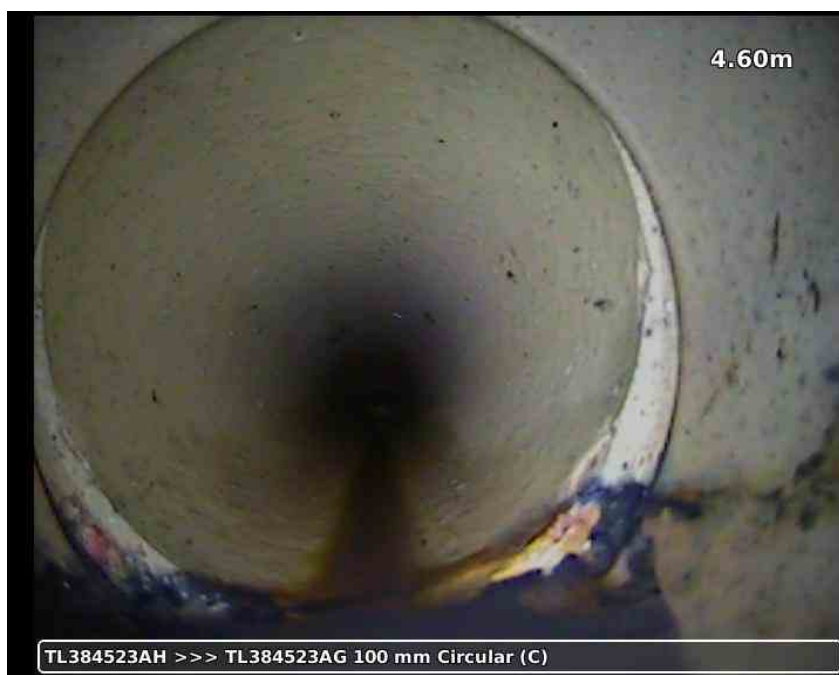
20210617-184209-snap0003.jpg, 00:00:53, 4.60 m
Joint displaced, medium

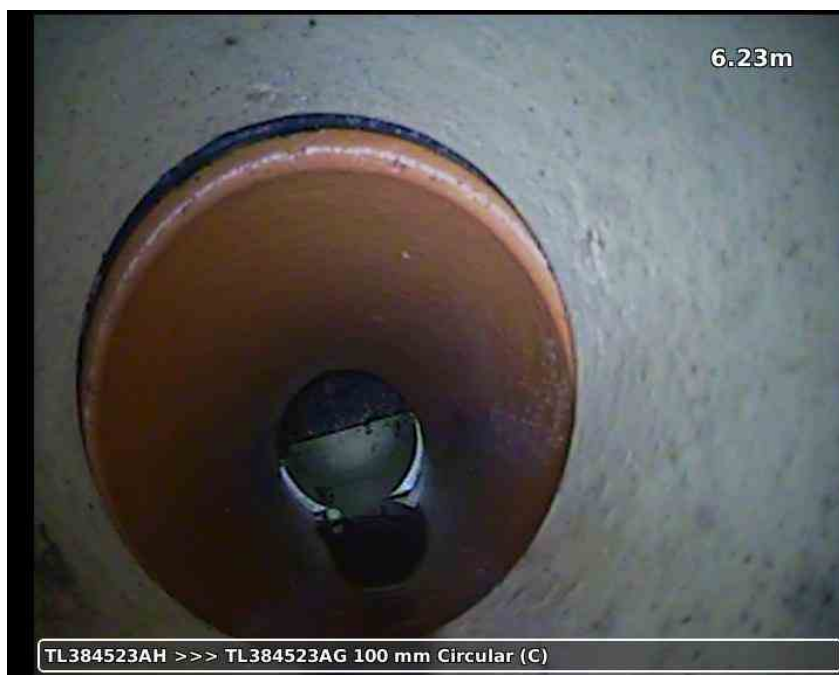
20210617-184209-snap0004.jpg, 00:01:12, 6.23 m
Joint displaced, medium

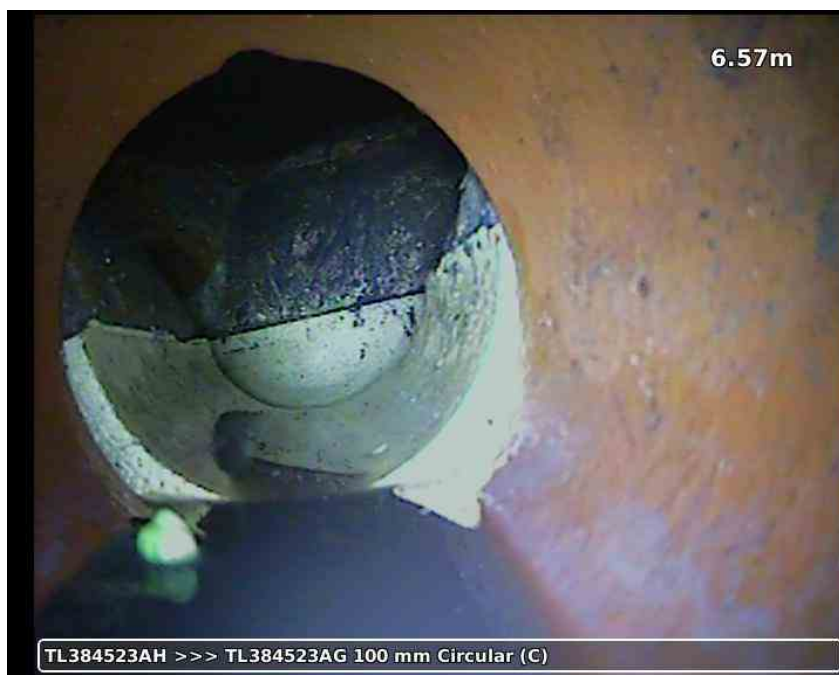
20210617-184209-snap0006.jpg, 00:01:30, 6.57 m
Joint displaced, 10 mm displacement

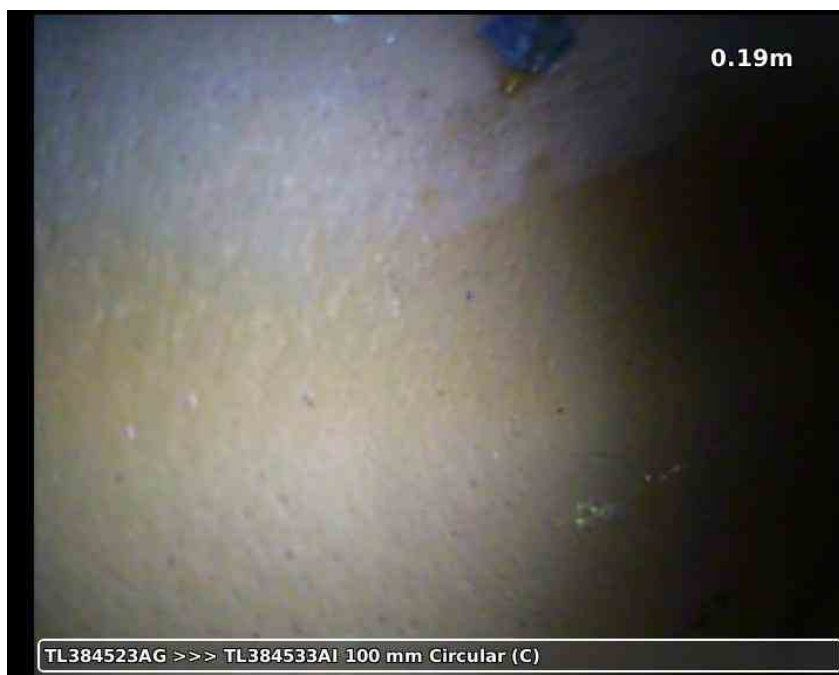
20210617-185600-snap0002.jpg, 00:00:12, 0.19 m
 Line deviates right

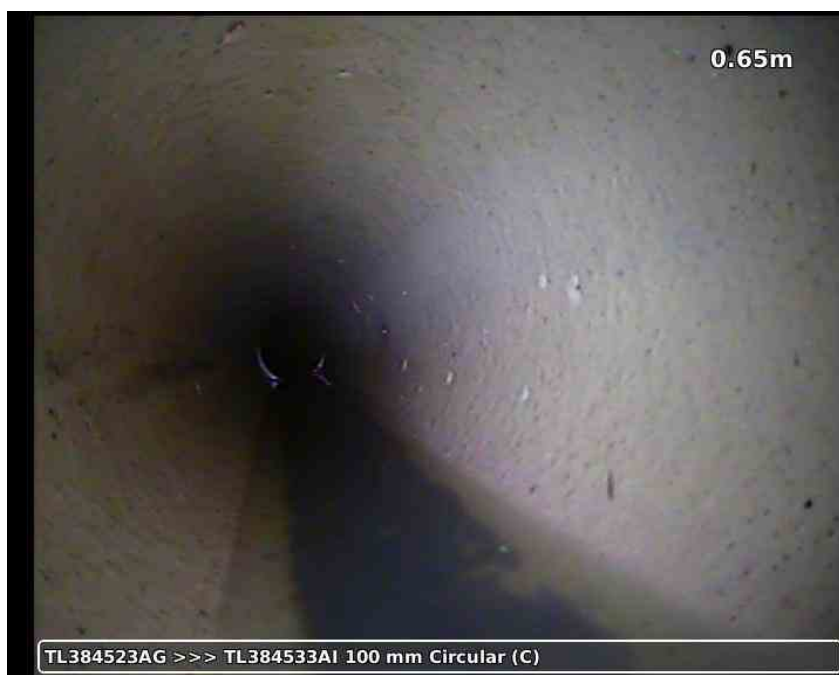
20210617-185600-snap0003.jpg, 00:00:19, 0.65 m
 Settled deposits, fine, 5% % cross-sectional area loss, S01

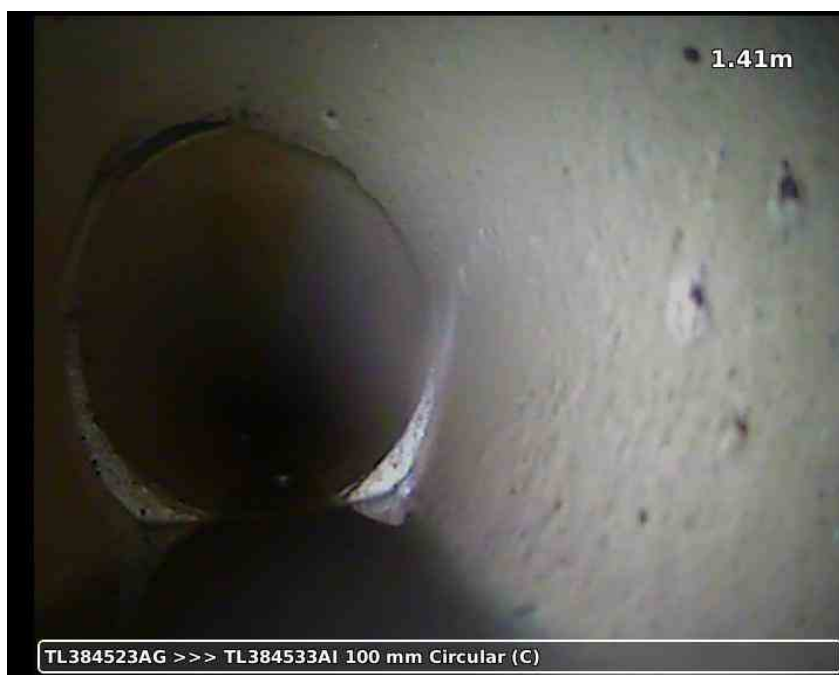
20210617-185600-snap0005.jpg, 00:00:45, 1.41 m
Joint displaced, medium

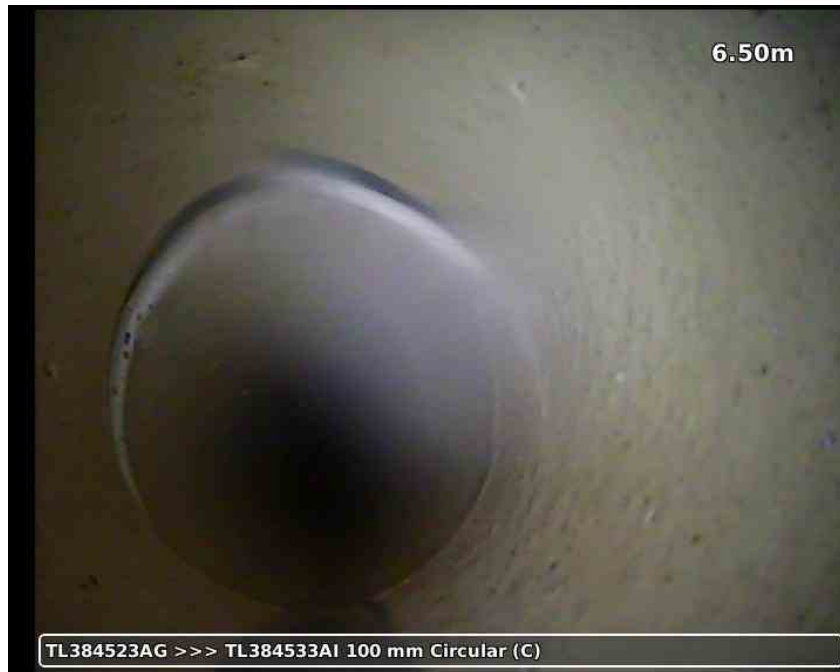
20210617-185600-snap0010.jpg, 00:02:16, 6.50 m
Joint displaced, medium

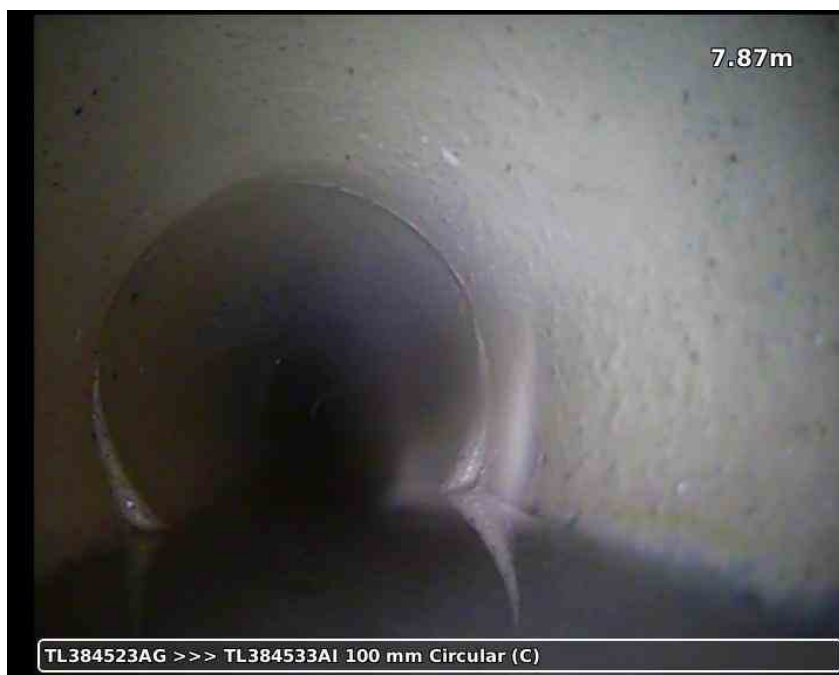
20210617-185600-snap0012.jpg, 00:02:36, 7.87 m
Joint displaced, medium

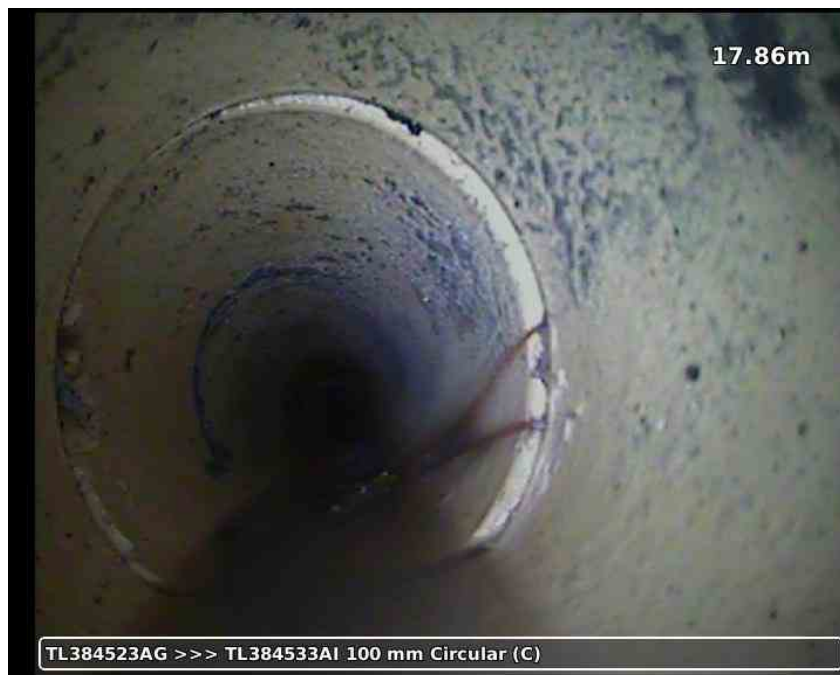
20210617-185600-snap0020.jpg, 00:04:16, 17.86 m
Roots, fine at joint

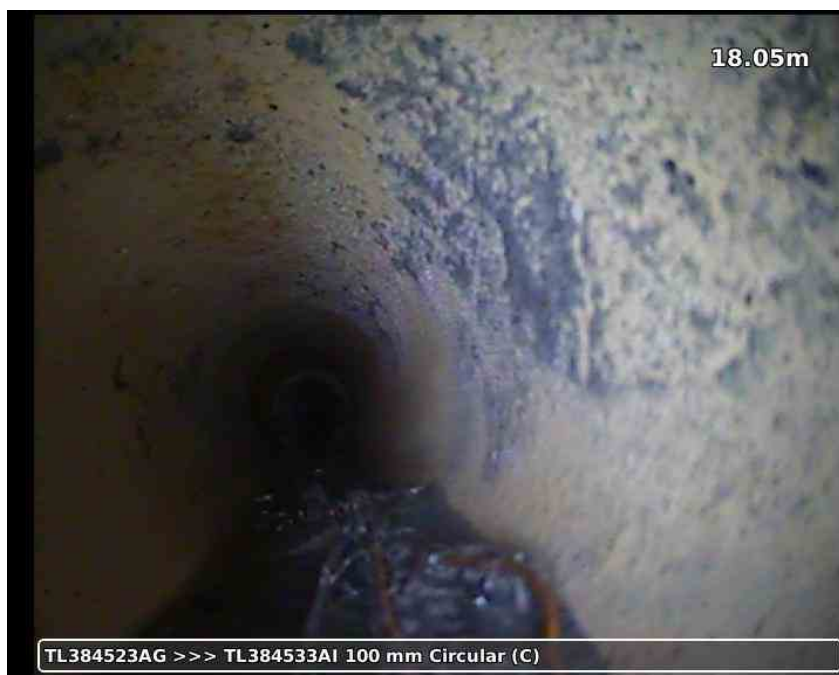
20210617-185600-snap0022.jpg, 00:04:28, 18.05 m
Roots, mass, 20% % cross-sectional area loss

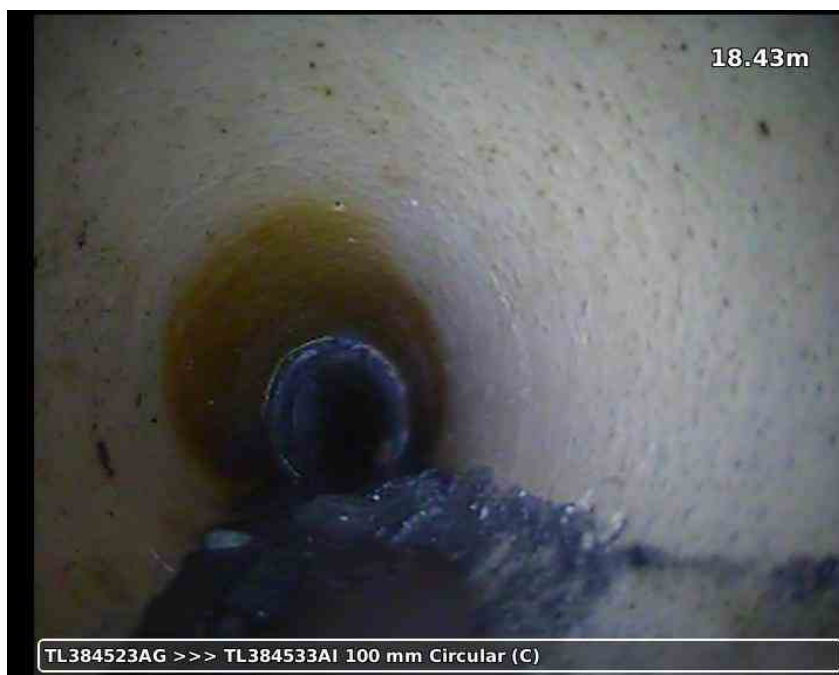
20210617-185600-snap0024.jpg, 00:04:45, 18.43 m
Settled deposits, fine, 10% % cross-sectional area loss, S02

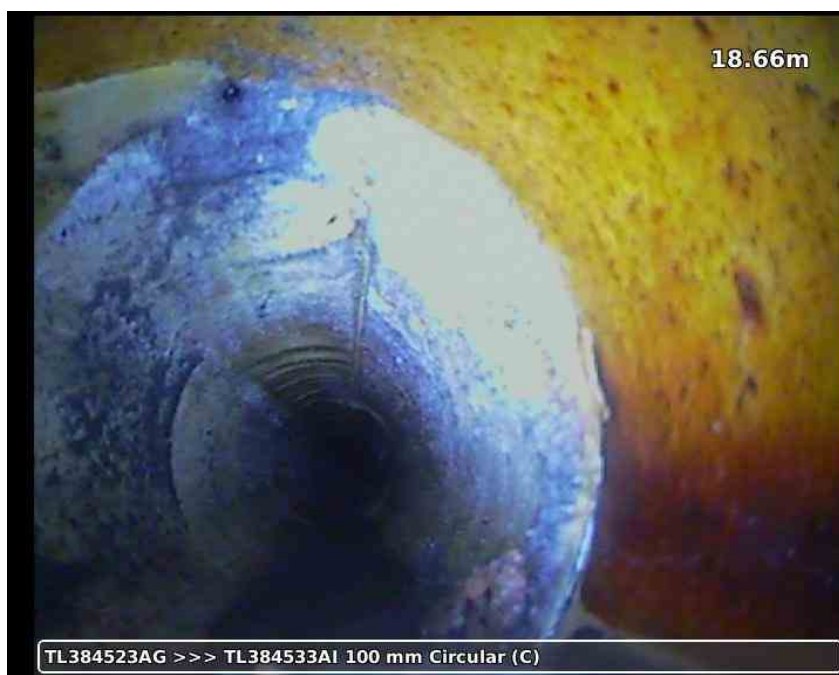
20210617-185600-snap0025.jpg, 00:04:58, 18.66 m
Lining of drain or sewer with cured-in-place lining changes to polyester at this point

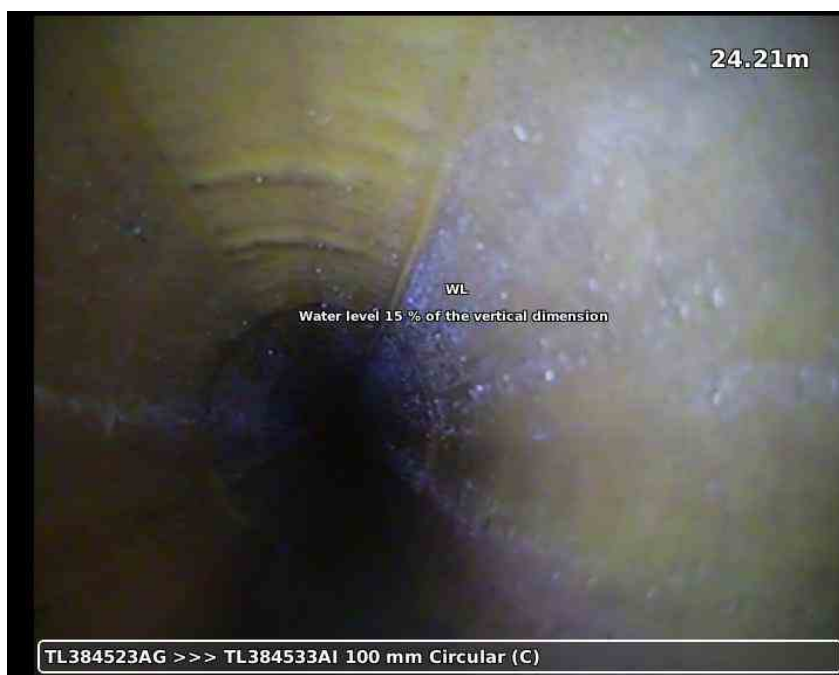
20210617-185600-snap0027.jpg, 00:05:54, 24.21 m
Settled deposits, fine, 10% % cross-sectional area loss, S03

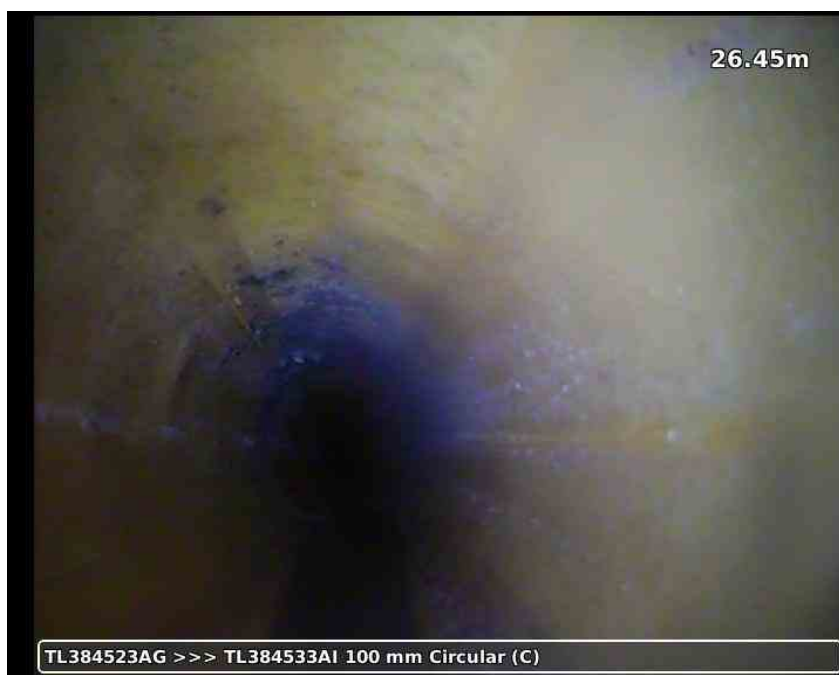
20210617-185600-snap0029.jpg, 00:06:26, 26.41 m
Settled deposits, fine, 5% % cross-sectional area loss, S04

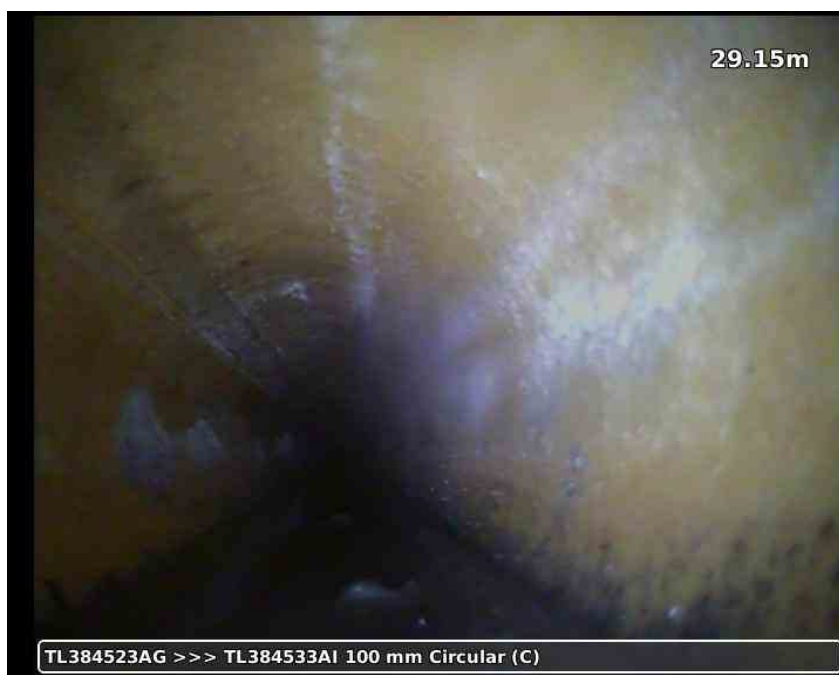
20210617-185600-snap0031.jpg, 00:06:58, 29.15 m
Settled deposits, fine, 20% % cross-sectional area loss, S05

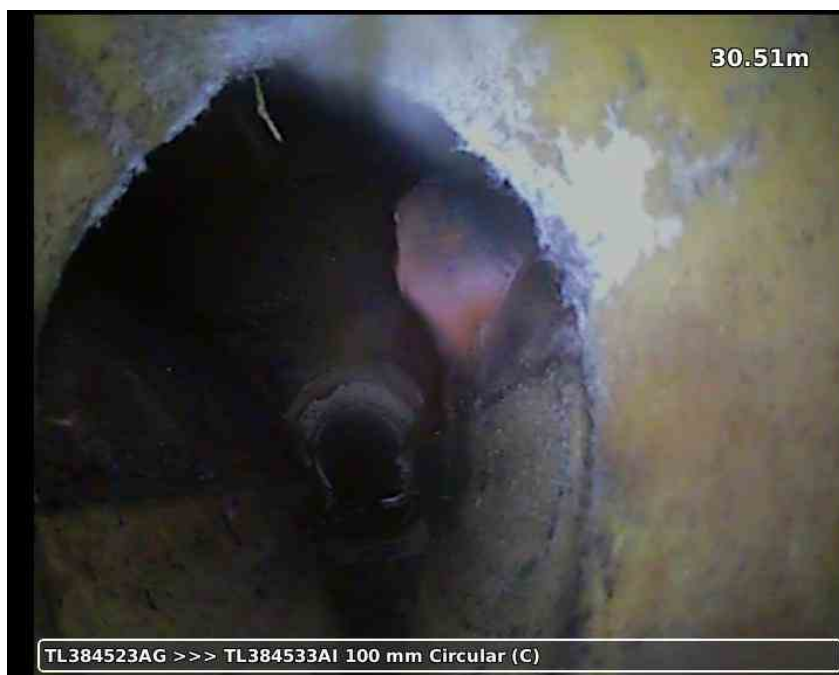
20210617-185600-snap0032.jpg, 00:07:27, 30.51 m
Cured-in-place lining ends at this point

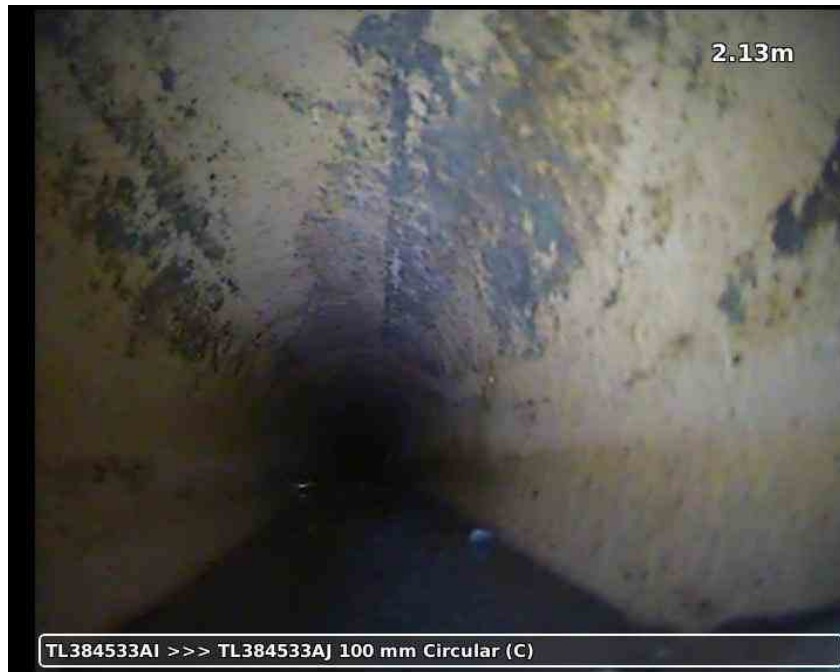
20210617-191337-snap0006.jpg, 00:01:20, 2.13 m
Settled deposits, fine, 10% % cross-sectional area loss, S01

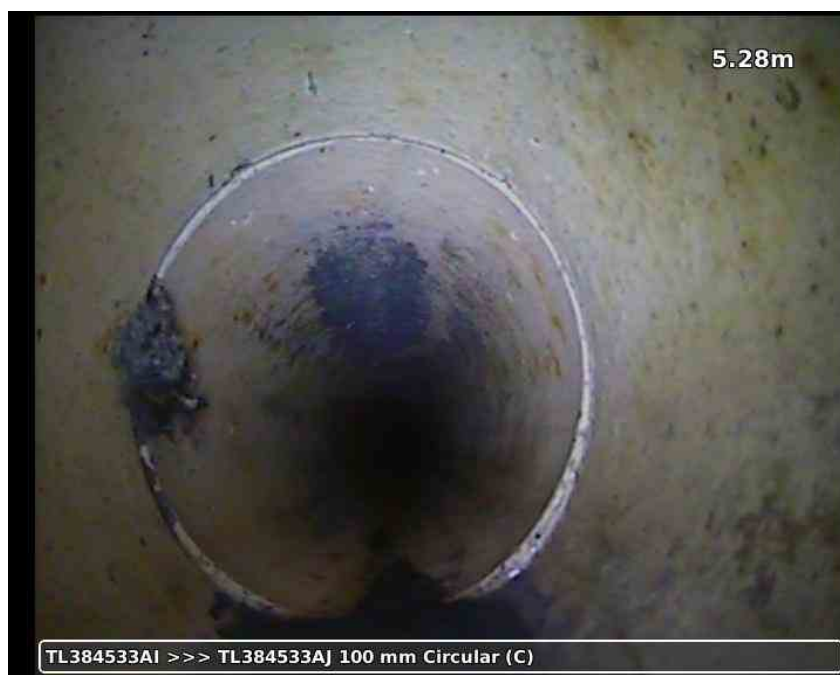
20210617-191337-snap0007.jpg, 00:01:58, 5.28 m
Roots, mass at joint, 5% % cross-sectional area loss

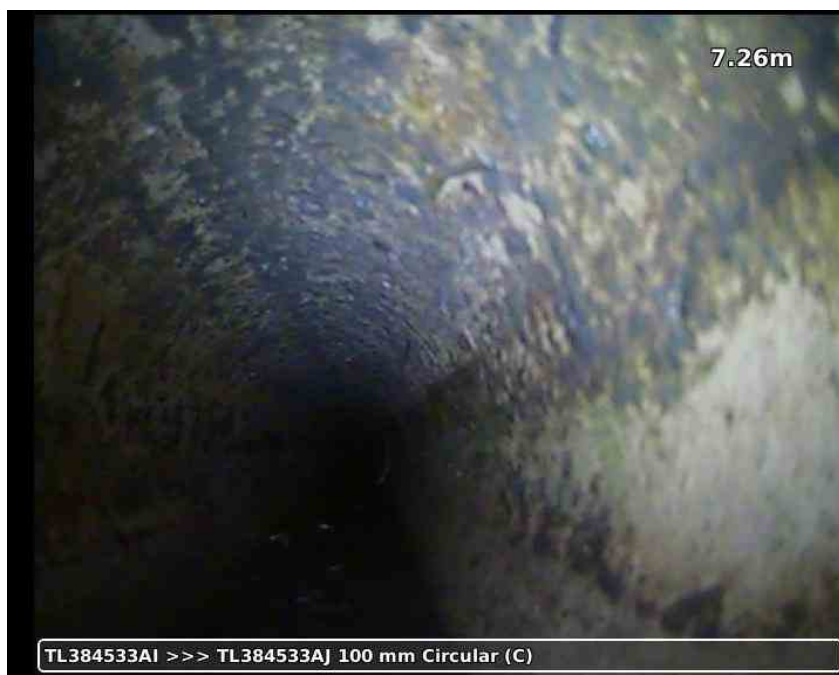
20210617-191337-snap0010.jpg, 00:02:38, 7.26 m
Attached deposits, fouling, from 07 to 05 o'clock, 5% % cross-sectional area loss, S02

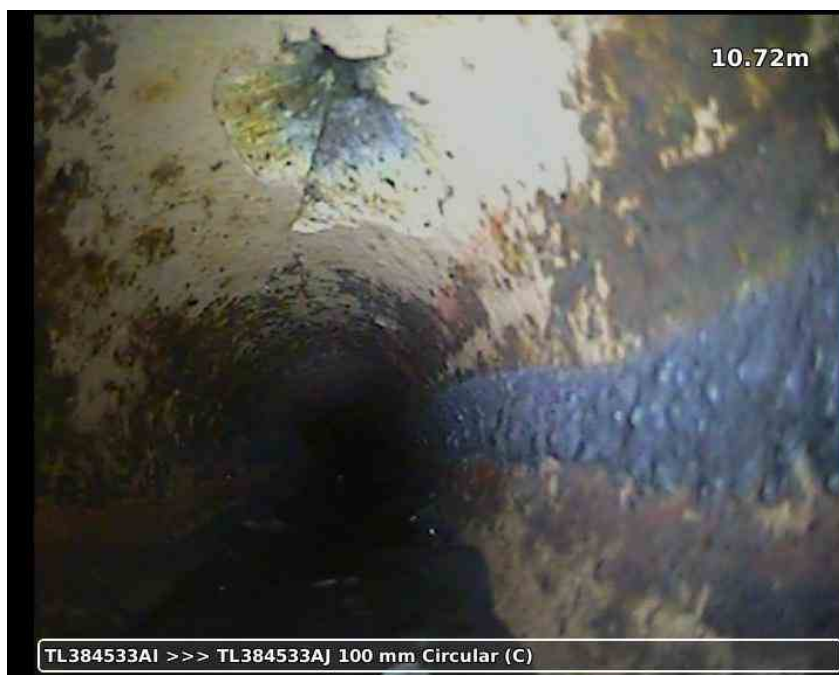
20210617-191337-snap0012.jpg, 00:03:34, 10.72 m
Hole in drain or sewer, from 11 to 01 o'clock

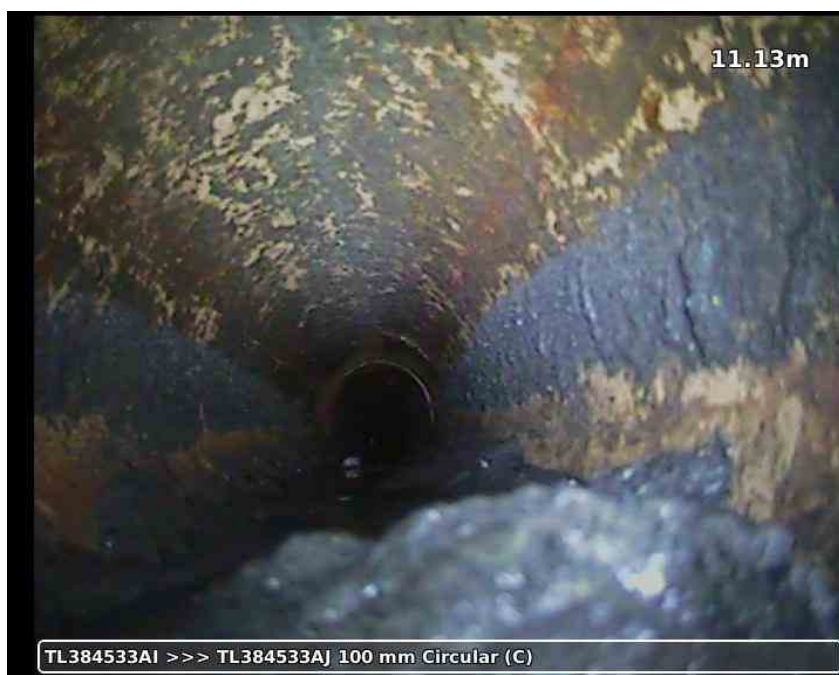
20210617-191337-snap0013.jpg, 00:03:52, 11.13 m
Settled deposits, fine, 20% % cross-sectional area loss, S03

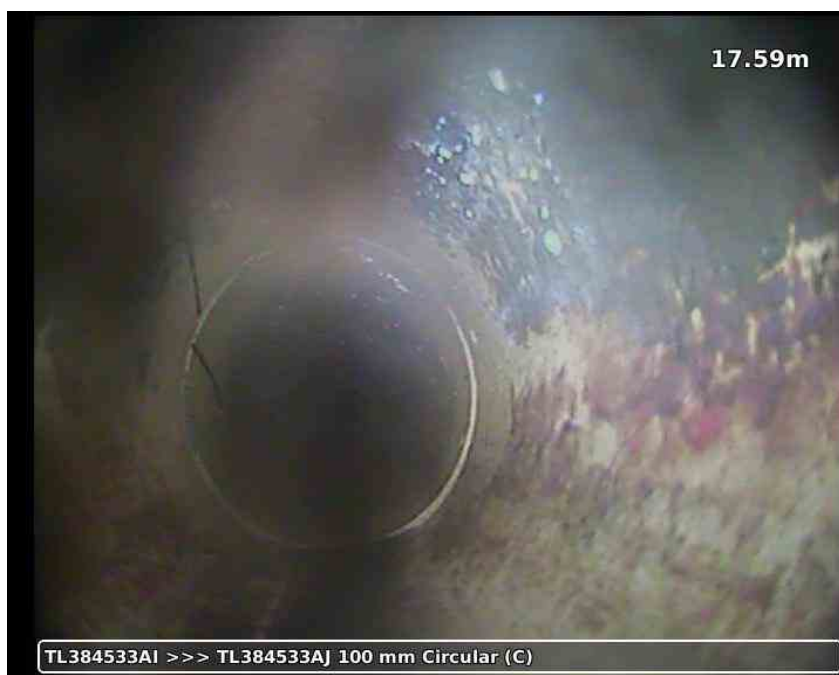
20210617-191337-snap0015.jpg, 00:05:00, 17.59 m
 Roots, fine at joint

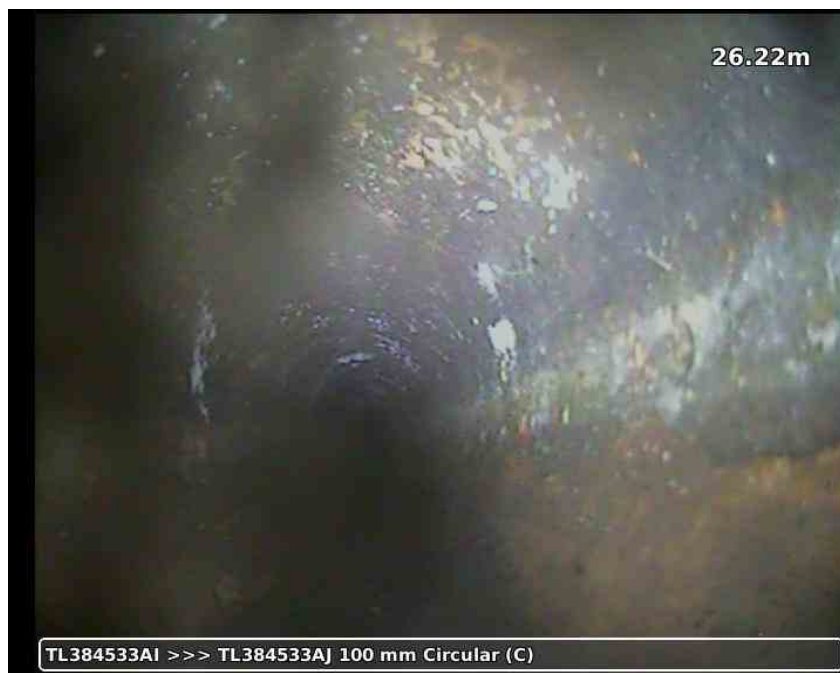
20210617-191337-snap0019.jpg, 00:06:24, 26.22 m
Settled deposits, fine, 10% % cross-sectional area loss, S05

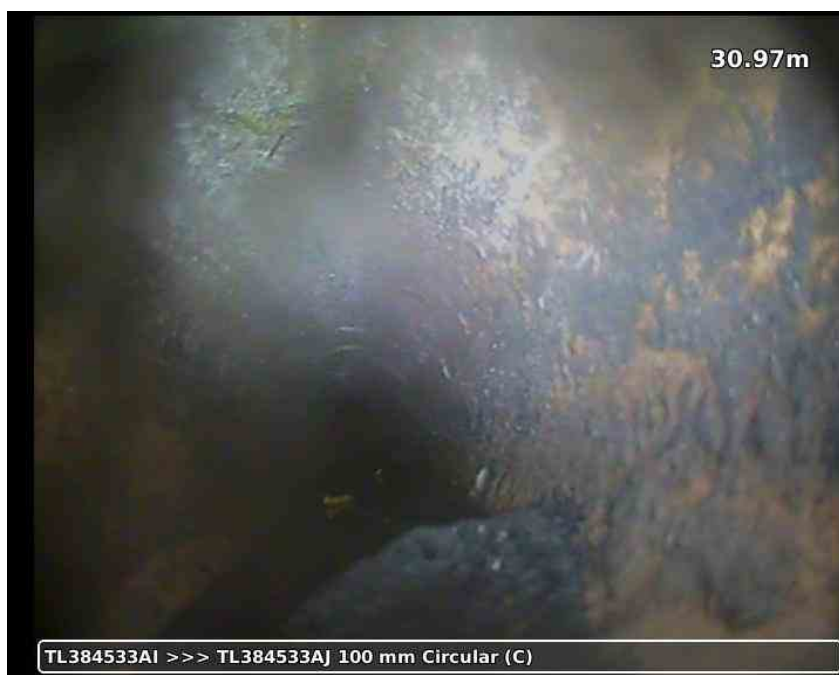
20210617-191337-snap0021.jpg, 00:07:19, 30.97 m
Settled deposits, fine, 10% % cross-sectional area loss, S06

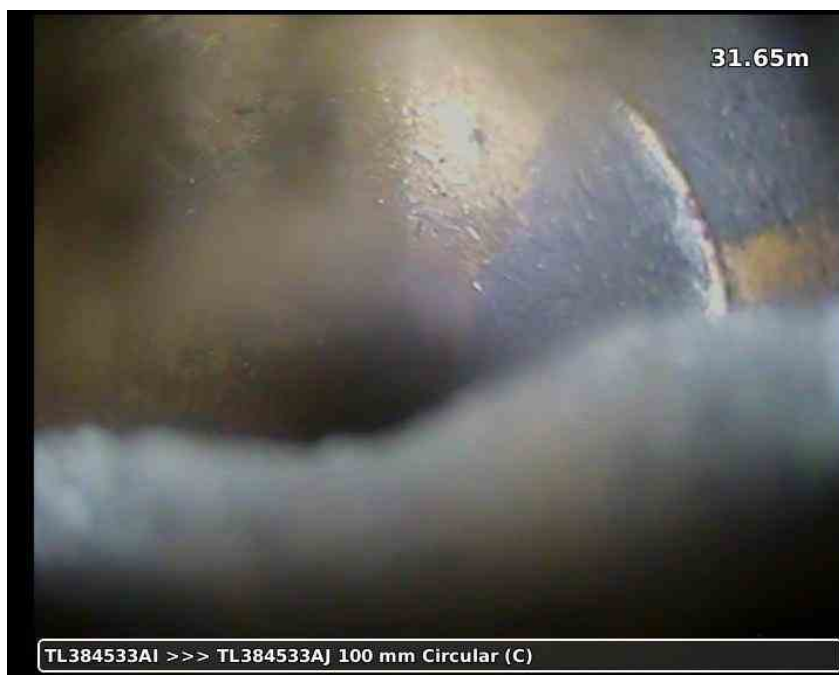
20210617-191337-snap0022.jpg, 00:07:42, 31.65 m
Settled deposits, fine, 30% % cross-sectional area loss

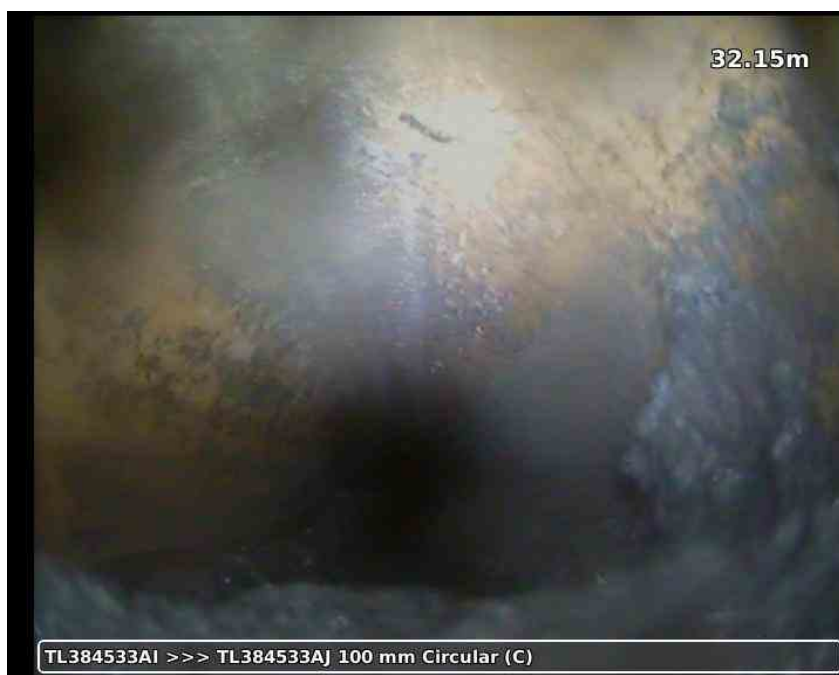
20210617-191337-snap0023.jpg, 00:07:53, 32.15 m
Settled deposits, fine, 20% % cross-sectional area loss, S07

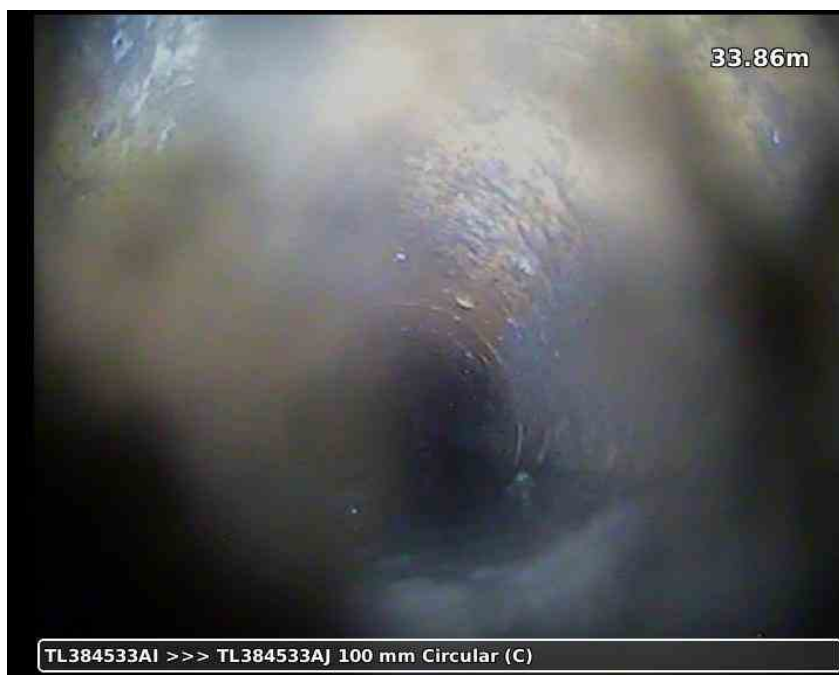
20210617-191337-snap0024.jpg, 00:08:16, 33.86 m
Settled deposits, fine, 30% % cross-sectional area loss, S08

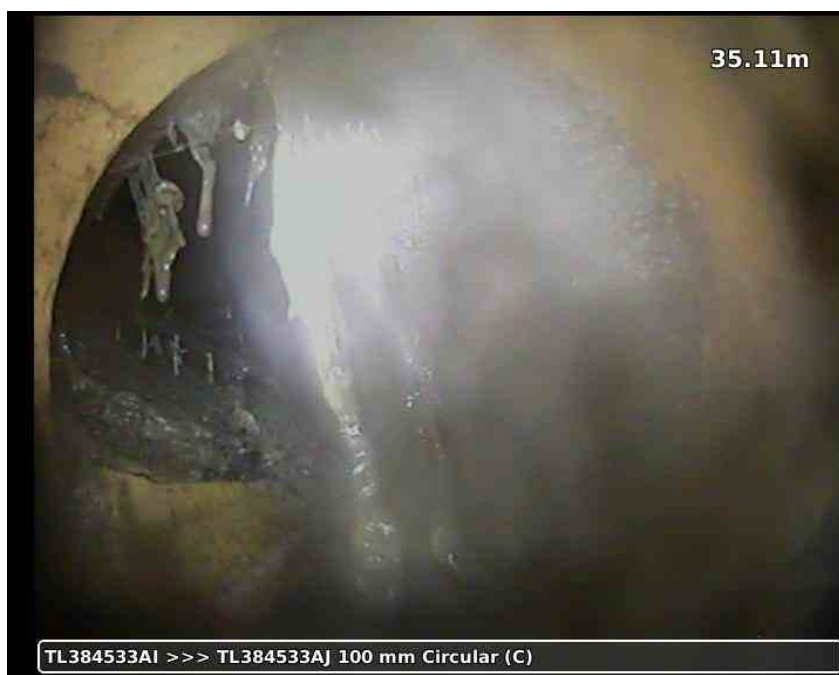
20210617-191337-snap0025.jpg, 00:08:34, 35.11 m
Roots, mass, 30% % cross-sectional area loss

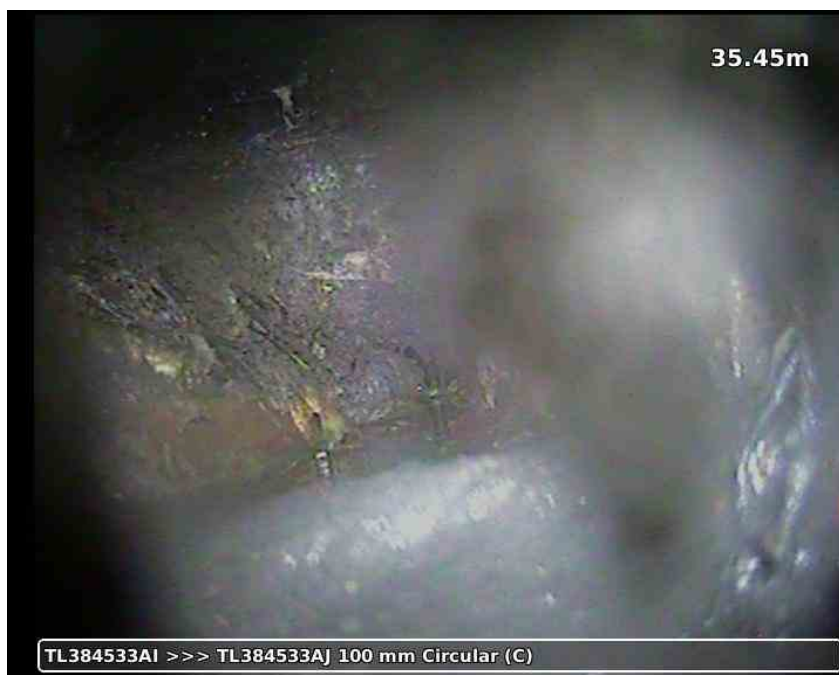
20210617-191337-snap0026.jpg, 00:08:48, 35.45 m
Finish node type, manhole, reference number: TL384533AJ, HIDDEN CHAMBER

Town or Village:	Melbourn	Inspection Direction:	Downstream	Upstream Node:	TL384533AI
Road:	Little Hands Nursery	Inspected Length:	35.45 m	Upstream Pipe Depth:	0.760 m
Location:	Other pedestrian area	Total Length:	35.45 m	Downstream Node:	TL384533AJ
Surface Type:	Grass In Childrens Playground	Joint Length:	0.70 m	Downstream Pipe Depth:	0.000 m
Use:	Foul	Pipe Shape: Circular Dia/Height: 100 mm Pipe Material: Vitrified clay pipe (i.e. all clayware) Lining Type: No Lining Lining Material: No Lining			
Type of Pipe:	Gravity drain/sewer				
Year Constructed:	1950				
Flow Control:	No flow control				
Inspection Purpose:	Sample survey to determine asset condition				
Comments:	TL384533AJ is buried & no access to measure invert depth				
Recommendations:	Trace hidden chamber
