# Safety Inspection Report

## Clear Crescent Play Area

Melbourn Parish Council

26 April 2022

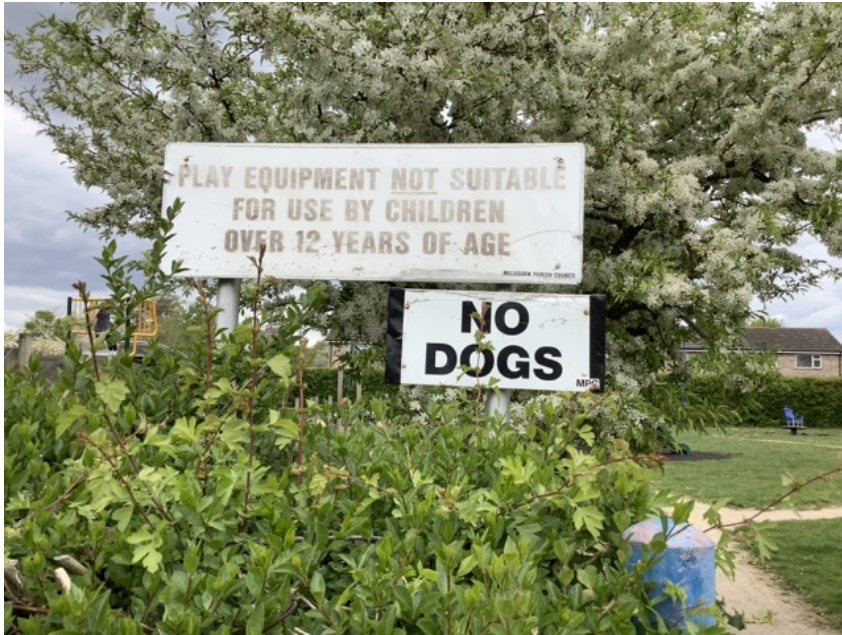
# Signage

Dog ban & ownership signs recommended.

Operator signs should be installed at each entrance with the correct information on them, operator's name and contact number etc. please see link attached. [www.rospa.com/Play-Safety/Advice/Signs.aspx](http://www.rospa.com/Play-Safety/Advice/Signs.aspx)

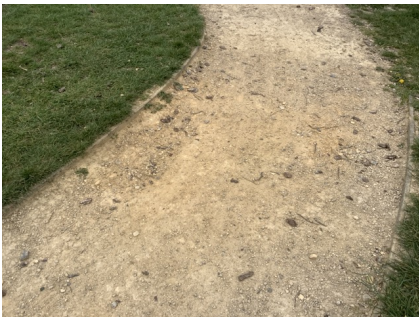
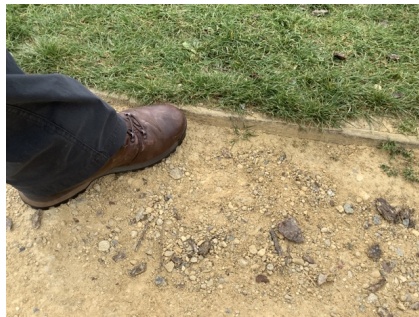
# Pathways

Surface is wearing.

Surface wearing and creating a trip point around the edgings.

Repair.

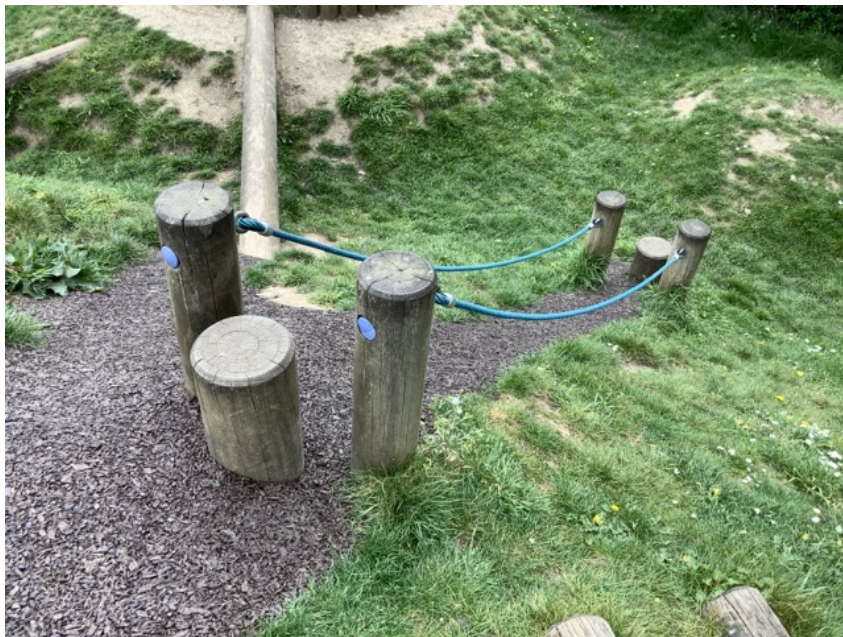
# Rope Balance - Embankment

Bolt cap damaged.

Replace.

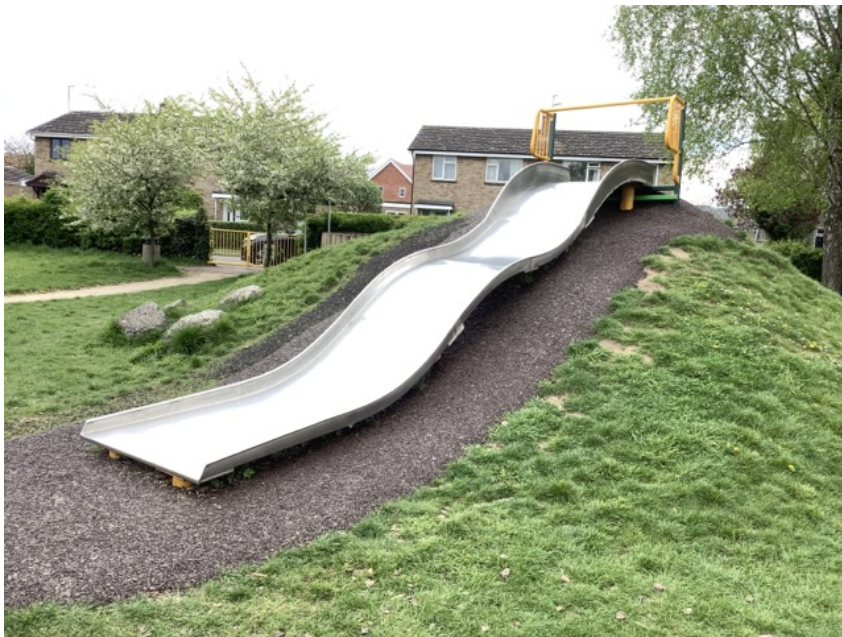
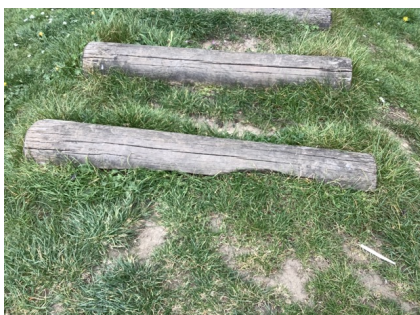
# Slide - Embankment - With Log Steps

Timber is decayed.

Top log is decayed through and loose in the ground and could lead to a fall - replace.

Replace affected parts.

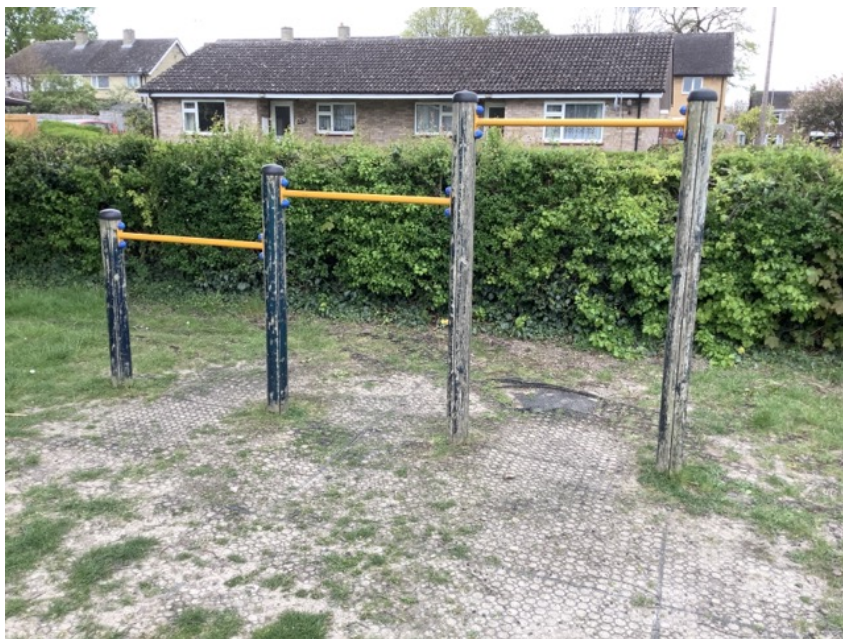
# Agility Bars - 3 Tier

Surface needs repair.

Grass mats are damaged - replace.

Replace.

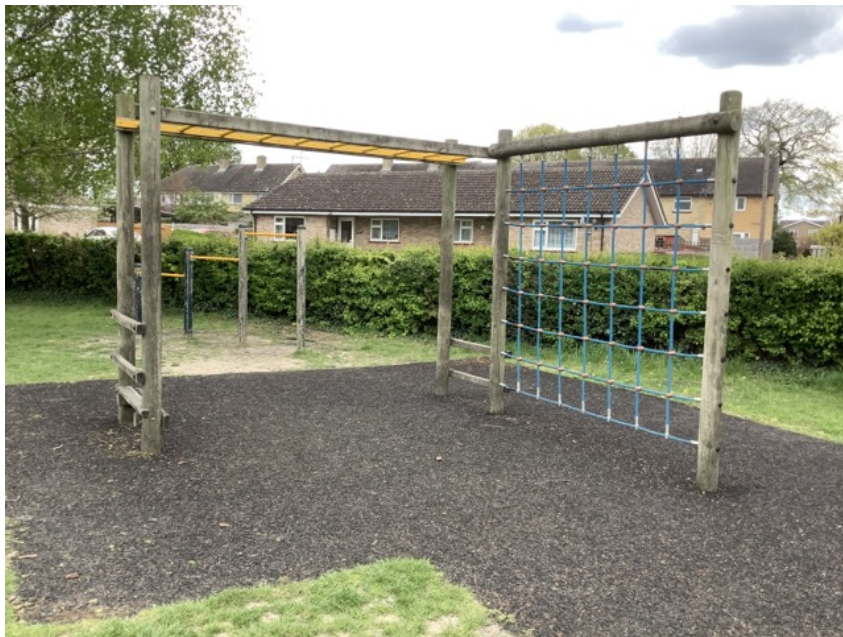
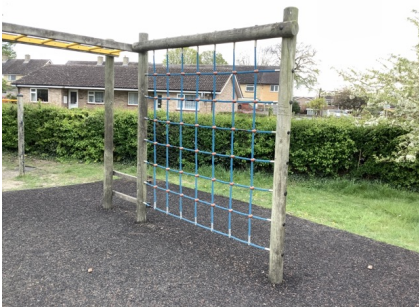
# Climber - Net & Ladder

Cap missing.

One post is showing signs of softening and decay at ground level - monitor.

Fixtures loose or missing.

Net fittings are loose to the posts - remove fittings to check for corrosion and replace if found and the. Secure the net.

Item has some parts missing.

One rung and two hand holds missing - replace.

Replace.

Replace the missing parts.

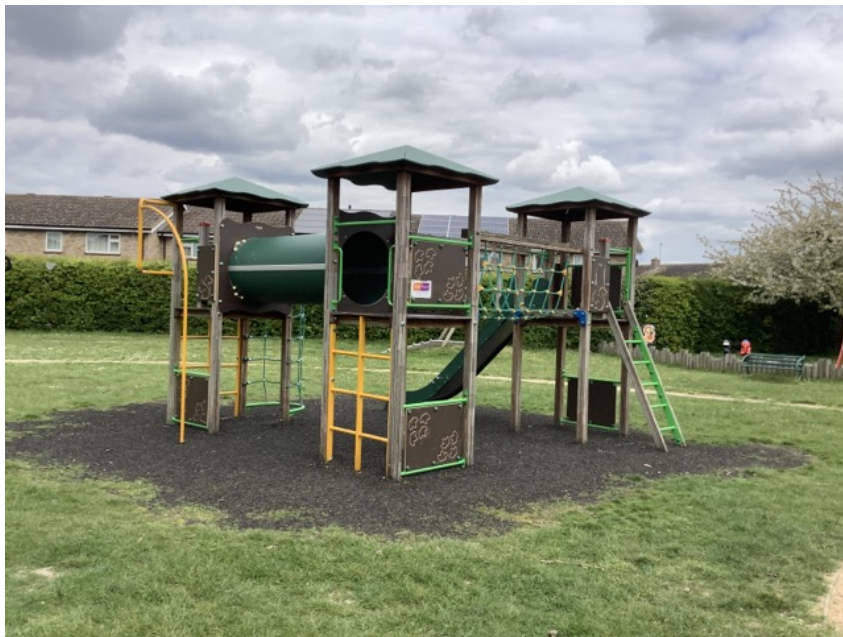
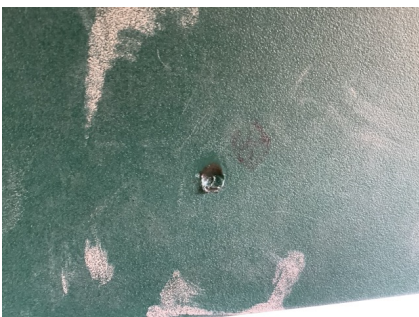
# Multiplay - Junior

Cap missing.

Cap plug missing exposing the thread - replace.

Bolt is missing.

Ladder guardrail bolt missing.

Two burn marks inside the tunnel - monitor.

Replace.

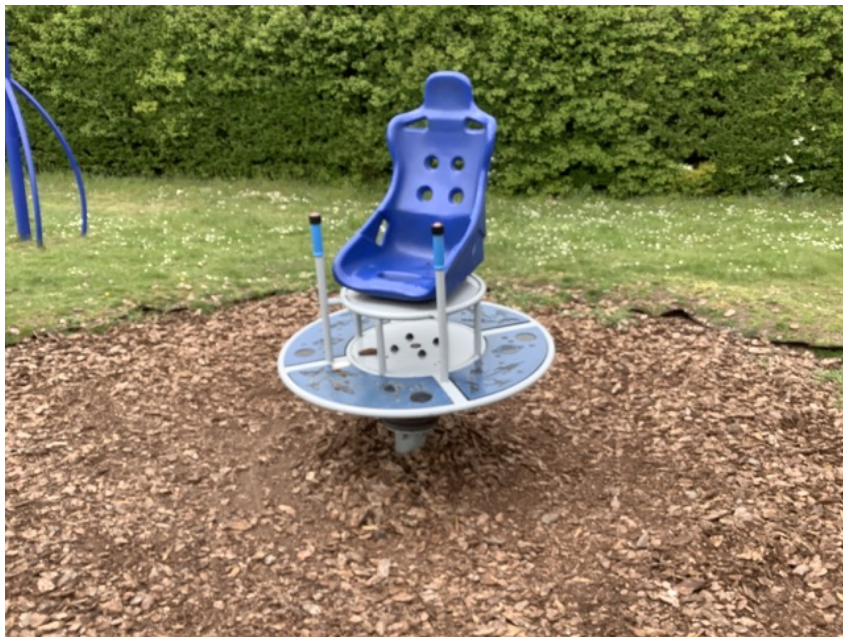
# Rocker / Rotator - Chair - Space Rocket

Surface needs repair.

The surfacing has worn away exposing and damaging the liner beneath. Grass & weeds have grown inside. The plastic edging strips are sharp - the whole area requires immediate repairs and alterations. Bark requires topping up.

Repair.

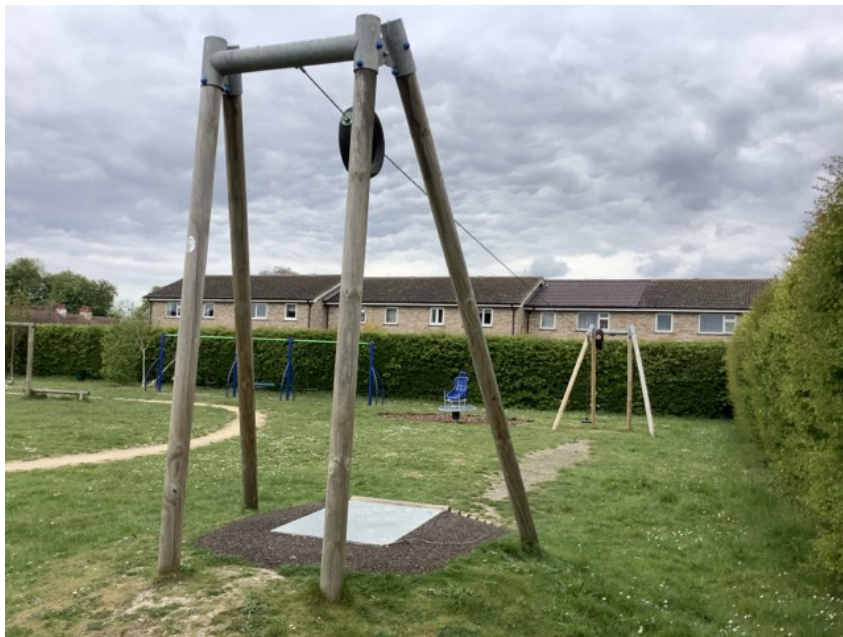
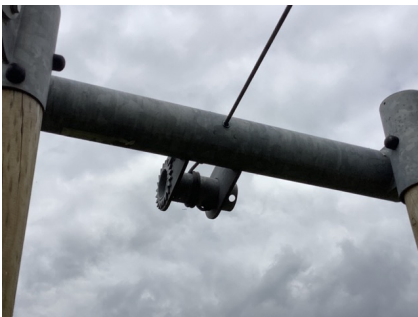
# Cableway

Chains links worn.

Chain link and seat connector worn.

Replace the worn parts.

Conduct an appropriate dismantling inspection.

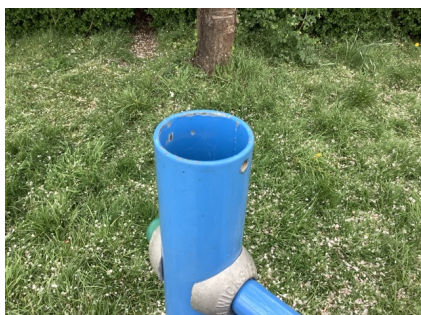
Cap missing.

Post caps missing where objects could be inserted and water ingress is likely to occur.

Replace.

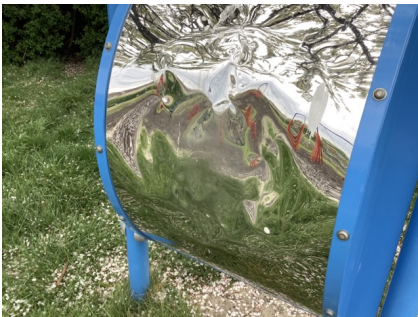
Mirror bent - monitor for splits / cracks, replace if found.
