MELBOURN PARISH COUNCIL - MAINTENANCE COMMITTEE
(District of South Cambridgeshire)

A meeting of the Maintenance Committee held on Thursday 17 August at 09:30
in the Austen Room, Community Hub, 30 High Street, Melbourn SG8 6DZ

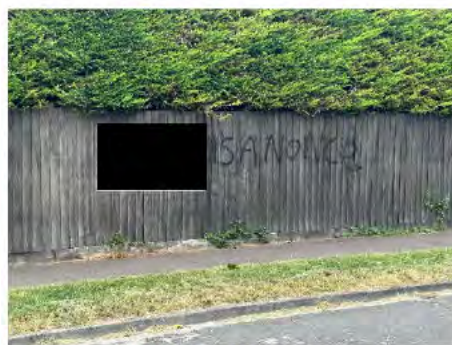
Orchard Way (private fence?)
///wardrobe.tadpole.pigs

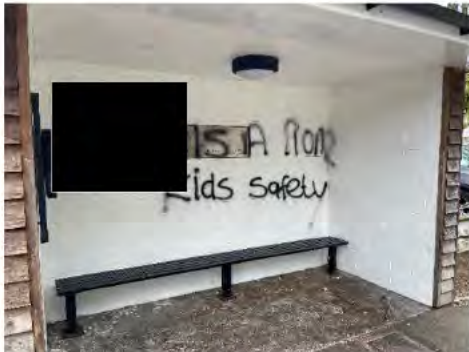
High Street Bus Stop
///chins.tripods.oasis

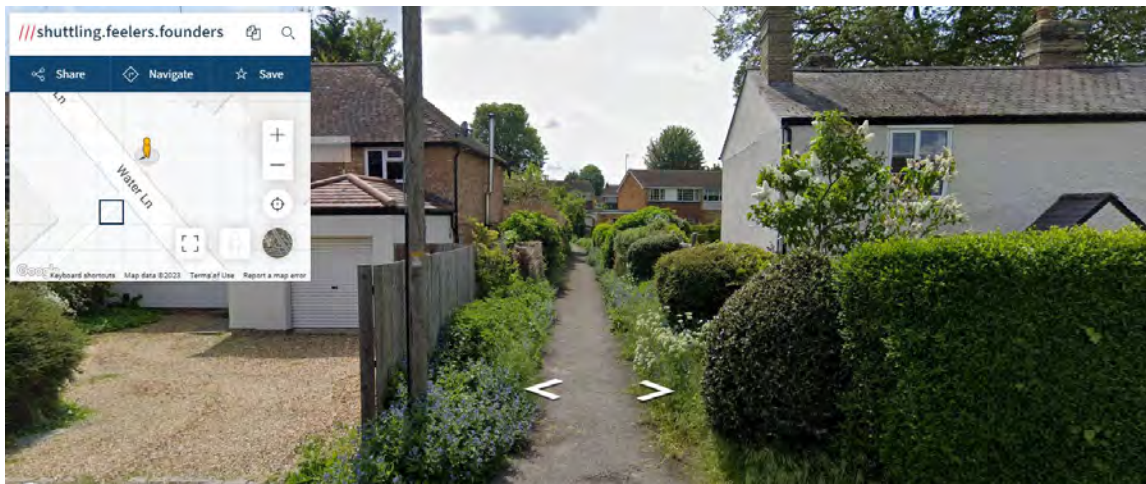
The passage way is rather overgrown and runs from Greenbanks to Water Lane – it requires cutting back, tidy and clearance.

The lane runs from [///shuttling.feelers.founders](#) to [///kitchen.curving.smuggled](#) and looks a little like this (but rather more overgrown...)

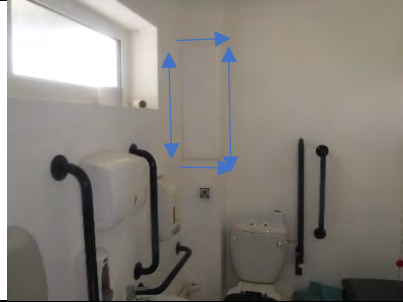
CENTRALISED TMV FITTED BEHIND PANEL IN DISABLED W/C

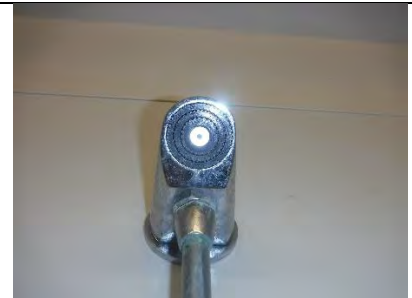
CLEAN SHOWER OUTLET

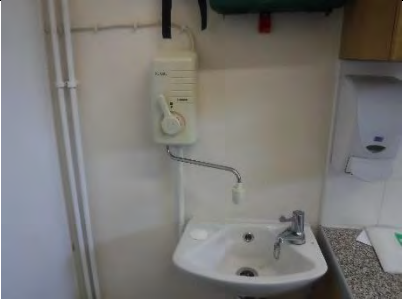
POU fitted over basin		
Additional Information			
LEGIONELLA RISK LEVEL	A

RECOMMENDATIONS	No.	Priority	Date Comp
SEE SECTION 9 FOR CORRESPONDING DETAIL	RWH 81 - Establish a monitoring regime where the hot water heater/s temperatures are logged on a minimum of a monthly basis.	P1	On going
	RWH 83 - Ensure appropriate operational and hygiene regime.	P1	On going
	RWH 84 - Ensure that all outlets and particularly showers are operated under a controlled and approved method on a minimum basis of weekly with record available in the site log book.	P1	On going
RISK EVALUATION WITH ADDITIONAL CONTROL COMPLETE	A
