# Safety Inspection Report

Annual Inspection

## Clear Crescent Play Area

Melbourn Parish Council

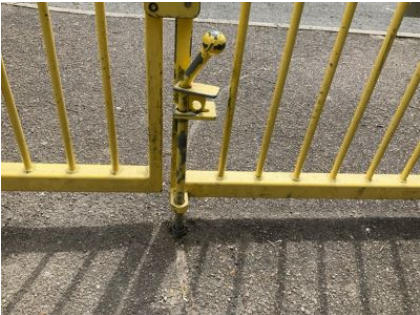
The maintenance gate is not locked and could be opened by the public. Clean out the drop bolt socket and lock the gate.

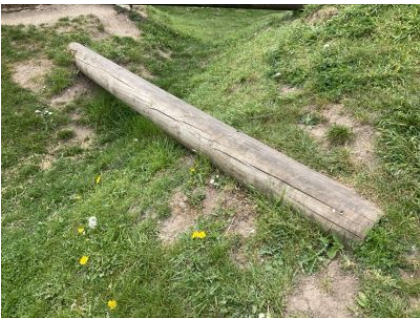
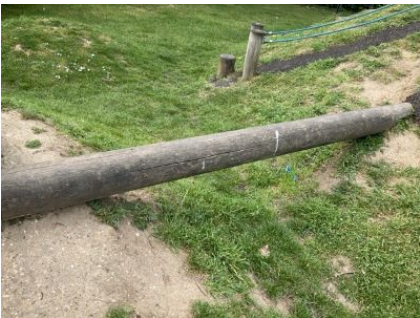
Timber is decayed.

Log adjacent to the rope balance has started to decay.

Replace affected parts.

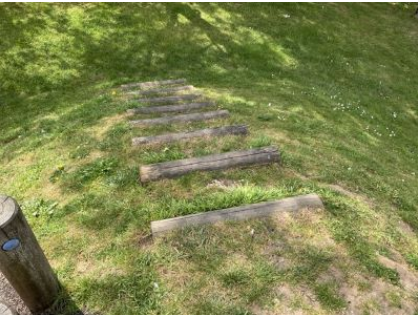
1. Ground erosion present.
2. Loose in ground.

Loose in ground.

Logs have slight movement and could cause trips and falls. Secure.

Repair the worn areas.

Repair.

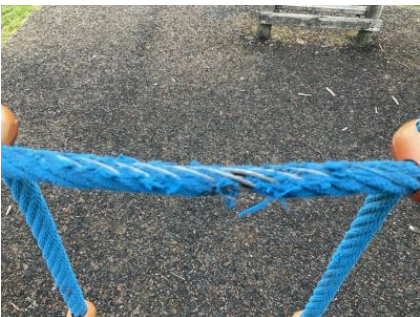
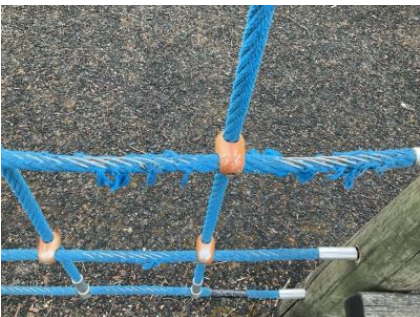
Fixtures loose or missing.

Loose and projecting rope screws. Secure.

Read the notes for further action., Tighten/replace.

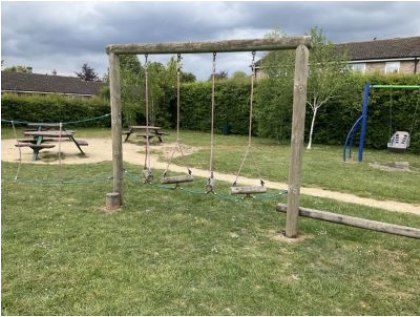
This equipment relies on one post for its stability. Special attention should be paid to maintenance (e.g. by monitoring degradation) and if necessary decommissioning the item before the end of its operating life. This is a requirement of the British Standard.

Log walk single post provides excess movement. Reset if necessary.

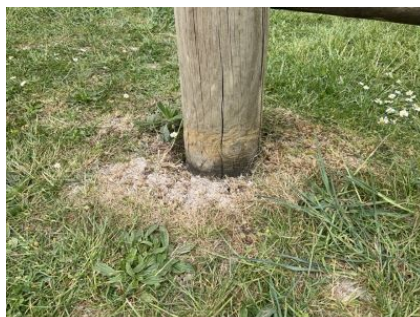
Strimmer damage is present on posts, allowing water to enter and timbers to soften. It can also remove the protective envelope around the timber. Prevent further damage and check timbers for decay throughout the year.

Monitor all timber items for decay throughout the year due to softening. Replace affected parts if found/necessary.

Prevent further damage., Read the notes for further action.

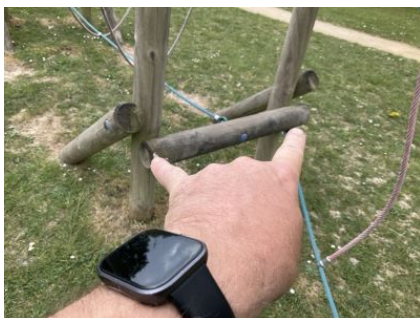
The rope is rubbing on the balance beam and wearing down to the wire. Monitor for broken wires and replace if found.

Read the notes for further action., Replace.

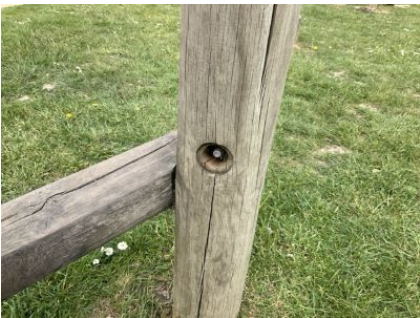
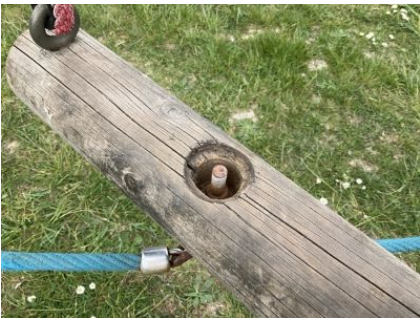
Bolt(s) loose.

Bridge cross beam loose.

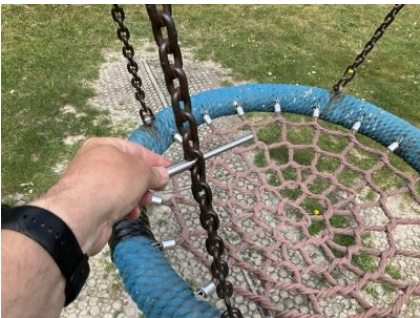
1. Surface needs repair.
2. Swing shackles, bushes and associated connections need servicing.
3. Swing seat rubber is deteriorating / degrading.
4. Moving parts require greasing.

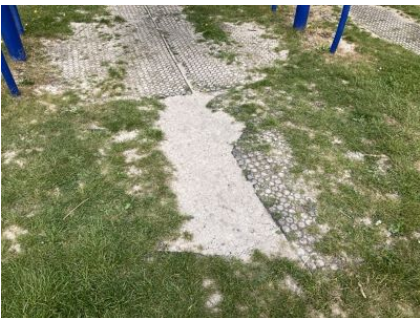
Surface needs repair.

Grass mats missing and loose.

Replace.

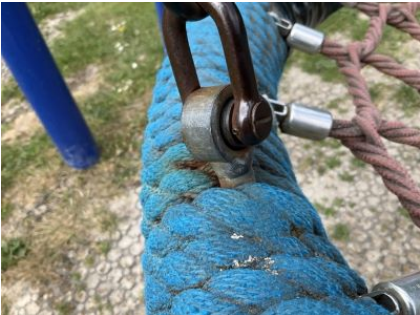
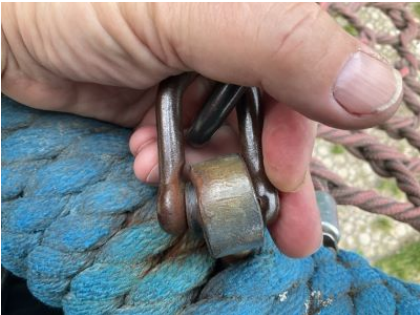
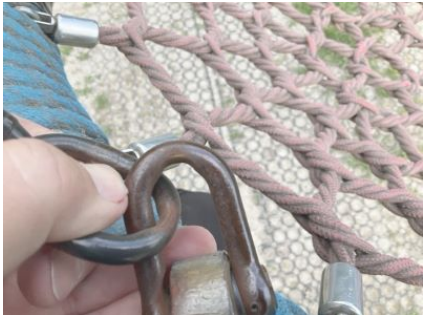
Basket seat shackles and seat bushes are worn.

Replace.

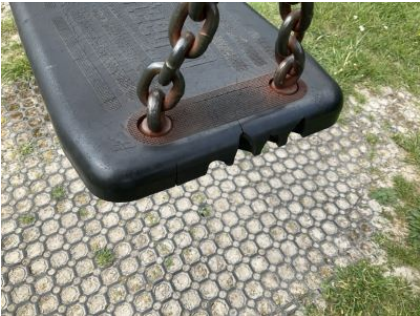
Swing seat rubber is deteriorating / degrading.

Replace one junior seat due to exposed metal frame.

Monitor and replace when hard material is exposed., Replace when metal is exposed.

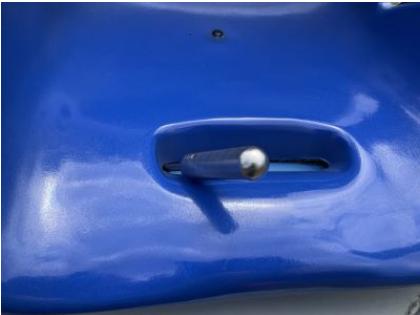
1. Surface needs repair.

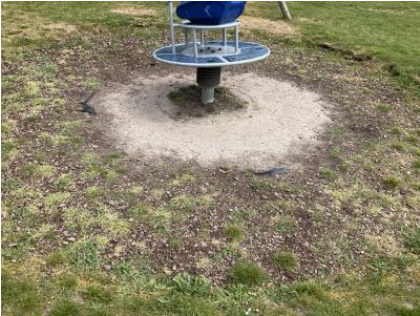
Surface needs repair.

The surfacing has worn away exposing and damaging the liner beneath. Grass and weeds have grown inside. The plastic edging strips are sharp. The whole area requires immediate repairs and alterations. Bark requires topping up.

Repair.

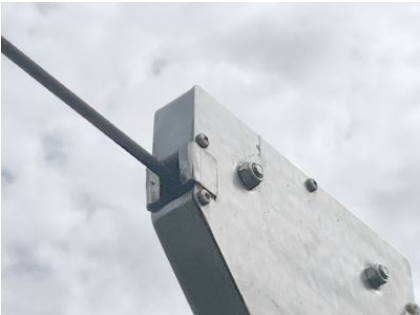
Item has some parts missing.

Traveller's plastic guard is missing.

Replace the missing parts.

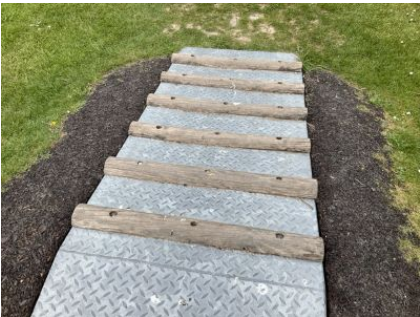
Bolt(s) loose.

Ramp footholds loose.

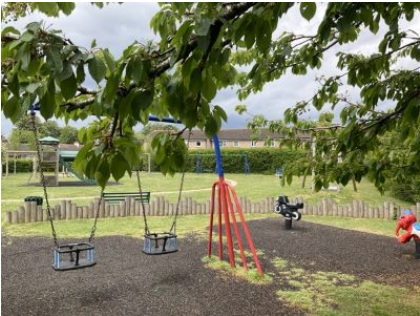
Wicksteed recommend that during routine inspections the area on the swing where the side frames meet the vertical support be checked for any cracks. In the event of cracks being found then remove the seats and contact Wicksteed for further advice.

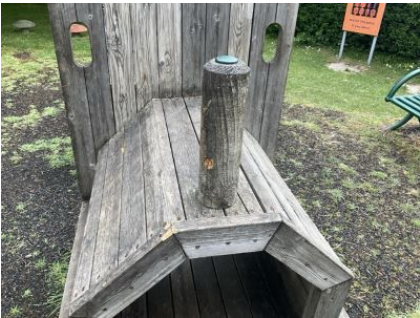
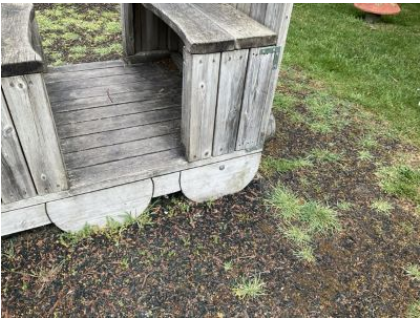
Fixtures loose or missing.

Tighten/replace.

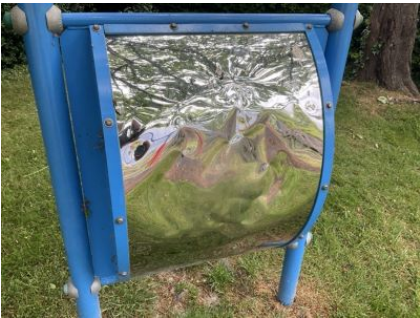
Mirror bent. Monitor for splits/cracks, replace if found.
